Pavement Condition Report

Lafayette-Purdue University Airport

Project 13801869

January 2013

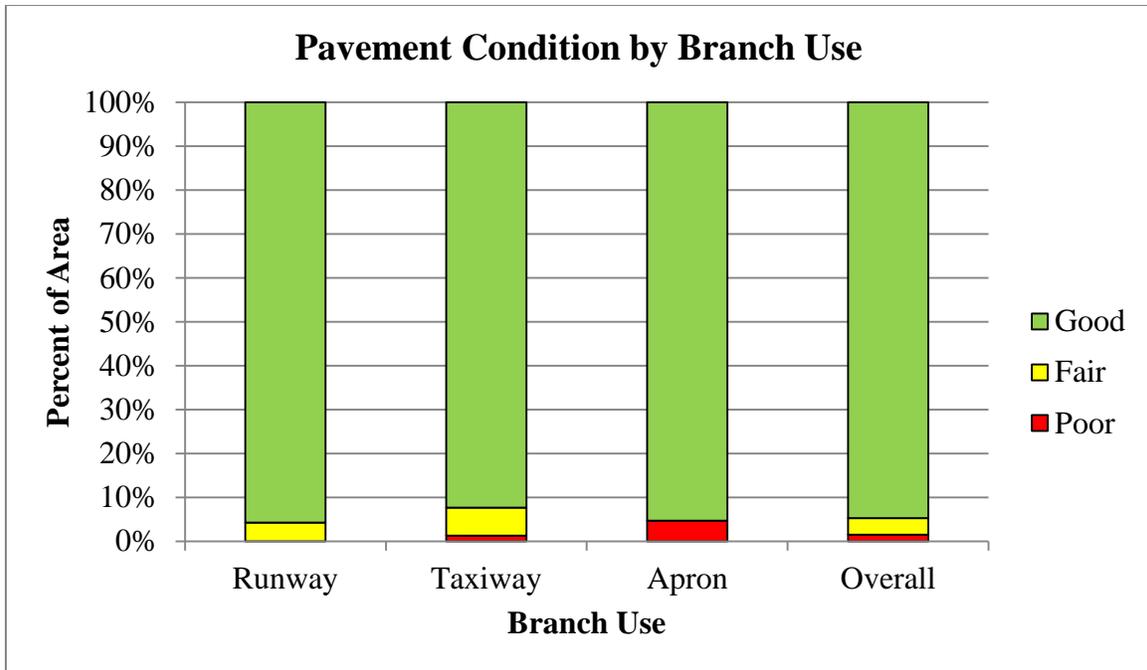
Figure 2-2. Pavement Condition by Branch Use

The overall Pavement Condition Index (PCI) for the airfield pavements was 81. Runways had an average inspected PCI of 79 and were above the desired MSL of 65. Taxiways had an average inspected PCI of 78, and ramps had an average inspected PCI of 88.

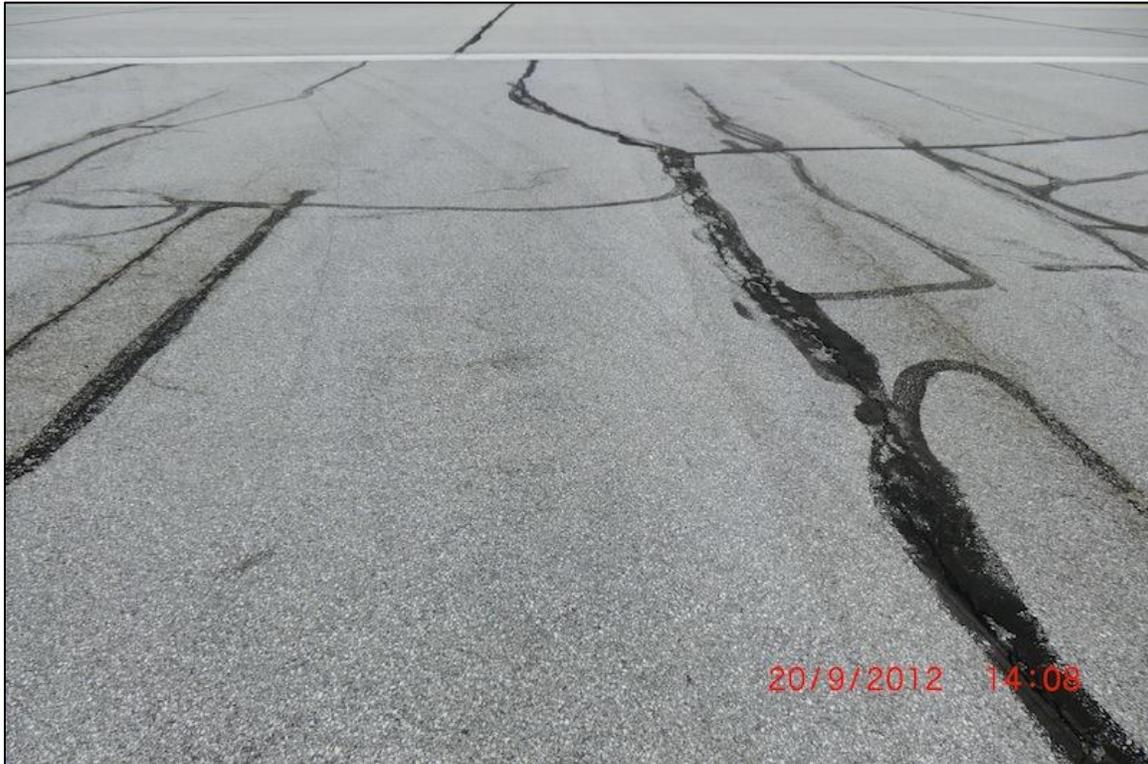
Figure 2-7. Typical Poor AAC Pavement (Feature 140)

Two pavement sections had simplified PCI ratings of Poor, indicating that major M&R may be needed. The pavement within each of the PCI condition categories is shown in Figure 2-1. The inspected PCI is summarized by branch use in Figure 2-2, and the photographs that follow provide examples of the condition categories.

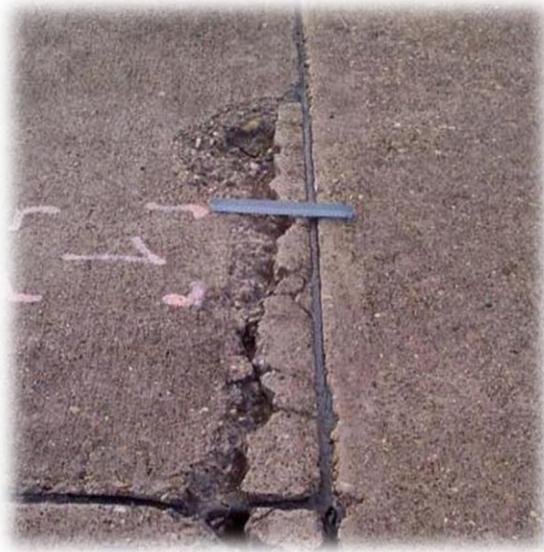
Joint Spall and Corner Spall

Spalls at slab joints and corners are caused by excessive internal stress in the pavement. Spalls occur when these stresses exceed the shear strength of the concrete.

Spalling usually results from thermal expansion during hot weather when slabs push and expand against one another. If the joints are filled with incompressible material, such as sand, stresses can become severe, causing spalls. Spalling can be reduced significantly by maintenance of joint sealant.

Spall repair requires patching. The extent and severity of spalling suggests the appropriate action. At low severity, spalled concrete remains securely in place in the slab. A low-severity spall should be monitored closely for further deterioration and should be patched when spalled particles become loose, or during the next scheduled patching activity. Medium- and high-severity spalls should be repaired immediately to prevent FOD. If the pavement can be restored to serviceable condition, spalls should be patched for long-term service. If the pavement is beyond repair, temporary patching should be considered to control FOD.

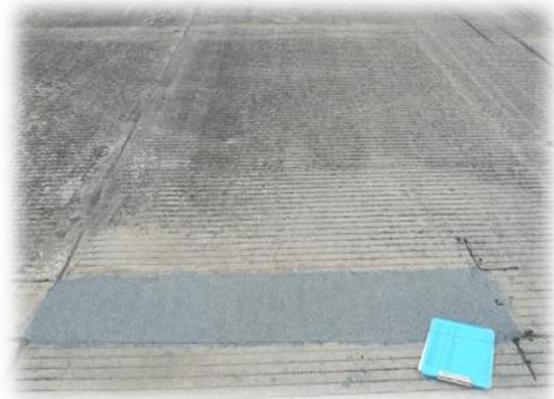
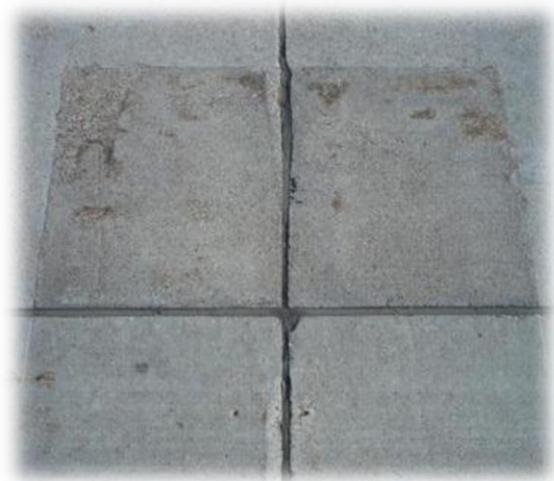
Patches, Large and Small

Large and small patches, by PCI inspection criteria, are distress conditions. Patches indicate deterioration and aging of pavement that contributes to shortened service life. However, patching also indicates that pavement is being maintained.

A patch that is performing well and shows no outward distress is recorded at low severity, and no corrective action is required. Medium-severity patches are serviceable but are beginning to deteriorate. Maintenance or replacement is indicated. At high severity, replacement is indicated.

By definition, small patches are smaller than 5 square feet in surface area, and they usually result from spall repair at slab joints and corners.

Large patches also may be the result of spall repair, but they often indicate more serious deficiencies, such as corner breaks or other full-depth failure smaller than panel size.

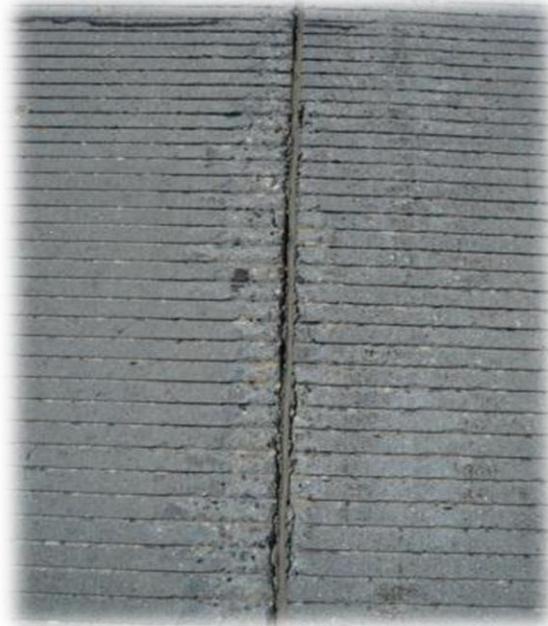
Joint Seal Damage

When joint sealant is in perfect condition (no damage), there is no distress.

At low severity, at least 10 percent of the sealant is debonded but still in contact with the joint edges. Medium-severity joint seal damage is recorded when at least 10 percent of the sealant has visible gaps smaller than 1/8 inch and is an indicator that replacement should be programmed as soon as is practical. In the meantime, aggressive inspection and sustaining maintenance is recommended to minimize subsurface damage from moisture penetration. At high severity, visible gaps exceed 1/8 inch, and the amount and degree of joint seal damage typically requires complete removal and replacement of the existing sealant.

On serviceable pavement, deteriorated joint sealant should be repaired or replaced to preserve pavement and subgrade integrity and prolong service life. The issue is not so clear-cut with unserviceable pavement. Pavement that can be restored to serviceable condition by maintenance activities such as patching and joint seal repair, or by slab replacement, should be so maintained as long as the process is cost-effective. However, when age and condition preclude economical return to serviceable condition by such means, joint seal repair would no longer be cost-effective and should be suspended except for an interim maintenance program to control FOD potential.

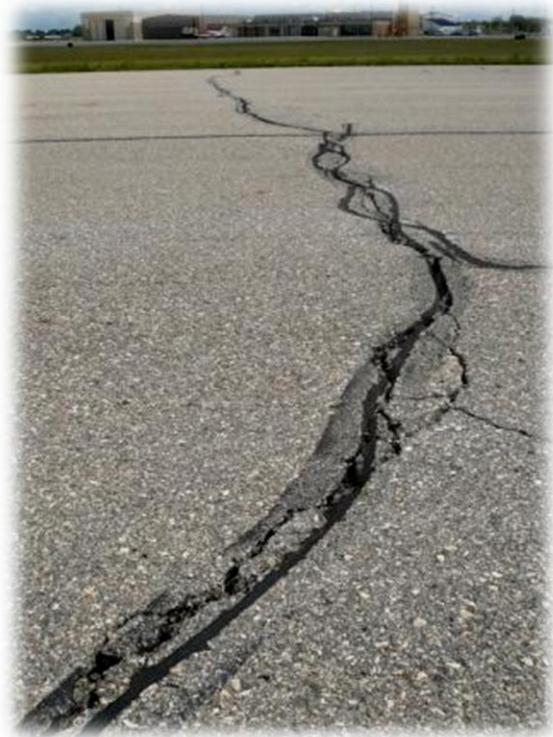
Longitudinal & Trans. Cracking

L&T cracks are caused by age, construction, and subsurface conditions. Age-related cracking occurs as oxidizing pavement loses components to the atmosphere and becomes more brittle. Consistent application of seal coats can help to prevent age-related cracks.

Construction-related cracking often develops along paving joints. Ensuring that joints are made when both sides are still hot, and near the same temperature, is one of the best ways to mitigate this potential problem.

Seasonal movement caused by changes in subsurface moisture or temperature differences also can cause pavement cracking. Asphalt pavement placed over a PCC pavement or cement stabilized base course may evidence reflective cracking from the underlying material. Wheel loads do not cause L&T cracks, although traffic may worsen their condition.

Low-severity L&T cracks are less than ¼ inch wide, or if sealed with suitable filler material in satisfactory condition can be any width less than 3 inches, if they are not spalled. Maintenance usually is not indicated for low-severity cracking. Moderately spalled cracks and cracks wider than ¼ inch which are not satisfactorily sealed are at medium severity. Medium-severity cracks should be sealed with a high-quality crack filling material. Severely spalled cracks and cracks wider than 3 inches are at high severity. High-severity L&T cracks normally require patching.
