# Pavement Condition Report

## Ft Wayne-Smith Field Airport

Project 1480370

**January 2014**

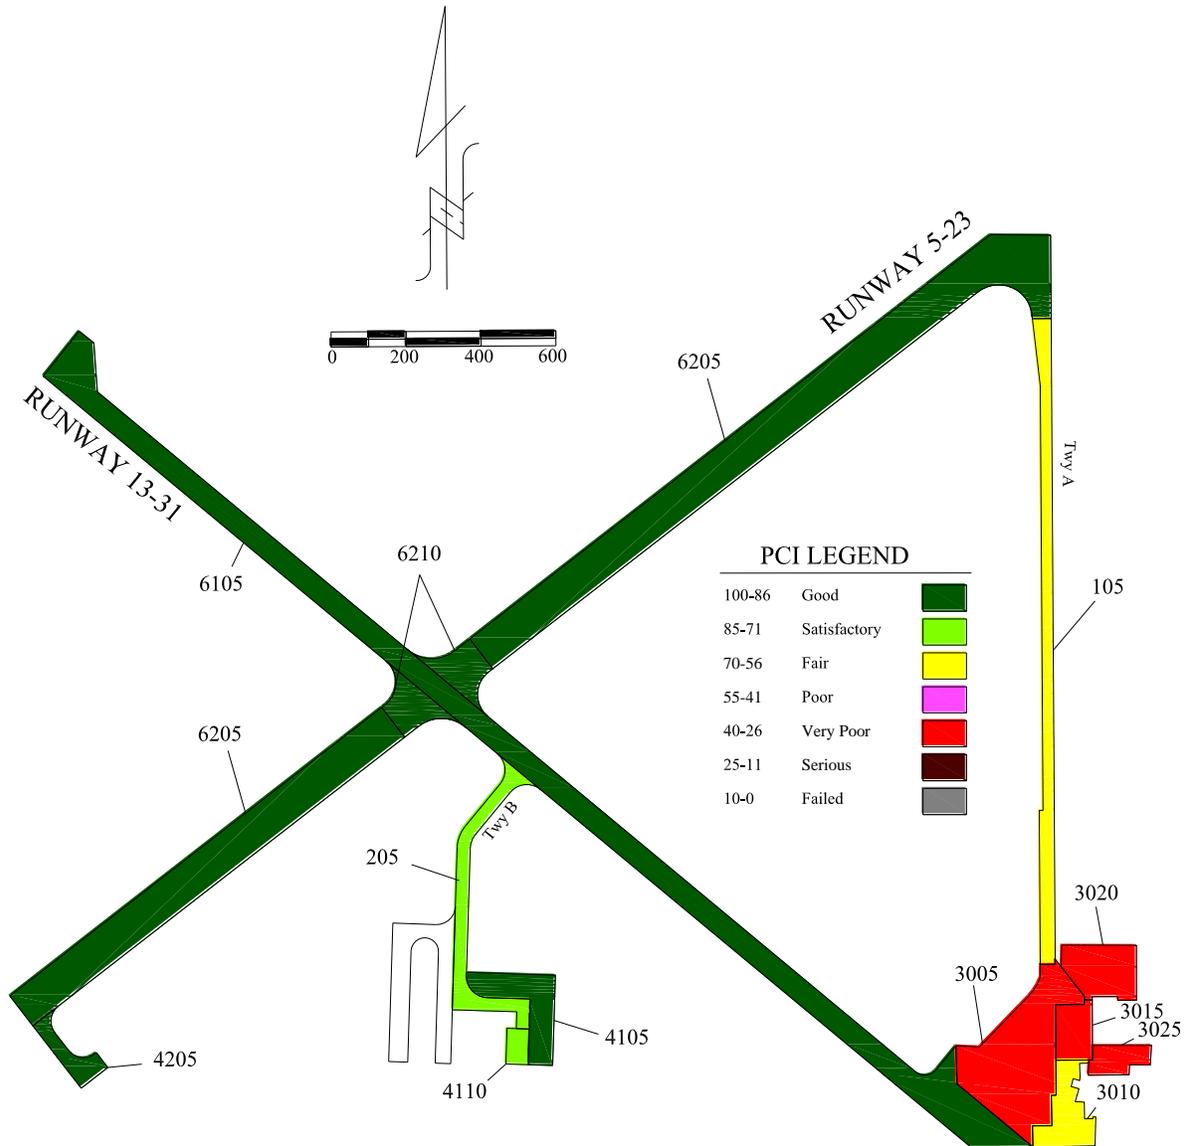
Figure 2-1. Inspected Pavement Condition

The overall Pavement Condition Index (PCI) for the airfield pavements was 80. Runways had an average inspected PCI of 93 and were above the desired MSL of 55. Taxiways had an average inspected PCI of 68, and ramps had an average inspected PCI of 49.

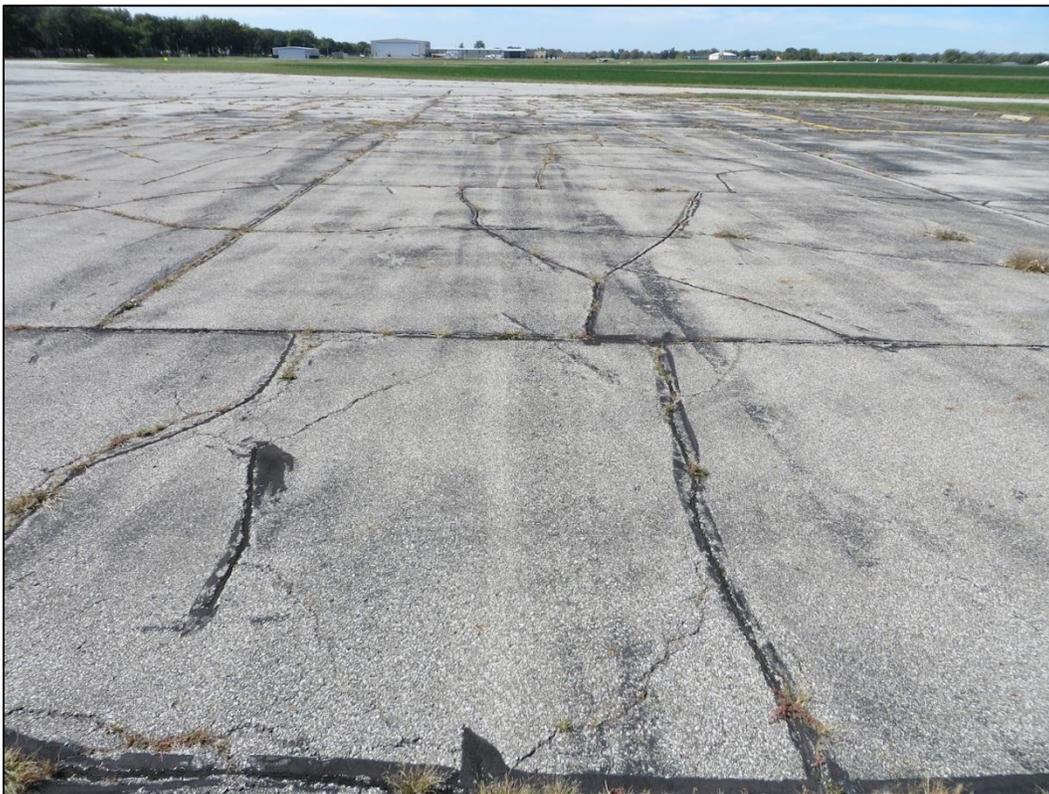
Figure 2-5. Poor AC Pavement (Feature 3020)

The 3000 series ramp consisted of 1 section of AAC pavement and 4 sections of APC pavement. The branch had a total area of 150,764 ft<sup>2</sup> with an area-weighted average PCI of 35 (Poor). Recorded distresses included: alligator cracking, block cracking, joint reflective cracking, L&T cracking, depression, patches, rutting, ravelling, weathering, and swell.

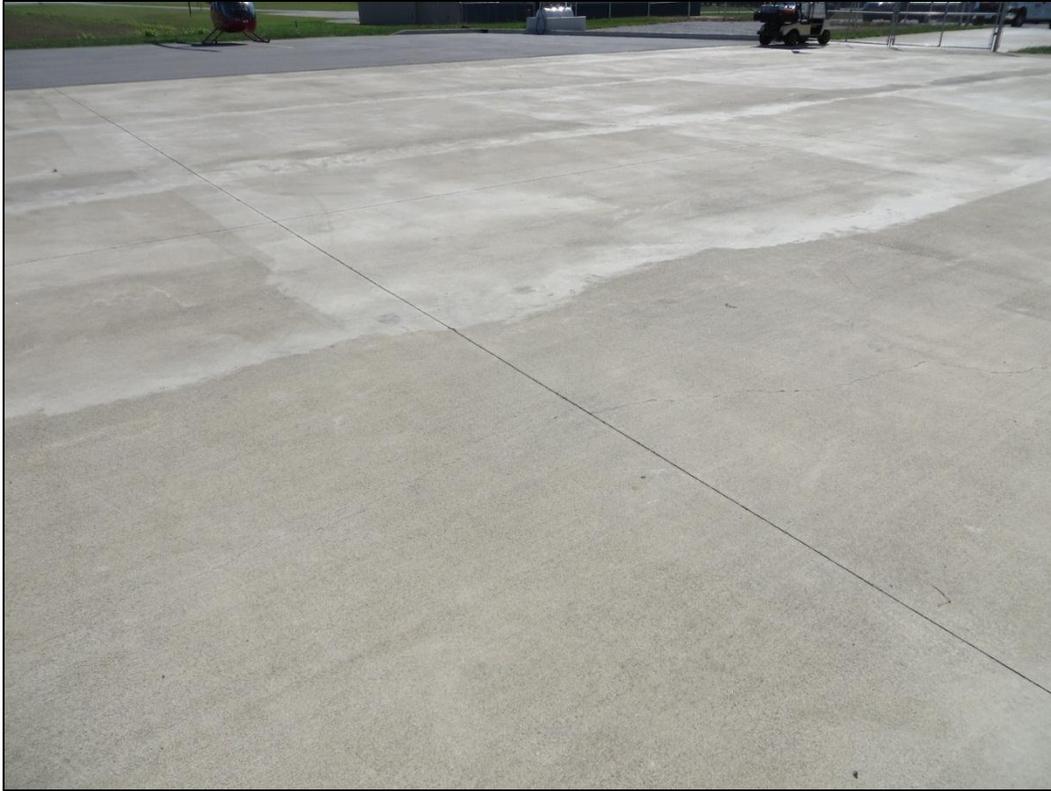
Figure 2-6. Good PCC Pavement (Feature 4110)

The 4100 ramp consists of 1 section of AC and 1 section of PCC pavement. The branch had a total area of 31,802 ft<sup>2</sup> with an area-weighted average PCI of 95 (Good). In in the AC pavement, the only recorded distress was L&T cracking. In the PCC pavement, recorded distresses included: corner breaks, shrinkage cracks, and LTD cracks.
