Pavement Condition Report

Sullivan County Airport

Project 13801869

January 2013

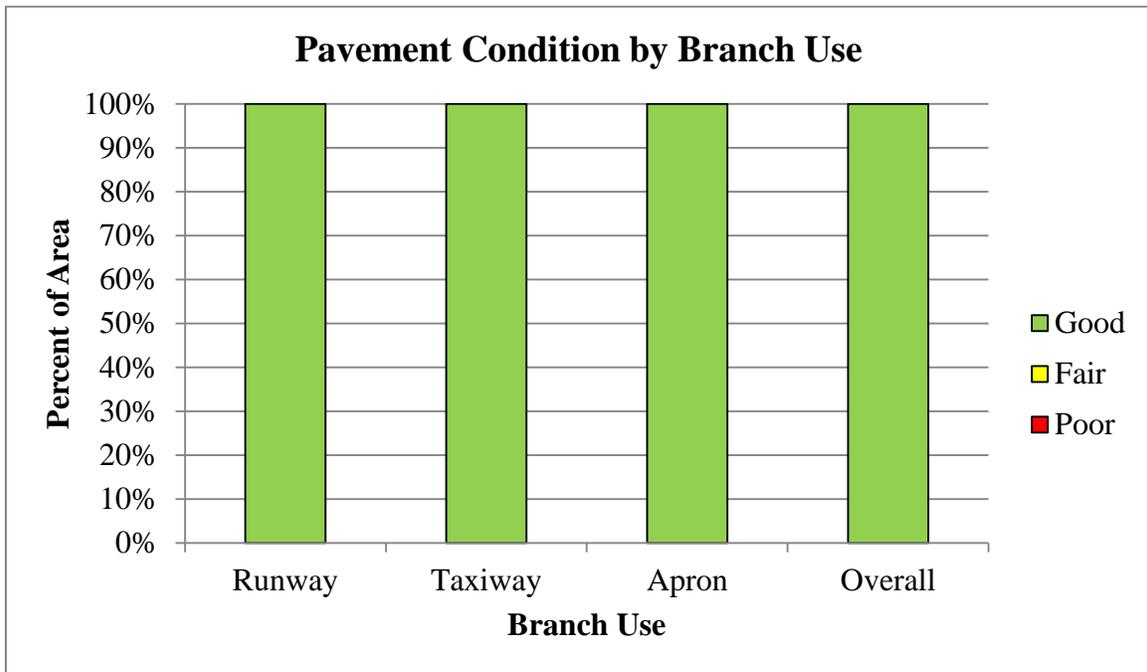
All inspected airside pavement had a simplified PCI rating of good. The pavement within each of the PCI condition categories is shown in Figure 2-1. The inspected PCI is summarized by branch use in Figure 2-2, and the photographs that follow provide examples of the condition categories.

Figure 2-2. Pavement Condition by Branch Use

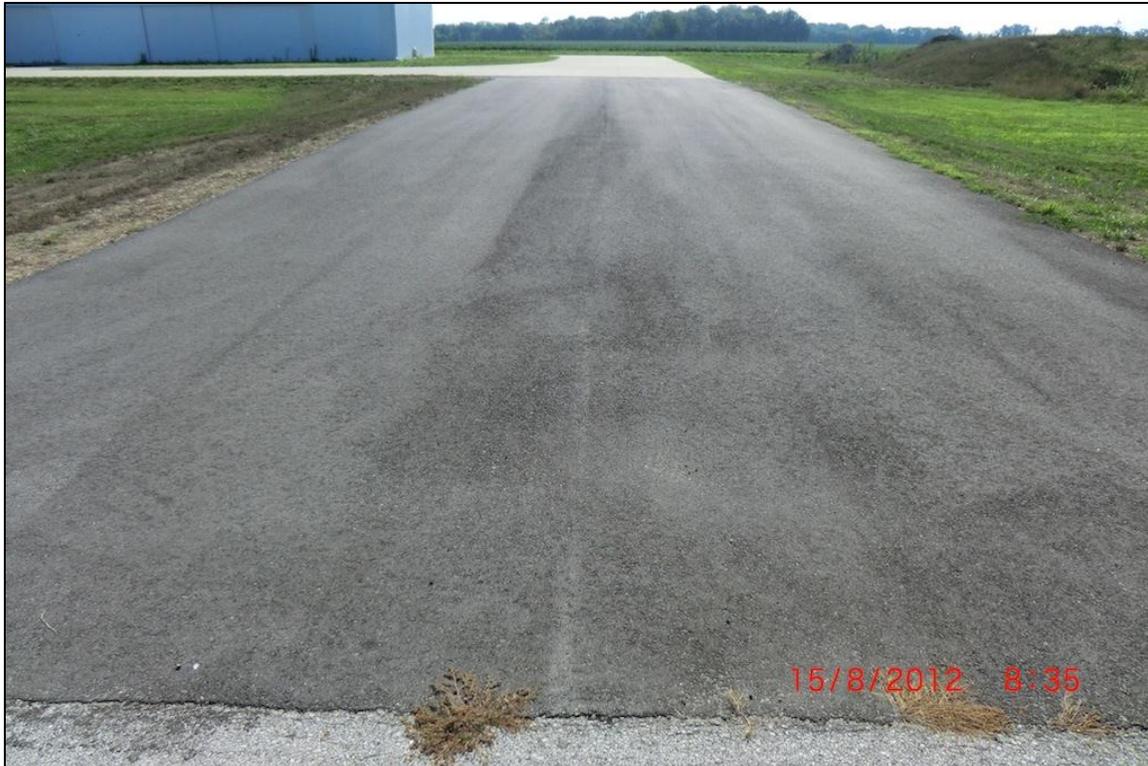
Figure 2-4. Typical Good AC Pavement (Feature 505)

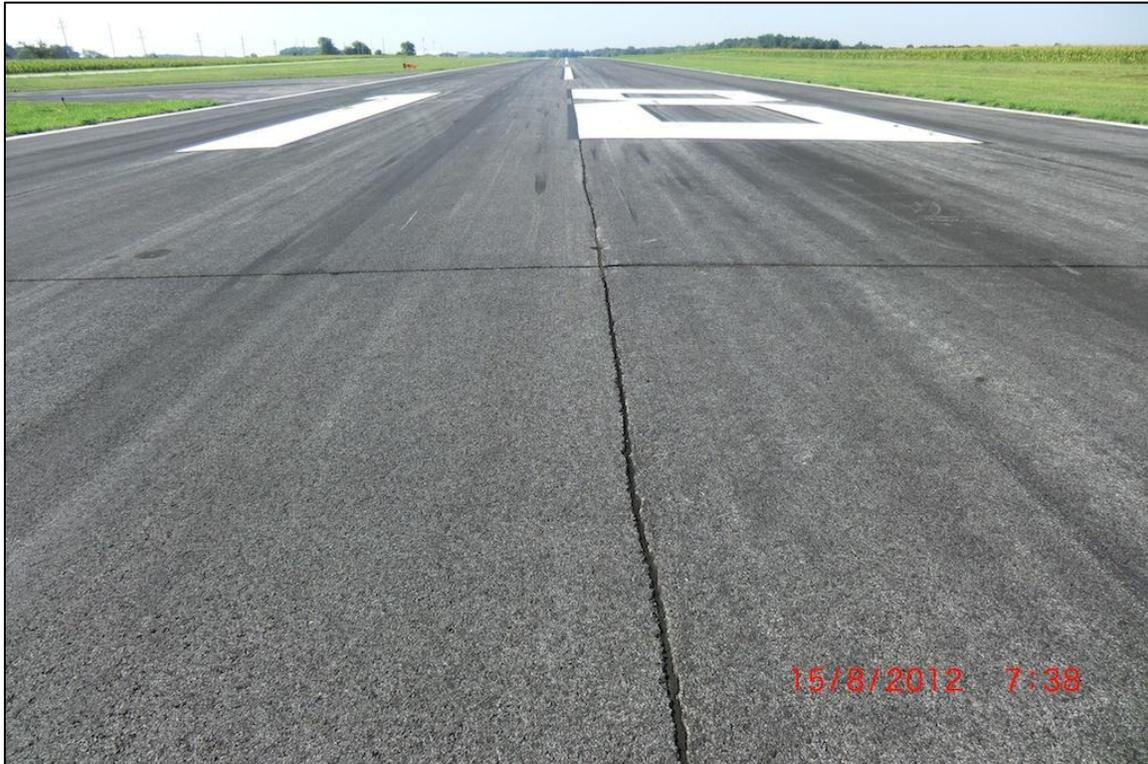
Figure 2-5. Typical Satisfactory AC Pavement (Feature 5001)

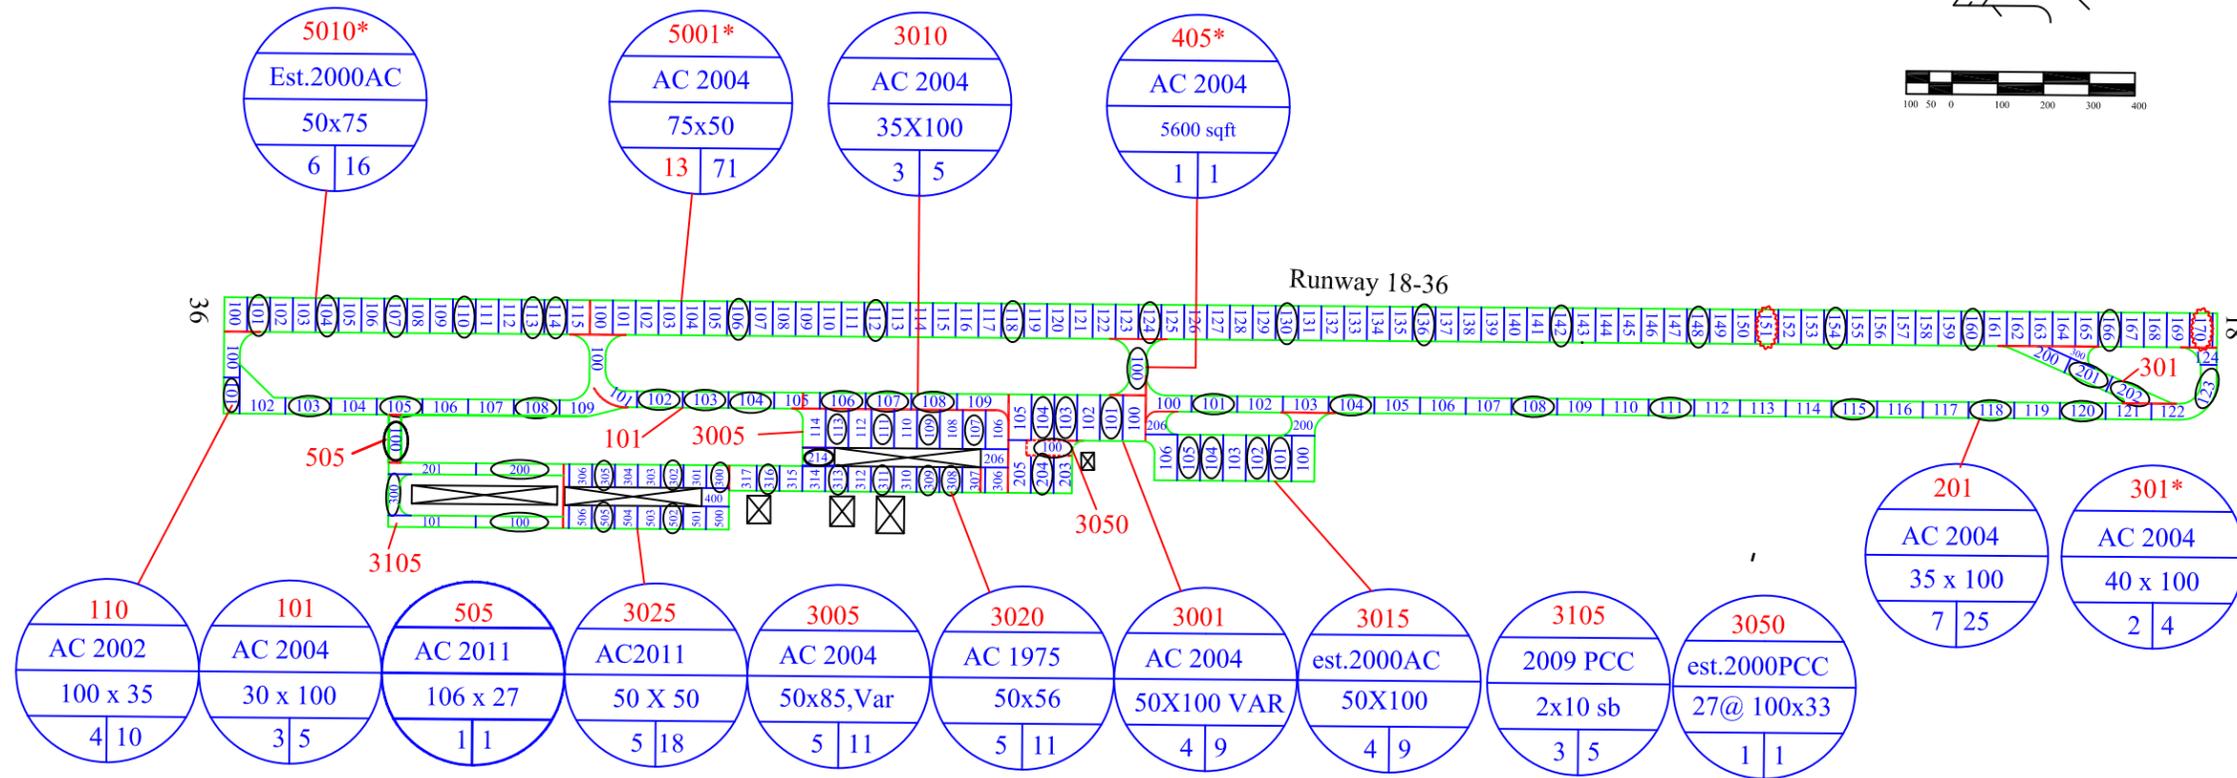
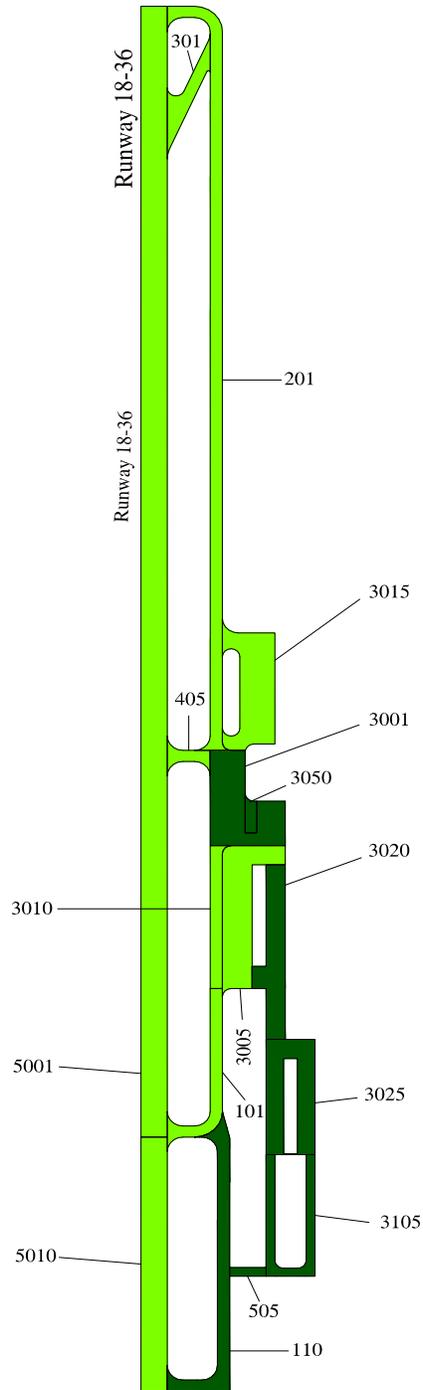
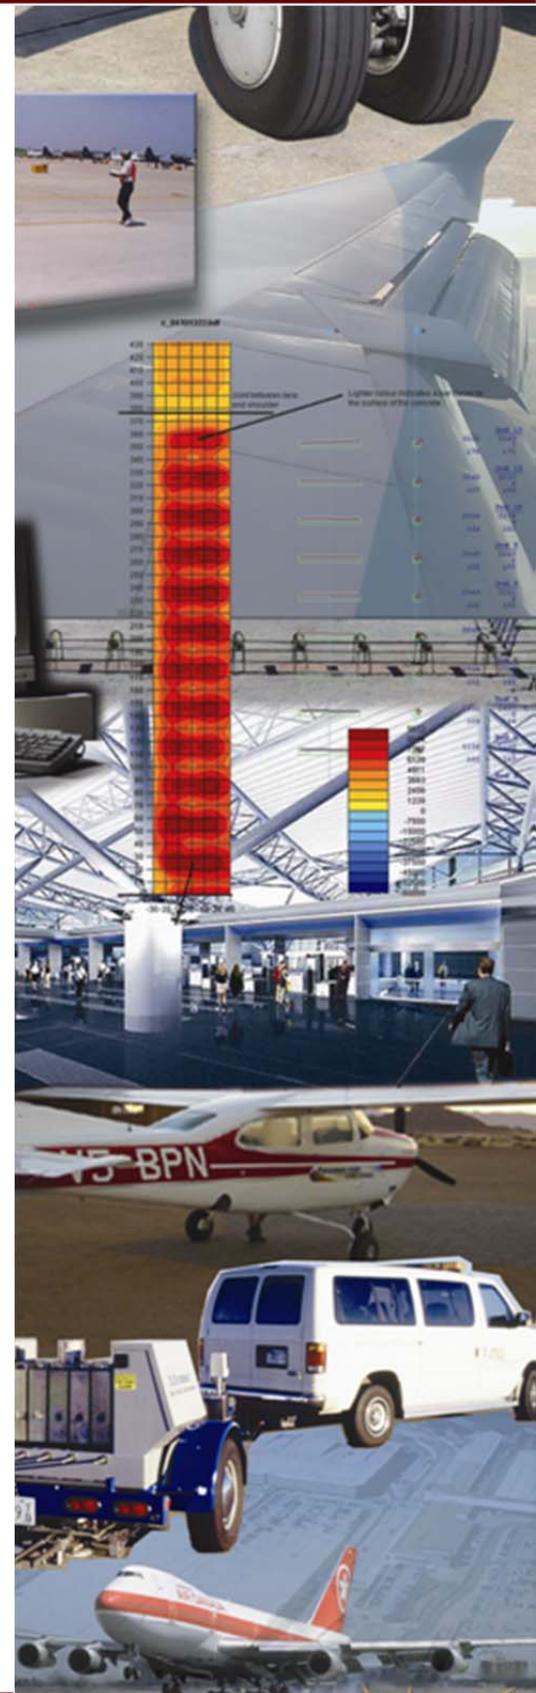
Sullivan County Airport 2012 PCI Inspection

* = 2010 Surface Treatment (coal tar / rejuvenator)
