Pavement Condition Report

Tell City-Perry County Municipal Airport

Project 15805741

February 2015

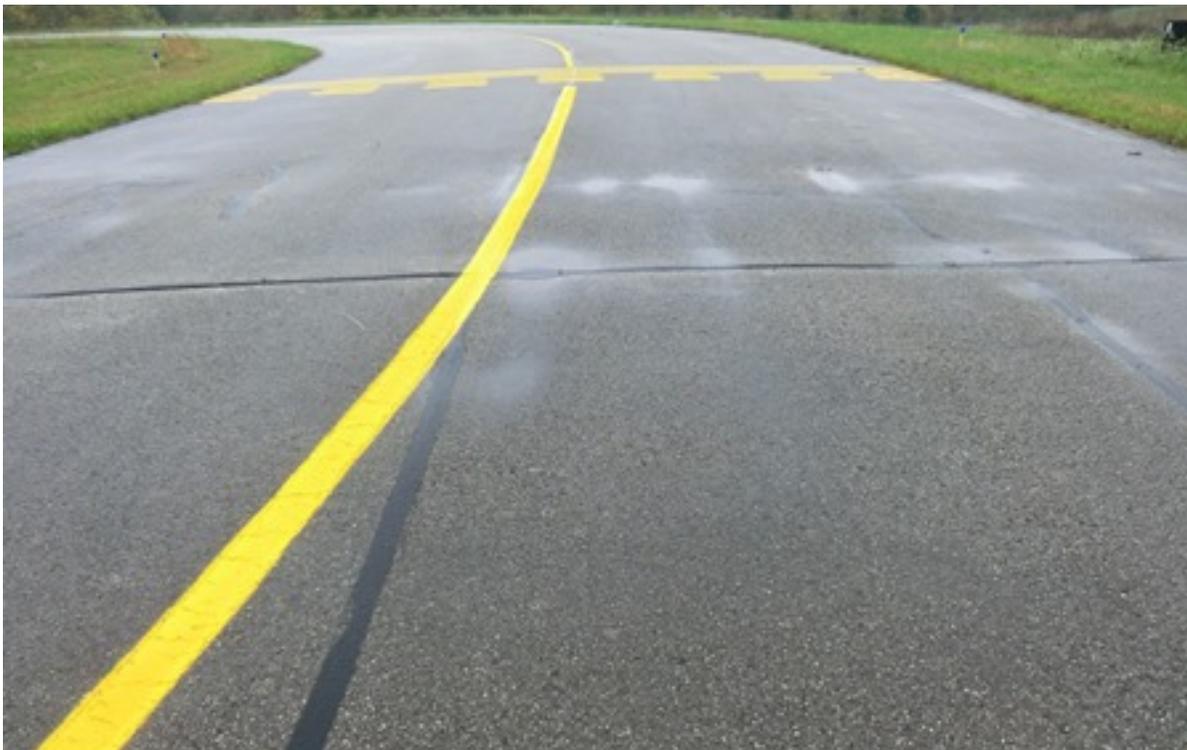
DISTRESS TYPE	SEVERITY	MEASURED QUANTITY	ESTIMATED TOTAL QUANTITY	UNITS	PERCENTAGE OF All DISTRESS
ALLIGATOR CRACKING	LOW	60	136	S.F.	50.2
DEPRESSION	LOW	35	79	S.F.	7.4
LONG.& TRANS. CRACK	LOW	348	789	L.F.	34.6
SWELL	LOW	70	158	S.F.	7.5

APPROXIMATE AMOUNT OF DISTRESS RELATED TO LOAD ON THE PAVEMENT IS:	50 %
APPROXIMATE AMOUNT OF DISTRESS RELATED TO MATERIALS PROBLEMS IN THE FEATURE IS:	38 %
APPROXIMATE AMOUNT OF DISTRESS RELATED TO AGE OF PAVEMENT AND TRAFFIC REPETITIONS IS:	12 %

LEGEND	DESCRIPTION	COST	LIFE EXTENSION
▲	STRUCTURAL OVERLAY	\$33,577	23 YEARS
●	NO ACTION	N/A	N/A
-	MINIMUM SERVICE LEVEL, CURRENTLY 55

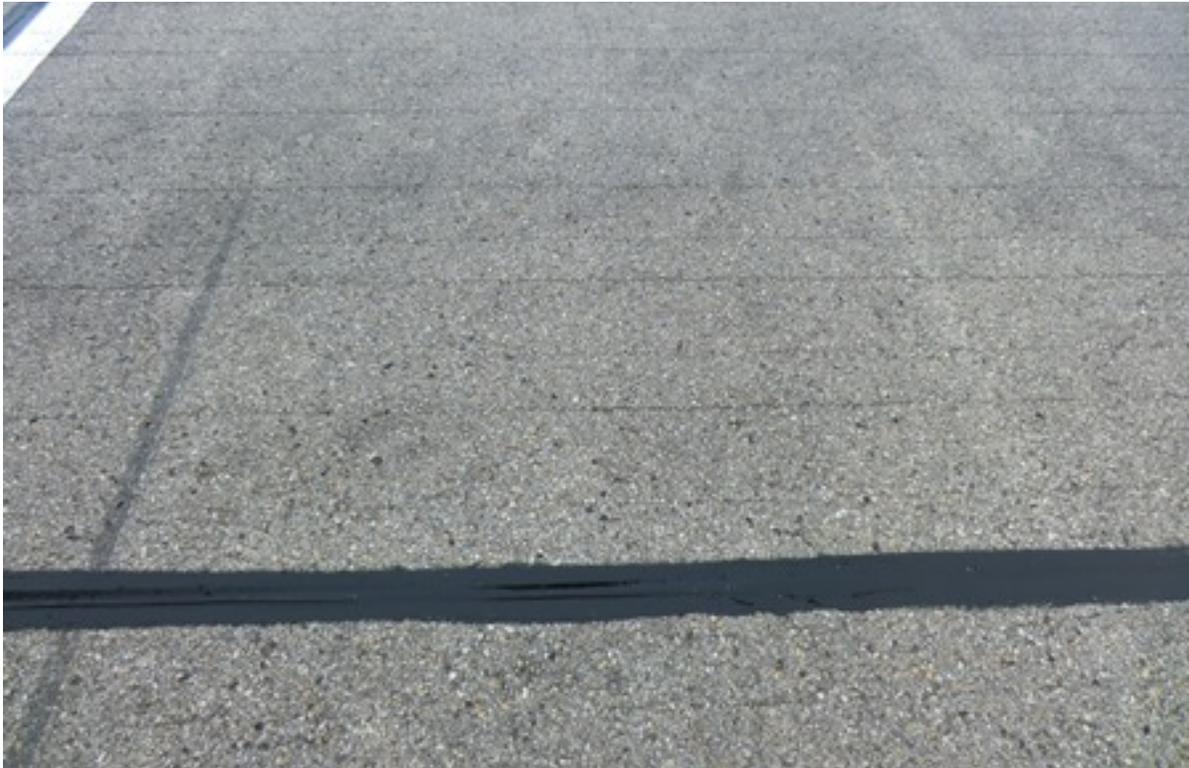
DISTRESS TYPE	SEVERITY	MEASURED QUANTITY	ESTIMATED TOTAL QUANTITY	UNITS	PERCENTAGE OF All DISTRESS
LONG.& TRANS. CRACK	MED	7	24	L.F.	2.9
LONG.& TRANS. CRACK	LOW	1,322	4,532	L.F.	58.8
RAVELING	LOW	2,200	7,542	S.F.	38.1

APPROXIMATE AMOUNT OF DISTRESS RELATED TO LOAD ON THE PAVEMENT IS:	0 %
APPROXIMATE AMOUNT OF DISTRESS RELATED TO MATERIALS PROBLEMS IN THE FEATURE IS:	54 %
APPROXIMATE AMOUNT OF DISTRESS RELATED TO AGE OF PAVEMENT AND TRAFFIC REPETITIONS IS:	46 %

LEGEND	DESCRIPTION	COST	LIFE EXTENSION
●	NO ACTION	N/A	N/A
-	MINIMUM SERVICE LEVEL, CURRENTLY 60

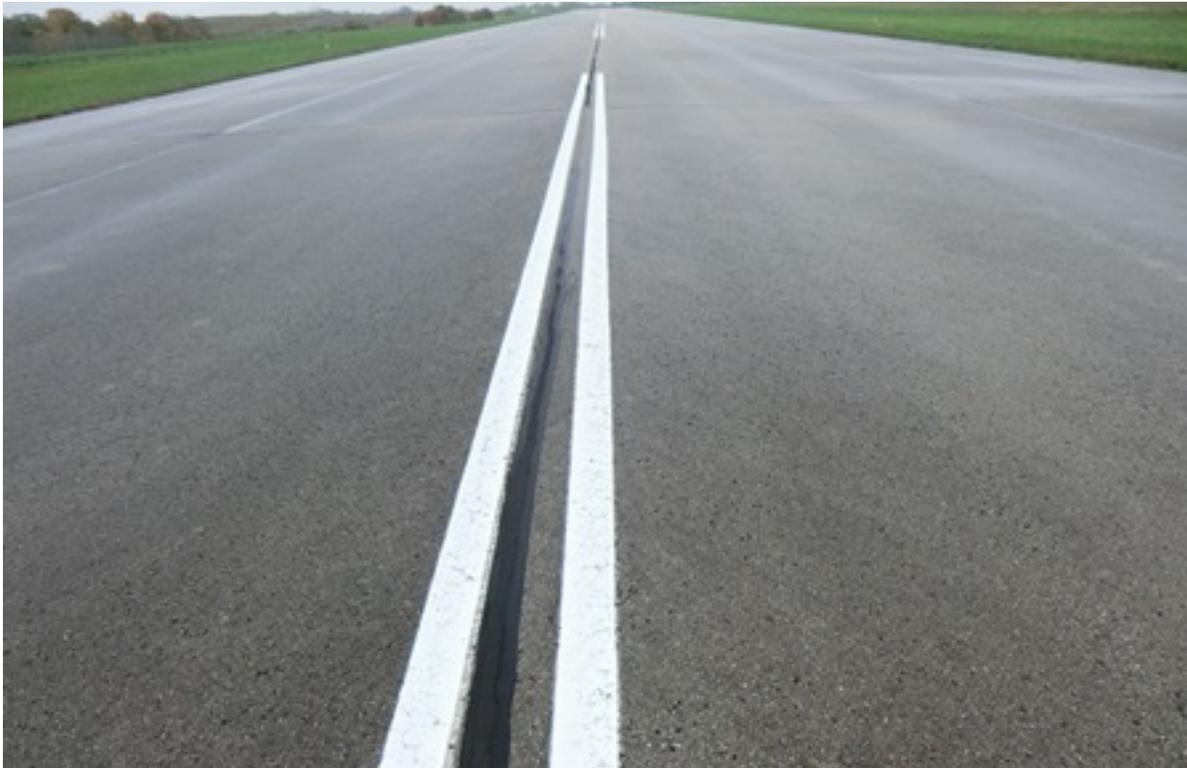
DISTRESS TYPE	SEVERITY	MEASURED QUANTITY	ESTIMATED TOTAL QUANTITY	UNITS	PERCENTAGE OF All DISTRESS
LONG.& TRANS. CRACK	MED	186	991	L.F.	20.7
LONG.& TRANS. CRACK	LOW	2,208	11,770	L.F.	47.9
RAVELING	LOW	3,600	19,191	S.F.	31.2

APPROXIMATE AMOUNT OF DISTRESS RELATED TO LOAD ON THE PAVEMENT IS:	0 %
APPROXIMATE AMOUNT OF DISTRESS RELATED TO MATERIALS PROBLEMS IN THE FEATURE IS:	56 %
APPROXIMATE AMOUNT OF DISTRESS RELATED TO AGE OF PAVEMENT AND TRAFFIC REPETITIONS IS:	44 %

LEGEND	DESCRIPTION	COST	LIFE EXTENSION
●	NO ACTION	N/A	N/A
-	MINIMUM SERVICE LEVEL, CURRENTLY 60
