Pavement Condition Report

Connersville-Mettel Field Airport

Project 16801839

January 2016

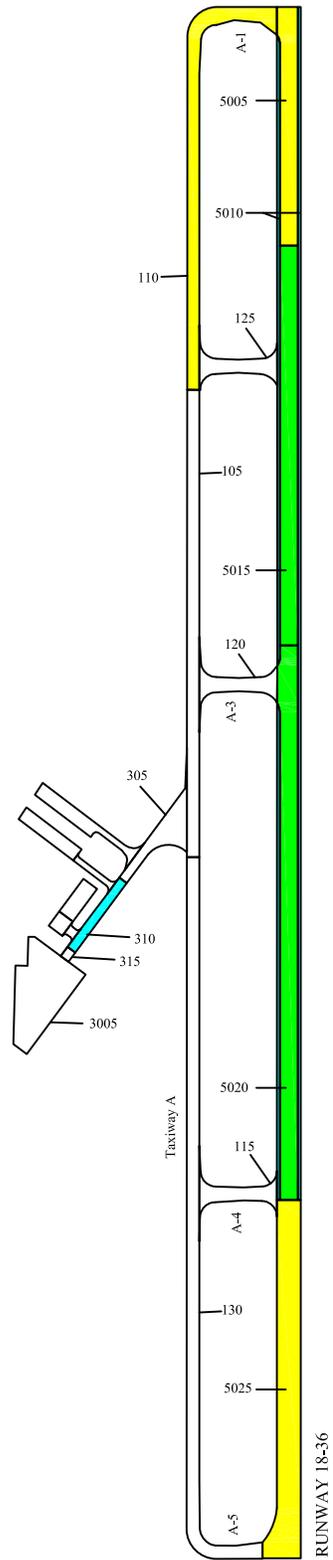
CONNERSVILLE MUNICIPAL AIRPORT 2015 PCI Inspection

Specific recommendations to help prioritize airfield maintenance are found in chapter 4 of this report. A summary of all identified maintenance needs is shown in the table below and in the figure on the following page.

Work Item	Quantity	Unit	Cost
AC PATCH	195	SF	\$1,691
AC RESTORATIVE CRACK REPAIR	6,287	LF	\$7,795
AC SUSTAINING CRACK REPAIR	6,531	LF	\$5,650
Total:			\$15,136

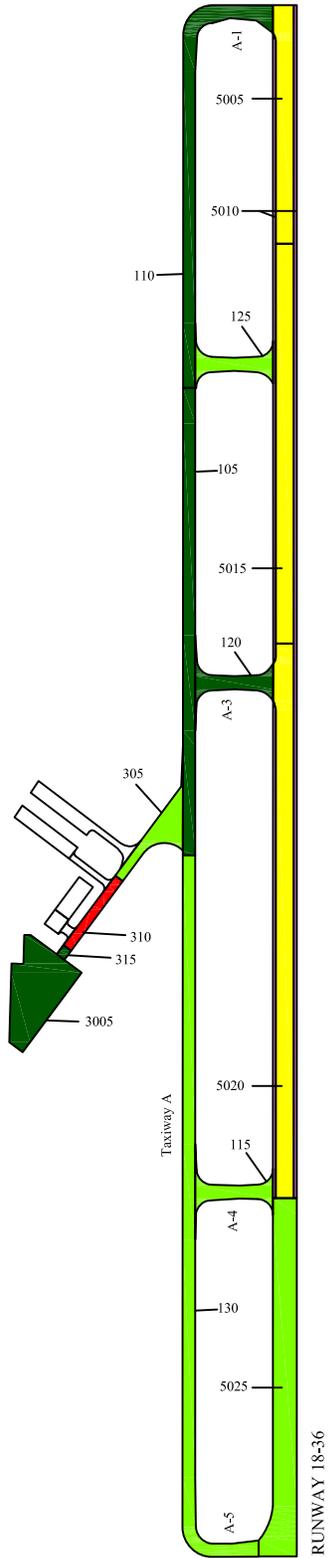
Figure 2-1. Inspected Pavement Condition at Connersville-Mettel Field Airport (CEV).

The pavement within each of the PCI condition categories is shown in Figure 2-1. The inspected PCI is summarized by branch use in Figure 2-2, and the photographs in Figure 2-3 through Figure 2-5 provide examples of the condition categories.

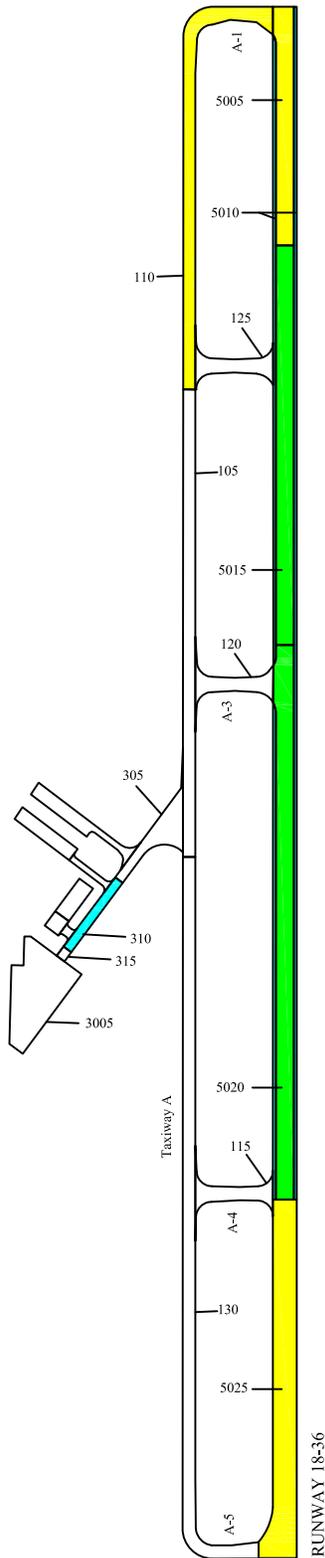
CONNERSVILLE MUNICIPAL AIRPORT 2015 PCI Inspection

Feature	Work Item	Amount	Insp. PCI	Change	Est. PCI
310	AC PATCH	67	32	23	55
5010	AC PATCH	9	53	8	61
5015	AC PATCH	55	62		62
5020	AC PATCH	63	62		62
	TOTAL:	194	S.F.		
EQUIPMENT: SAW, AIR COMPRESSOR, HEATING KETTLE, HAND TOOLS					
EST. MATERIALS: 2 TONS ASPHALT PATCH					
EST. MATERIAL COST: \$243					
EST. CREW HOURS: 5.6					
EST. CREW COST: \$1,448					
EST. PROJECT COST: \$1,691

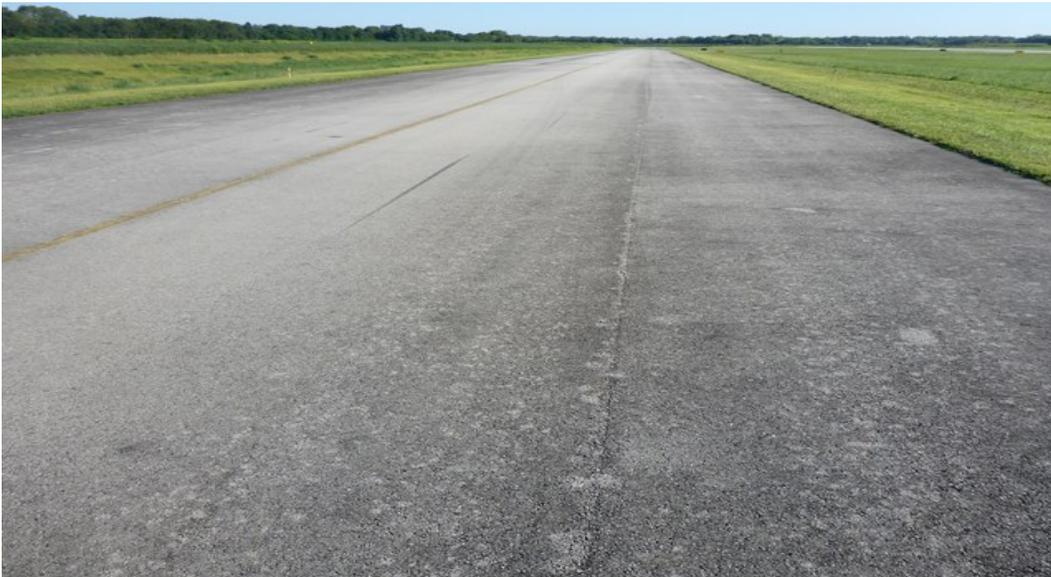
DISTRESS TYPE	SEVERITY	MEASURED QUANTITY	ESTIMATED TOTAL QUANTITY	UNITS	PERCENTAGE OF All DISTRESS
LONG.& TRANS. CRACK	MED	12	48	L.F.	7.8
LONG.& TRANS. CRACK	LOW	1,143	4,598	L.F.	91.4
WEATHERING	LOW	200	804	S.F.	.7

APPROXIMATE AMOUNT OF DISTRESS RELATED TO LOAD ON THE PAVEMENT IS:	0 %
APPROXIMATE AMOUNT OF DISTRESS RELATED TO MATERIALS PROBLEMS IN THE FEATURE IS:	66 %
APPROXIMATE AMOUNT OF DISTRESS RELATED TO AGE OF PAVEMENT AND TRAFFIC REPETITIONS IS:	34 %

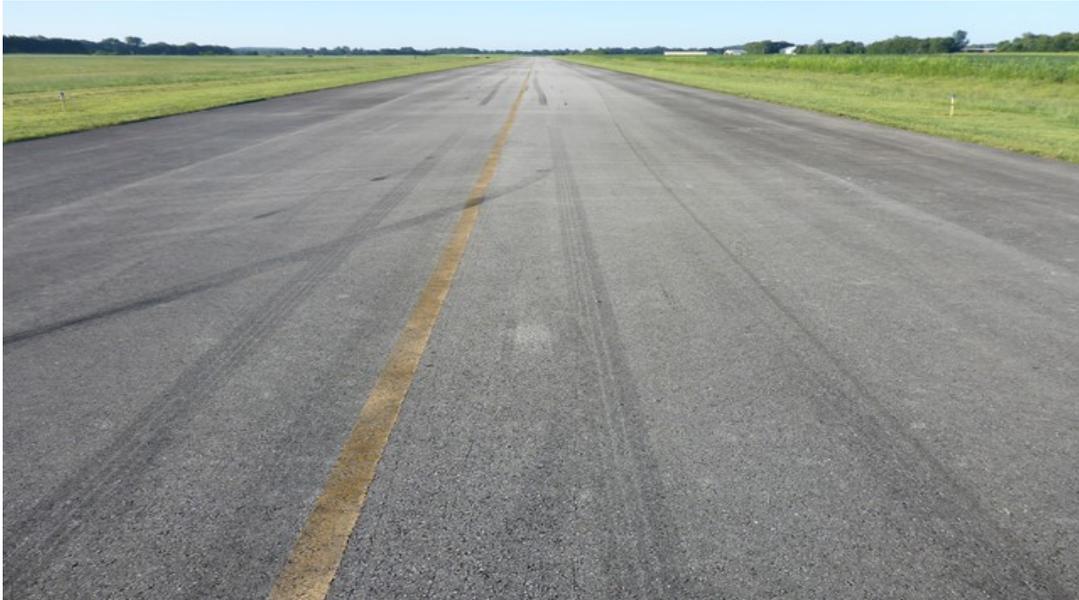
DISTRESS TYPE	SEVERITY	MEASURED QUANTITY	ESTIMATED TOTAL QUANTITY	UNITS	PERCENTAGE OF All DISTRESS
LONG.& TRANS. CRACK	MED	50	162	L.F.	21
LONG.& TRANS. CRACK	LOW	678	2,204	L.F.	78.9

APPROXIMATE AMOUNT OF DISTRESS RELATED TO LOAD ON THE PAVEMENT IS:	0 %
APPROXIMATE AMOUNT OF DISTRESS RELATED TO MATERIALS PROBLEMS IN THE FEATURE IS:	67 %
APPROXIMATE AMOUNT OF DISTRESS RELATED TO AGE OF PAVEMENT AND TRAFFIC REPETITIONS IS:	33 %

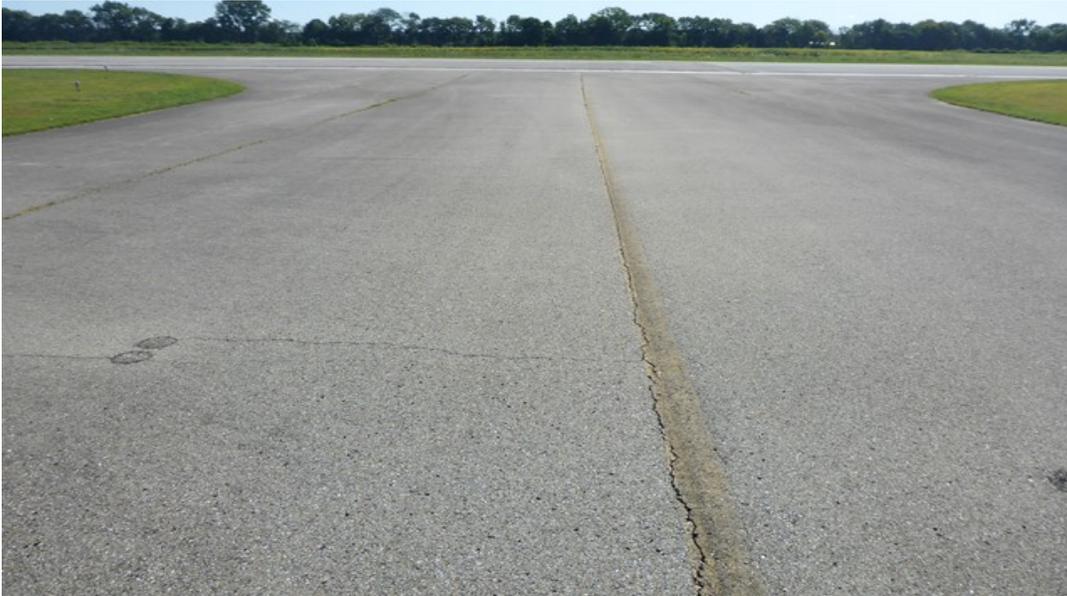
DISTRESS TYPE	SEVERITY	MEASURED QUANTITY	ESTIMATED TOTAL QUANTITY	UNITS	PERCENTAGE OF All DISTRESS
LONG.& TRANS. CRACK	MED	38	84	L.F.	17.8
LONG.& TRANS. CRACK	LOW	939	2,075	L.F.	81.2
WEATHERING	LOW	200	442	S.F.	.8

APPROXIMATE AMOUNT OF DISTRESS RELATED TO LOAD ON THE PAVEMENT IS:	0 %
APPROXIMATE AMOUNT OF DISTRESS RELATED TO MATERIALS PROBLEMS IN THE FEATURE IS:	66 %
APPROXIMATE AMOUNT OF DISTRESS RELATED TO AGE OF PAVEMENT AND TRAFFIC REPETITIONS IS:	34 %

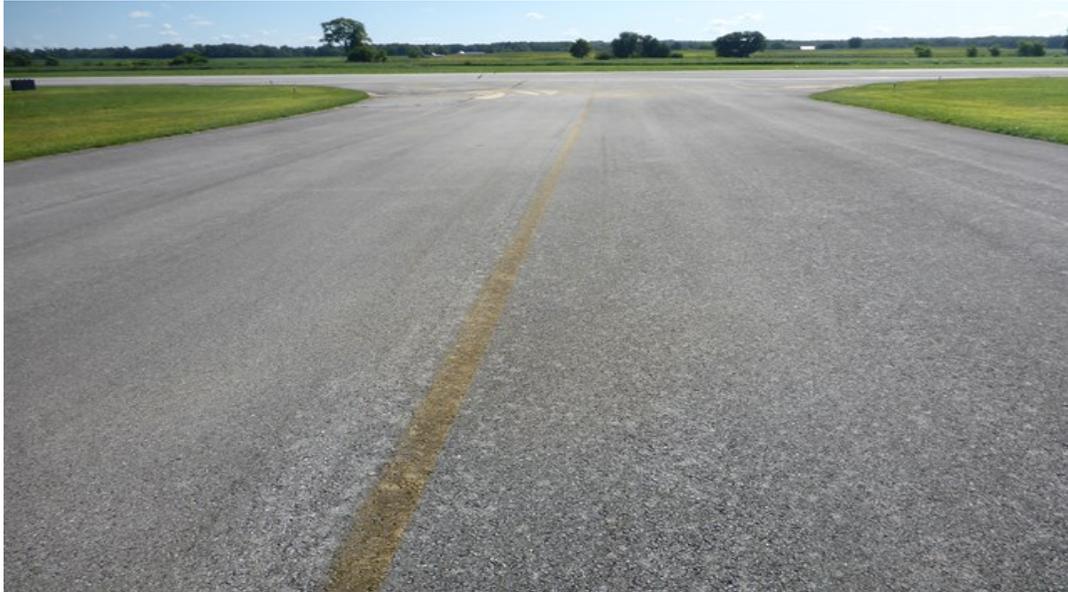
DISTRESS TYPE	SEVERITY	MEASURED QUANTITY	ESTIMATED TOTAL QUANTITY	UNITS	PERCENTAGE OF All DISTRESS
LONG.& TRANS. CRACK	LOW	159	364	L.F.	100

APPROXIMATE AMOUNT OF DISTRESS RELATED TO LOAD ON THE PAVEMENT IS:	0 %
APPROXIMATE AMOUNT OF DISTRESS RELATED TO MATERIALS PROBLEMS IN THE FEATURE IS:	67 %
APPROXIMATE AMOUNT OF DISTRESS RELATED TO AGE OF PAVEMENT AND TRAFFIC REPETITIONS IS:	33 %

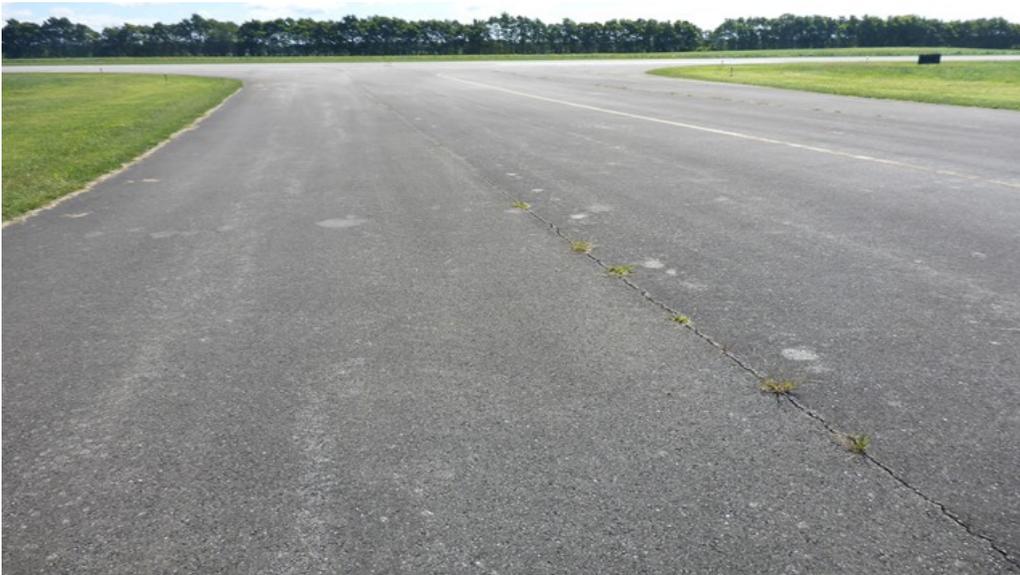
DISTRESS TYPE	SEVERITY	MEASURED QUANTITY	ESTIMATED TOTAL QUANTITY	UNITS	PERCENTAGE OF All DISTRESS
DEPRESSION	LOW	88	196	S.F.	20.7
LONG.& TRANS. CRACK	MED	14	31	L.F.	12.3
LONG.& TRANS. CRACK	LOW	600	1,339	L.F.	66.8

APPROXIMATE AMOUNT OF DISTRESS RELATED TO LOAD ON THE PAVEMENT IS:	0 %
APPROXIMATE AMOUNT OF DISTRESS RELATED TO MATERIALS PROBLEMS IN THE FEATURE IS:	74 %
APPROXIMATE AMOUNT OF DISTRESS RELATED TO AGE OF PAVEMENT AND TRAFFIC REPETITIONS IS:	26 %

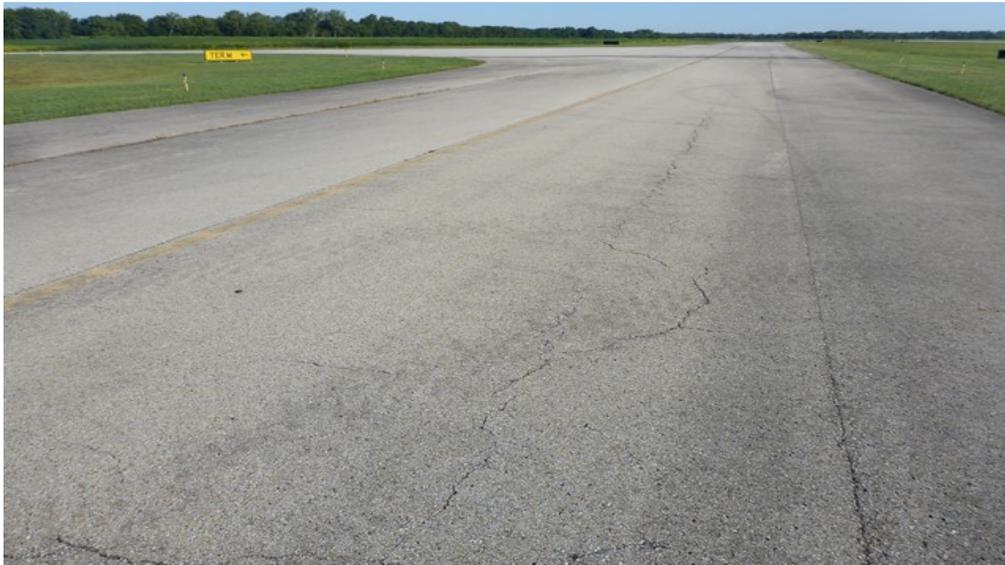
DISTRESS TYPE	SEVERITY	MEASURED QUANTITY	ESTIMATED TOTAL QUANTITY	UNITS	PERCENTAGE OF ALL DISTRESS
BLOCK CRACKING	LOW	600	2,190	S.F.	6.3
LONG.& TRANS. CRACK	MED	52	189	L.F.	5.7
LONG.& TRANS. CRACK	LOW	5,579	20,363	L.F.	87.5
WEATHERING	LOW	400	1,460	S.F.	.3

APPROXIMATE AMOUNT OF DISTRESS RELATED TO LOAD ON THE PAVEMENT IS:	0 %
APPROXIMATE AMOUNT OF DISTRESS RELATED TO MATERIALS PROBLEMS IN THE FEATURE IS:	62 %
APPROXIMATE AMOUNT OF DISTRESS RELATED TO AGE OF PAVEMENT AND TRAFFIC REPETITIONS IS:	38 %

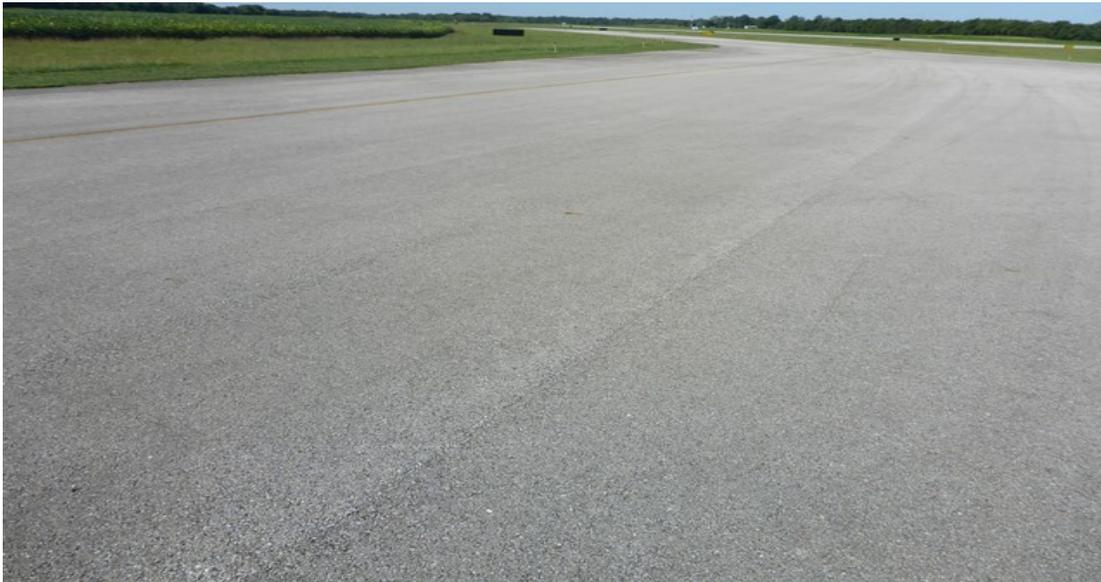
DISTRESS TYPE	SEVERITY	MEASURED QUANTITY	ESTIMATED TOTAL QUANTITY	UNITS	PERCENTAGE OF All DISTRESS
LONG.& TRANS. CRACK	MED	6	11	L.F.	7
LONG.& TRANS. CRACK	LOW	1,024	1,903	L.F.	92.9

APPROXIMATE AMOUNT OF DISTRESS RELATED TO MATERIALS PROBLEMS IN THE FEATURE IS: 67 %

APPROXIMATE AMOUNT OF DISTRESS RELATED TO AGE OF PAVEMENT AND TRAFFIC REPETITIONS IS: 33 %

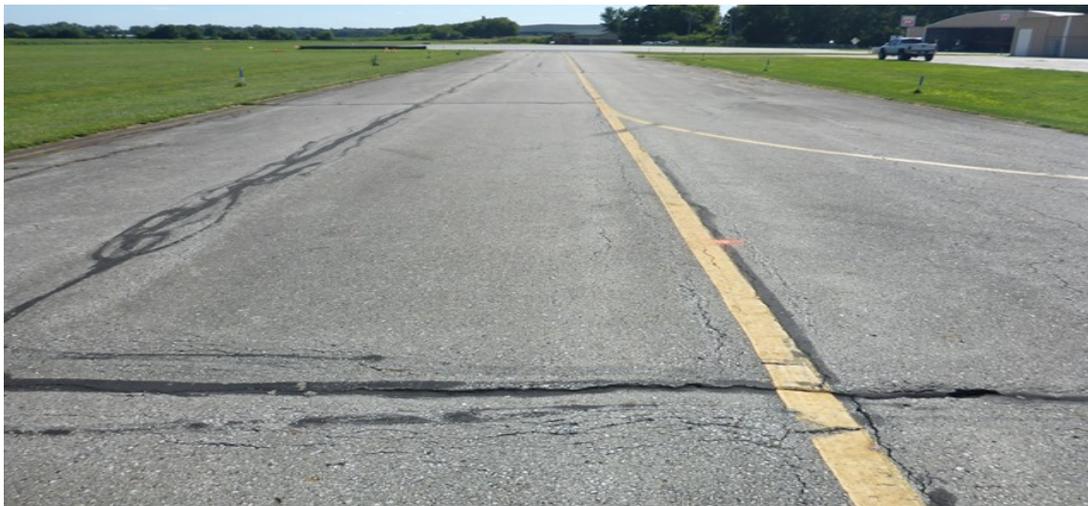
DISTRESS TYPE	SEVERITY	MEASURED QUANTITY	ESTIMATED TOTAL QUANTITY	UNITS	PERCENTAGE OF All DISTRESS
ALLIGATOR CRACKING	LOW	880	1,277	S.F.	34.2
DEPRESSION	LOW	200	290	S.F.	9.6
LONG.& TRANS. CRACK	HIGH	31	45	L.F.	9.2
LONG.& TRANS. CRACK	MED	173	251	L.F.	11.1
LONG.& TRANS. CRACK	LOW	1,100	1,597	L.F.	20.4
RAVELING	HIGH	30	43	S.F.	3.9
RAVELING	LOW	120	174	S.F.	2.2
RUTTING	LOW	60	87	S.F.	4.8
SWELL	LOW	207	300	S.F.	4.2

APPROXIMATE AMOUNT OF DISTRESS RELATED TO LOAD ON THE PAVEMENT IS:	37 %
APPROXIMATE AMOUNT OF DISTRESS RELATED TO MATERIALS PROBLEMS IN THE FEATURE IS:	45 %
APPROXIMATE AMOUNT OF DISTRESS RELATED TO AGE OF PAVEMENT AND TRAFFIC REPETITIONS IS:	18 %

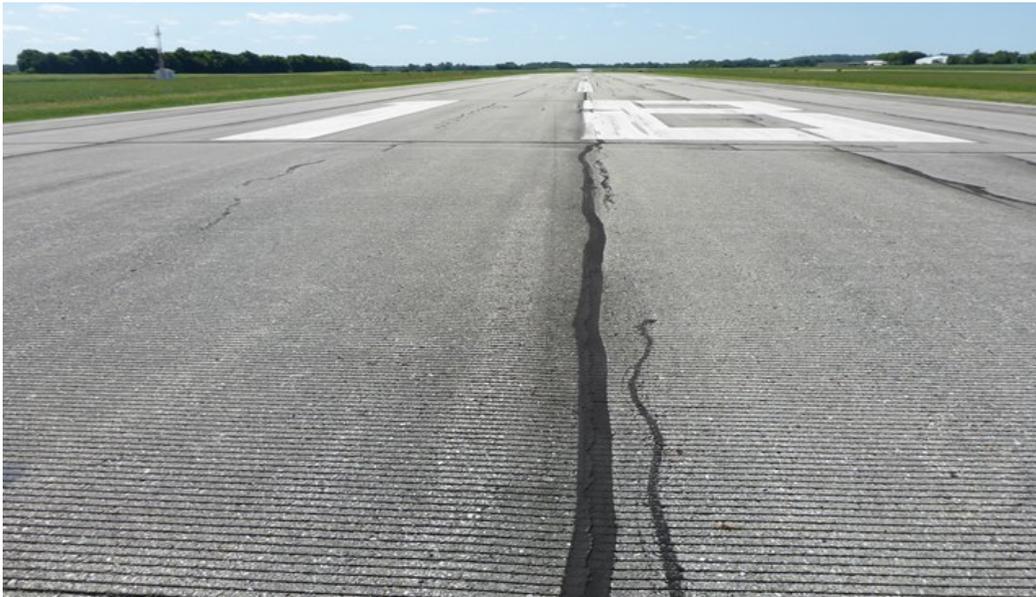
DISTRESS TYPE	SEVERITY	MEASURED QUANTITY	ESTIMATED TOTAL QUANTITY	UNITS	PERCENTAGE OF All DISTRESS
DEPRESSION	LOW	135	393	S.F.	7.1
LONG.& TRANS. CRACK	MED	240	700	L.F.	22.9
LONG.& TRANS. CRACK	LOW	4,347	12,683	L.F.	69.8

APPROXIMATE AMOUNT OF DISTRESS RELATED TO LOAD ON THE PAVEMENT IS:	0 %
APPROXIMATE AMOUNT OF DISTRESS RELATED TO MATERIALS PROBLEMS IN THE FEATURE IS:	69 %
APPROXIMATE AMOUNT OF DISTRESS RELATED TO AGE OF PAVEMENT AND TRAFFIC REPETITIONS IS:	31 %

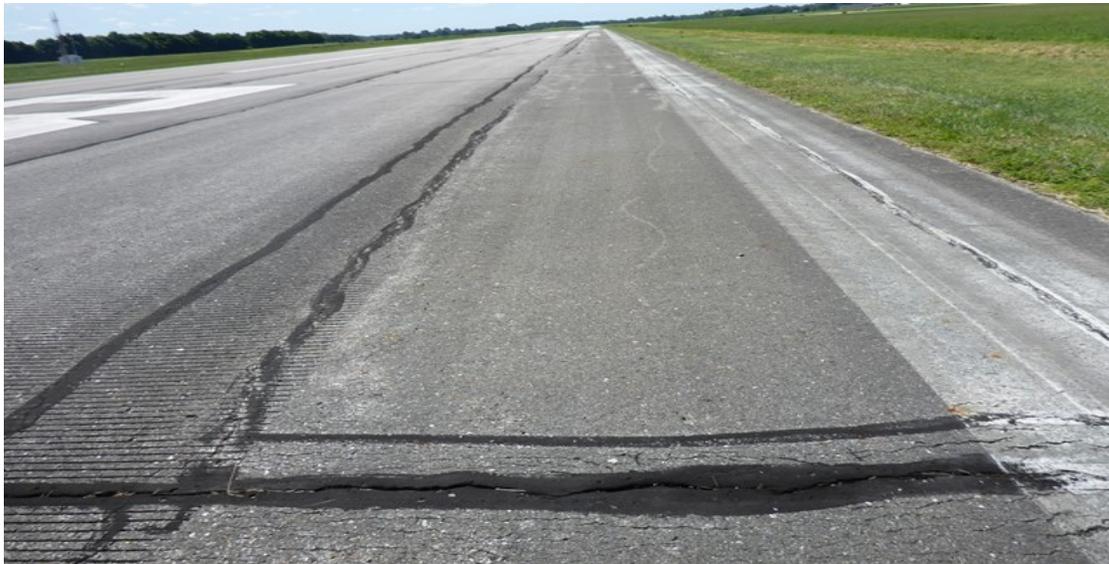
DISTRESS TYPE	SEVERITY	MEASURED QUANTITY	ESTIMATED TOTAL QUANTITY	UNITS	PERCENTAGE OF All DISTRESS
ALLIGATOR CRACKING	LOW	450	1,520	S.F.	31.4
DEPRESSION	LOW	172	581	S.F.	3.7
LONG.& TRANS. CRACK	HIGH	2	6	L.F.	1.3
LONG.& TRANS. CRACK	MED	664	2,243	L.F.	18.8
LONG.& TRANS. CRACK	LOW	7,016	23,701	L.F.	44.4

APPROXIMATE AMOUNT OF DISTRESS RELATED TO LOAD ON THE PAVEMENT IS:	31 %
APPROXIMATE AMOUNT OF DISTRESS RELATED TO MATERIALS PROBLEMS IN THE FEATURE IS:	47 %
APPROXIMATE AMOUNT OF DISTRESS RELATED TO AGE OF PAVEMENT AND TRAFFIC REPETITIONS IS:	22 %

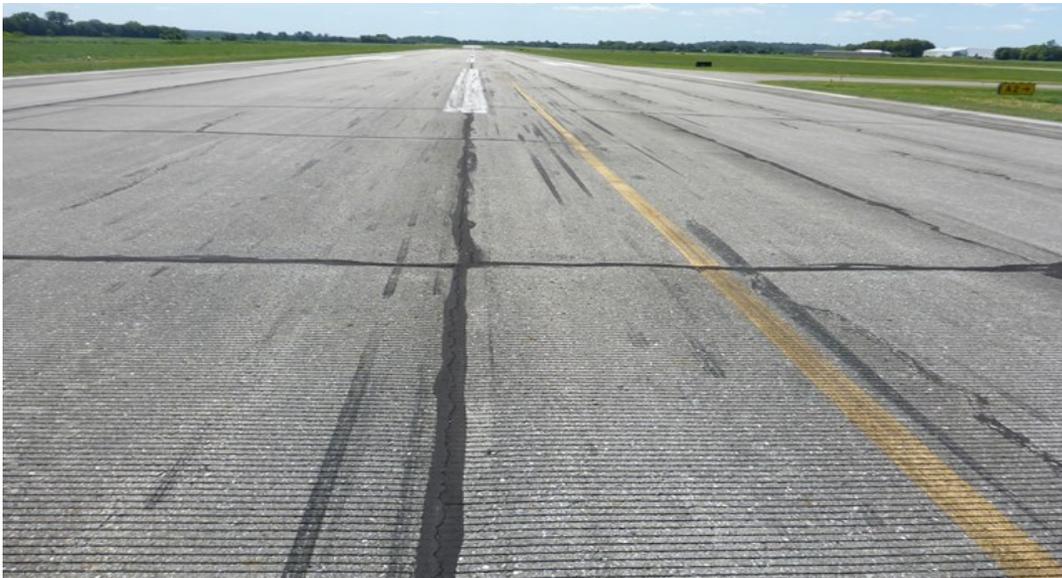
DISTRESS TYPE	SEVERITY	MEASURED QUANTITY	ESTIMATED TOTAL QUANTITY	UNITS	PERCENTAGE OF ALL DISTRESS
DEPRESSION	LOW	143	532	S.F.	5.9
LONG.& TRANS. CRACK	HIGH	10	37	L.F.	2.7
LONG.& TRANS. CRACK	MED	250	930	L.F.	20.7
LONG.& TRANS. CRACK	LOW	5,543	20,632	L.F.	70.2
WEATHERING	MED	135	502	S.F.	.3

APPROXIMATE AMOUNT OF DISTRESS RELATED TO LOAD ON THE PAVEMENT IS:	0 %
APPROXIMATE AMOUNT OF DISTRESS RELATED TO MATERIALS PROBLEMS IN THE FEATURE IS:	69 %
APPROXIMATE AMOUNT OF DISTRESS RELATED TO AGE OF PAVEMENT AND TRAFFIC REPETITIONS IS:	31 %

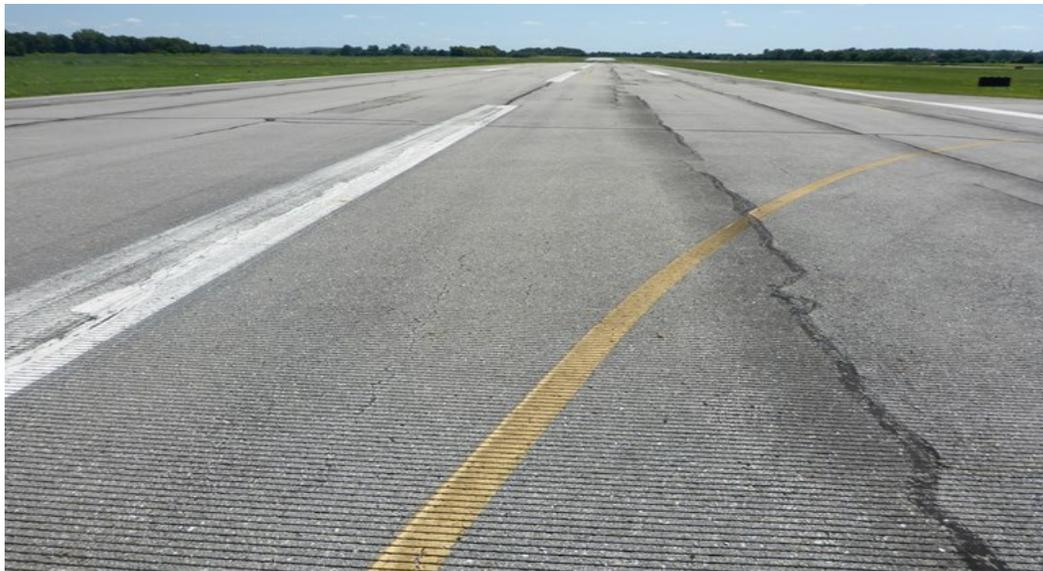
DISTRESS TYPE	SEVERITY	MEASURED QUANTITY	ESTIMATED TOTAL QUANTITY	UNITS	PERCENTAGE OF All DISTRESS
BLOCK CRACKING	MED	150	641	S.F.	5.4
BLOCK CRACKING	LOW	22,025	94,142	S.F.	52.5
DEPRESSION	LOW	15	64	S.F.	.1
LONG.& TRANS. CRACK	HIGH	10	42	L.F.	2
LONG.& TRANS. CRACK	MED	118	504	L.F.	7.2
LONG.& TRANS. CRACK	LOW	2,812	12,019	L.F.	31
RAVELING	HIGH	4	17	S.F.	1.3
WEATHERING	MED	65	277	S.F.	.1

APPROXIMATE AMOUNT OF DISTRESS RELATED TO LOAD ON THE PAVEMENT IS:	0 %
APPROXIMATE AMOUNT OF DISTRESS RELATED TO MATERIALS PROBLEMS IN THE FEATURE IS:	28 %
APPROXIMATE AMOUNT OF DISTRESS RELATED TO AGE OF PAVEMENT AND TRAFFIC REPETITIONS IS:	72 %

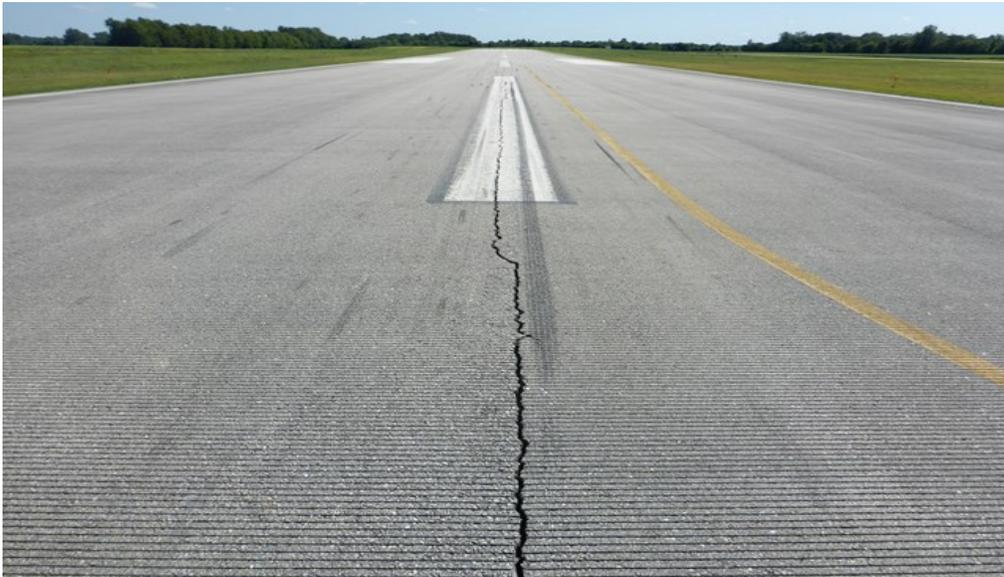
DISTRESS TYPE	SEVERITY	MEASURED QUANTITY	ESTIMATED TOTAL QUANTITY	UNITS	PERCENTAGE OF All DISTRESS
LONG.& TRANS. CRACK	MED	846	2,955	L.F.	64.6
LONG.& TRANS. CRACK	LOW	954	3,332	L.F.	32.4
WEATHERING	MED	200	698	S.F.	1.2
WEATHERING	LOW	1,300	4,541	S.F.	1.6

APPROXIMATE AMOUNT OF DISTRESS RELATED TO LOAD ON THE PAVEMENT IS:	0 %
APPROXIMATE AMOUNT OF DISTRESS RELATED TO MATERIALS PROBLEMS IN THE FEATURE IS:	66 %
APPROXIMATE AMOUNT OF DISTRESS RELATED TO AGE OF PAVEMENT AND TRAFFIC REPETITIONS IS:	34 %
