# Pavement Condition Report

## LaPorte Municipal Airport

Project 16801839

January 2016

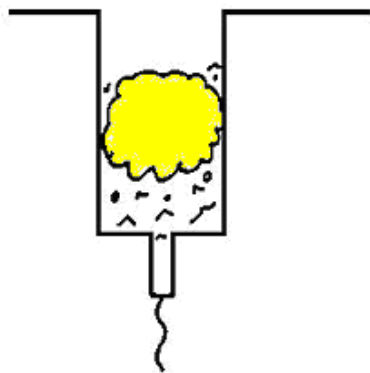
Typical failed joint sealant, w/  
debris and incompressibles.

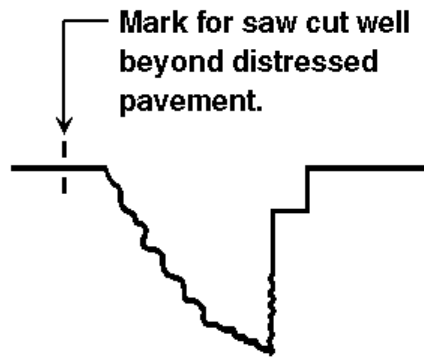
**SPALLED JOINT**  
(Typical distress)

Saw cut 2 inches deep. Break out pavement to below distressed area.

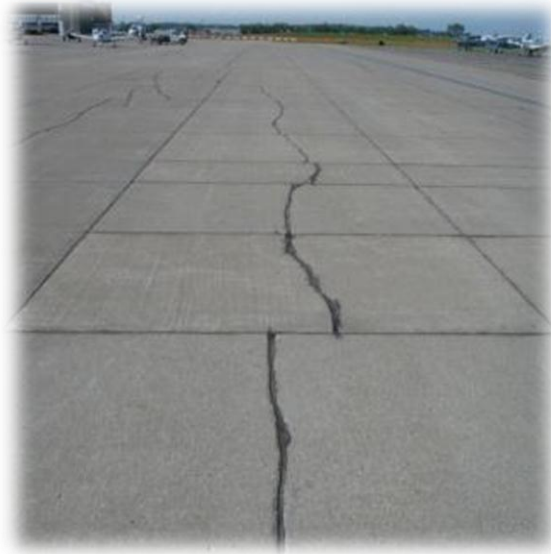
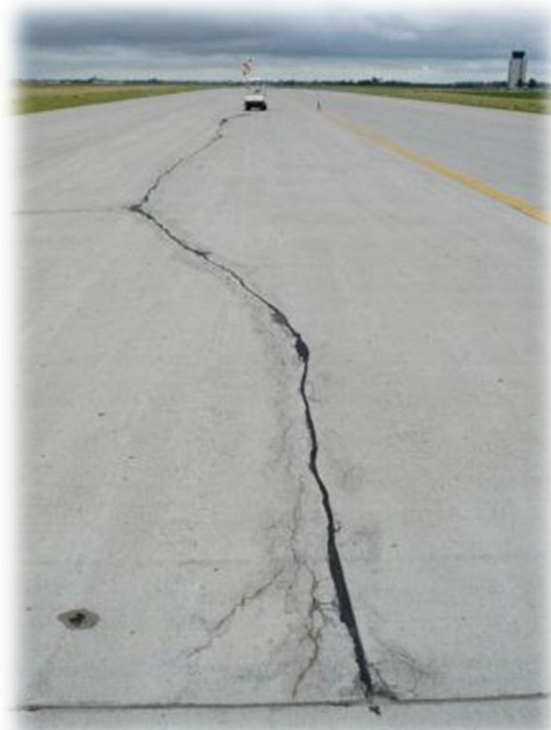
#### *Longitudinal, Transverse & Diagonal Cracking*

LTD cracking is often a result of load or temperature deformations. External loads cause flexure. Temperature changes can cause curling. When any of these stresses exceed the slab strength, cracking occurs.

LTD cracking is recorded at low, medium, or high severity, depending on the width of crack opening and degree of deterioration.

At low severity, a crack is less than 1/8 inch wide with little spalling, and no corrective action is indicated. At medium severity, LTD cracks can be up to 1 inch wide with moderate spalling and should be repaired using procedures similar to joint sealing. At high severity, cracks exceed 1 inch in width and may be severely spalled. High-severity LTD cracking is evidence of serious load failure, and correction may require patching or slab replacement. If distress occurs in several adjacent slabs at medium or high severity, major rehabilitation of that area is indicated.

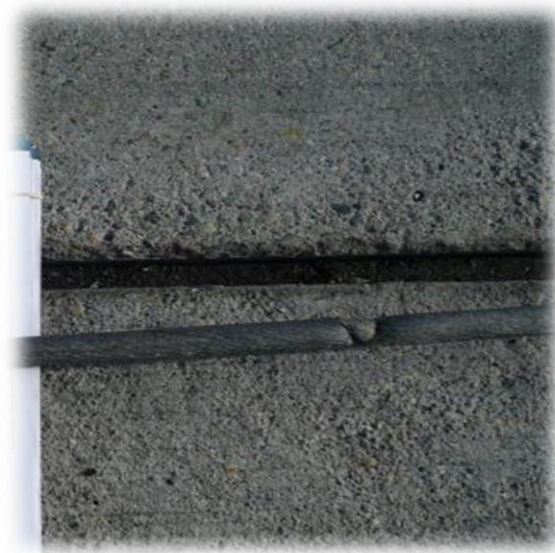
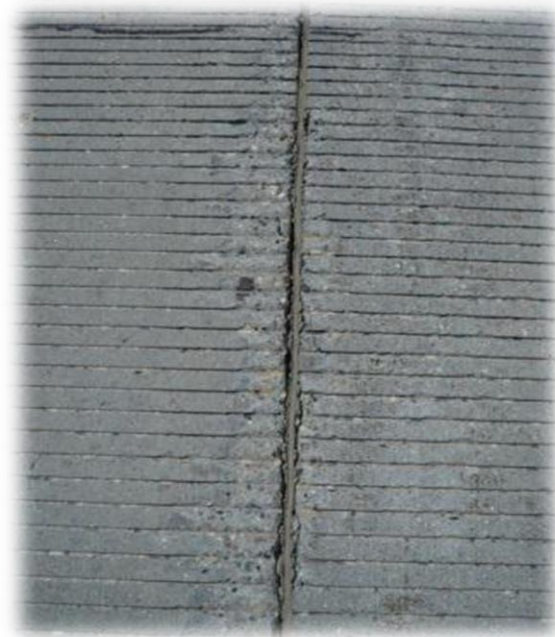
## Joint Seal Damage

When joint sealant is in perfect condition (no damage), there is no distress.

At low severity, at least 10 percent of the sealant is debonded but still in contact with the joint edges. Medium-severity joint seal damage is recorded when at least 10 percent of the sealant has visible gaps smaller than 1/8 inch and is an indicator that replacement should be programmed as soon as is practical. In the meantime, aggressive inspection and sustaining maintenance is recommended to minimize subsurface damage from moisture penetration. At high severity, visible gaps exceed 1/8 inch, and the amount and degree of joint seal damage typically requires complete removal and replacement of the existing sealant.

On serviceable pavement, deteriorated joint sealant should be repaired or replaced to preserve pavement and subgrade integrity and prolong service life. The issue is not so clear-cut with unserviceable pavement. Pavement that can be restored to serviceable condition by maintenance activities such as patching and joint seal repair, or by slab replacement, should be so maintained as long as the process is cost-effective. However, when age and condition preclude economical return to serviceable condition by such means, joint seal repair would no longer be cost-effective and should be suspended except for an interim maintenance program to control FOD potential.

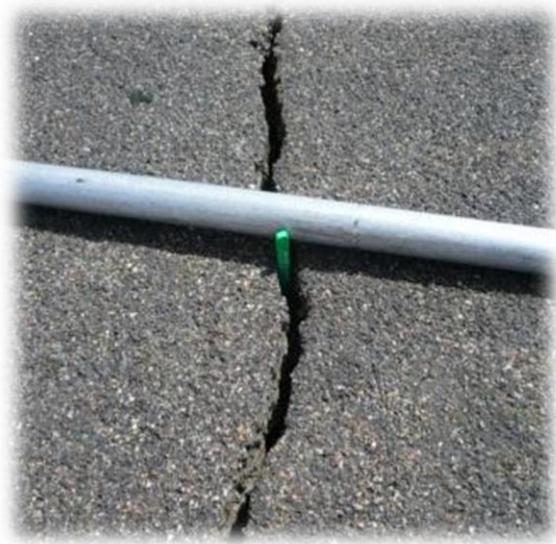
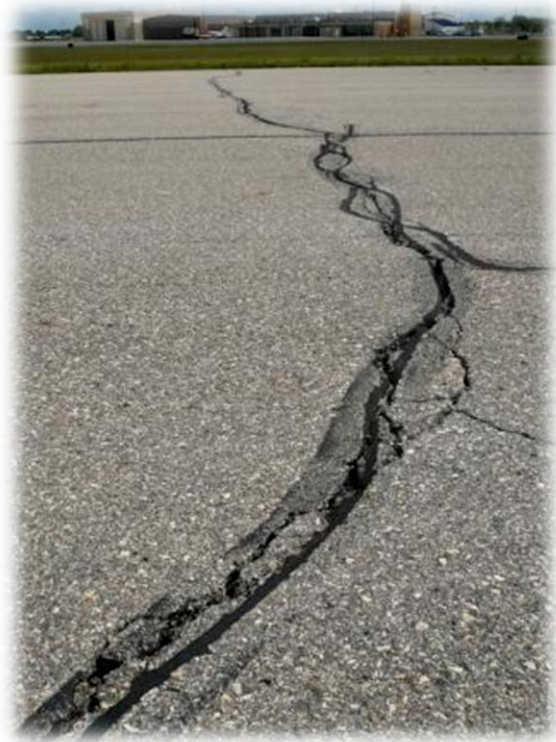
### *Longitudinal & Transverse Cracking*

L&T cracks are caused by age, construction, and subsurface conditions. Age-related cracking occurs as oxidizing pavement loses components to the atmosphere and becomes more brittle. Consistent application of seal coats can help to prevent age-related cracks.

Construction-related cracking often develops along paving joints. Ensuring that joints are made when both sides are still hot, and near the same temperature, is one of the best ways to mitigate this potential problem.

Seasonal movement caused by changes in subsurface moisture or temperature differences also can cause pavement cracking. Asphalt pavement placed over a PCC pavement or cement stabilized base course may evidence reflective cracking from the underlying material. Wheel loads do not cause L&T cracks, although traffic may worsen their condition.

Low-severity L&T cracks are less than  $\frac{1}{4}$  inch wide, or if sealed with suitable filler material in satisfactory condition can be any width less than 3 inches, if they are not spalled. Maintenance usually is not indicated for low-severity cracking. Moderately spalled cracks and cracks wider than  $\frac{1}{4}$  inch which are not satisfactorily sealed are at medium severity. Medium-severity cracks should be sealed with a high-quality crack filling material. Severely spalled cracks and cracks wider than 3 inches are at high severity. High-severity L&T cracks normally require patching.

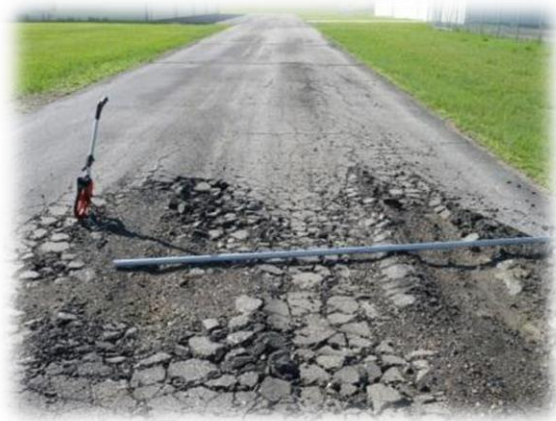
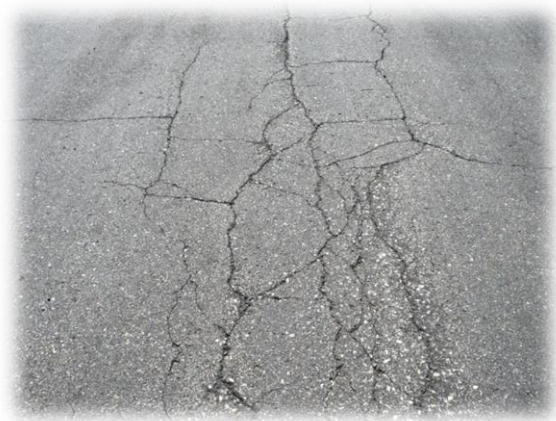
### *Alligator Cracking*

Alligator cracks are a series of interconnected load-related cracks caused by fatigue of the asphalt surface. Alligator cracking is a significant structural distress and develops only in places subject to traffic loads. These cracks typically initiate at the bottom of the asphalt layer and propagate upward. Once a fatigue crack is visible at the surface, significant damage has already occurred.

At low severity, alligator cracks are evidenced by a series of parallel hairline cracks (usually in a wheel path). Medium-severity alligator cracking is a well-defined pattern of interconnected cracks, and some spalling may be present. High-severity alligator cracks have lost aggregate interlock between adjacent pieces, and the cracks may be severely spalled with FOD potential. Most likely, the pieces will move freely under traffic.

Alligator cracking is a serious structural failure that cannot be repaired with sealant. The proper repair is patching.

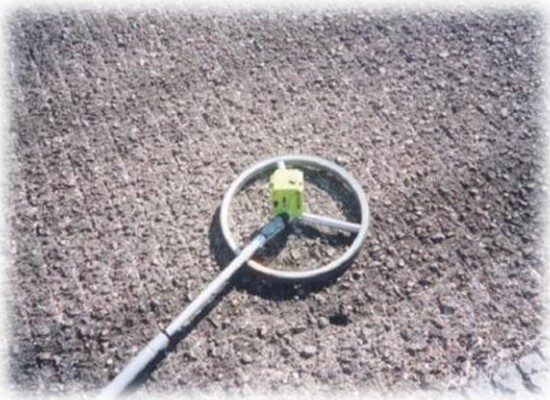
## Raveling/Weathering

Raveling and weathering are the wearing away of the pavement surface. Failure can be caused by the dislodging of aggregate particles or the loss of asphalt binder. These distresses are usually evident over large areas and may indicate that the asphalt binder has hardened significantly.

Raveling: At low severity, 5 to 20 coarse aggregate particles are missing per square yard. Medium severity is defined by 20 to 40 missing coarse aggregate particles per square yard. At high severity, more than 40 coarse aggregate particles are missing per square yard, and the top layer of aggregate has eroded away.

Weathering: At low severity, edges of coarse aggregate are exposed less than 1 mm. At medium severity, loss of fine aggregate is noticeable and edges of coarse aggregate are exposed up to 6 mm (1/4 inch). High severity weathering has edges of coarse aggregate exposed > 6 mm, with considerable loss of fine aggregate matrix and potential for loss of coarse aggregate.

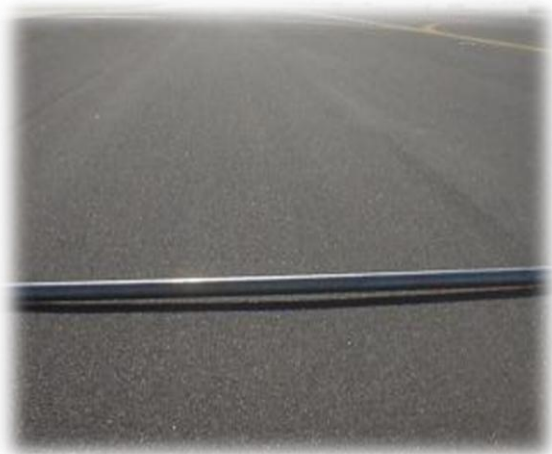
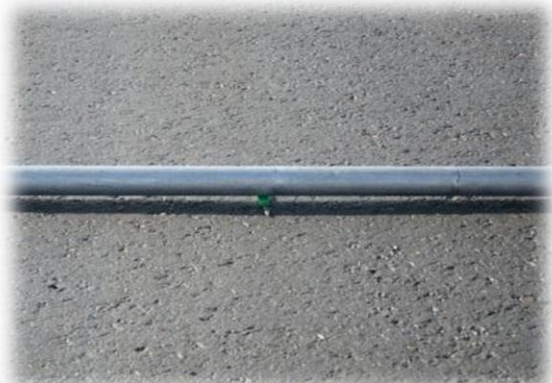
## Rutting

Ruts are localized areas of pavement having elevations lower than the surrounding sections.

Rutting is due to base and subgrade consolidation caused by excessive wheel loads or poor compaction. Ruts indicate structural failure and can cause hydroplaning.

At low severity, ruts have an average depth of 1/4 to 1/2 inches. At medium severity, ruts have an average depth of 1/2 to 1 inch. At high severity, ruts have an average depth greater than 1 inch. Patching is the appropriate repair for ruts.
