## Pipeline Safety Division Investigation Report

### Investigation regarding: Miller Pipeline

UPPAC Database Record ID: 4446

Damage Address: 213 S Dexter Ave, Knight, Vanderburgh

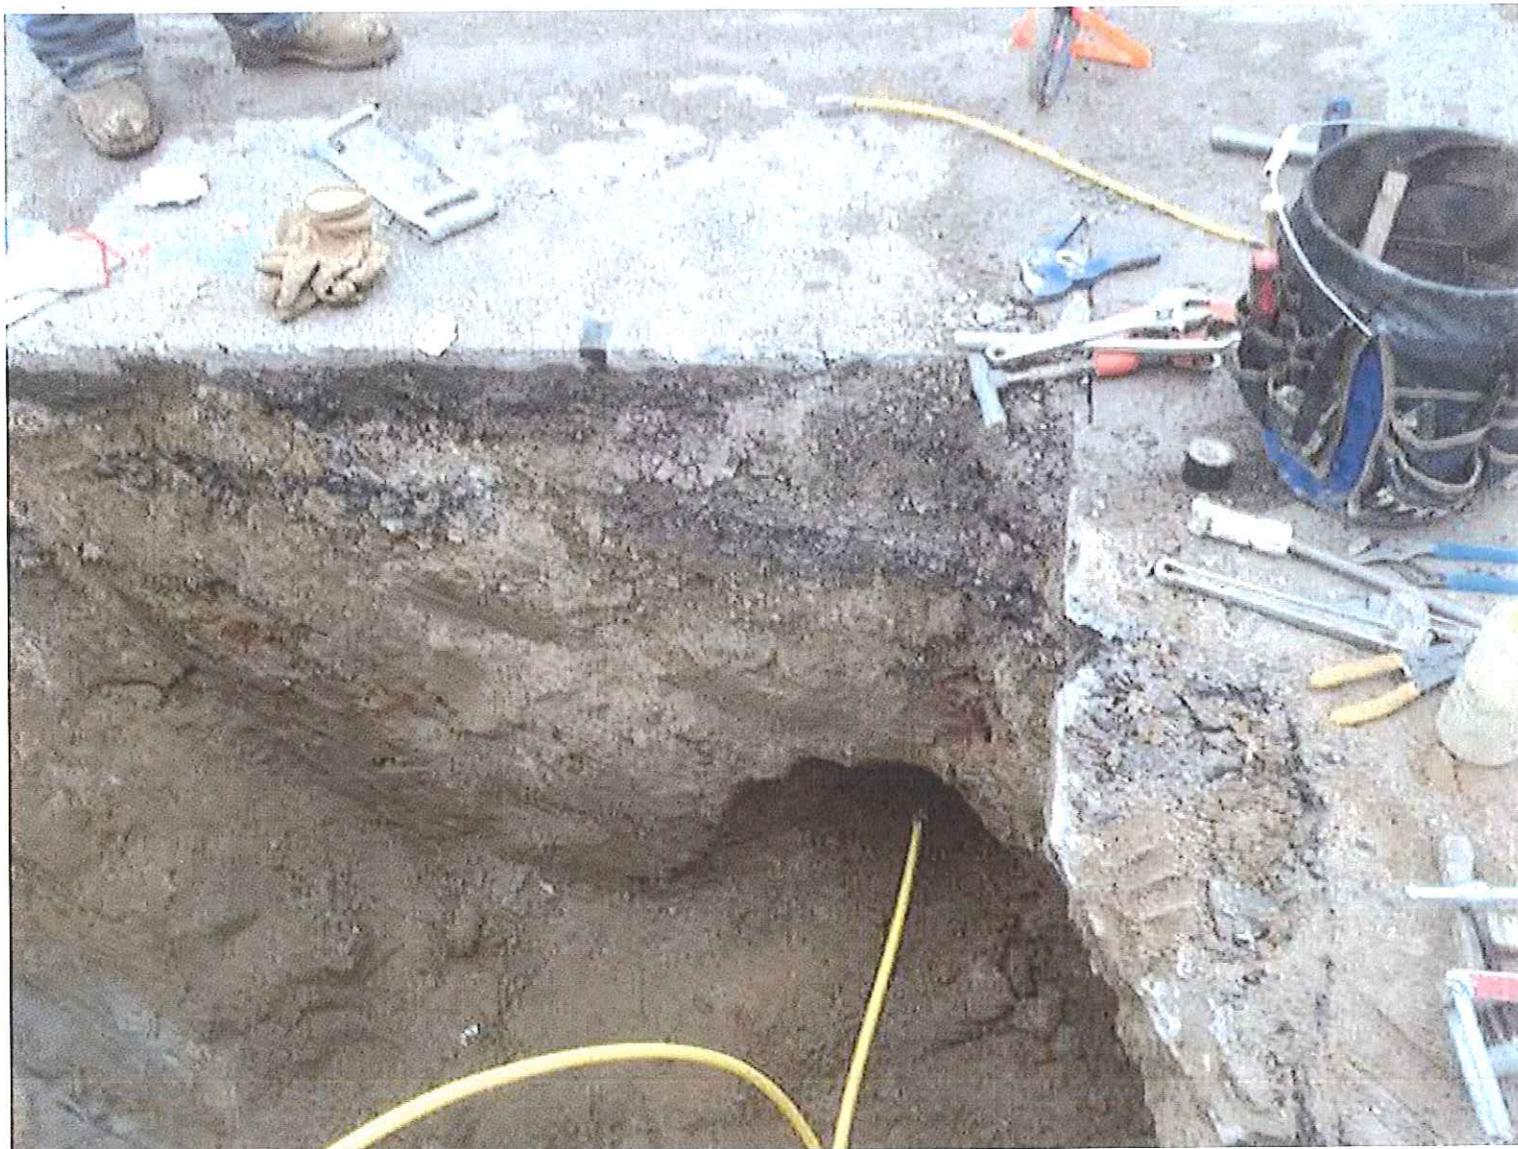
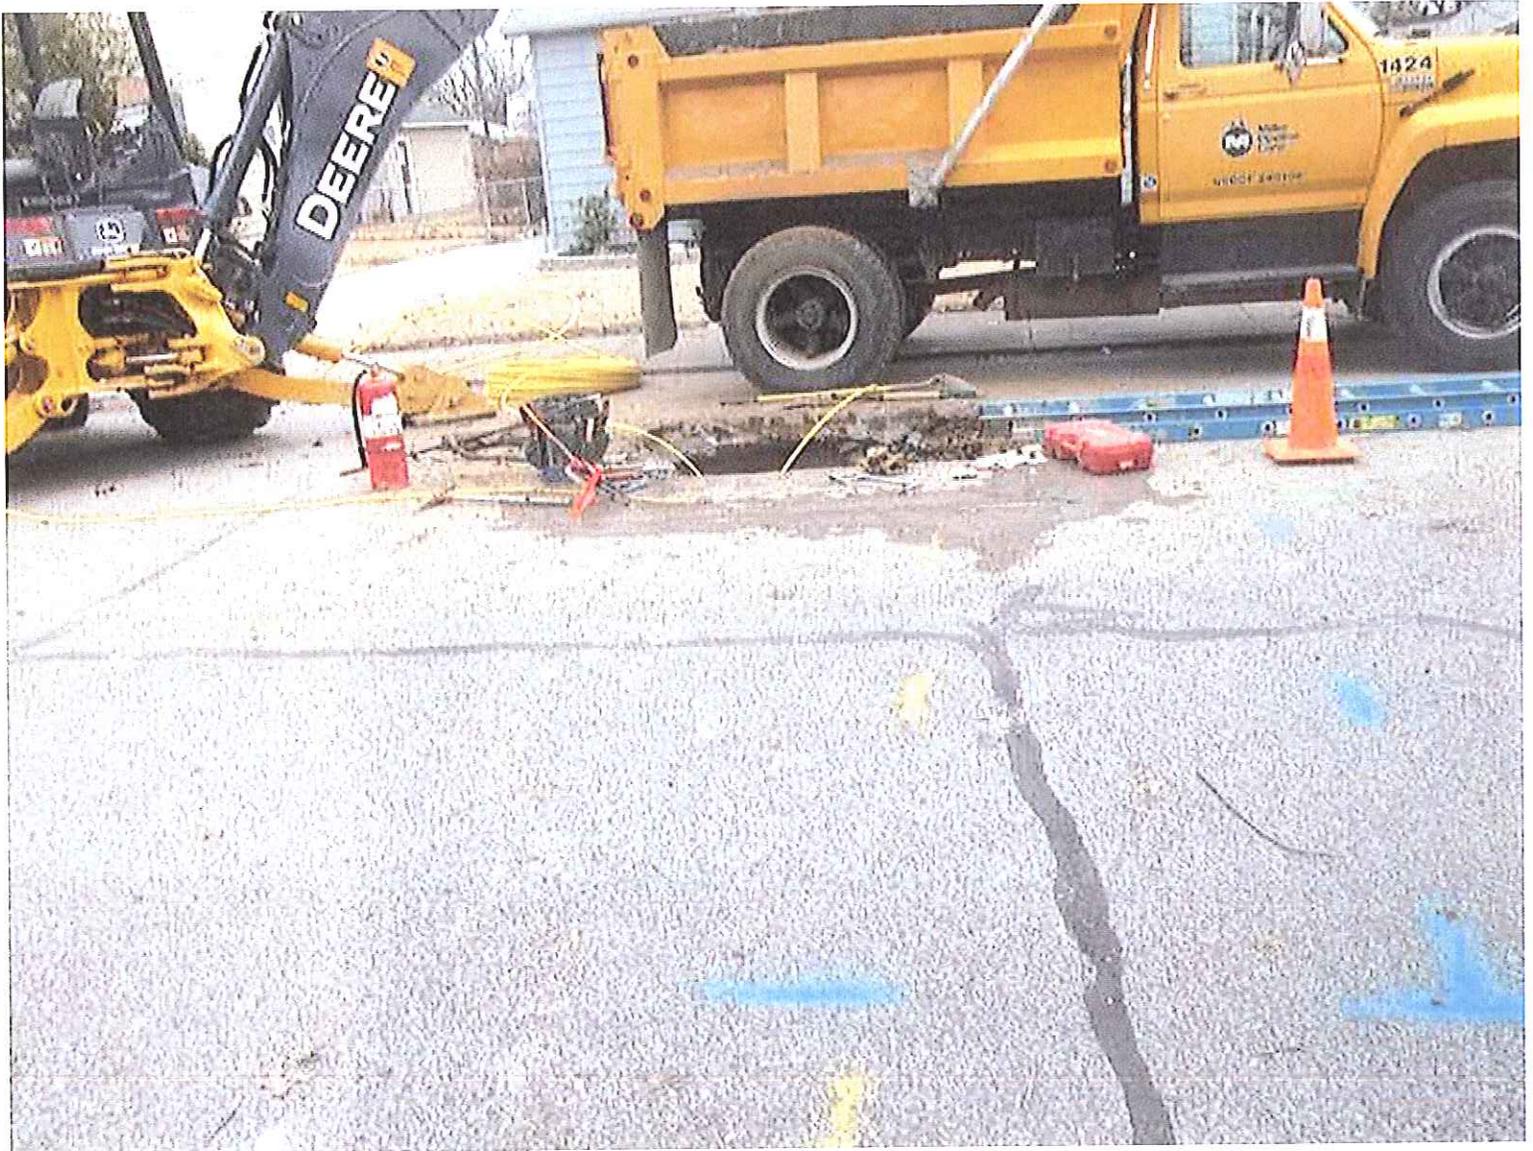
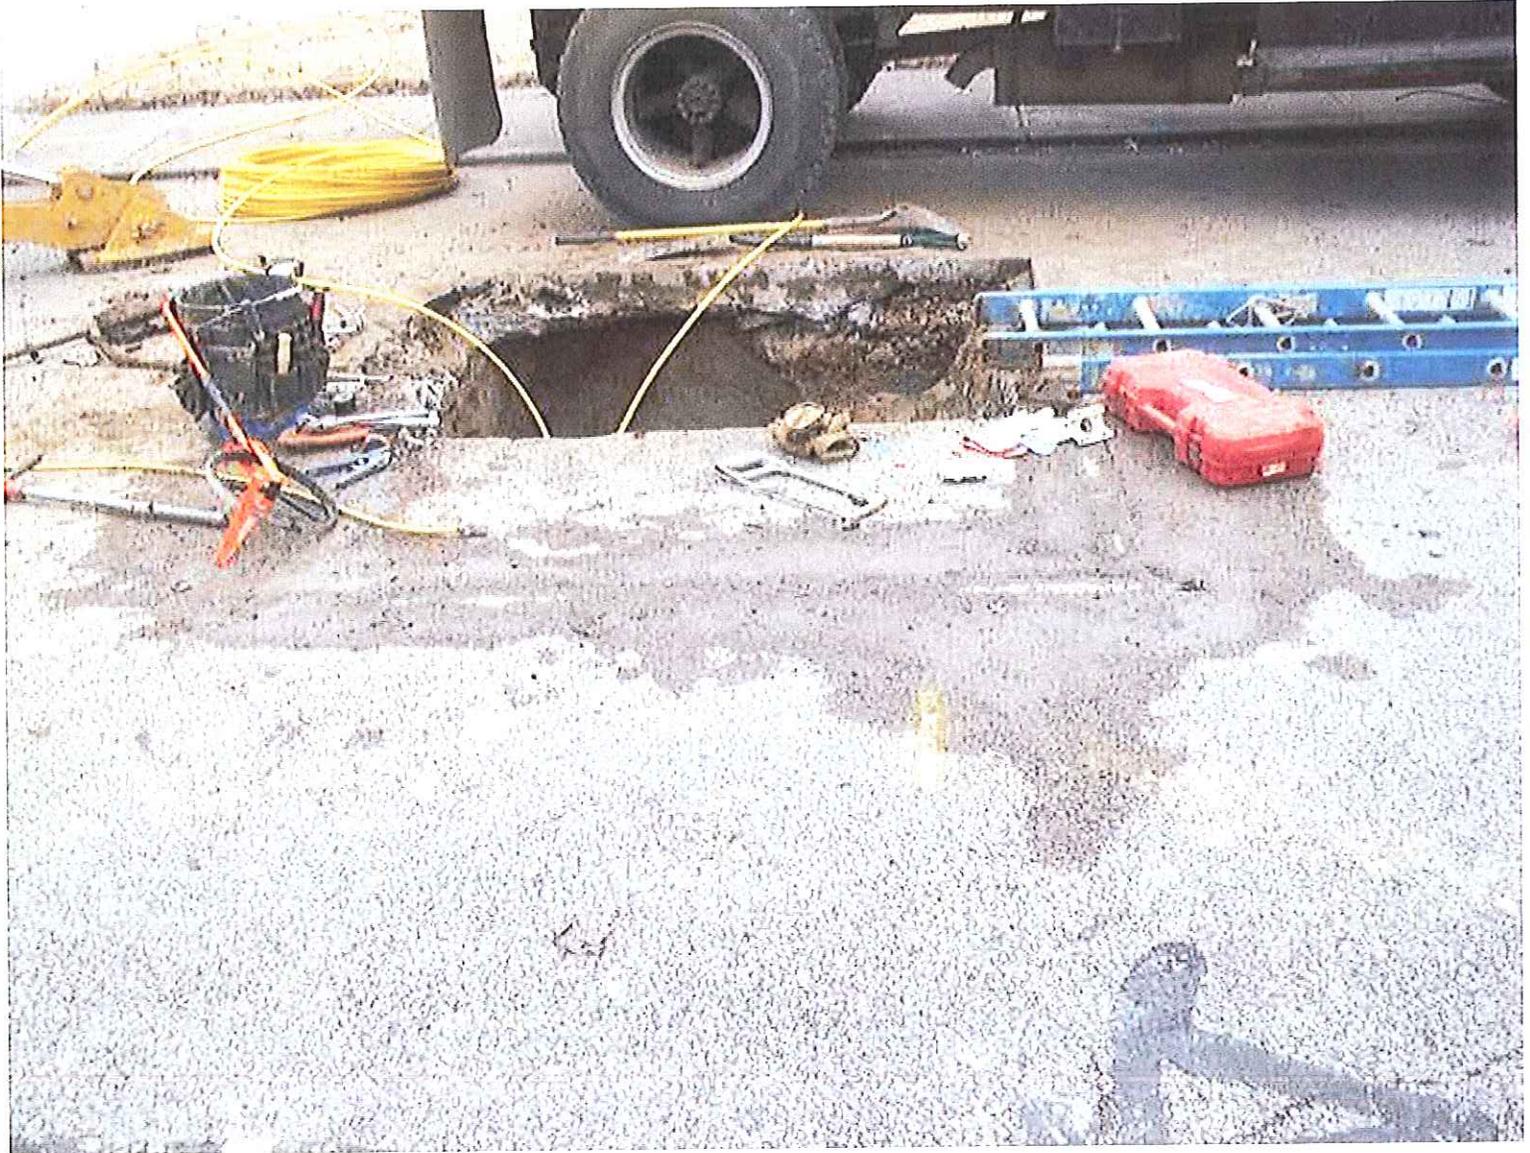
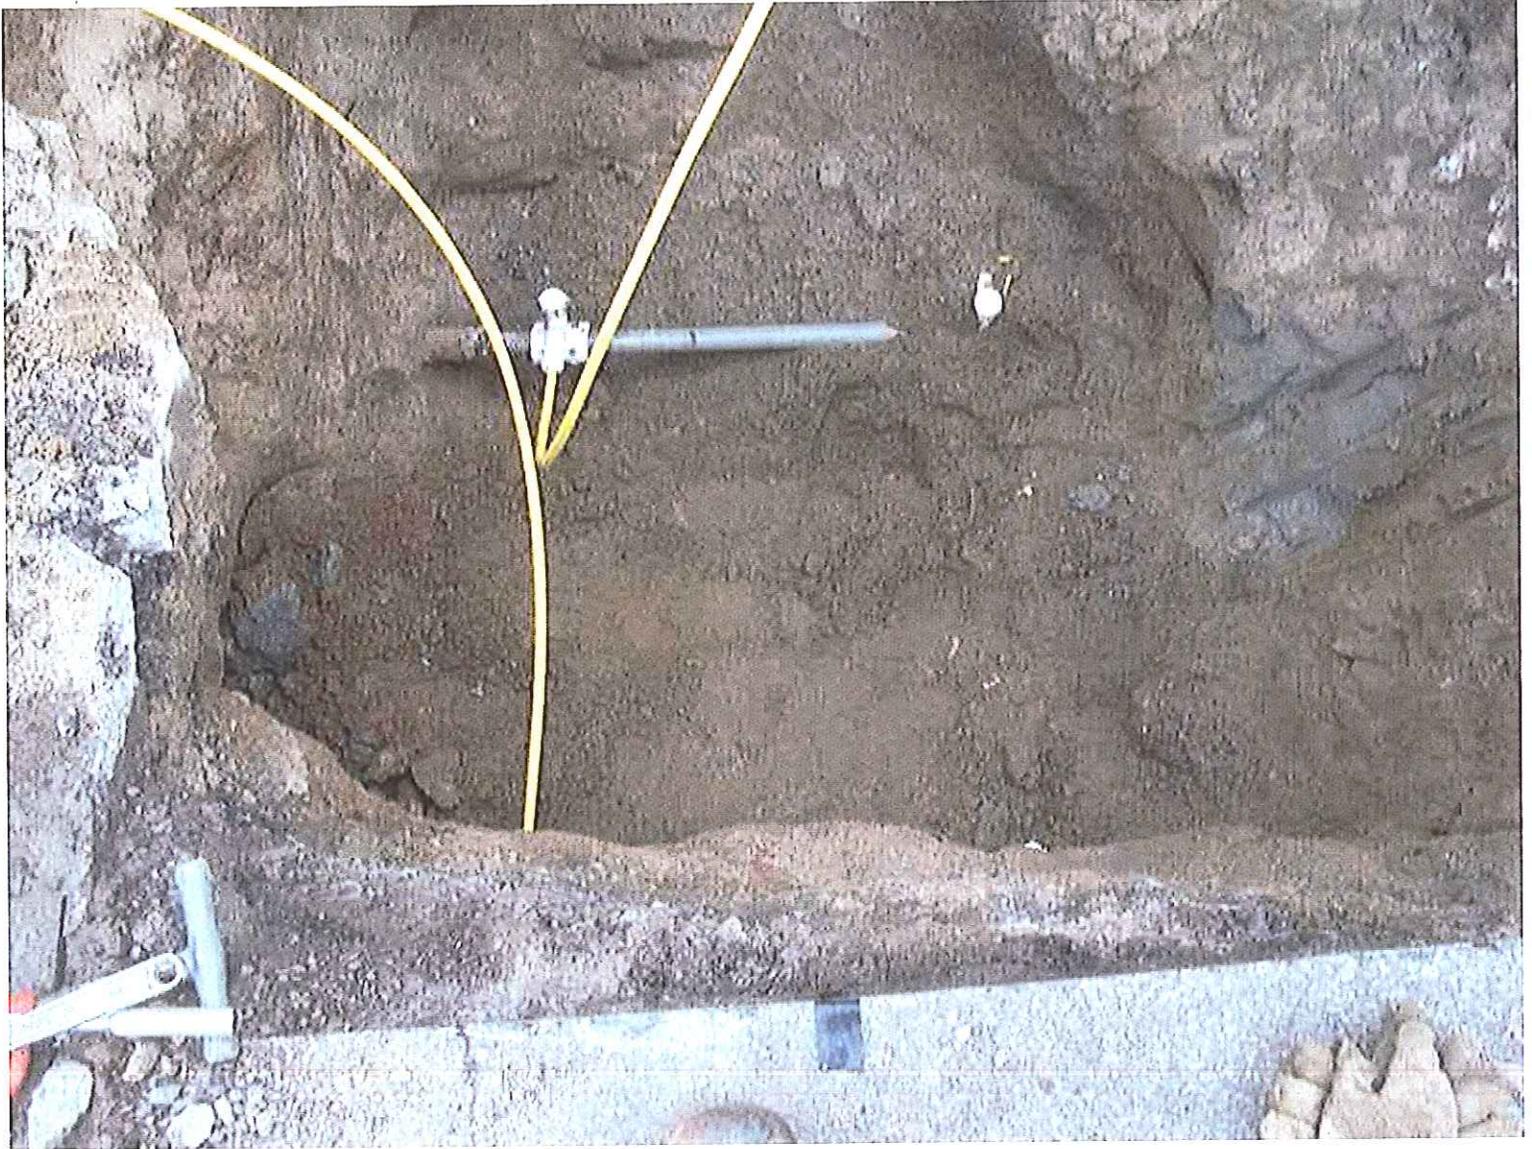
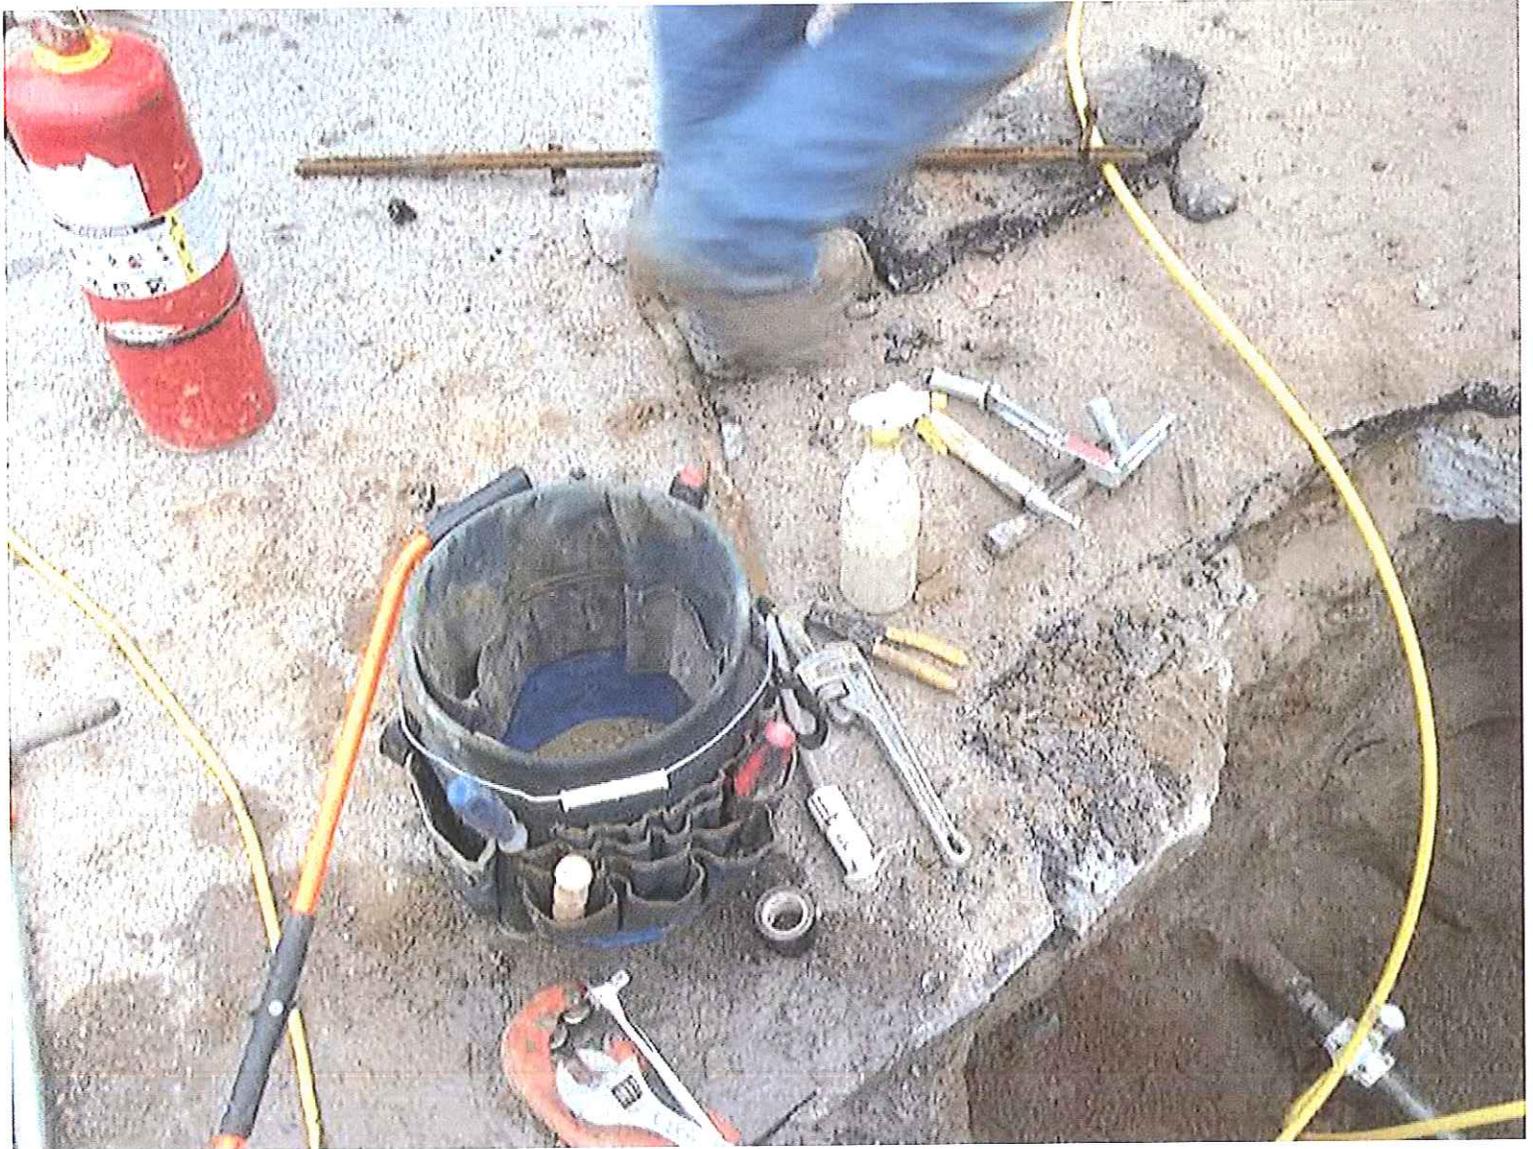
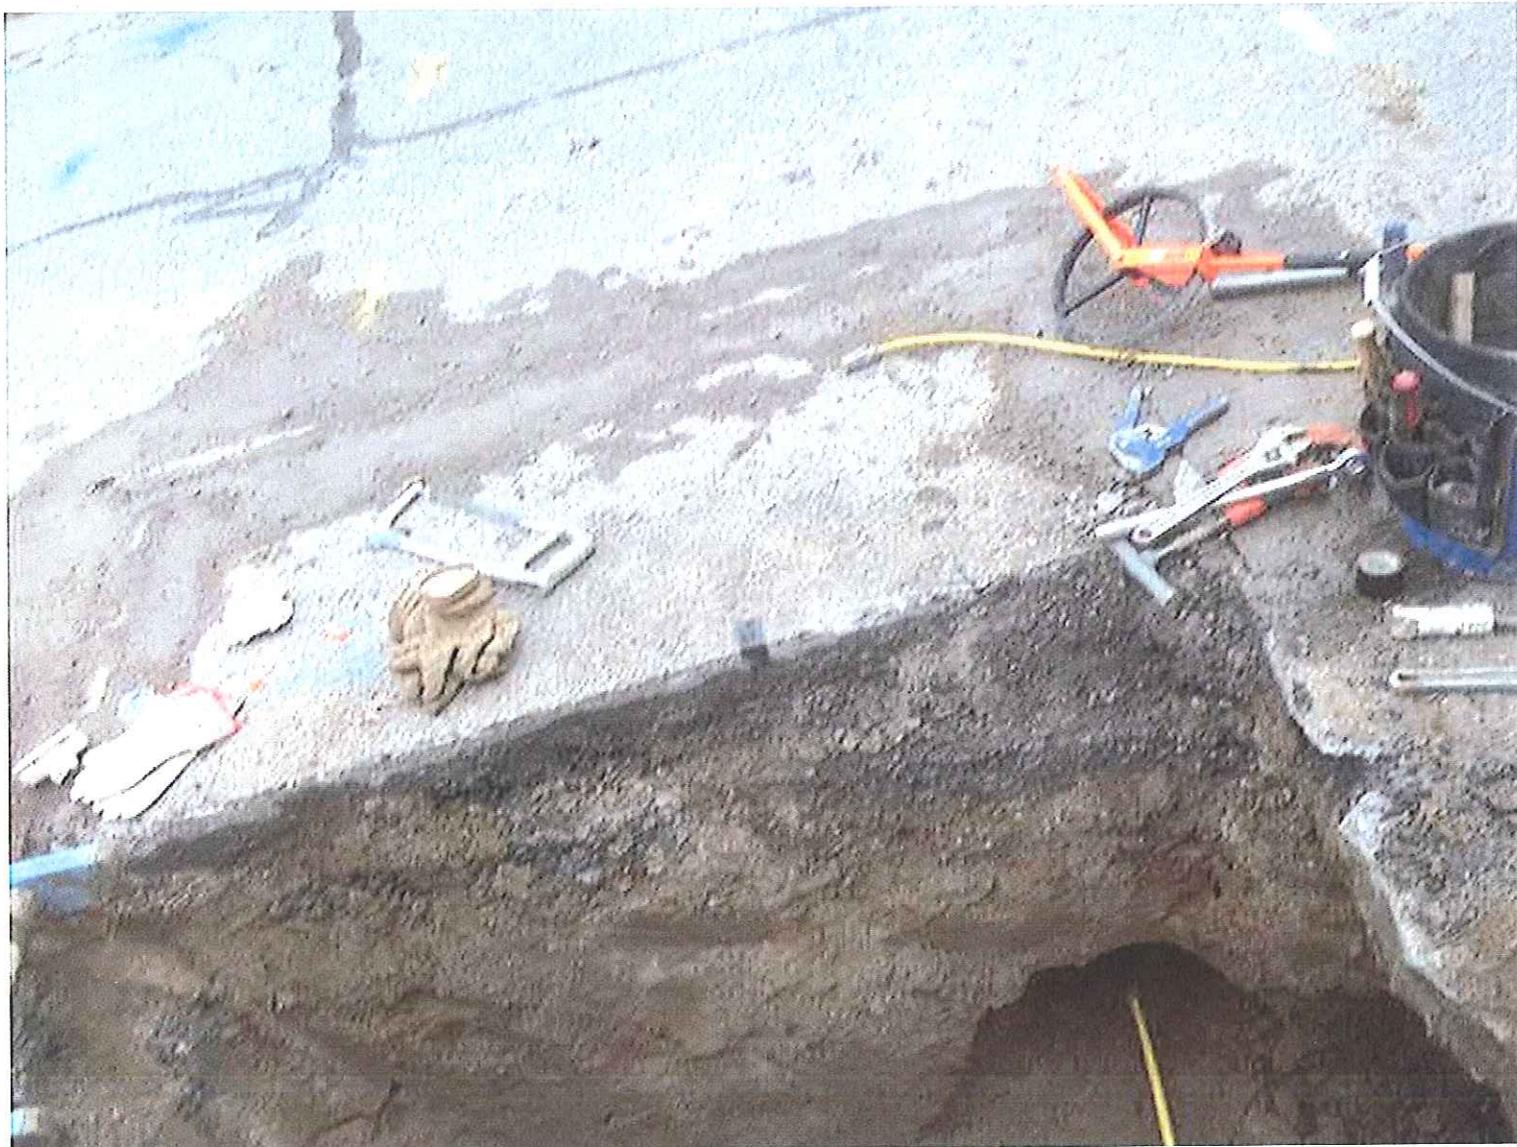
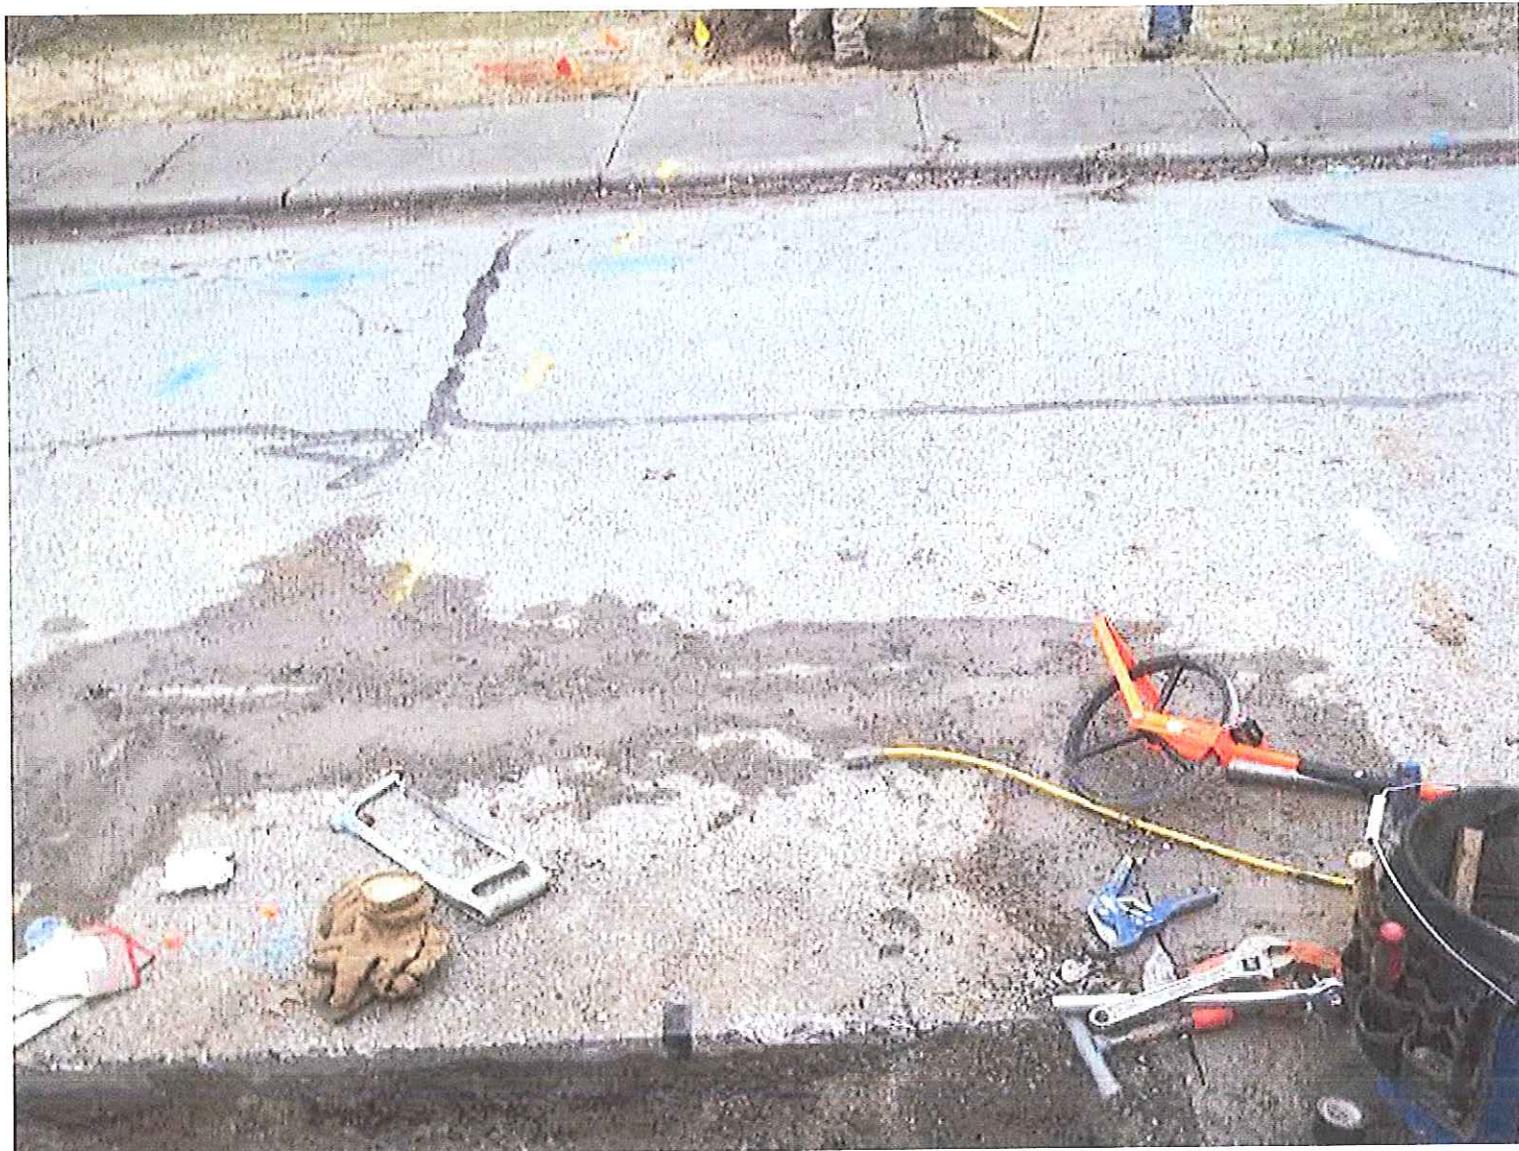
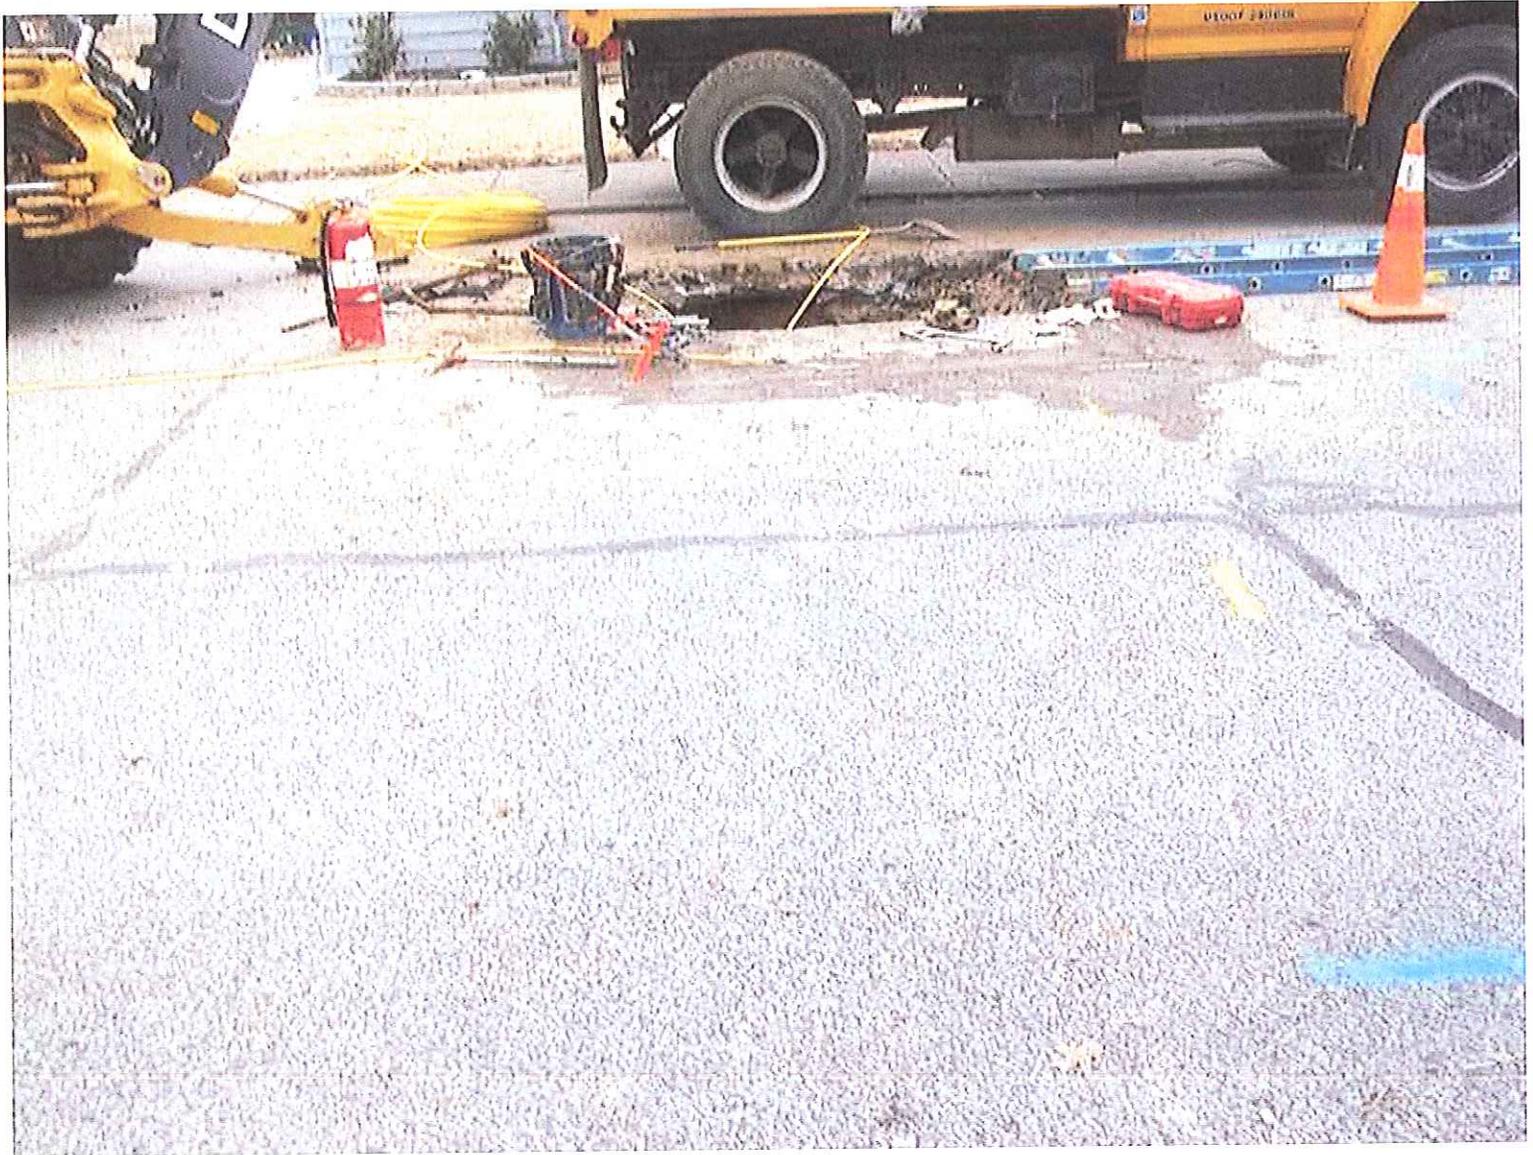
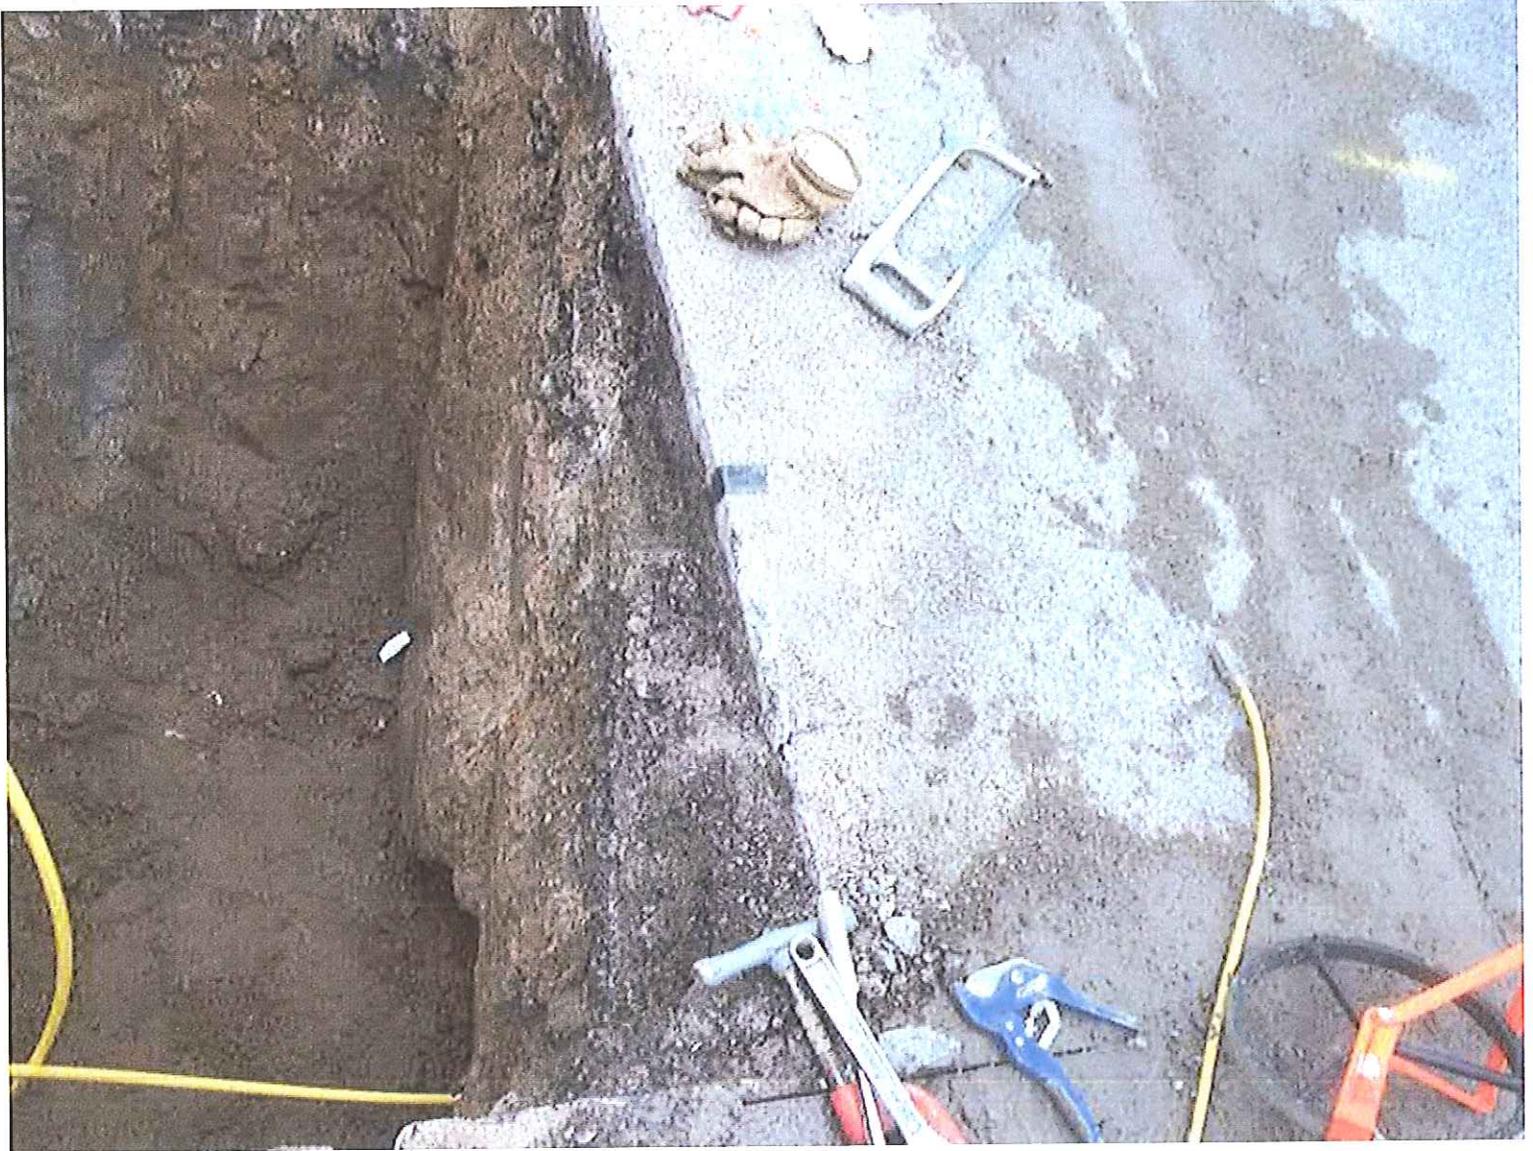
1/2" plastic service tee pulled from main. Broken or No Tracer Wire.

Property of United States Infrastructure Corporation  
Photo taken on 1/31/2013 4:22:16 PM

Property of United States Infrastructure Corporation  
Photo taken on 1/31/2013 4:22:44 PM

Property of United States Infrastructure Corporation  
Photo taken on 1/31/2013 4:23:30 PM

Property of United States Infrastructure Corporation  
Photo taken on 1/31/2013 4:23:38 PM

Property of United States Infrastructure Corporation  
Photo taken on 1/31/2013 4:23:46 PM

Property of United States Infrastructure Corporation  
Photo taken on 1/31/2013 4:24:26 PM

Property of United States Infrastructure Corporation  
Photo taken on 1/31/2013 4:24:36 PM

Property of United States Infrastructure Corporation  
Photo taken on 1/31/2013 4:24:52 PM

Property of United States Infrastructure Corporation  
Photo taken on 1/31/2013 4:25:24 PM

We were digging a bell hole for a service renewal and hand spotted main and found service tee for house across the street (214 S. Dexter). We began digging down 2 feet away from main and locate marks and when back-hoe operator curled his bucket he struck gas service 45" away from locate marks. see drawing and photos enclosed
