ANALYSIS OF BROWNFIELD CLEANUP ALTERNATIVES

Former Dodge Manufacturing Company / Former RMG Foundry Facility

500 South Union Street

Former Dodge Manufacturing Company / Former RMG Foundry
Main Foundry Building
500 Union Street
Mishawaka, Indiana 46544
Heartland Project #5306-24-01

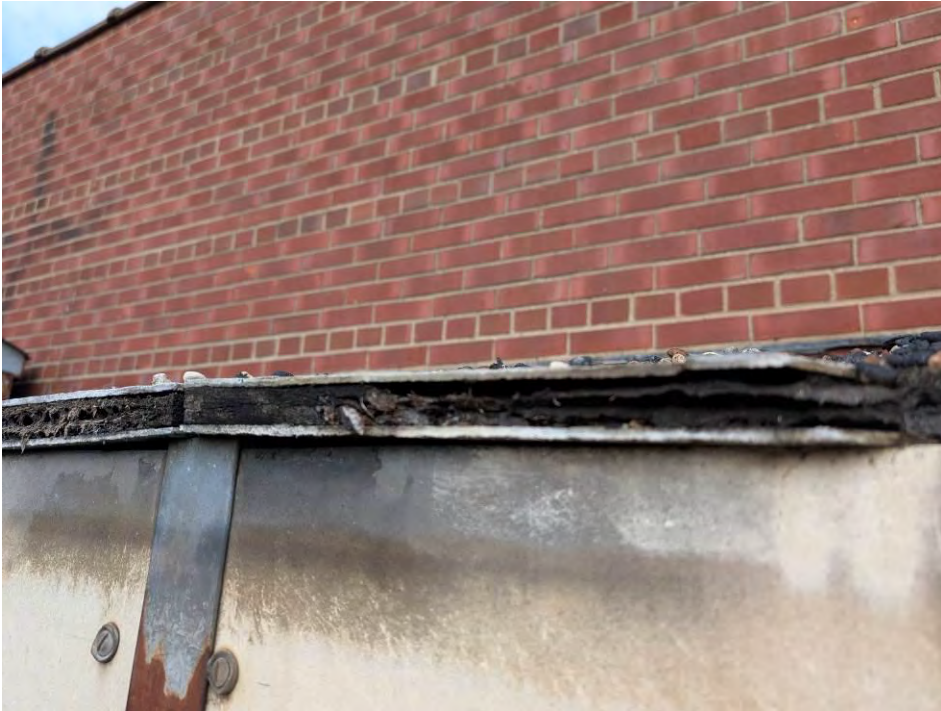
DATE: December 10, 2024
LOCATION: 500 Union Street in Mishawaka, Indiana
SUBJECT: View of double paneling structure of smooth panel transite siding
PHOTOGRAPHER: Ryan M. Orzechowicz (Heartland)
PHOTO: 27

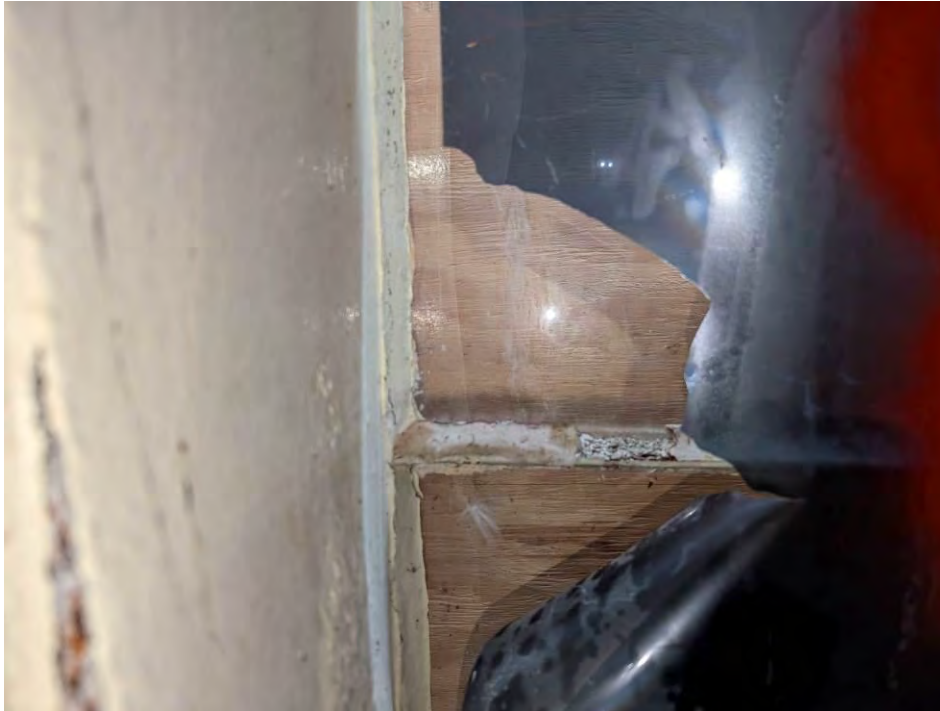
DATE: December 10, 2024
LOCATION: 500 Union Street in Mishawaka, Indiana
SUBJECT: View of sampled window glazing (WG-2)
PHOTOGRAPHER: Ryan M. Orzechowicz (Heartland)
PHOTO: 29

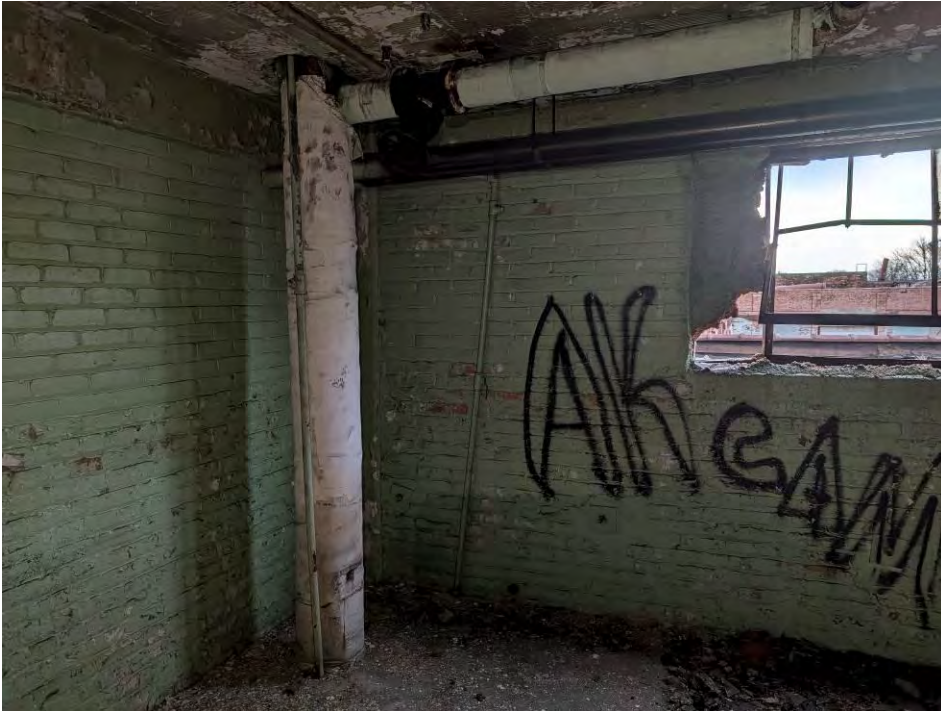
DATE: December 10, 2024
LOCATION: 500 Union Street in Mishawaka, Indiana
SUBJECT: View of ACM TSI pipe wrap
PHOTOGRAPHER: Ryan M. Orzechowicz (Heartland)
PHOTO: 65

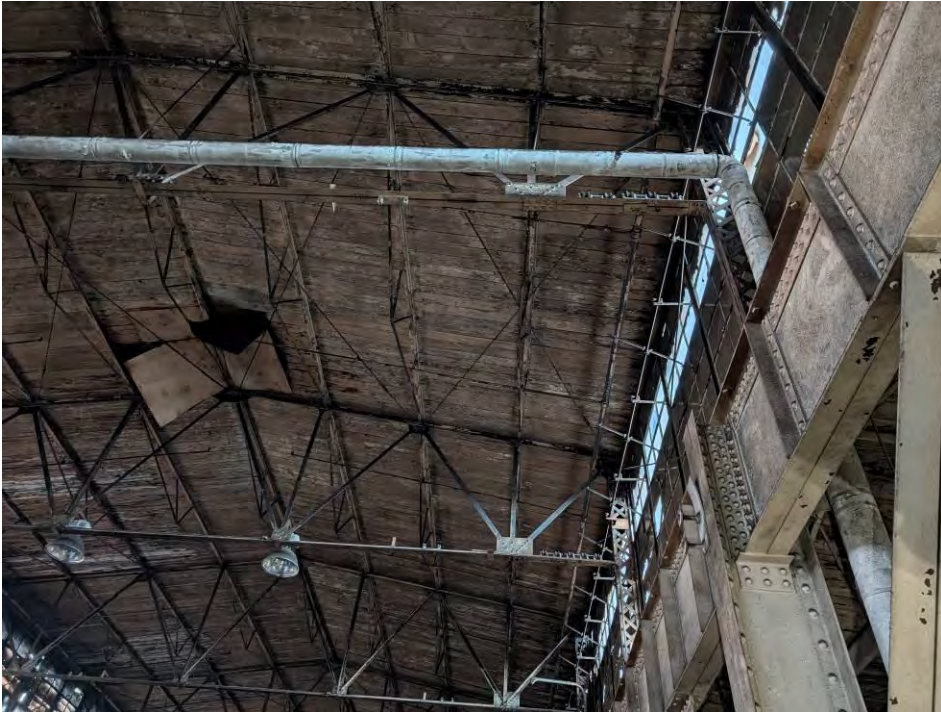
DATE: December 10, 2024
LOCATION: 500 Union Street in Mishawaka, Indiana
SUBJECT: View of ACM TSI pipe wrap
PHOTOGRAPHER: Ryan M. Orzechowicz (Heartland)
PHOTO: 69

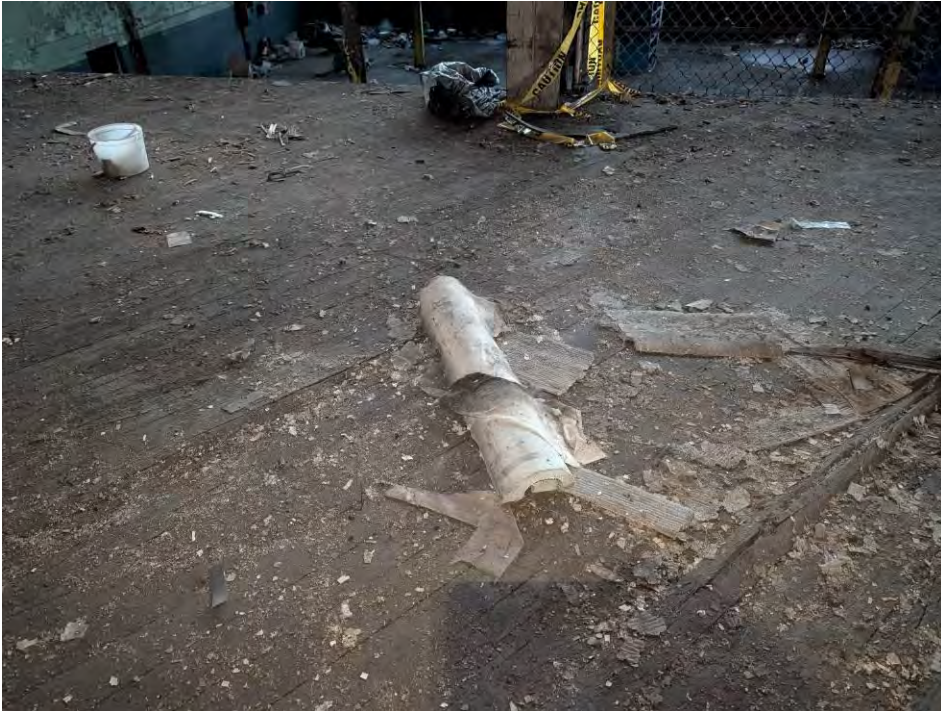
DATE: December 10, 2024
LOCATION: 500 Union Street in Mishawaka, Indiana
SUBJECT: View of ACM TSI pipe wrap scattered as debris
PHOTOGRAPHER: Ryan M. Orzechowicz (Heartland)
PHOTO: 71

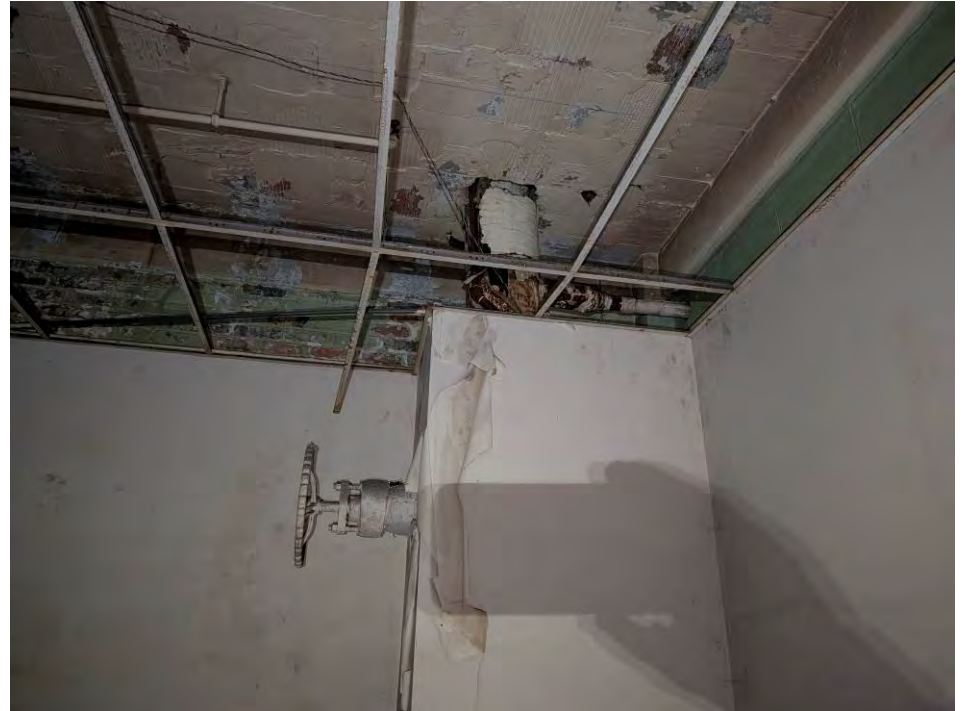
DATE: December 10, 2024
LOCATION: 500 Union Street in Mishawaka, Indiana
SUBJECT: View of ACM TSI pipe wrap
PHOTOGRAPHER: Ryan M. Orzechowicz (Heartland)
PHOTO: 72

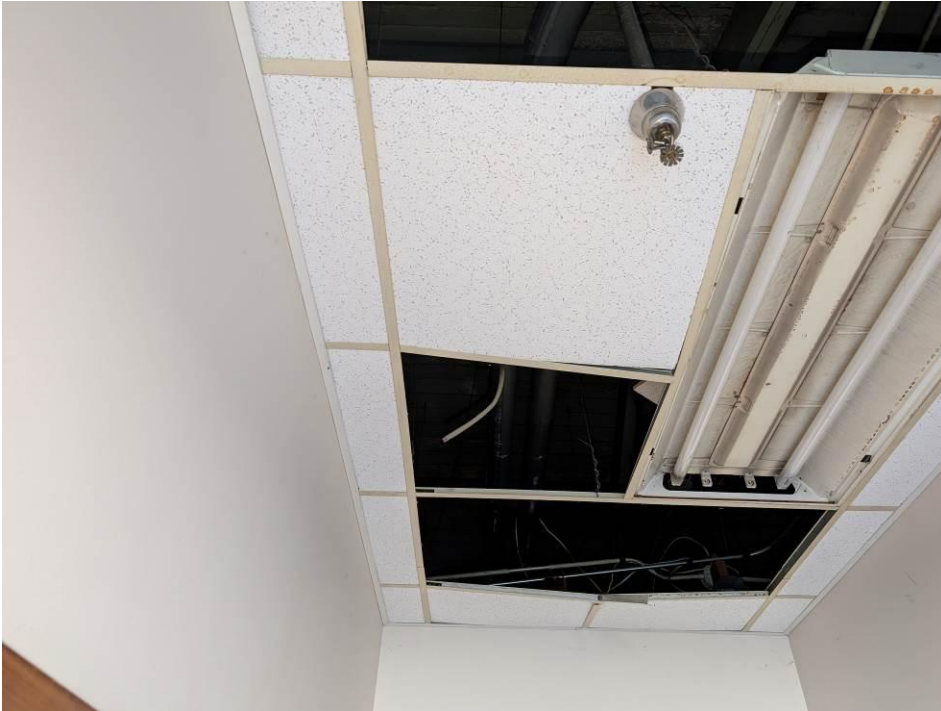
DATE: December 10, 2024
LOCATION: 628 Western Avenue in South Bend, Indian
SUBJECT: View of sampled floor tile (FT-4)
PHOTOGRAPHER: Ryan M. Orzechowicz (Heartland)
PHOTO: 12

As non-friable ACMs in the form of resilient vinyl flooring materials and associated mastics and asphalt roof flashing materials encountered are non-friable, these materials are recommended to be removed as part of demolition activities, provided the materials are not subject to sanding, grinding, abrading or any other mechanical operations which may damage the roofing materials and cause them to become friable. The flooring and roofing materials can be disposed of as construction related debris and will not require special abatement.

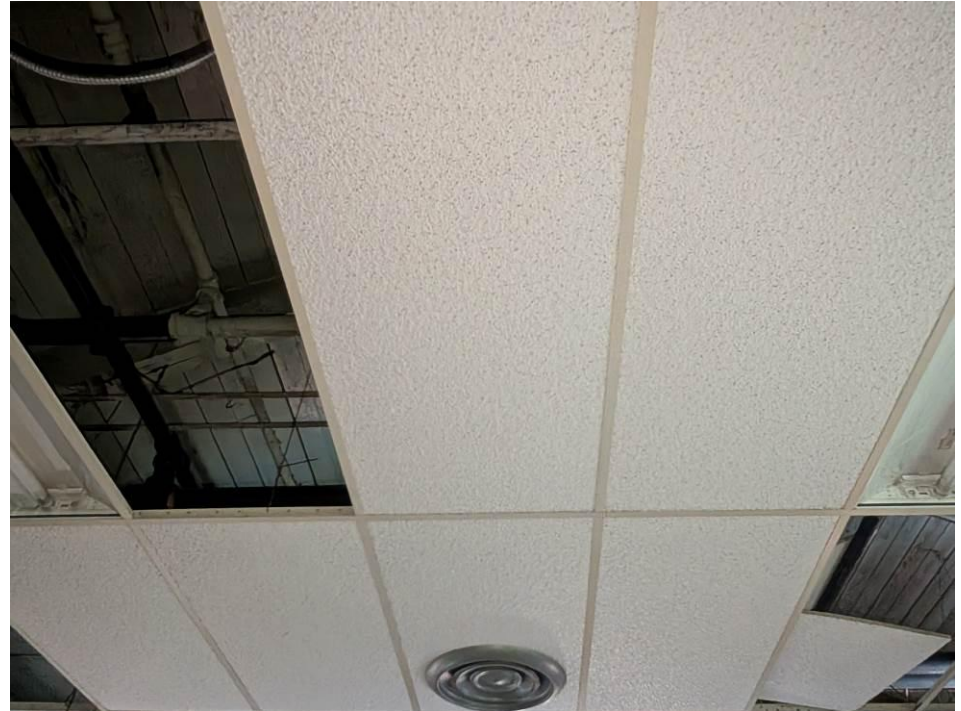
DATE: December 10, 2024
LOCATION: 500 Union Street in Mishawaka, Indiana (Power House Building)
SUBJECT: View of sampled ceiling tile (CT-1)
PHOTOGRAPHER: Ryan M. Orzechowicz (Heartland)
PHOTO: 13

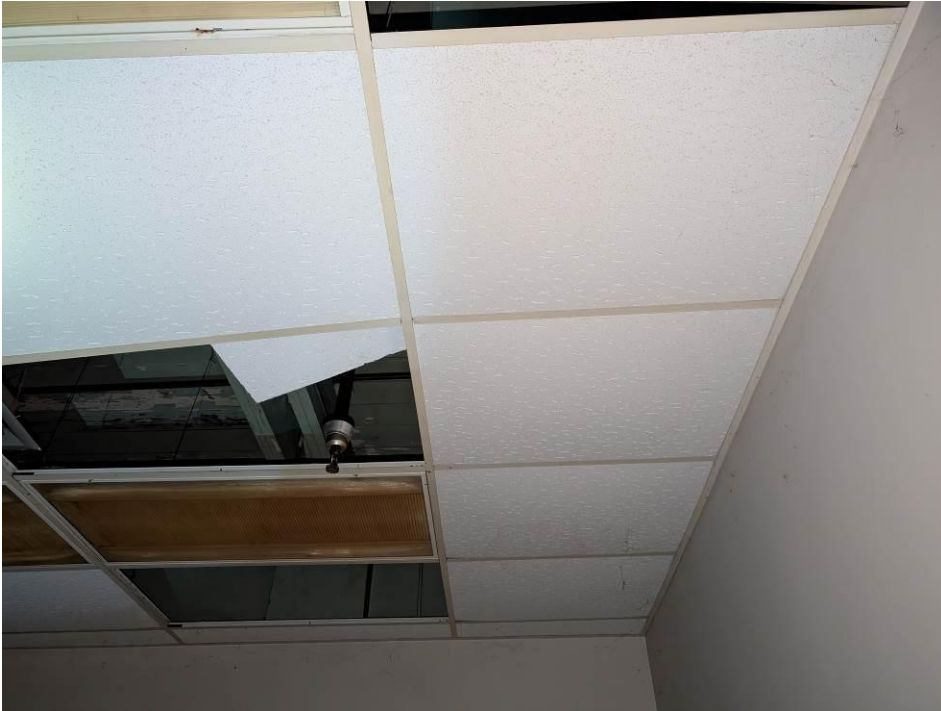
DATE: December 10, 2024
LOCATION: 500 Union Street in Mishawaka, Indiana (Power House Building)
SUBJECT: View of sampled ceiling tile (CT-2)
PHOTOGRAPHER: Ryan M. Orzechowicz (Heartland)
PHOTO: 14

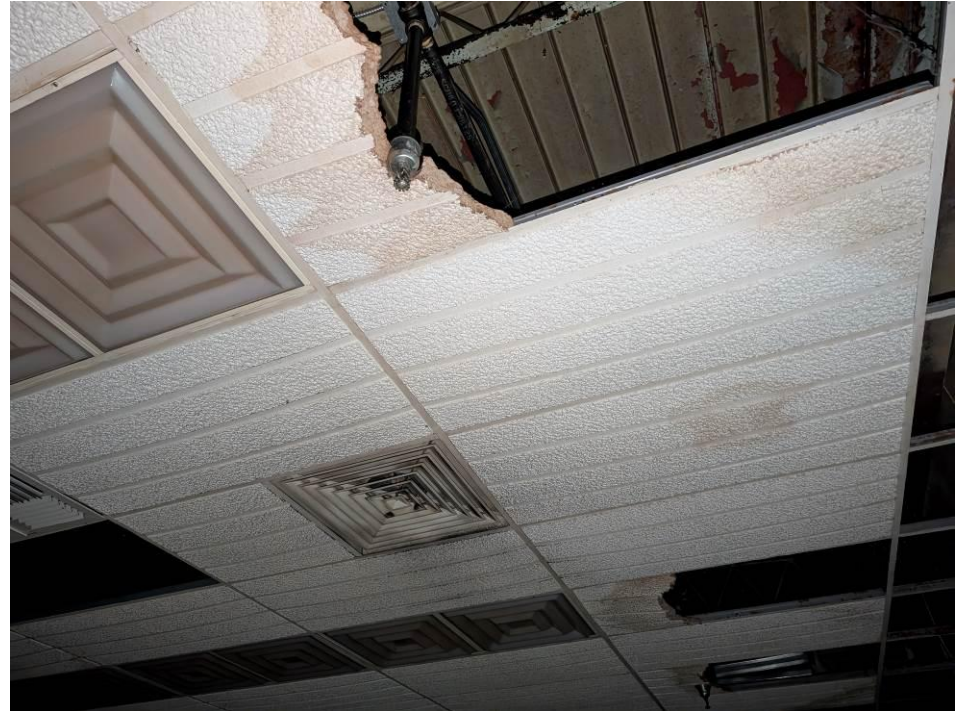
DATE: December 10, 2024
LOCATION: 500 Union Street in Mishawaka, Indiana (Power House Building)
SUBJECT: View of sampled ceiling tile (CT-3)
PHOTOGRAPHER: Ryan M. Orzechowicz (Heartland)
PHOTO: 15

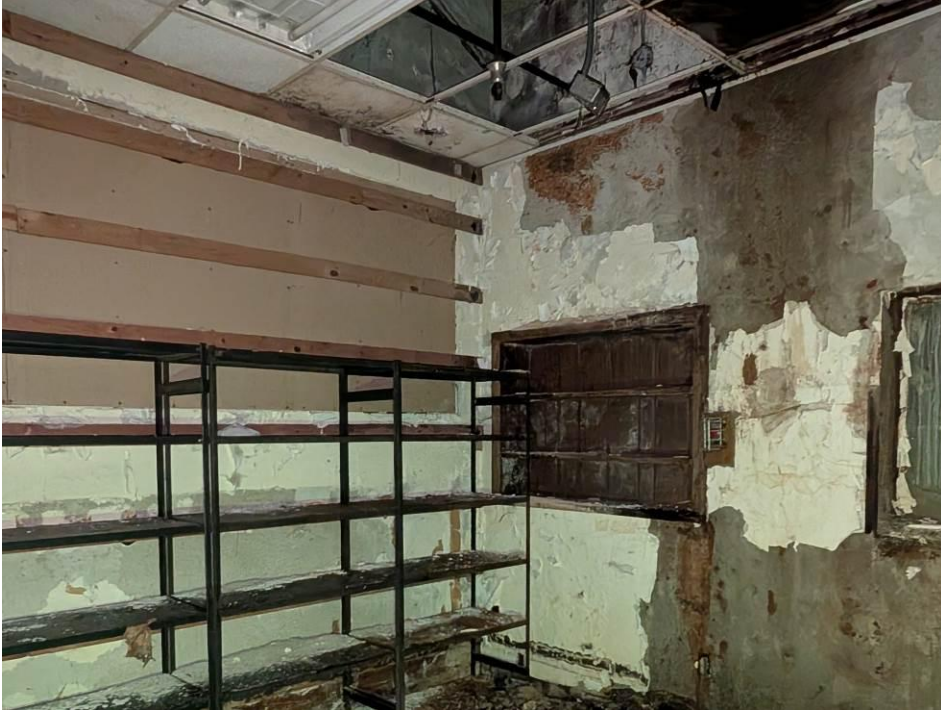
DATE: December 10, 2024
LOCATION: 500 Union Street in Mishawaka, Indiana (Power House Building)
SUBJECT: View of sampled ceiling tile (CT-4)
PHOTOGRAPHER: Ryan M. Orzechowicz (Heartland)
PHOTO: 16

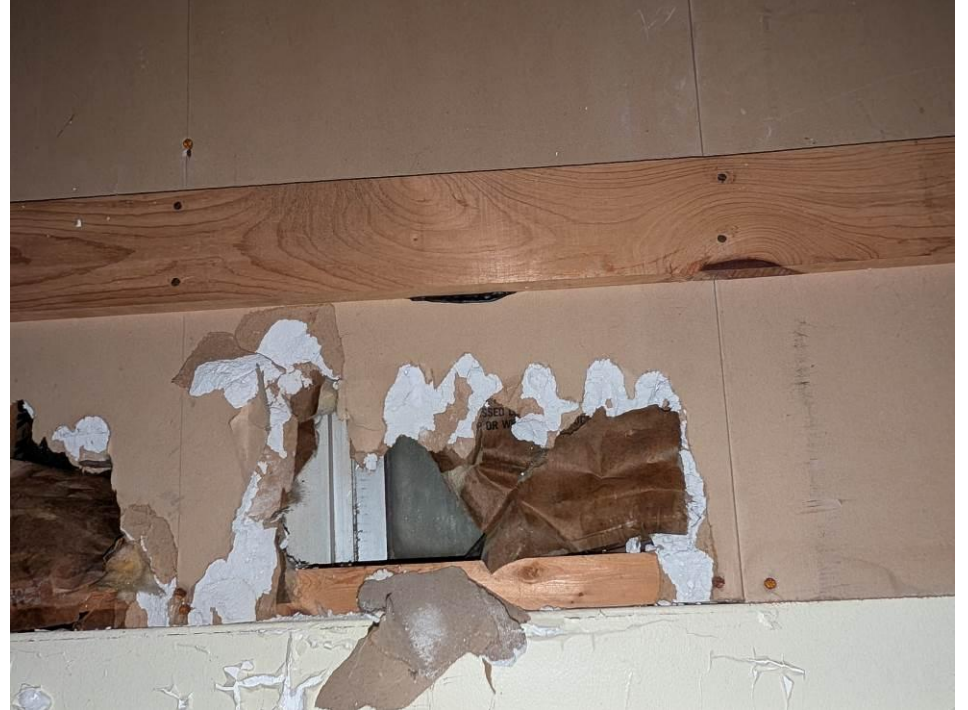
DATE: December 10, 2024
LOCATION: 500 Union Street in Mishawaka, Indiana (Power House Building)
SUBJECT: View of sampled plaster (PL-1)
PHOTOGRAPHER: Ryan M. Orzechowicz (Heartland)
PHOTO: 17

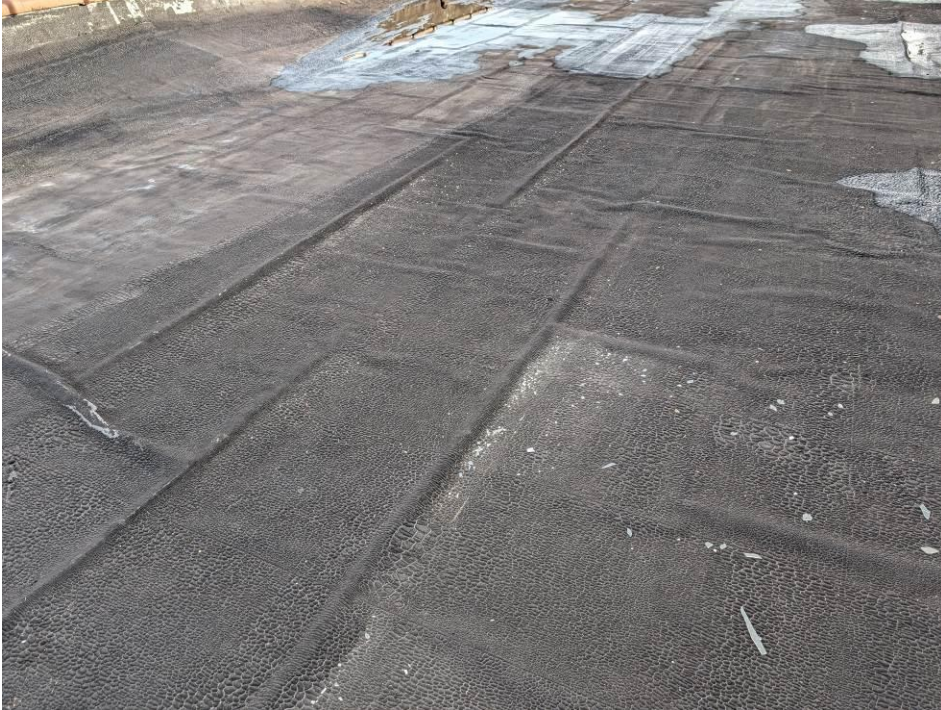
DATE: December 10, 2024
LOCATION: 500 Union Street in Mishawaka, Indiana (Power House Building)
SUBJECT: View of sampled rolled asphalt roofing (RF-1)
PHOTOGRAPHER: Ryan M. Orzechowicz (Heartland)
PHOTO: 22

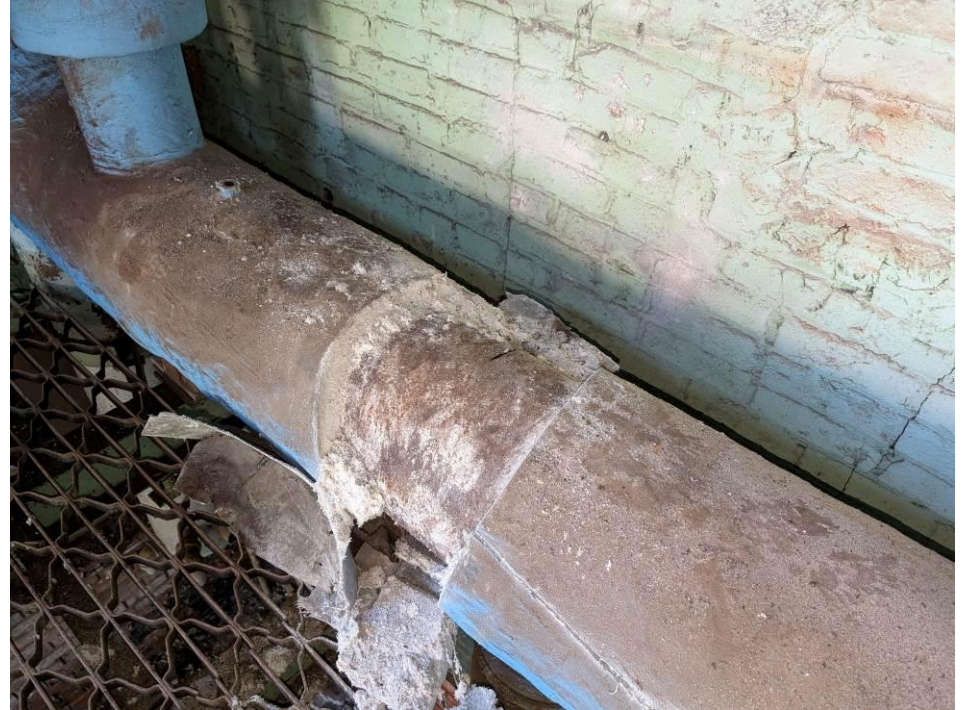
DATE: December 10, 2024
LOCATION: 500 Union Street in Mishawaka, Indiana (Power House Building)
SUBJECT: View of sampled mudded joint (MJ-1)
PHOTOGRAPHER: Ryan M. Orzechowicz (Heartland)
PHOTO: 27

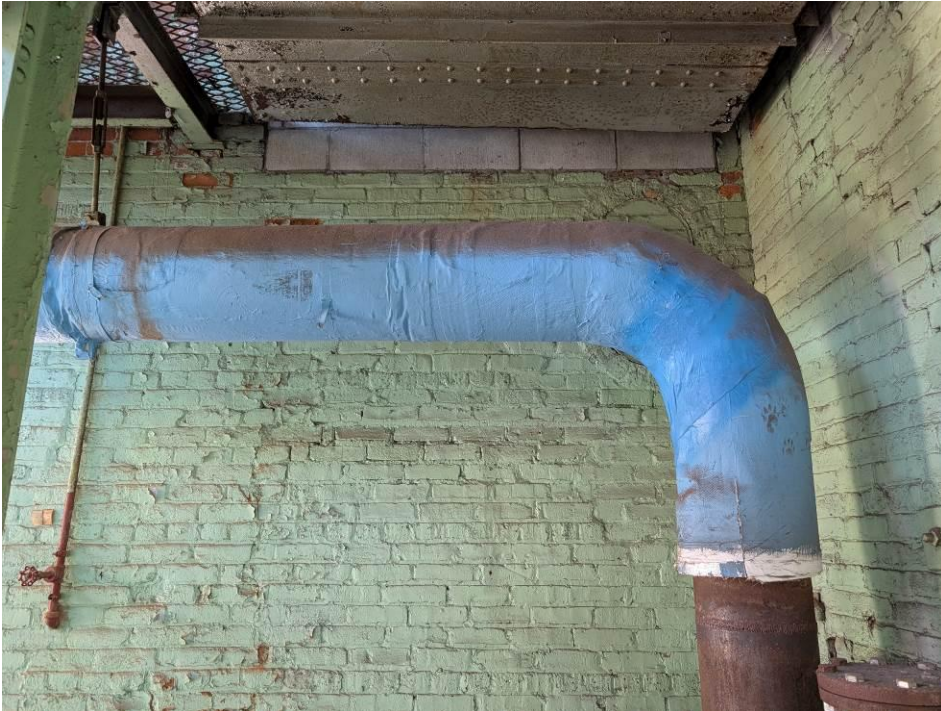
DATE: December 10, 2024
LOCATION: 500 Union Street in Mishawaka, Indiana (Power House Building)
SUBJECT: View of sampled TSI pipe wrap (PW-1)
PHOTOGRAPHER: Ryan M. Orzechowicz (Heartland)
PHOTO: 28

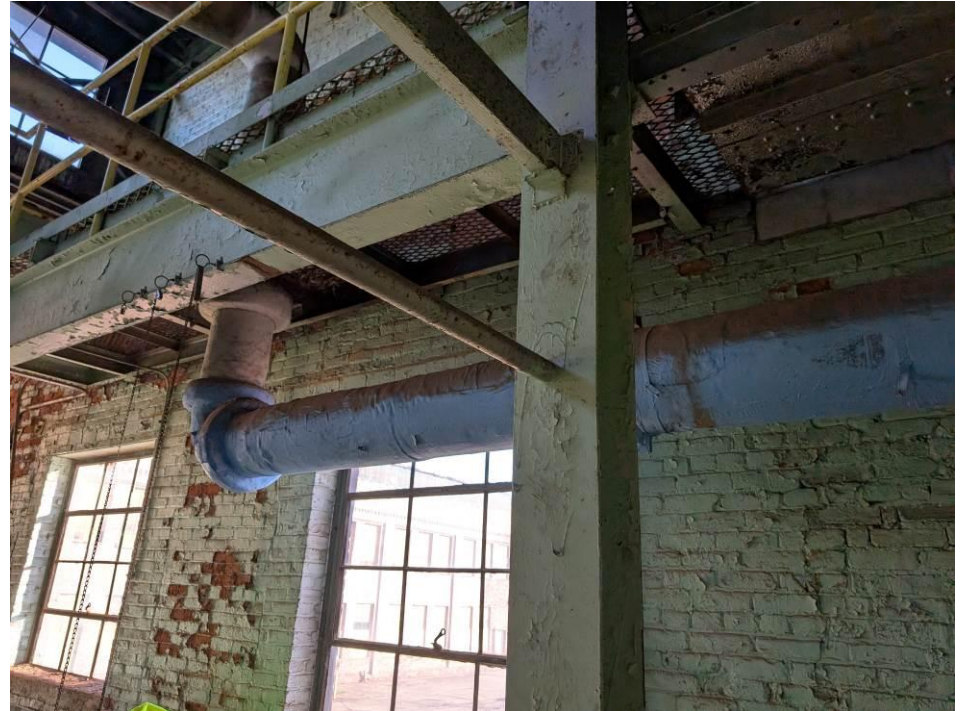
DATE: December 10, 2024
LOCATION: 500 Union Street in Mishawaka, Indiana (Power House Building)
SUBJECT: View of ACM TSI pipe wrap
PHOTOGRAPHER: Ryan M. Orzechowicz (Heartland)
PHOTO: 29

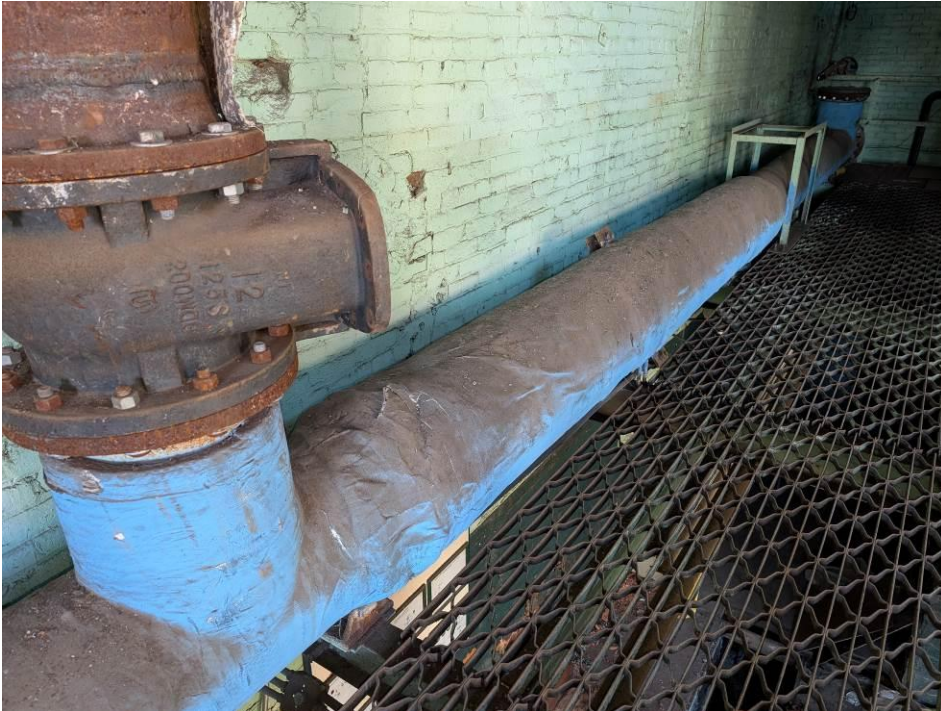
DATE: December 10, 2024
LOCATION: 500 Union Street in Mishawaka, Indiana (Power House Building)
SUBJECT: View of ACM TSI pipe wrap
PHOTOGRAPHER: Ryan M. Orzechowicz (Heartland)
PHOTO: 30

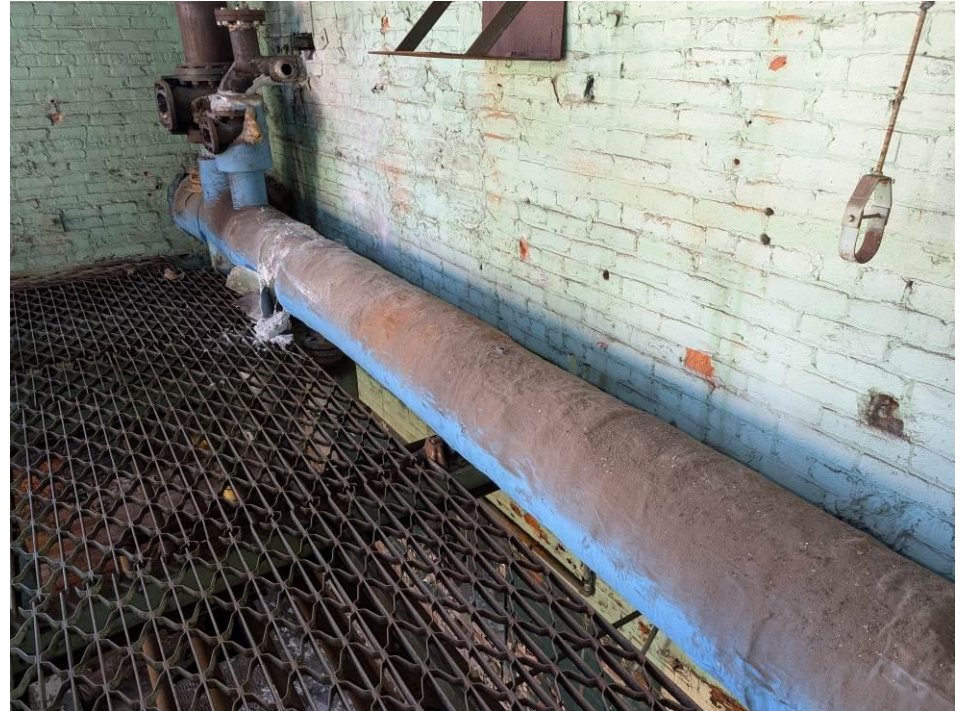
DATE: December 10, 2024
LOCATION: 500 Union Street in Mishawaka, Indiana (Power House Building)
SUBJECT: View of ACM TSI pipe wrap
PHOTOGRAPHER: Ryan M. Orzechowicz (Heartland)
PHOTO: 31
