**Re: Final Remediation Work Plan for Asbestos Containing Materials Abatement
Former Dodge Manufacturing Company / Former RMG Foundry Facility
500 South Union Street in Mishawaka, Indiana
Indiana Brownfields Program Site #4060054
USEPA Revolving Loan Fund Cooperative Agreement #4B-00E03232
Heartland Project #5113-26-04**

**Former Dodge Manufacturing Company / Former RMG Foundry
Main Foundry Building
500 South Union Street
Mishawaka, Indiana 46544**

Former Dodge Manufacturing Company / Former RMG Foundry
Main Foundry Building
500 Union Street
Mishawaka, Indiana 46544
Heartland Project #5306-24-01

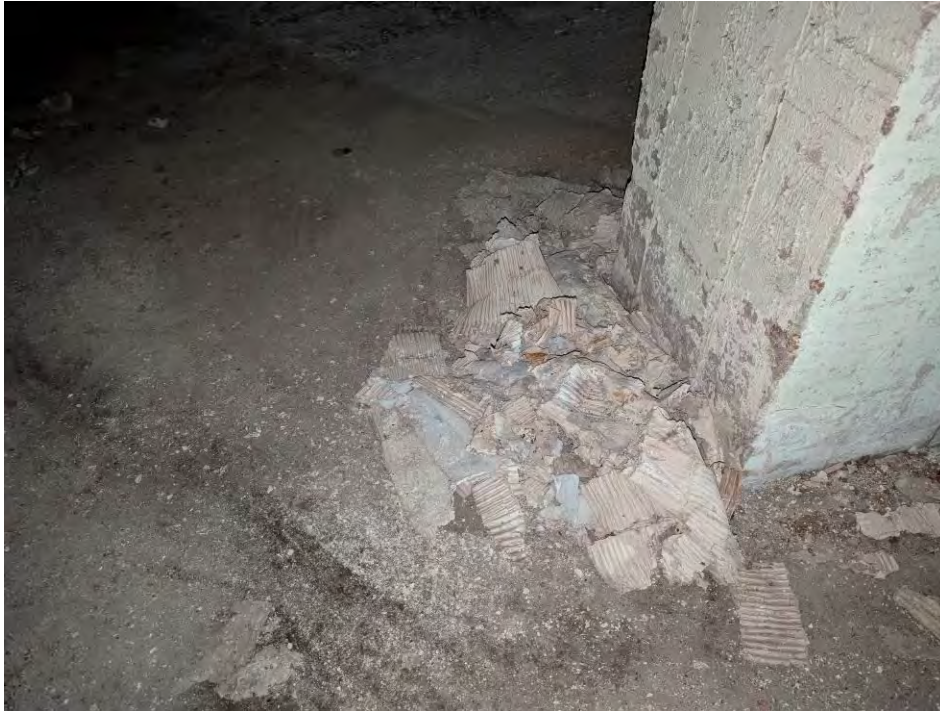
DATE: December 10, 2024
LOCATION: 500 Union Street in Mishawaka, Indiana
SUBJECT: View of sampled corrugated debris in basement of warehouse (DB-1)
PHOTOGRAPHER: Ryan M. Orzechowicz (Heartland)
PHOTO: 33

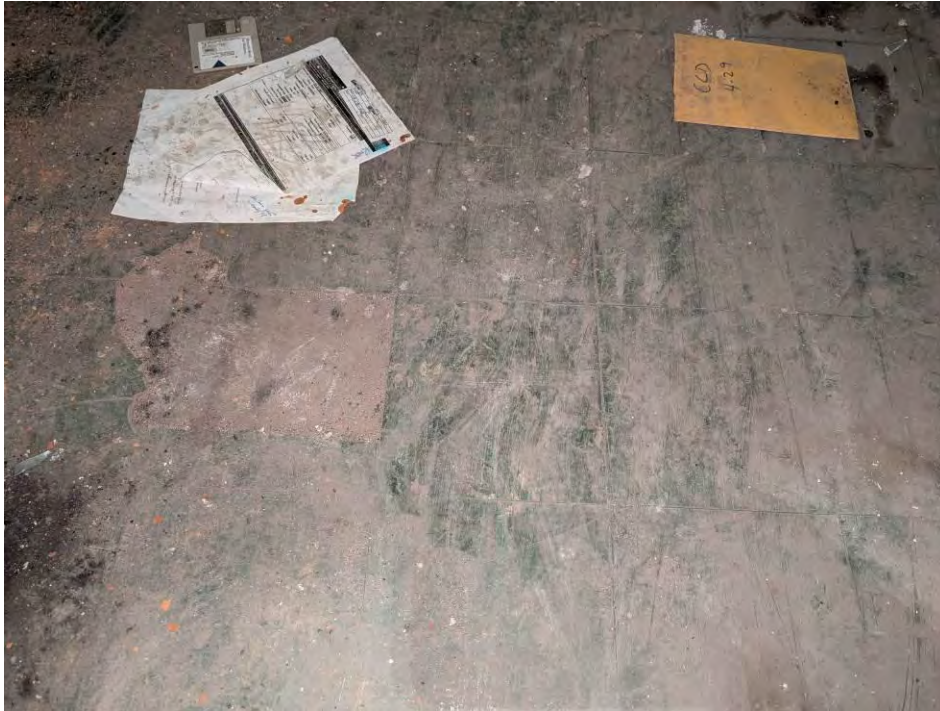
Floor Tile/Mastic – 9” x 9” Green / Streaks – Main Foundry Rooms	No	I (Mastic Only)	2% Chrysotile (Tile and Mastic)	~1,500	FT – 2 (A-E)
Floor Tile/Mastic – 12” x 12” Gray / Marble – Southeast Rooms in Main Foundry	No	I (Mastic Only)	ND	~800	FT – 3 (A-C)

DATE: December 10, 2024
LOCATION: 500 Union Street in Mishawaka, Indiana
SUBJECT: View of sampled floor tile (FT-2)
PHOTOGRAPHER: Ryan M. Orzechowicz (Heartland)
PHOTO: 35

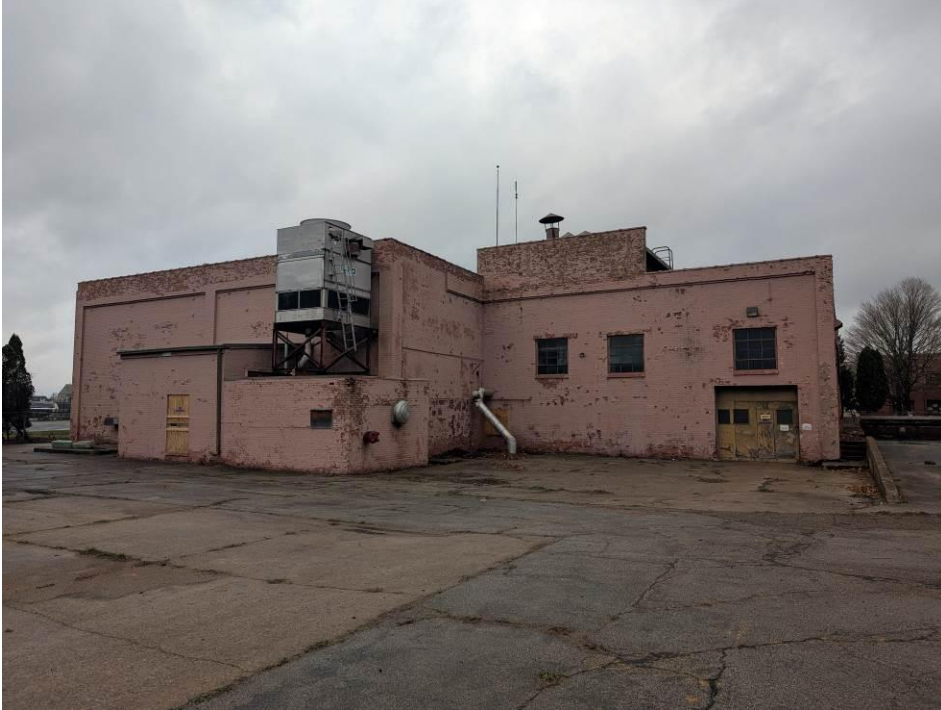
DATE: December 10, 2024
LOCATION: 500 Union Street in Mishawaka, Indiana (Power House Building)
SUBJECT: View of east face of power house building
PHOTOGRAPHER: Ryan M. Orzechowicz (Heartland)
PHOTO: 4

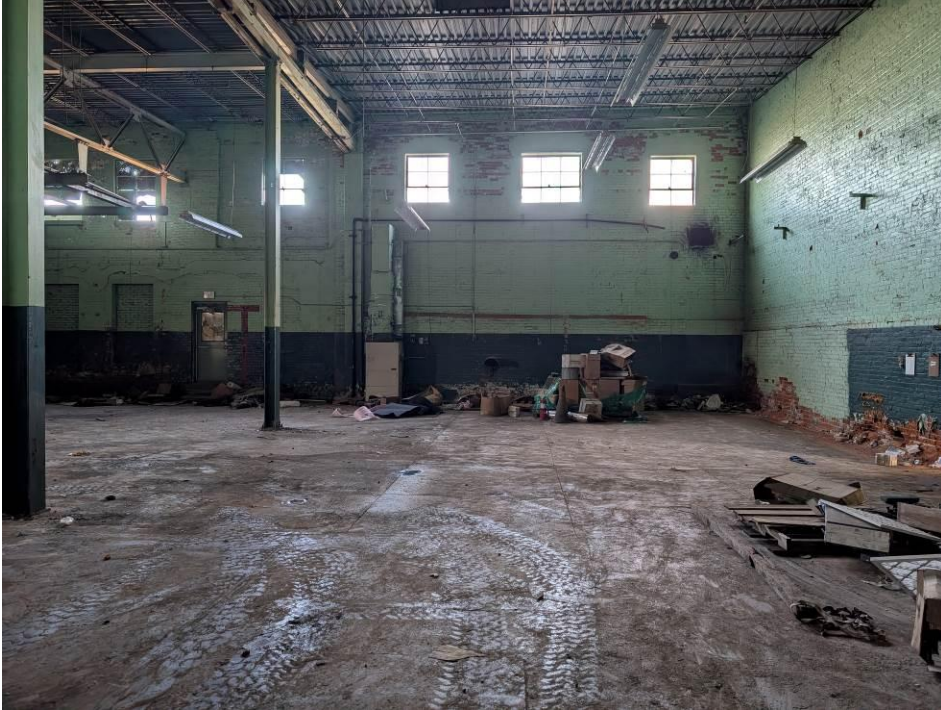
DATE: December 10, 2024
LOCATION: 500 Union Street in Mishawaka, Indiana (Power House Building)
SUBJECT: View of interior of power house building
PHOTOGRAPHER: Ryan M. Orzechowicz (Heartland)
PHOTO: 6

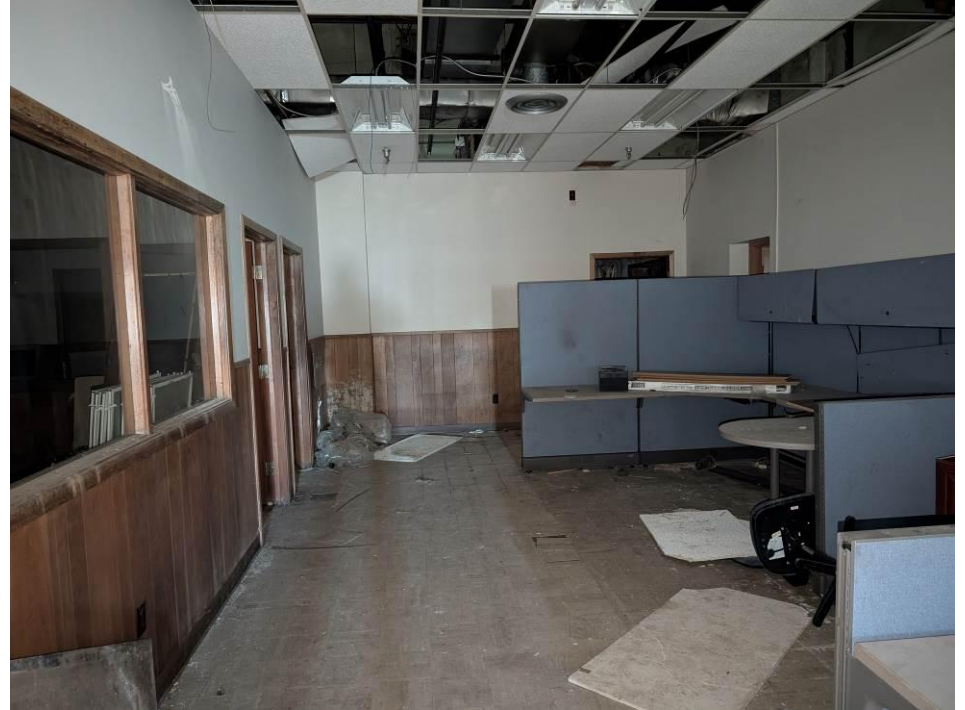
DATE: December 10, 2024
LOCATION: 500 Union Street in Mishawaka, Indiana (Power House Building)
SUBJECT: View of interior of power house building
PHOTOGRAPHER: Ryan M. Orzechowicz (Heartland)
PHOTO: 7

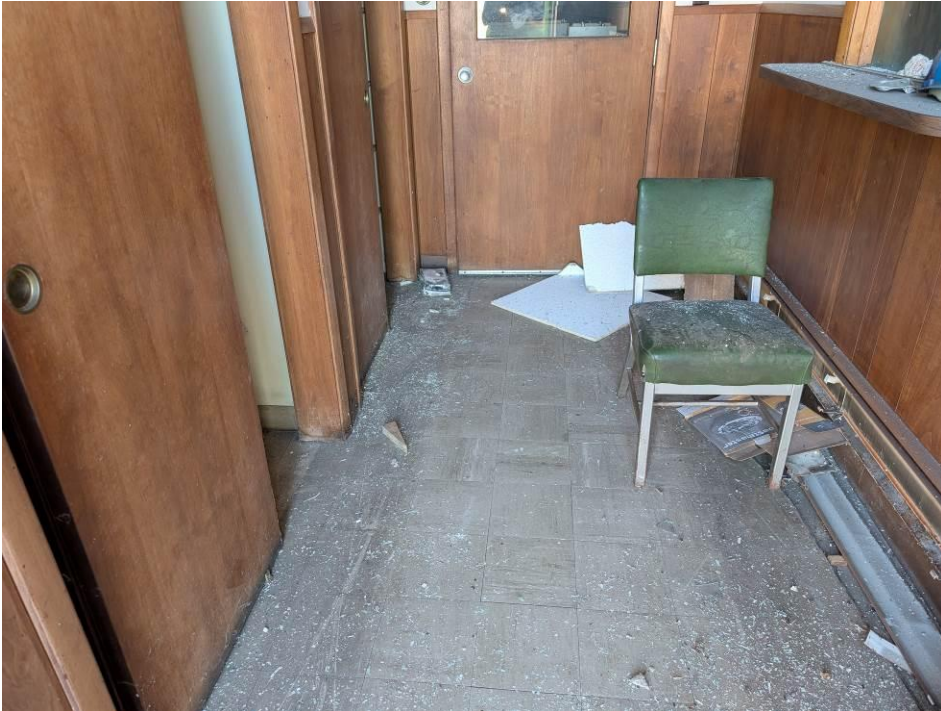
DATE: December 10, 2024
LOCATION: 500 Union Street in Mishawaka, Indiana (Power House Building)
SUBJECT: View of interior of office portion of power house building
PHOTOGRAPHER: Ryan M. Orzechowicz (Heartland)
PHOTO: 8

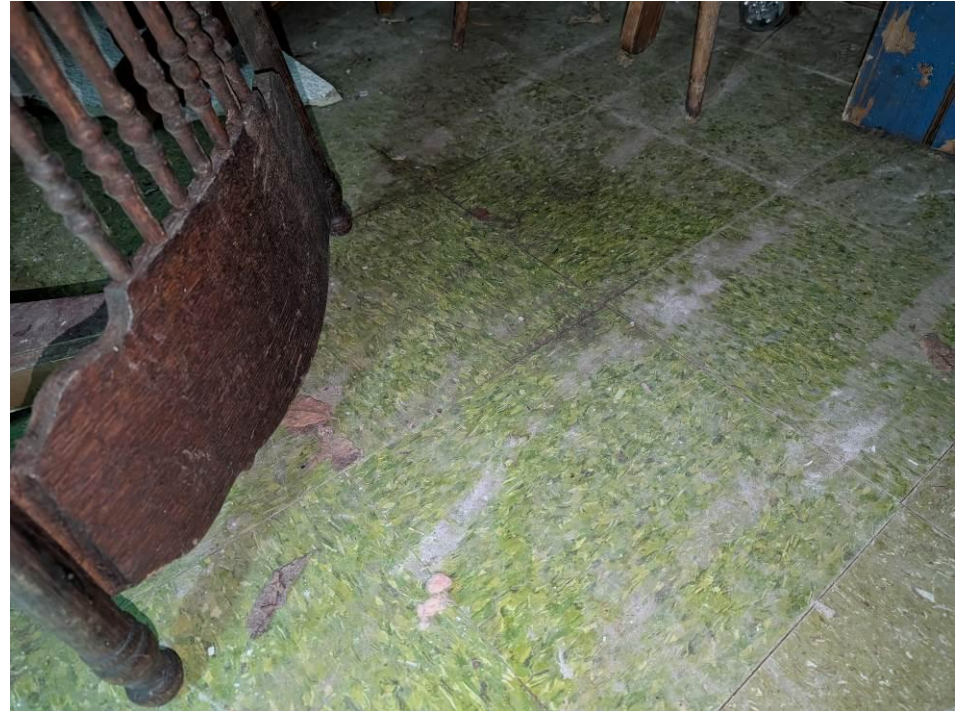
DATE: December 10, 2024
LOCATION: 500 Union Street in Mishawaka, Indiana (Power House Building)
SUBJECT: View of sampled floor tile (FT-1)
PHOTOGRAPHER: Ryan M. Orzechowicz (Heartland)
PHOTO: 9

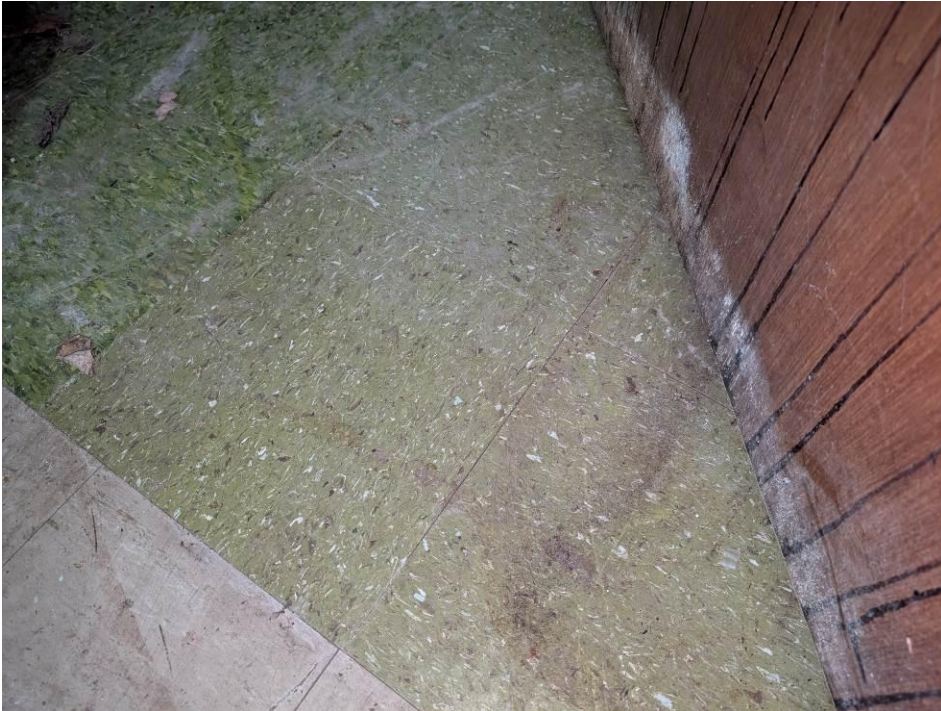
DATE: December 10, 2024
LOCATION: 500 Union Street in Mishawaka, Indiana (Power House Building)
SUBJECT: View of sampled floor tile (FT-2)
PHOTOGRAPHER: Ryan M. Orzechowicz (Heartland)
PHOTO: 10

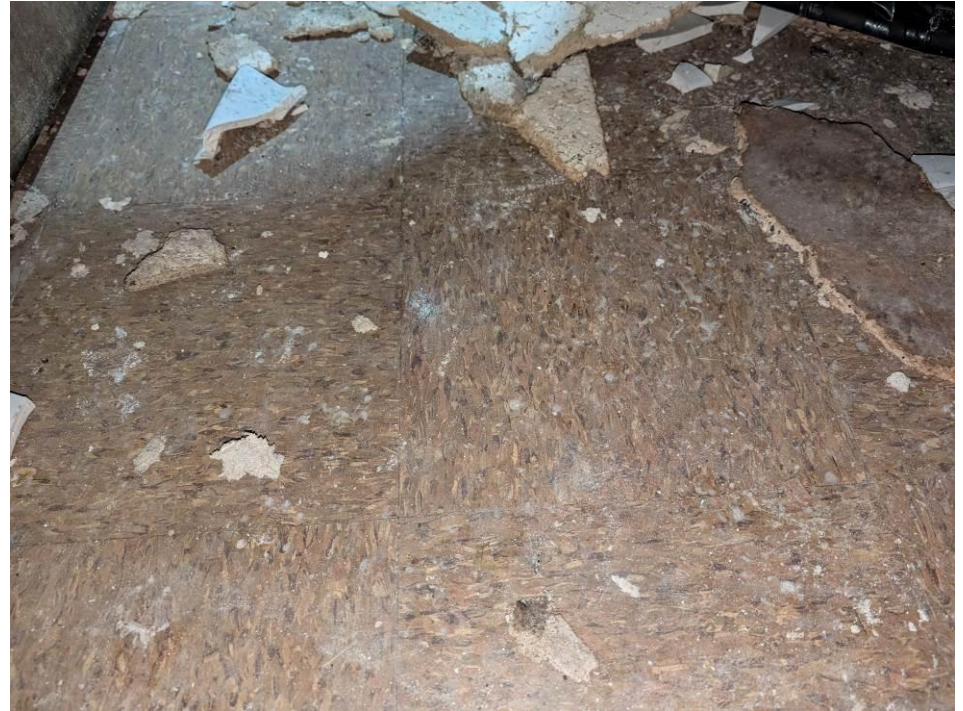
DATE: December 10, 2024
LOCATION: 500 Union Street in Mishawaka, Indiana (Power House Building)
SUBJECT: View of sampled floor tile (FT-3)
PHOTOGRAPHER: Ryan M. Orzechowicz (Heartland)
PHOTO: 11

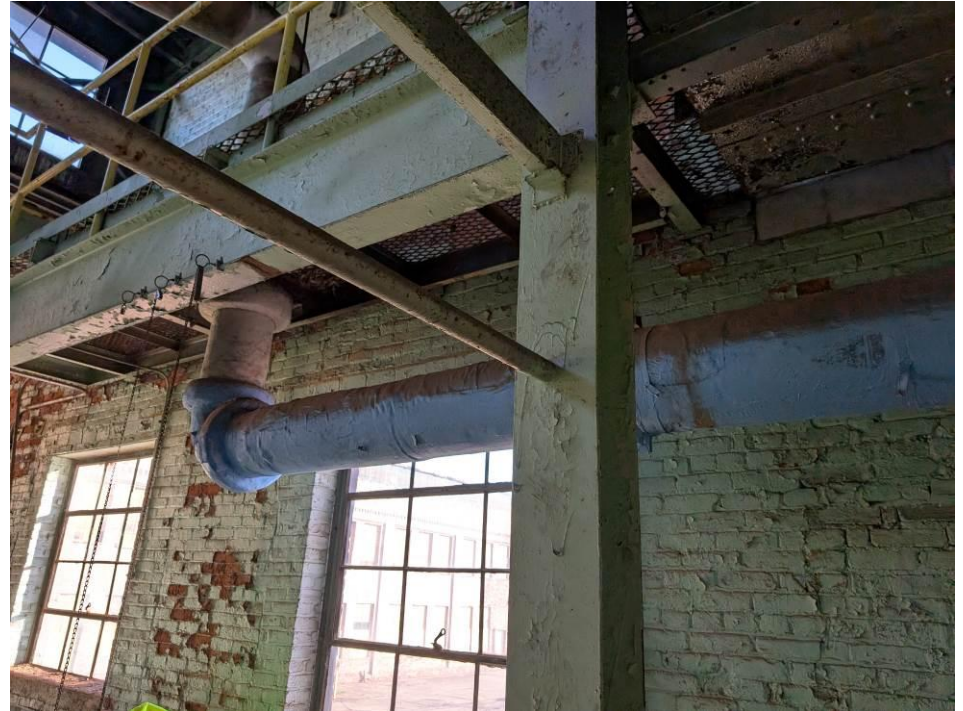
In general, the RACMs were encountered in fair to poor condition, with several sections of TSI pipe wrap and pipe fittings encountered either intact or slightly damaged. However, significant amounts of TSI were observed to be damaged or significantly damaged. Potential exposure to damaged and friable RACMs is a concern at this time, and care should be taken to limit entry into the site building until abatement activities can commence.

DATE: December 10, 2024
LOCATION: 500 Union Street in Mishawaka, Indiana (Power House Building)
SUBJECT: View of ACM TSI pipe wrap
PHOTOGRAPHER: Ryan M. Orzechowicz (Heartland)
PHOTO: 29
