## **Traders Point Lake Dam Inspection**

July 2020 Dam Inspection and Repair Report December 2020

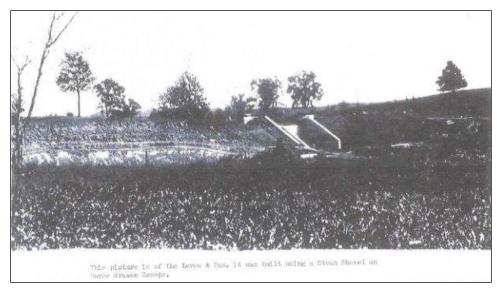
Figure No. 1 1927 Construction Photo

According to the Owner, the dam was constructed in 1927 (93 years ago). A record photo of the dam has a caption that states it was built using a steam shovel and horse drawn scoops. See photo below.

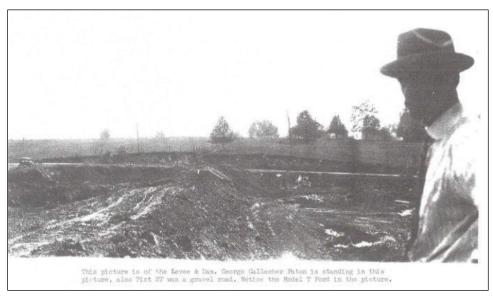
Figure No. 2 1927 Construction Photo

Another photo from the Owner is of a man named George Gallacher Paton, assumed to be the builder of this dam. See photo below. No designs or plans are known to have been prepared for this dam.

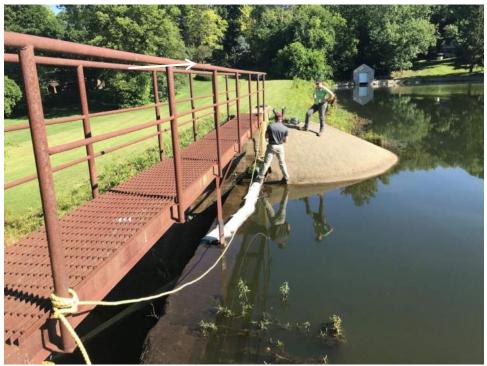
**Photo A1:** View of bridge over the spillway looking North. Note poured concrete on the upstream corners of the connection from the concrete spillway to the upstream embankment. This concrete has voids under the concrete.

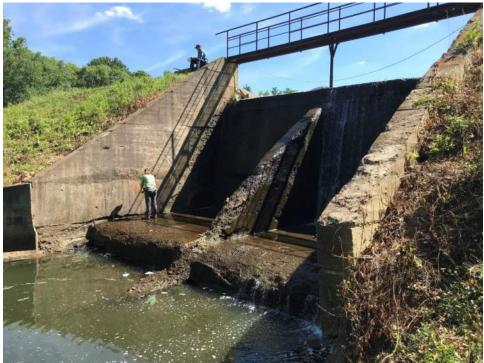
Photo A2: Full view of the downstream side of the spillway looking NE.

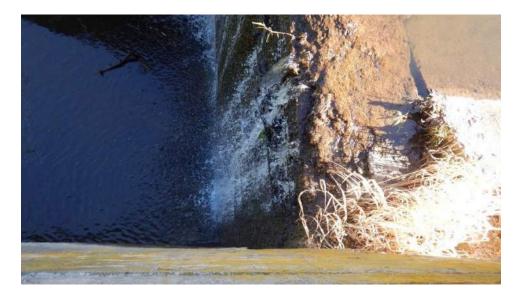
**Photo A12:** View of the connection of the spillway wall looking down at the LT spillway abutment wall. Note spillway wall shows erosion of the concrete.

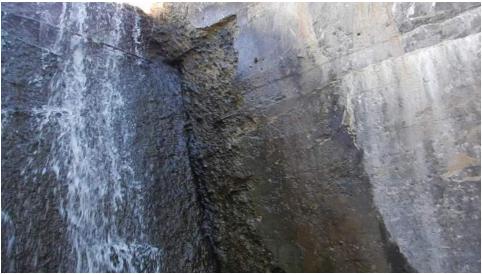
**Photo A13:** View of the connection of the spillway wall looking up at the LT spillway abutment wall. Note spillway wall shows erosion of the concrete.

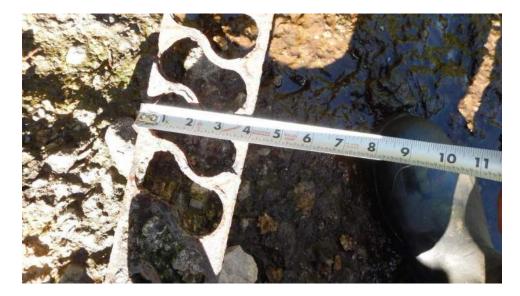
**Photo A16:** Close-up view of what appears to be stamped metal plates that were used as reinforcing.

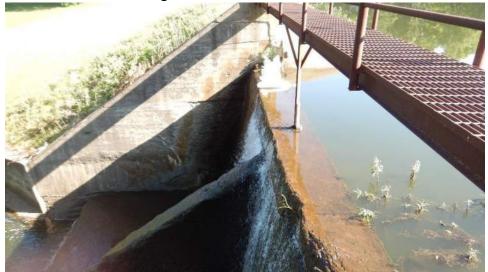
**Photo A17:** View of the spillway looking north. Note the buttress wall in the center of the spillway.

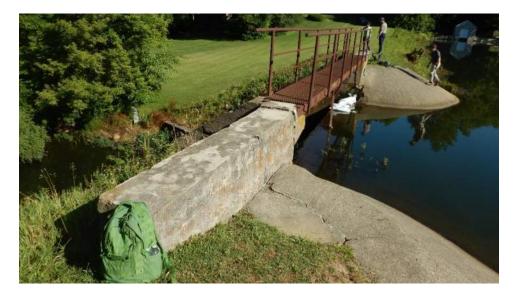
**Photo A18:** View of the upstream and crest area of the spillway structure. Note the concrete abutment walls

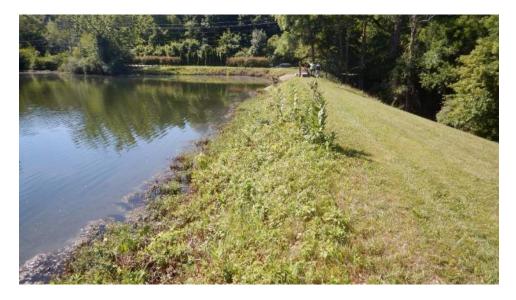
**Photo A24:** View looking South, at upstream embankment east of the spillway where the crest width is only 2 ft wide. Note the downstream sideslope is flat enough to be drivable.

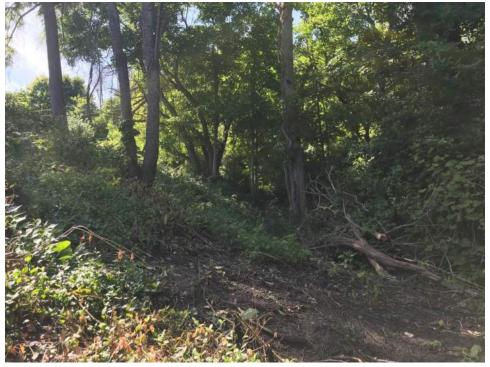
**Photo A36:** View of the left, downstream embankment. Note trees need to be removed.

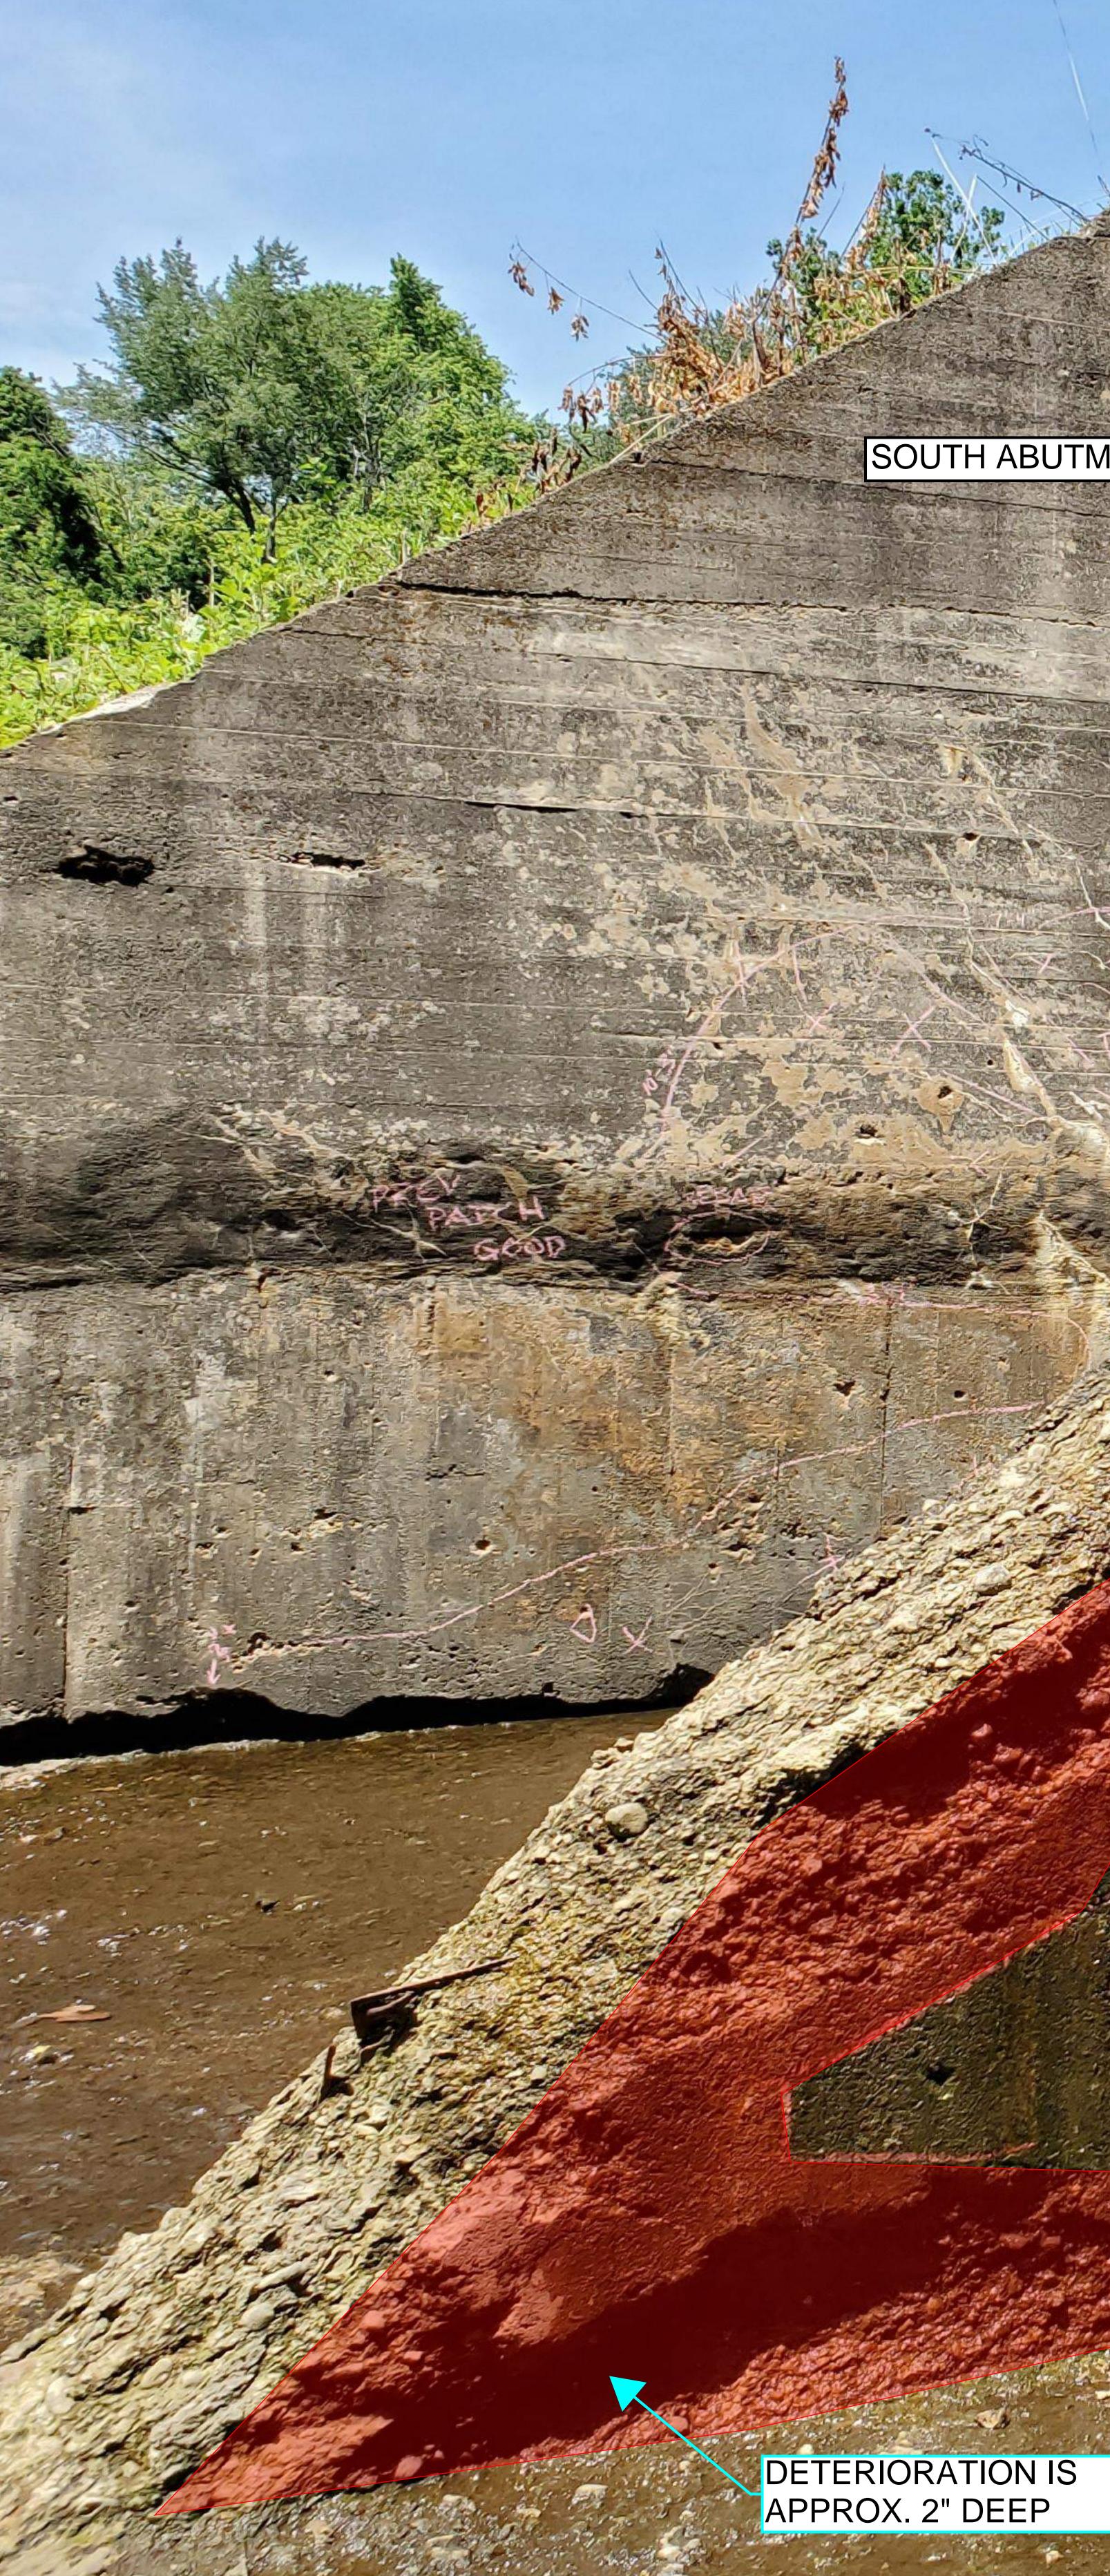
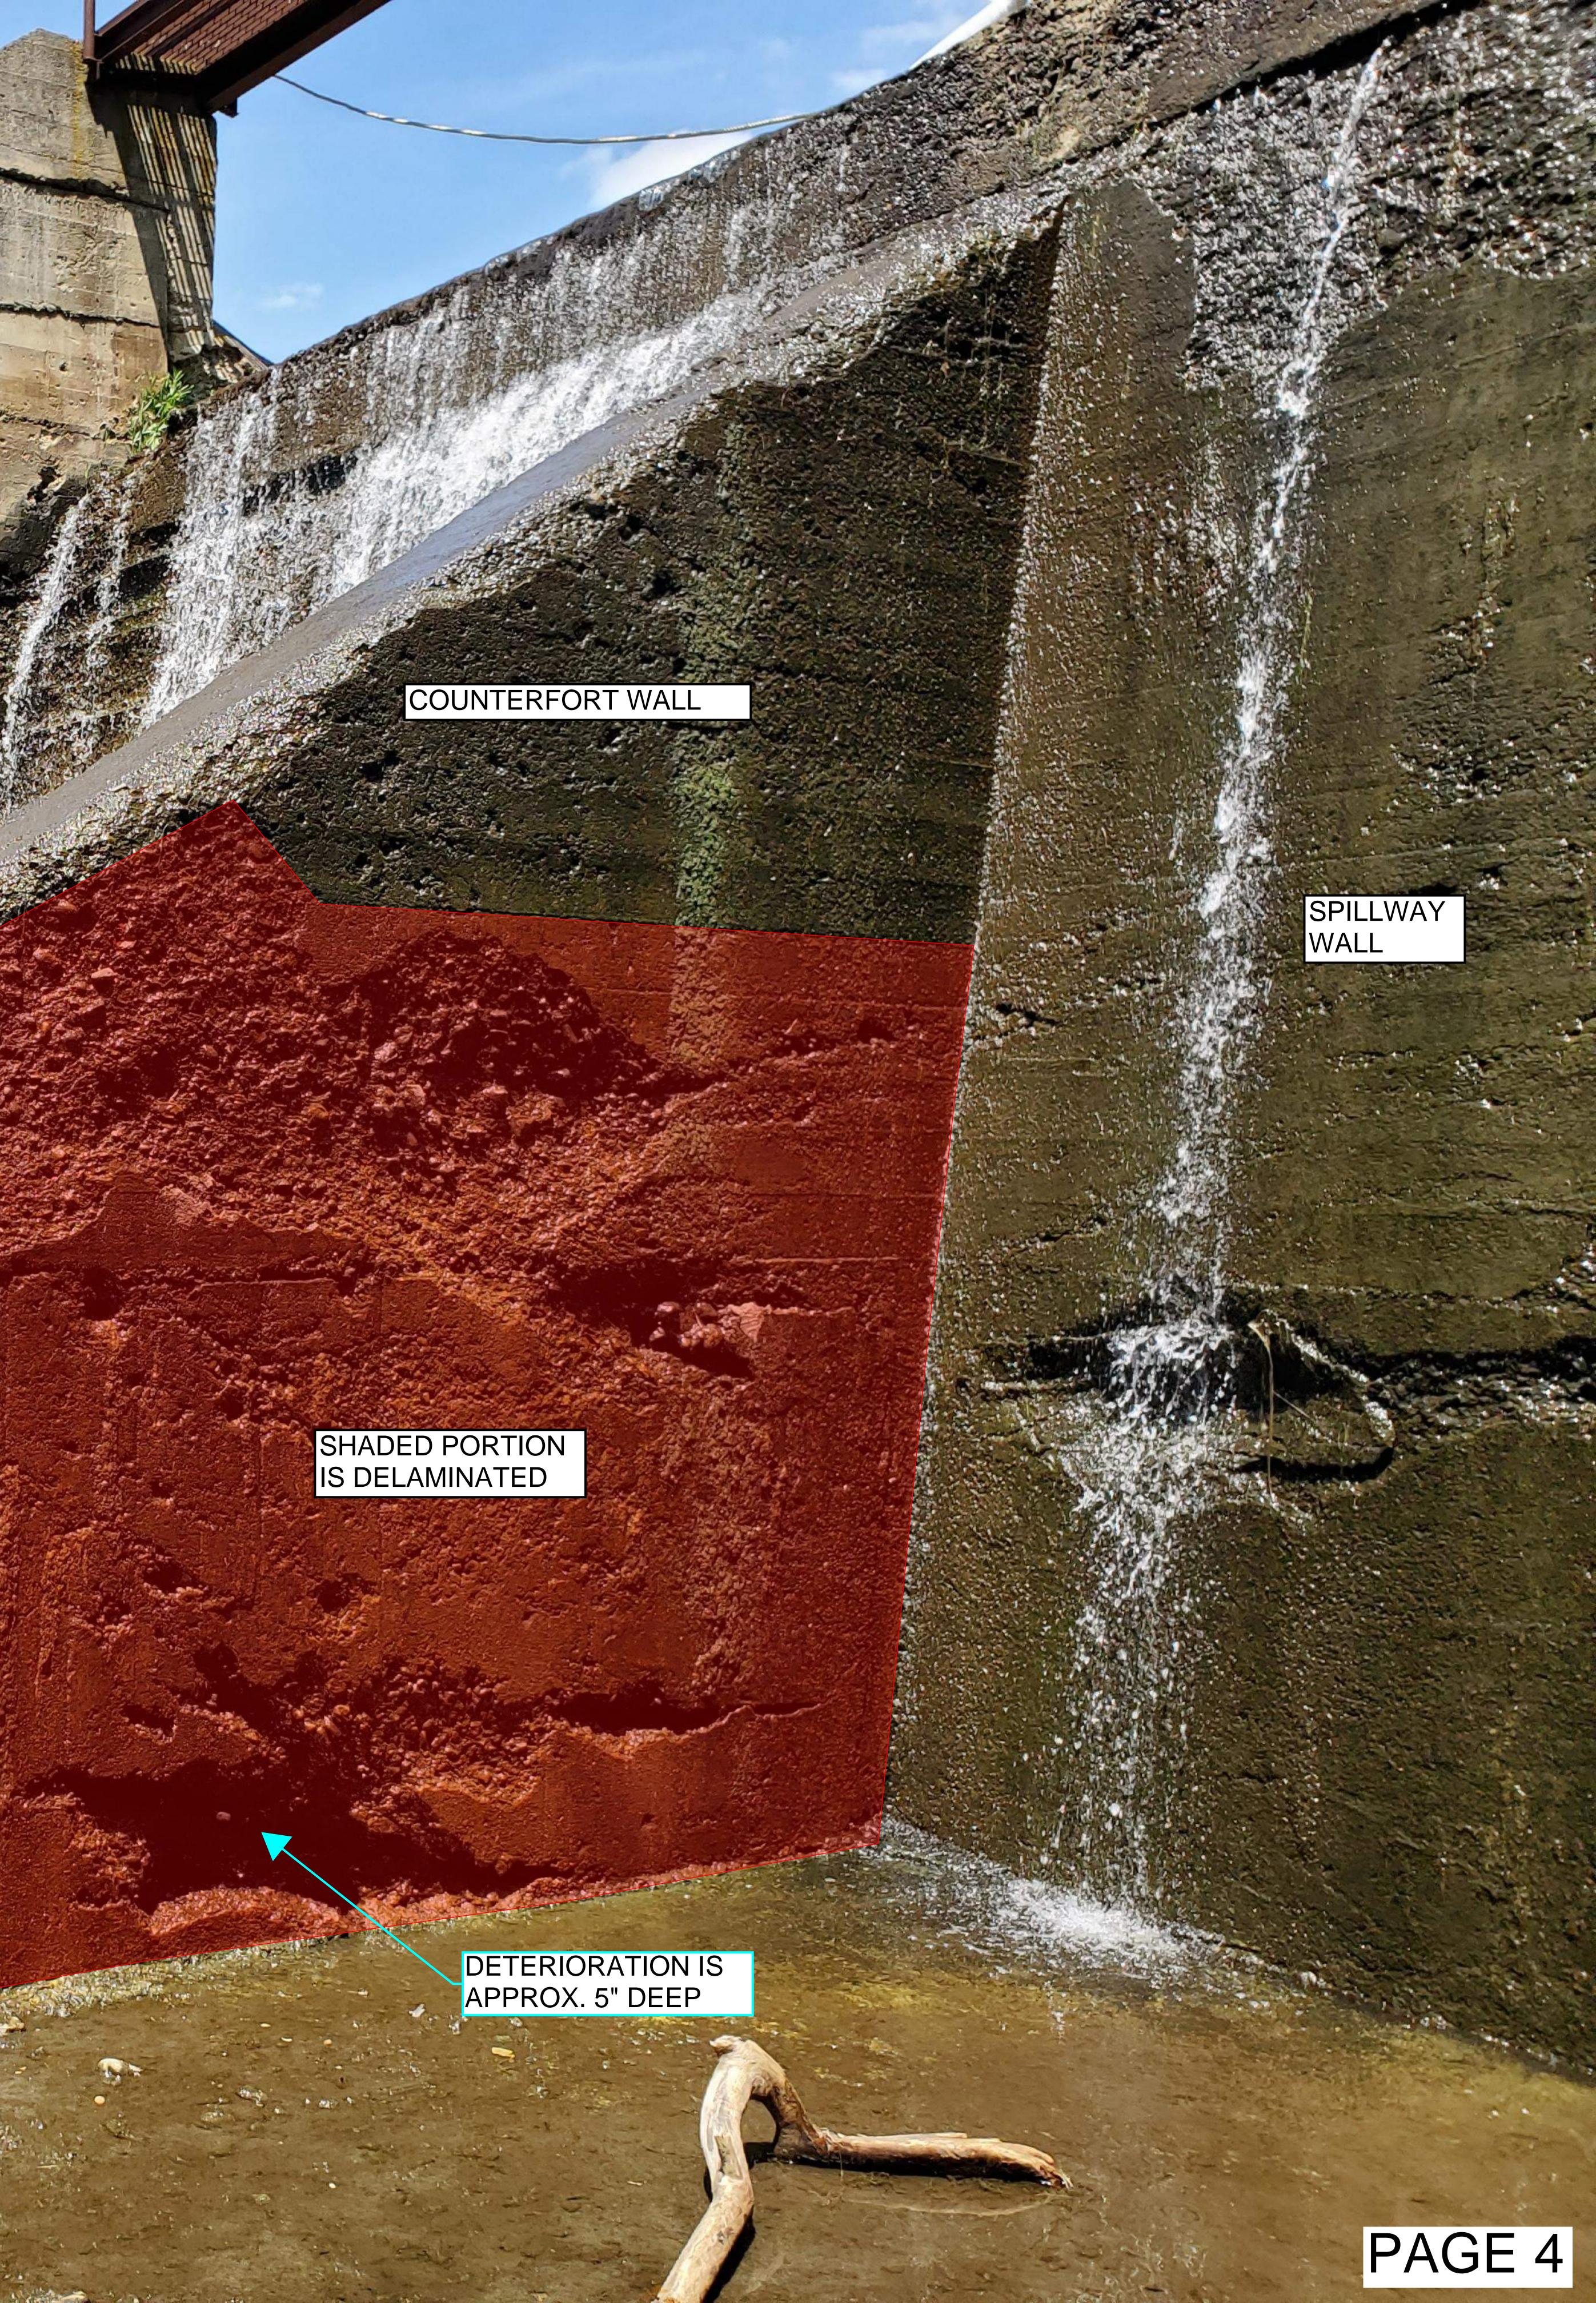
# COUNTERFORT WALL DETERIORATION

CRACK

DETERIORATION IS APPROX. 6 1/2" DEEP

LOCALIZED SPALLING IN THIS AREA

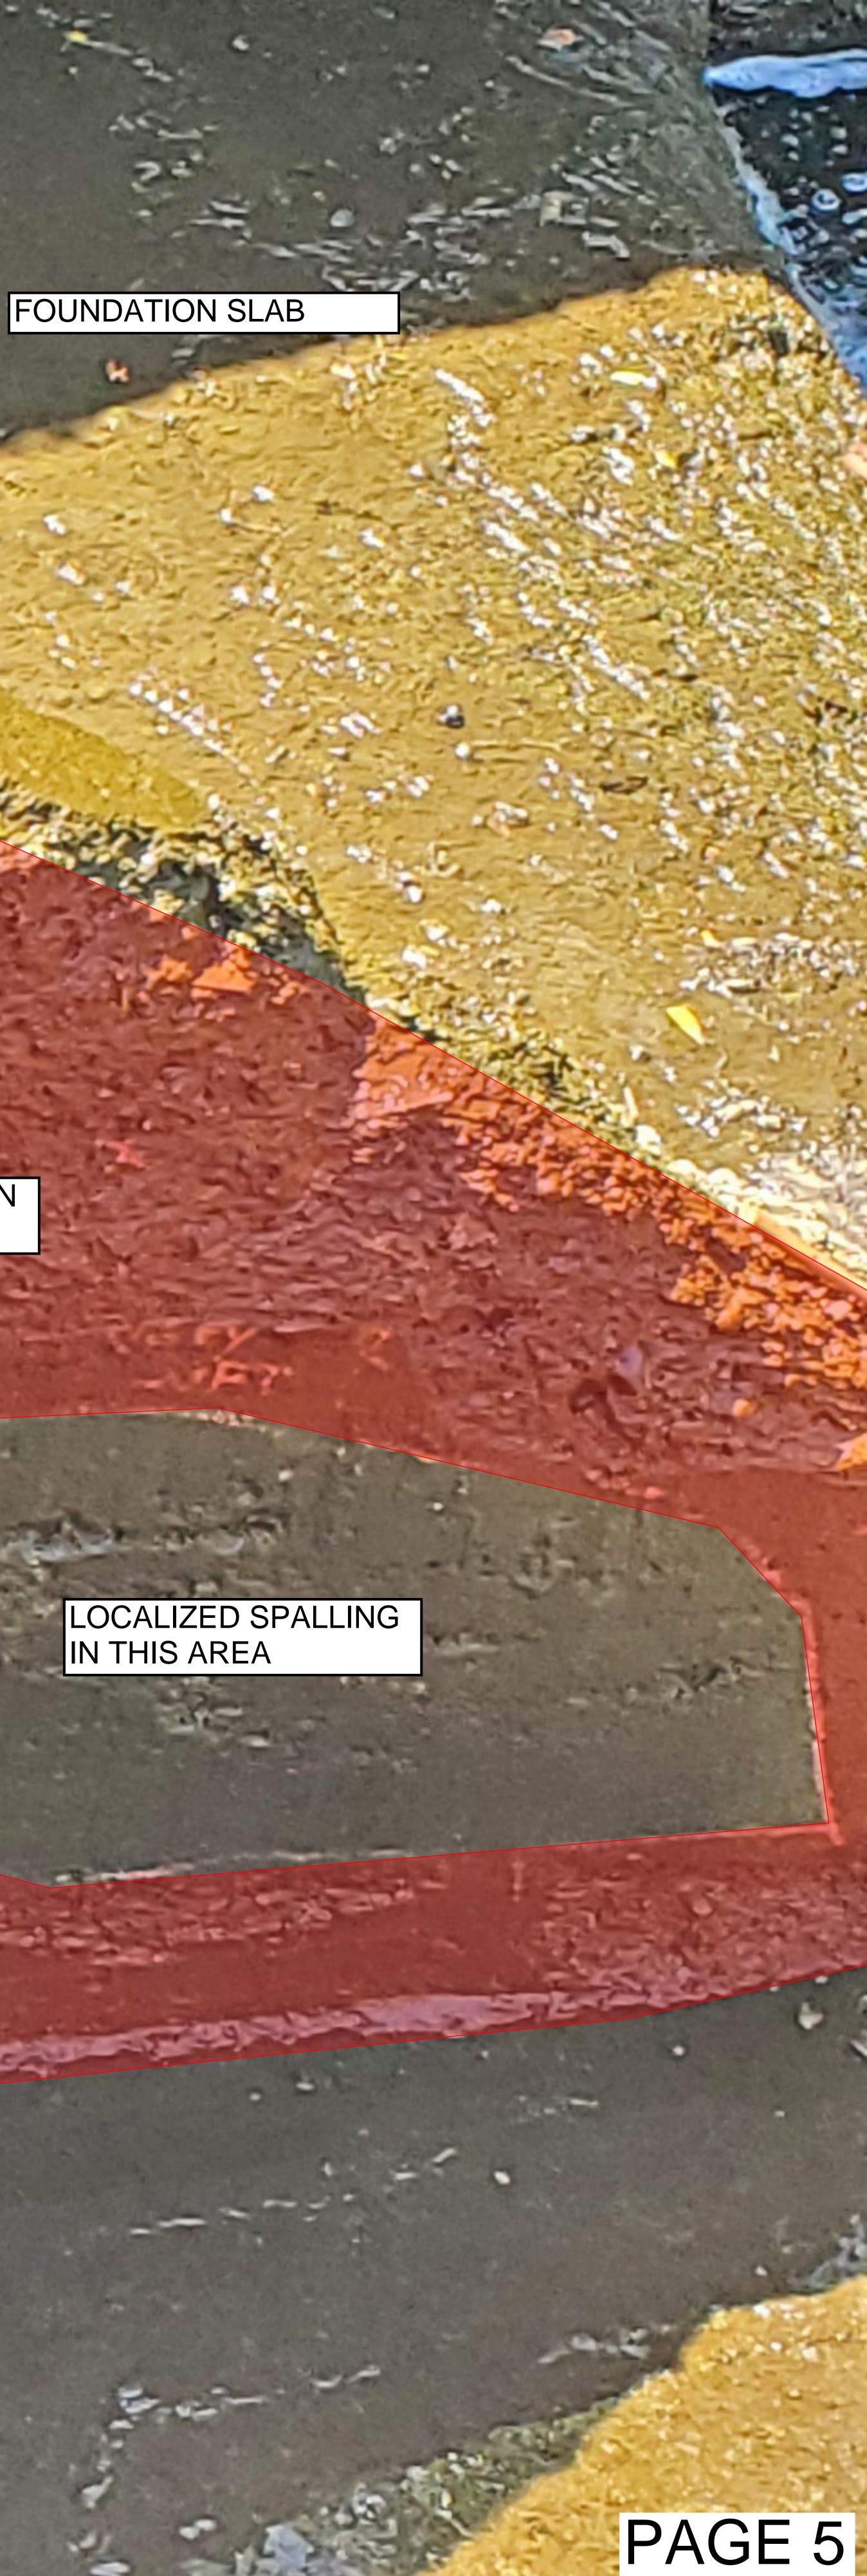
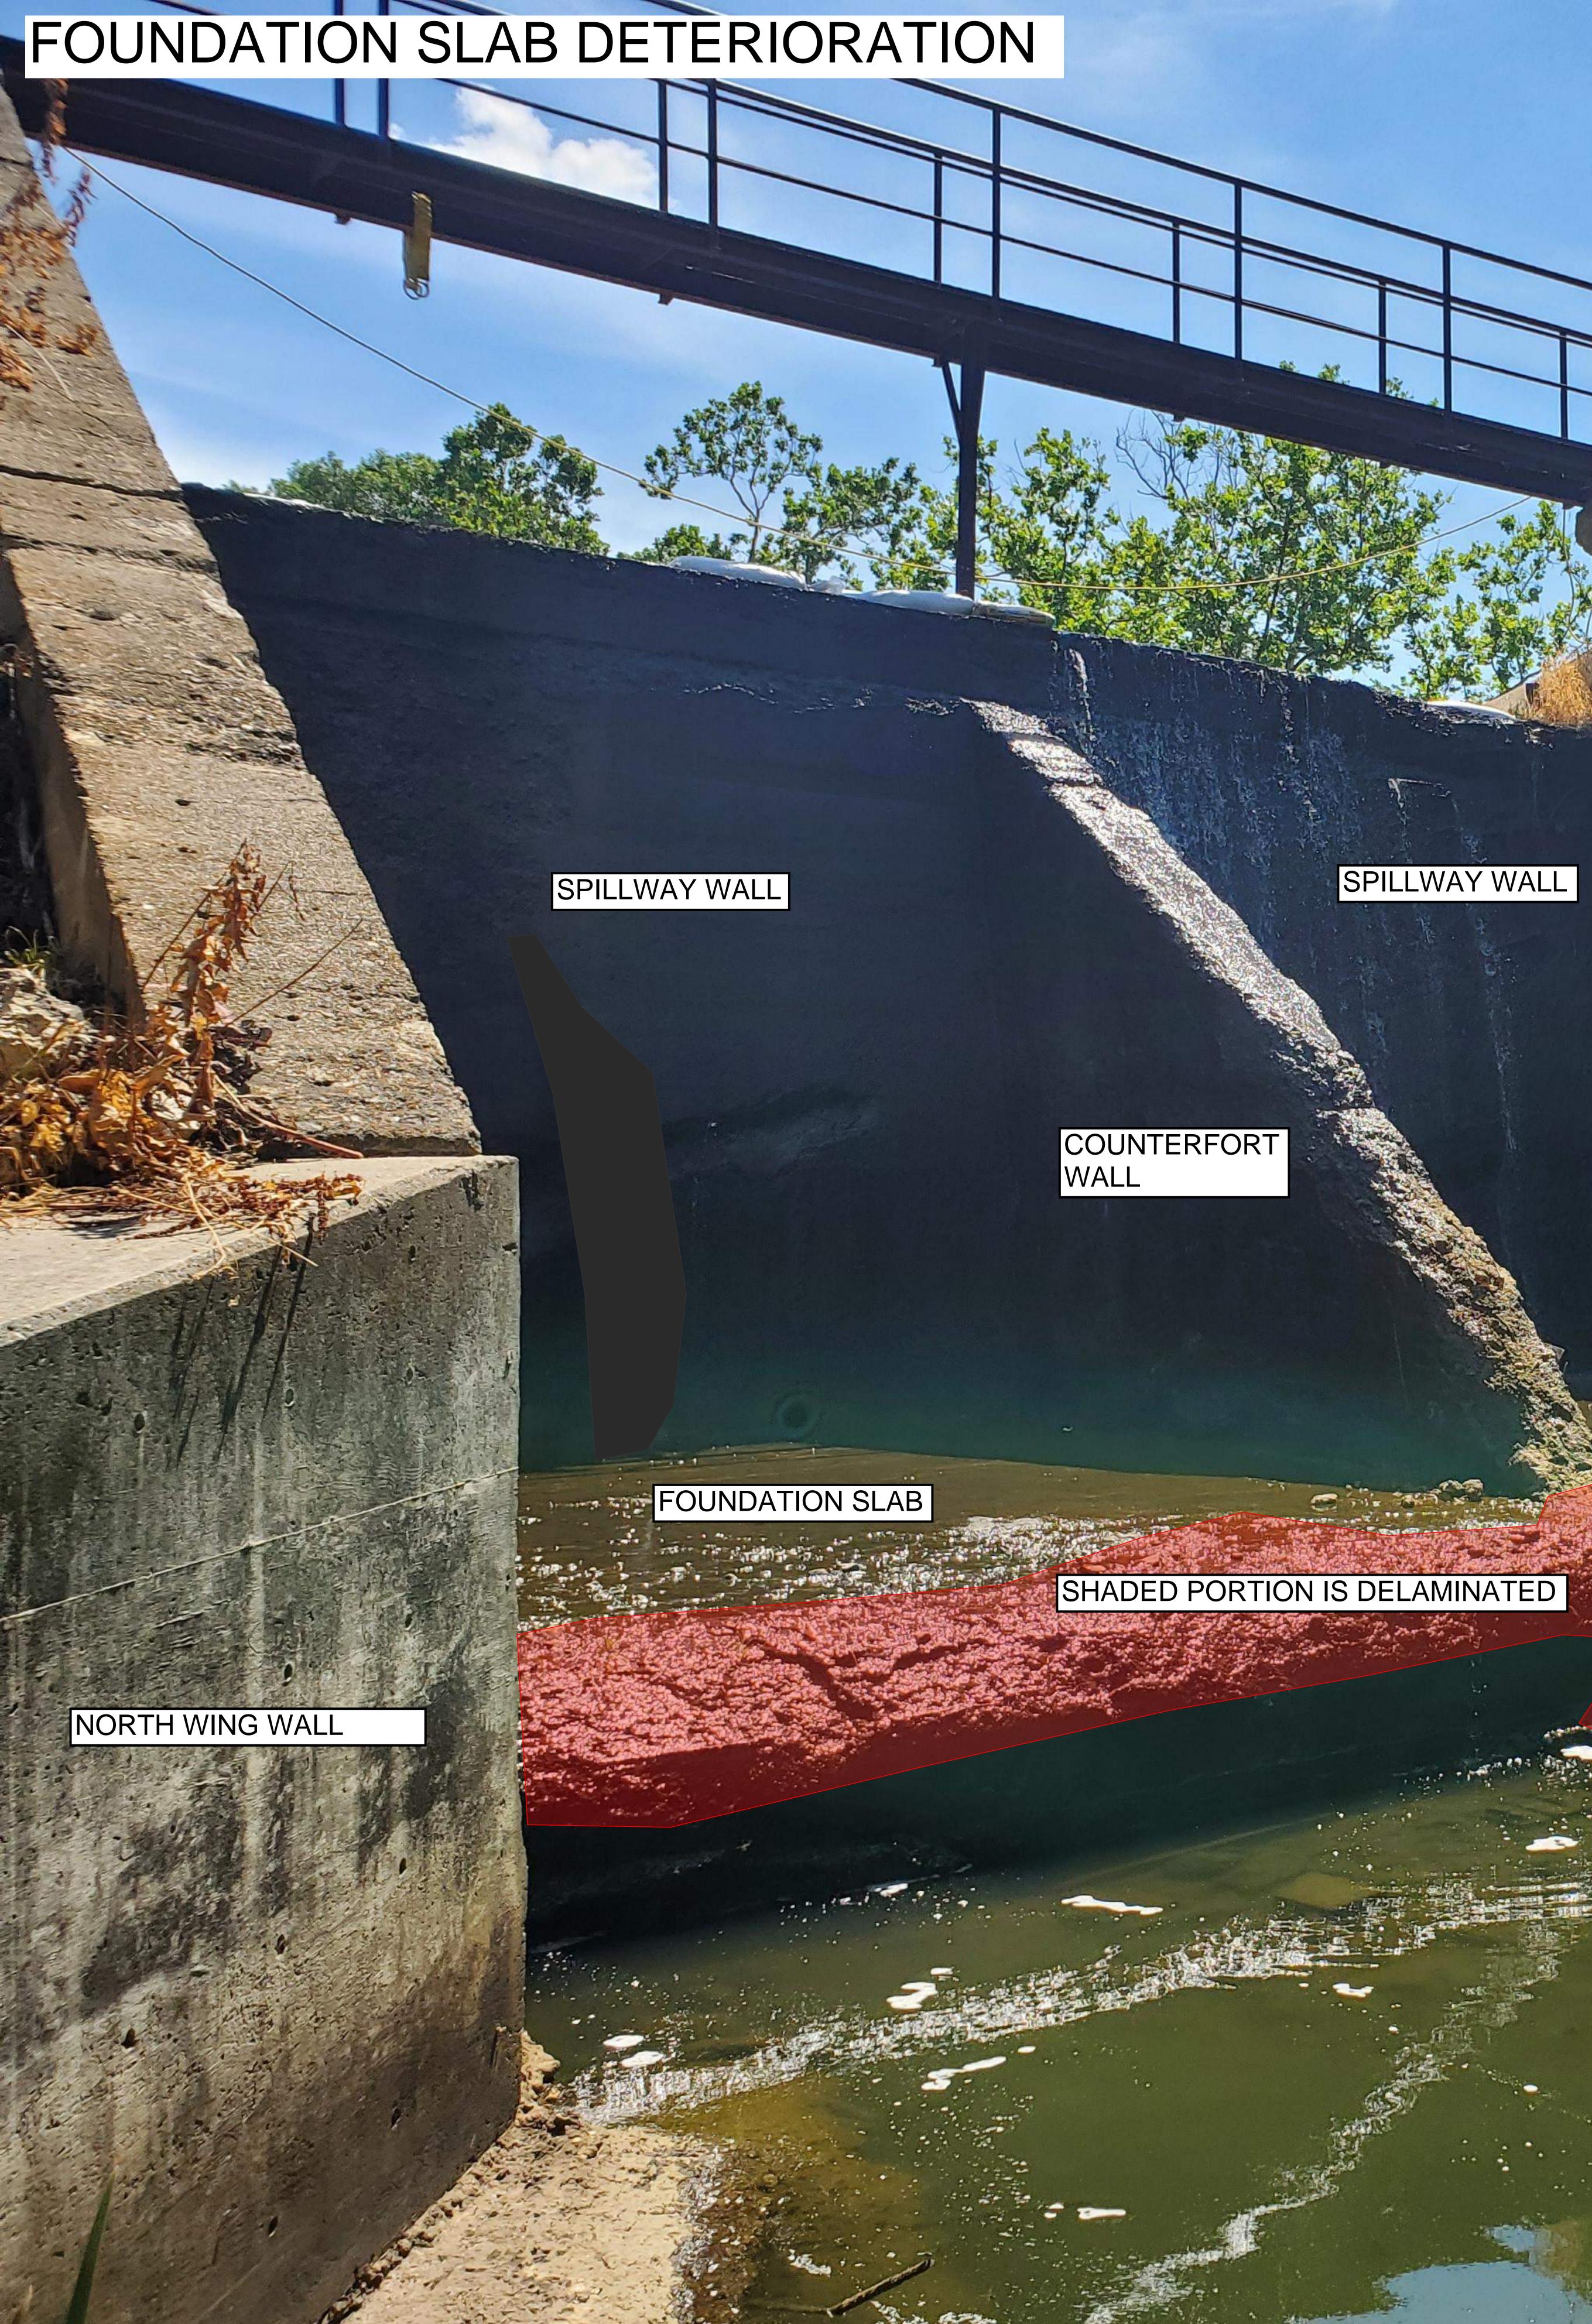
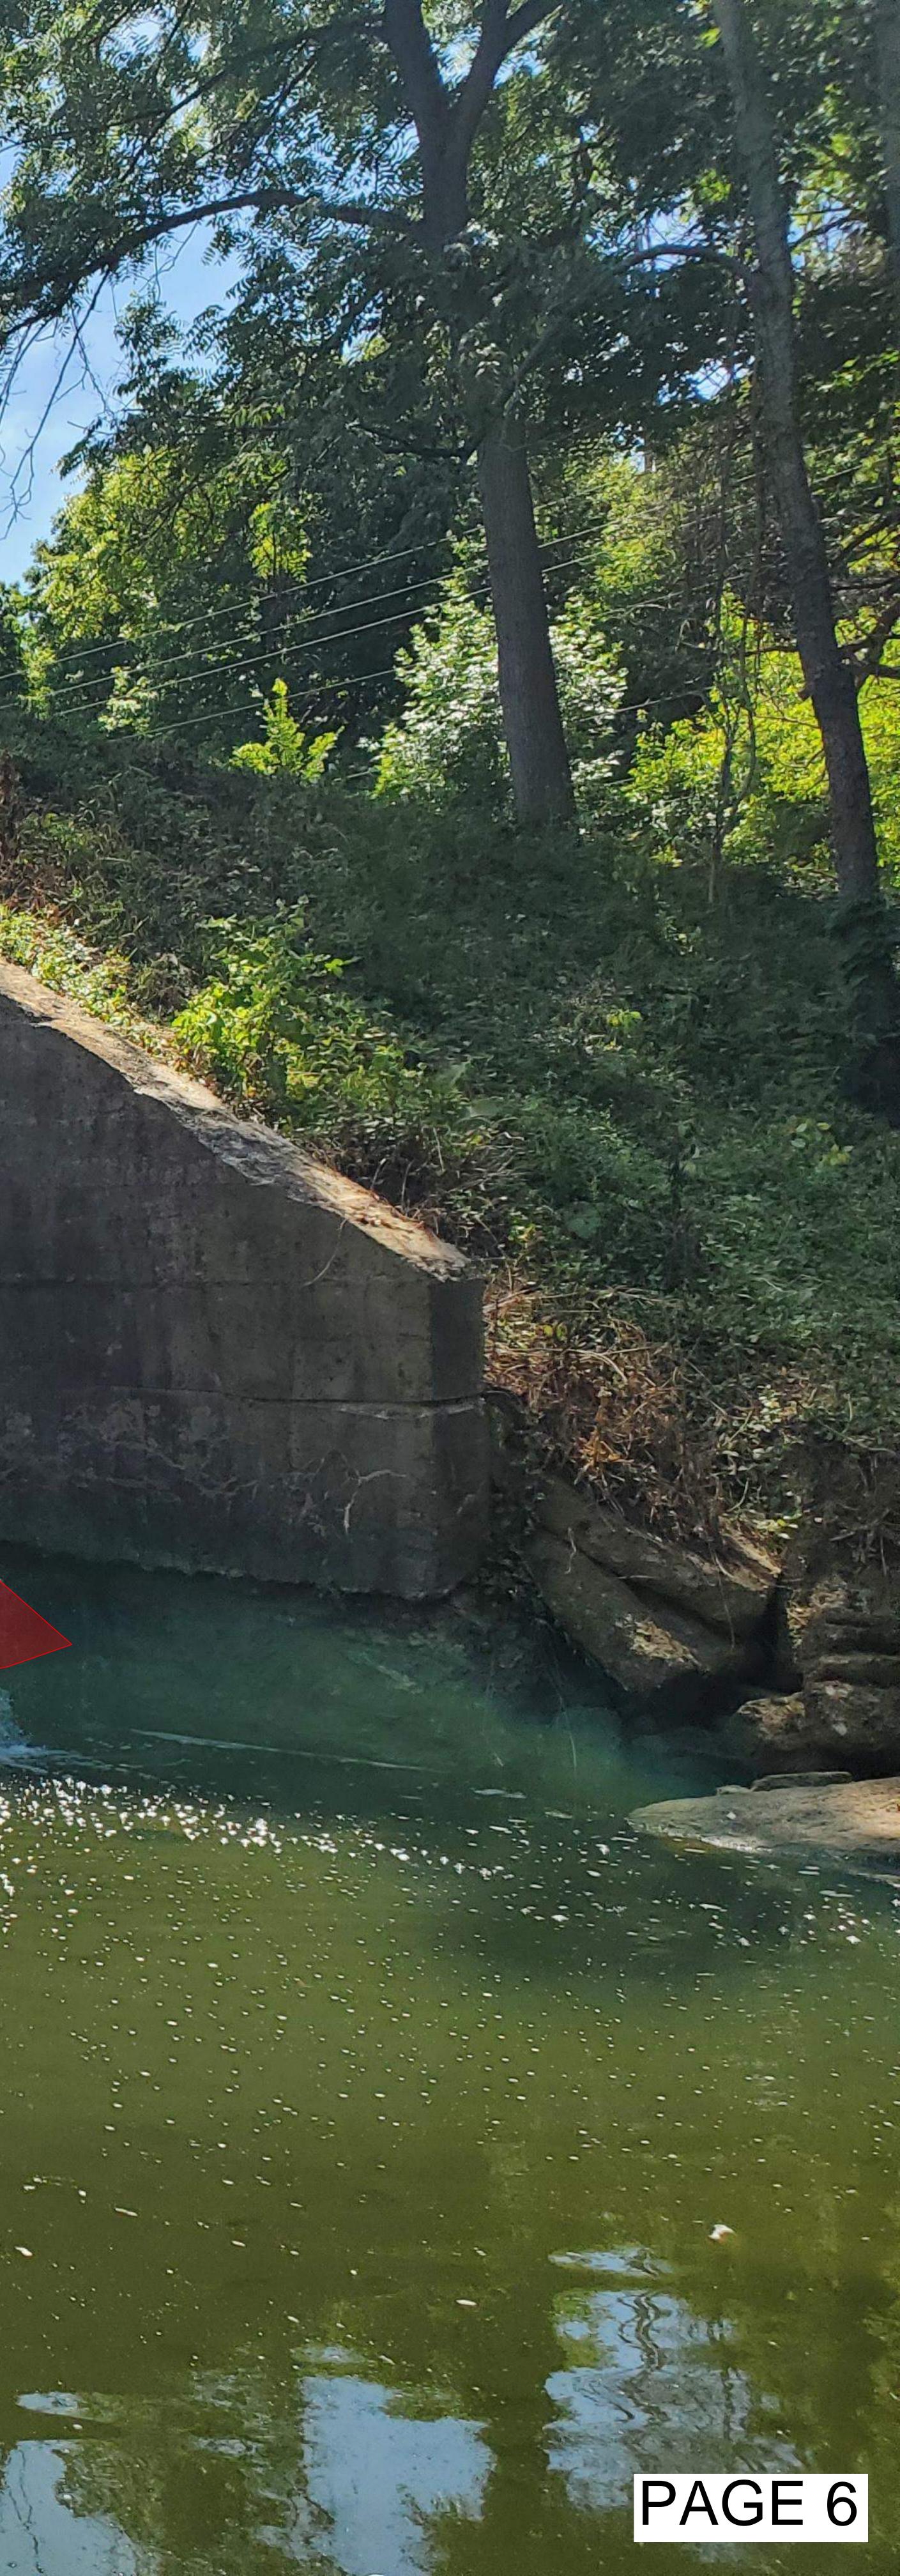
#### SHADED PORTION IS DELAMINATED
