# Pavement Condition Report

## Columbus Municipal Airport

Project 1480370

**January 2014**

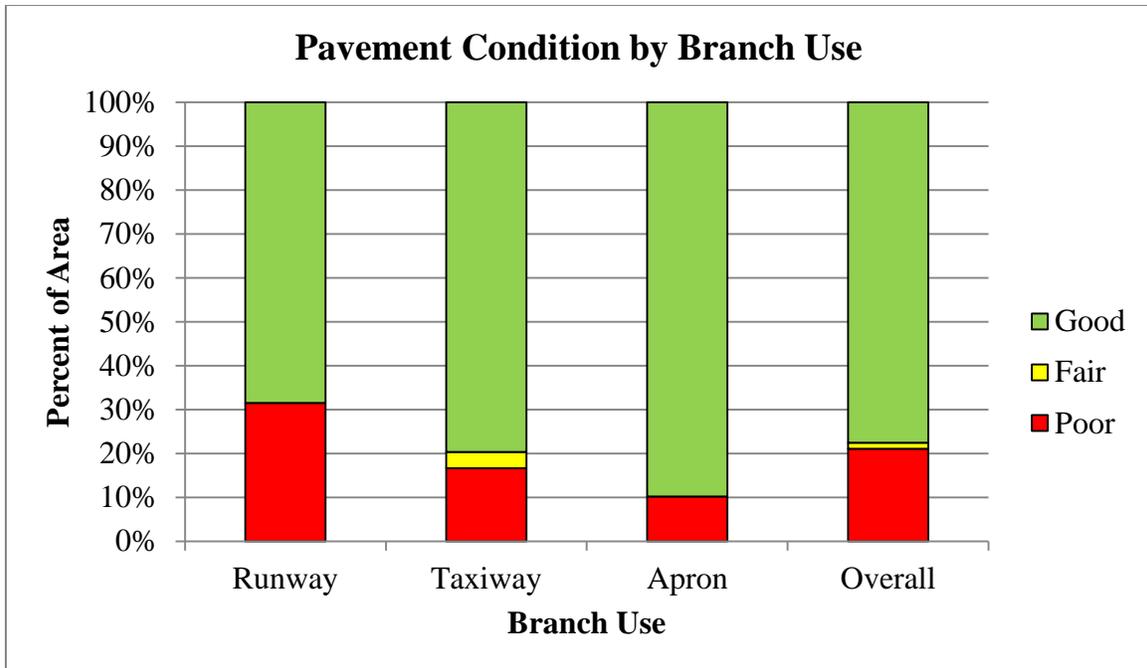
The overall Pavement Condition Index (PCI) for the airfield pavements was 63. Runways had an average inspected PCI of 84 and were above the desired MSL of 60. Taxiways had an average inspected PCI of 78, and ramps had an average inspected PCI of 41.

Figure 2-2. Pavement Condition by Branch Use

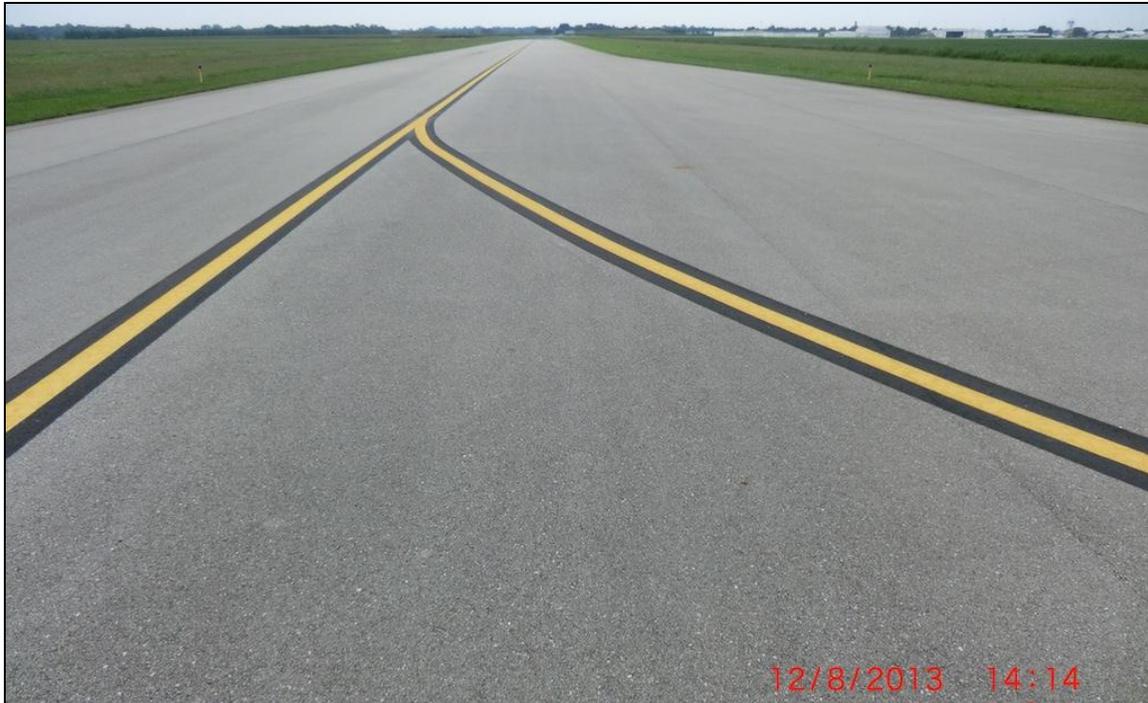
Figure 2-4. Typical Good AC Pavement (Feature 105)

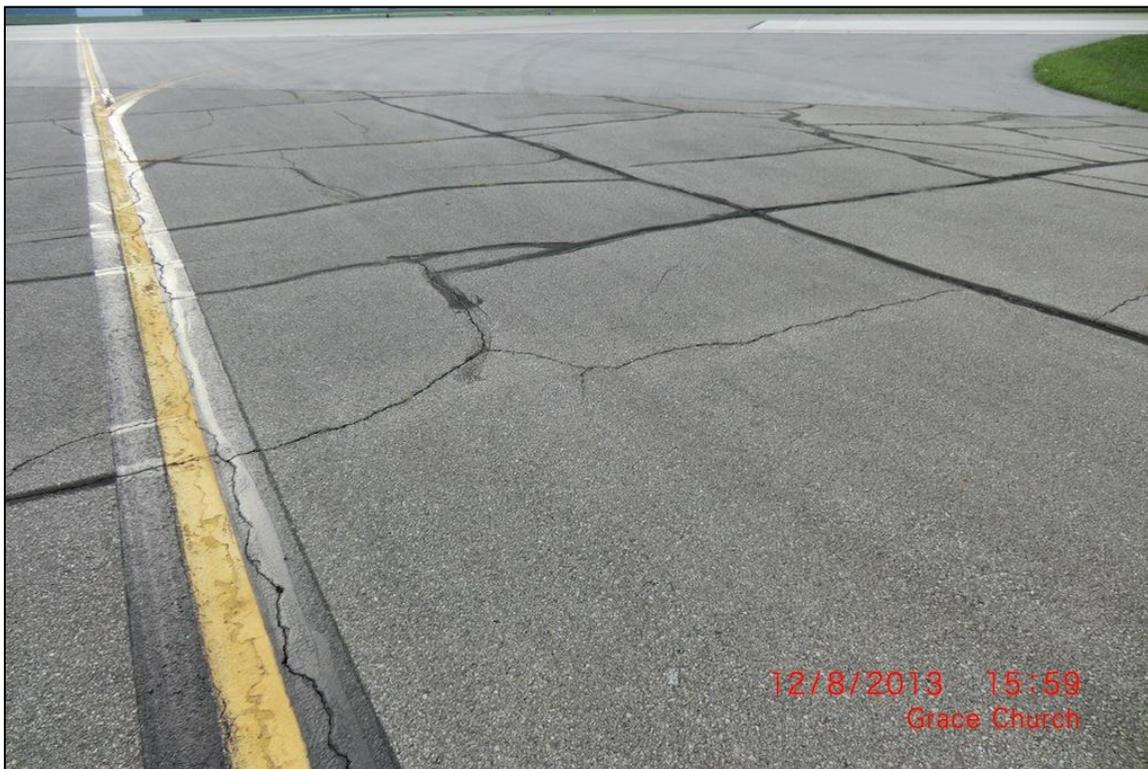
Figure 2-5. Typical Fair AC Pavement (Feature 420)

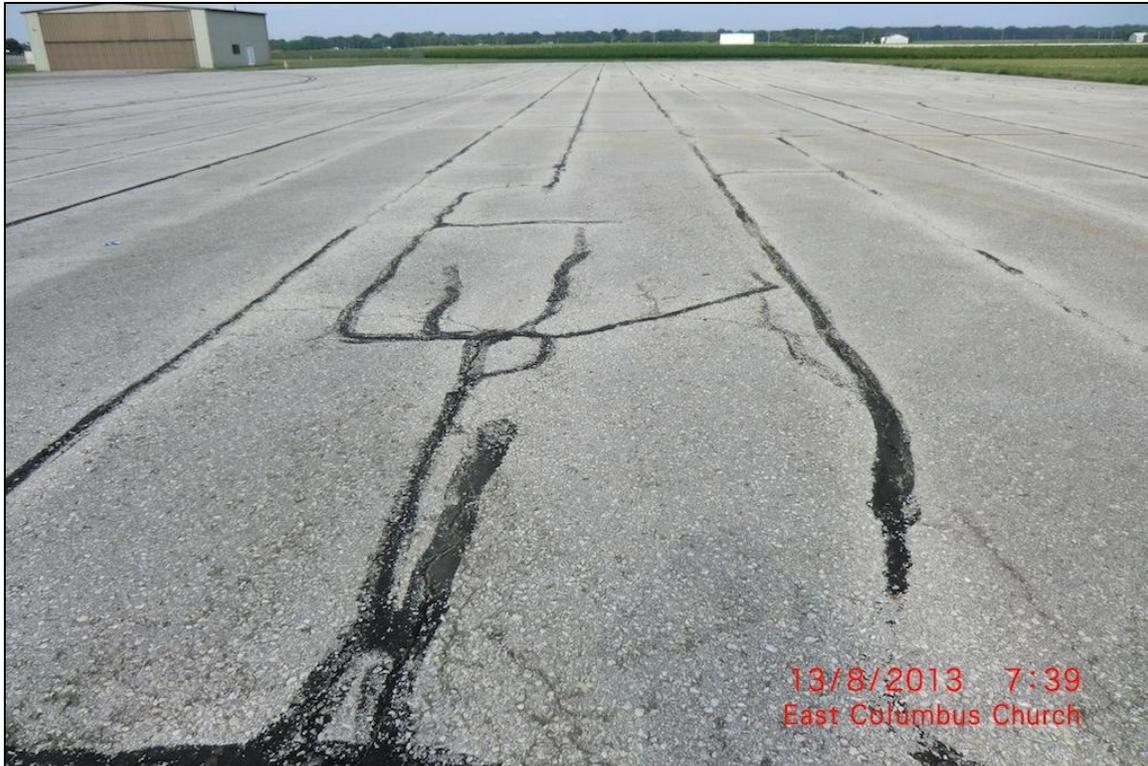
Figure 2-6. Typical Poor AC Pavement (Feature 3003)

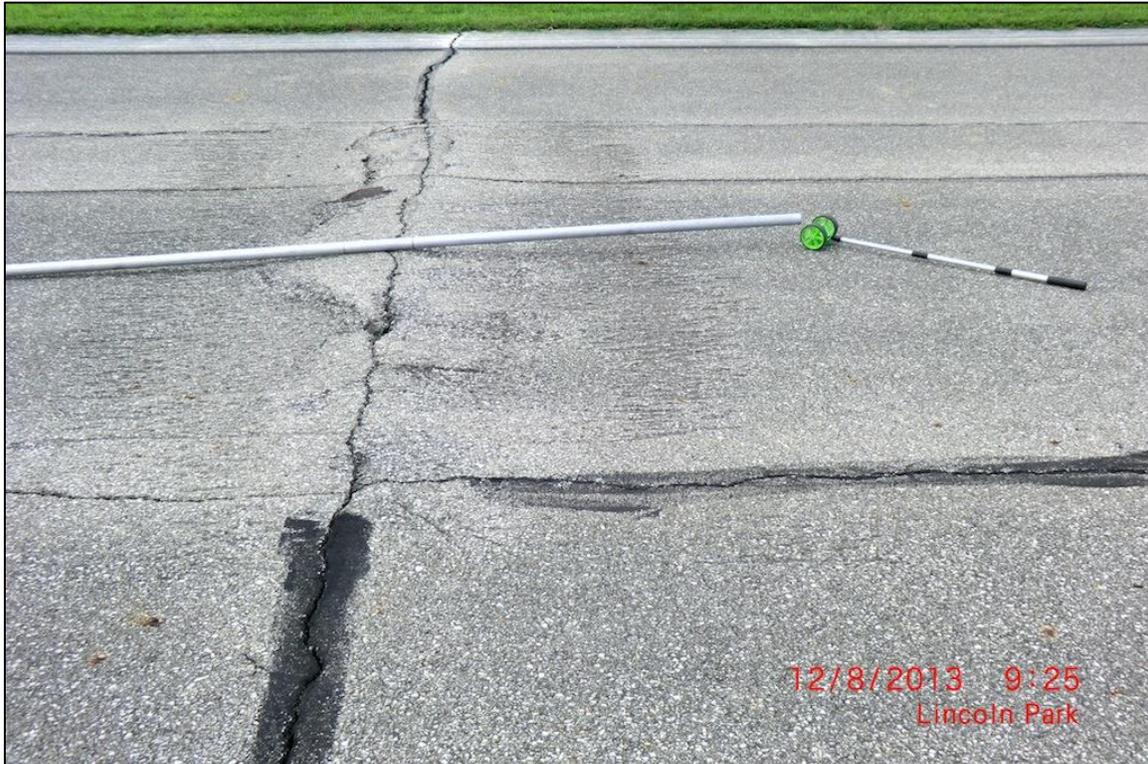
Figure 2-7. AC Swell (Feature 5005)

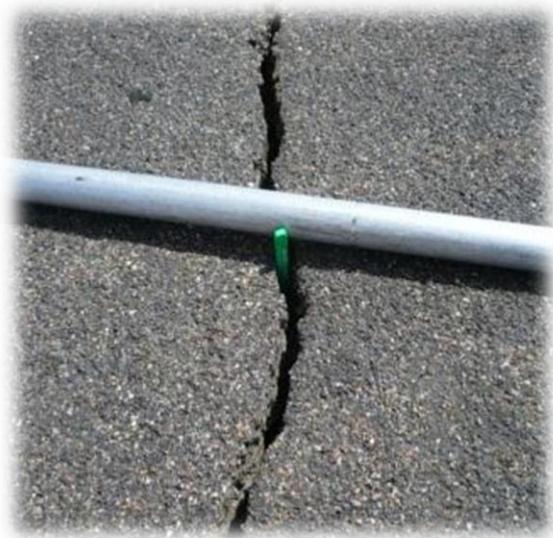
### *Longitudinal & Trans. Cracking*

L&T cracks are caused by age, construction, and subsurface conditions. Age-related cracking occurs as oxidizing pavement loses components to the atmosphere and becomes more brittle. Consistent application of seal coats can help to prevent age-related cracks.

Construction-related cracking often develops along paving joints. Ensuring that joints are made when both sides are still hot, and near the same temperature, is one of the best ways to mitigate this potential problem.

Seasonal movement caused by changes in subsurface moisture or temperature differences also can cause pavement cracking. Asphalt pavement placed over a PCC pavement or cement stabilized base course may evidence reflective cracking from the underlying material. Wheel loads do not cause L&T cracks, although traffic may worsen their condition.

Low-severity L&T cracks are less than ¼ inch wide, or if sealed with suitable filler material in satisfactory condition can be any width less than 3 inches, if they are not spalled. Maintenance usually is not indicated for low-severity cracking. Moderately spalled cracks and cracks wider than ¼ inch which are not satisfactorily sealed are at medium severity. Medium-severity cracks should be sealed with a high-quality crack filling material. Severely spalled cracks and cracks wider than 3 inches are at high severity. High-severity L&T cracks normally require patching.
