Pavement Condition Report

Delphi Municipal Airport

Project 1480370

January 2014

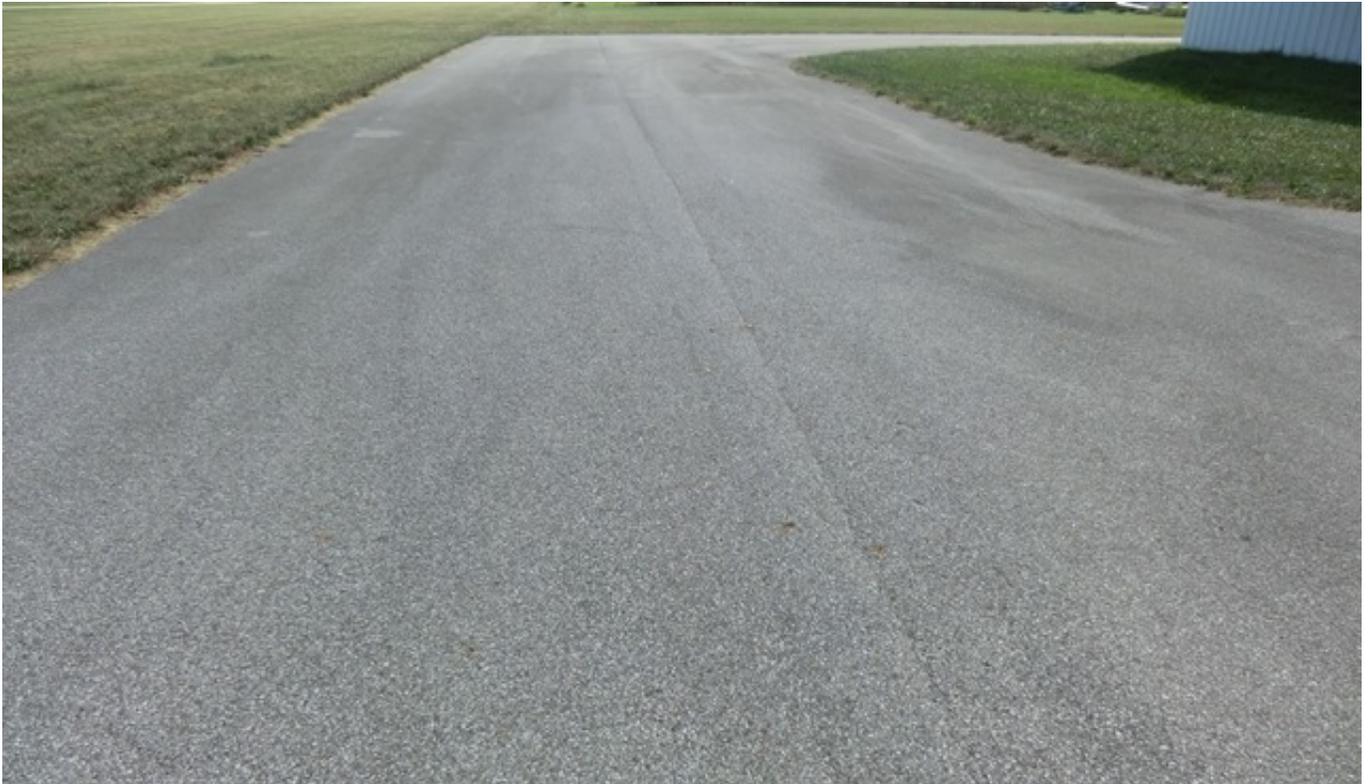
APPROXIMATE AMOUNT OF DISTRESS RELATED TO LOAD ON THE PAVEMENT IS:	33 %
APPROXIMATE AMOUNT OF DISTRESS RELATED TO MATERIALS PROBLEMS IN THE FEATURE IS:	63 %
APPROXIMATE AMOUNT OF DISTRESS RELATED TO AGE OF PAVEMENT AND TRAFFIC REPETITIONS IS:	4 %

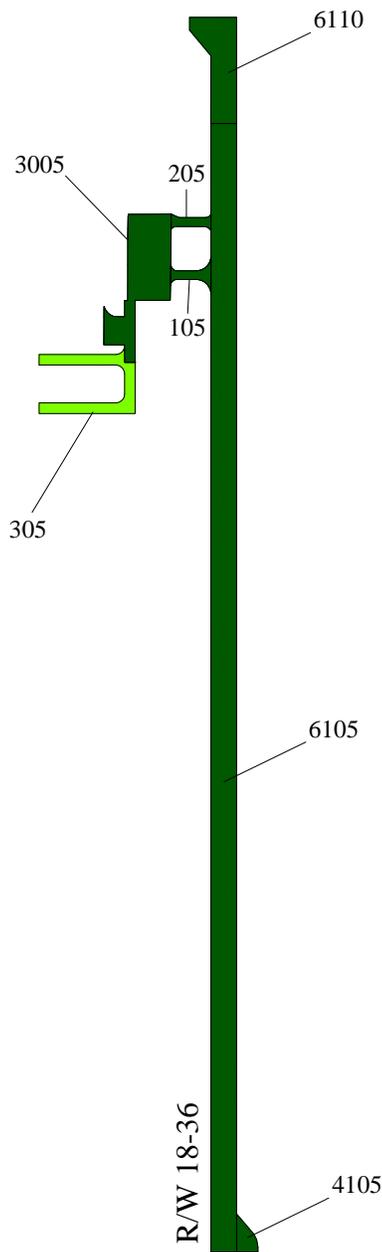
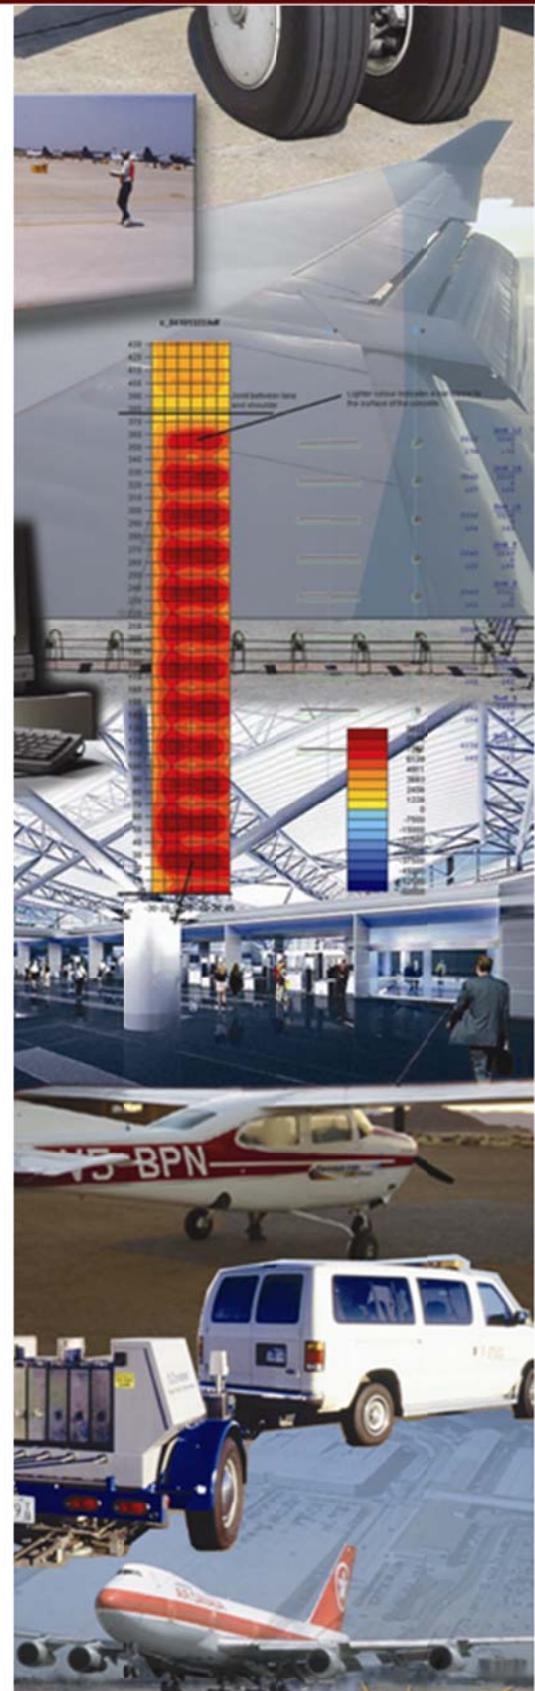
DELPHI MUNICIPAL AIRPORT 2013 PCI Inpsection

The overall Pavement Condition Index (PCI) for the airfield pavements was 98. Runways had an average inspected PCI of 99 and were above the desired MSL of 55. Taxiways had an average inspected PCI of 90, and ramps had an average inspected PCI of 100.
