# Pavement Condition Report

## Elkhart Municipal Airport

Project 15805741

**February 2015**

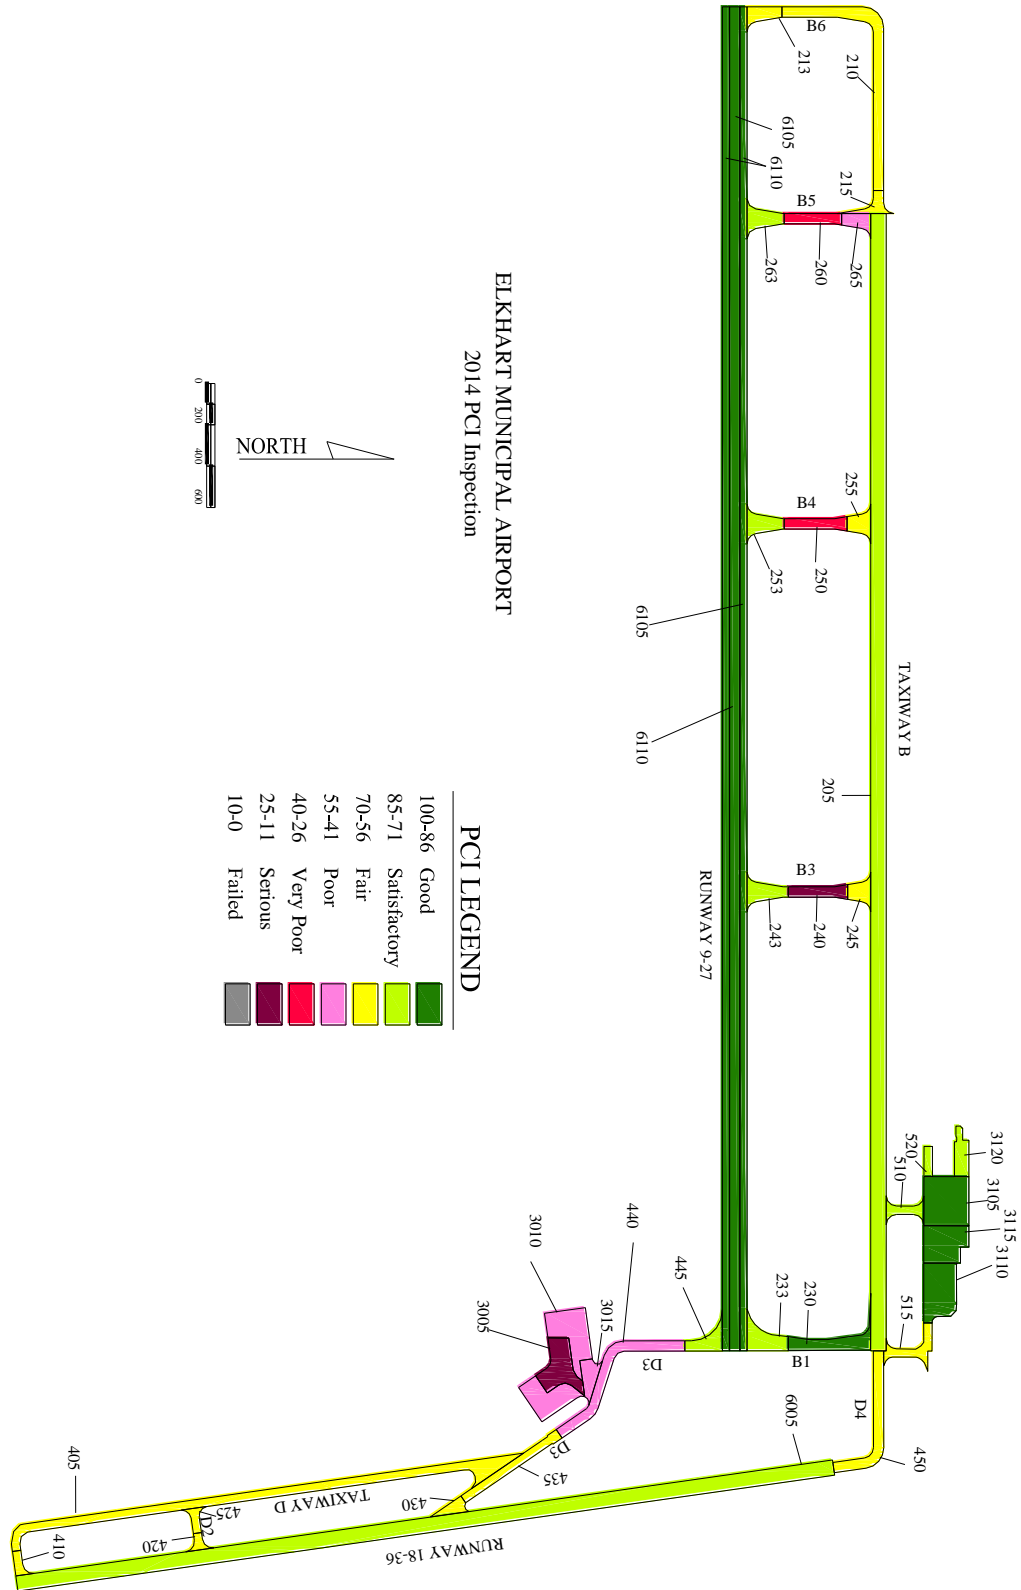
Figure 2-1. Inspected Pavement Condition

The pavement within each of the PCI condition categories is shown in Figure 2-1. The inspected PCI is summarized by branch use in Figure 2-2, and the photographs in Figure 2-3 through Figure 2-7 provide examples of the condition categories.

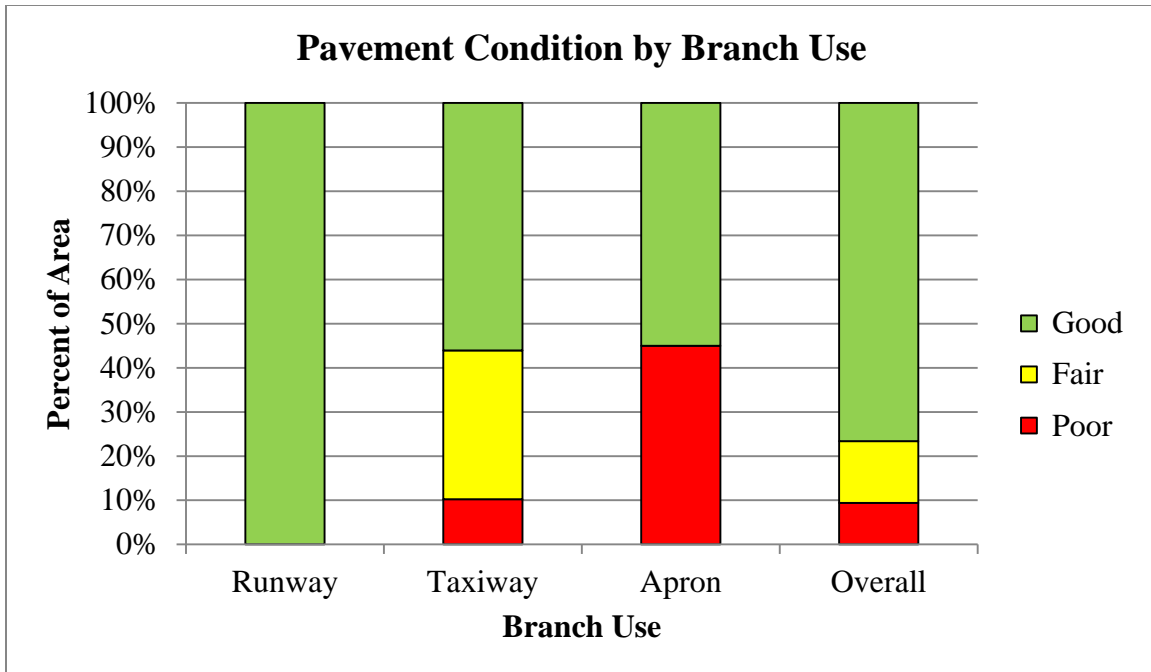
Figure 2-2. Pavement Condition by Branch Use

The average inspected Pavement Condition Index (PCI) for all the airfield pavements was 81. Runways had an average inspected PCI of 93 and were above the desired MSL of 60. Taxiways had an average inspected PCI of 71, and ramps had an average inspected PCI of 72.

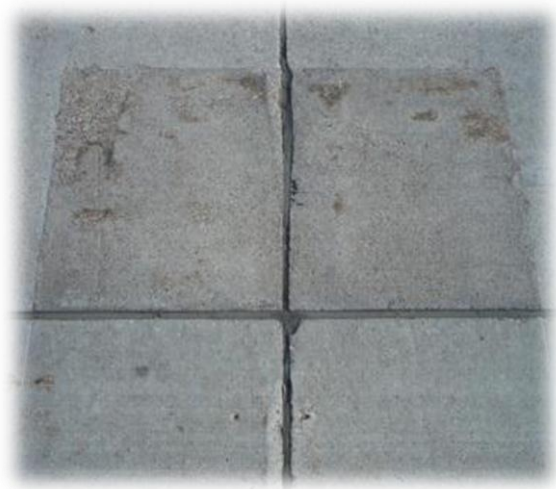
Large and small patches, by PCI inspection criteria, are distress conditions. Patches indicate deterioration and aging of pavement that contributes to shortened service life. However, patching also indicates that pavement is being maintained.

A patch that is performing well and shows no outward distress is recorded at low severity, and no corrective action is required. Medium-severity patches are serviceable but are beginning to deteriorate. Maintenance or replacement is indicated. At high severity, replacement is indicated.

By definition, small patches are smaller than 5 square feet in surface area, and they usually result from spall repair at slab joints and corners.

Large patches also may be the result of spall repair, but they often indicate more serious deficiencies, such as corner breaks or other full-depth failure smaller than panel size.

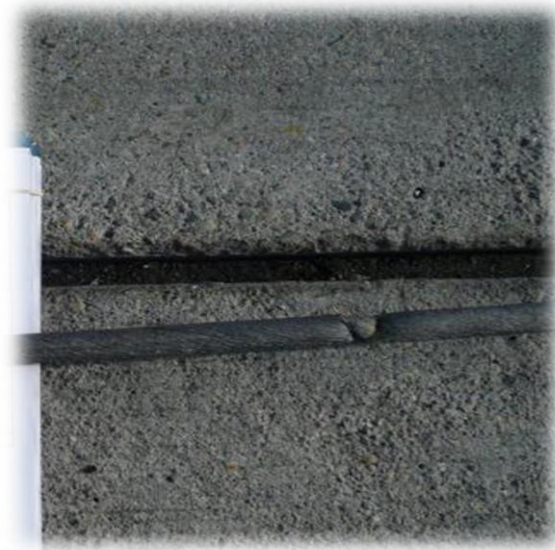
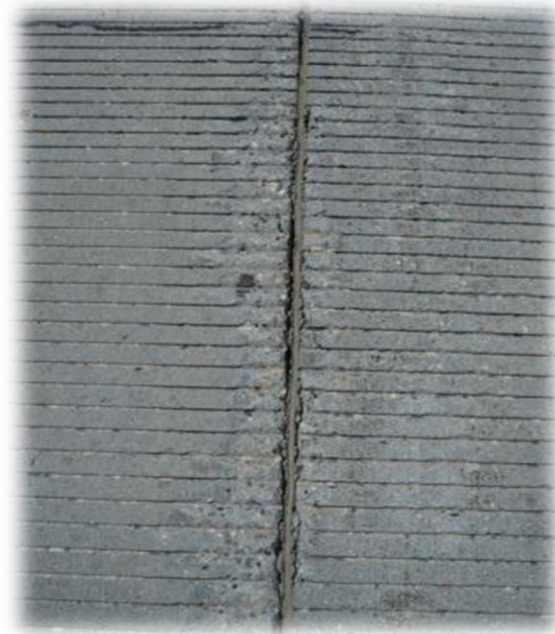
## Joint Seal Damage

When joint sealant is in perfect condition (no damage), there is no distress.

At low severity, at least 10 percent of the sealant is debonded but still in contact with the joint edges. Medium-severity joint seal damage is recorded when at least 10 percent of the sealant has visible gaps smaller than 1/8 inch and is an indicator that replacement should be programmed as soon as is practical. In the meantime, aggressive inspection and sustaining maintenance is recommended to minimize subsurface damage from moisture penetration. At high severity, visible gaps exceed 1/8 inch, and the amount and degree of joint seal damage typically requires complete removal and replacement of the existing sealant.

On serviceable pavement, deteriorated joint sealant should be repaired or replaced to preserve pavement and subgrade integrity and prolong service life. The issue is not so clear-cut with unserviceable pavement. Pavement that can be restored to serviceable condition by maintenance activities such as patching and joint seal repair, or by slab replacement, should be so maintained as long as the process is cost-effective. However, when age and condition preclude economical return to serviceable condition by such means, joint seal repair would no longer be cost-effective and should be suspended except for an interim maintenance program to control FOD potential.

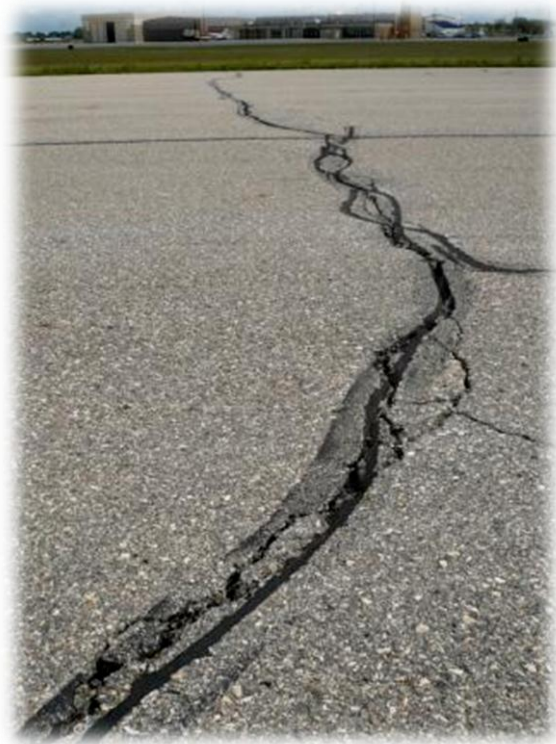
## Alligator Cracking

Alligator cracks are a series of interconnected load-related cracks caused by fatigue of the asphalt surface. Alligator cracking is a significant structural distress and develops only in places subject to traffic loads. These cracks typically initiate at the bottom of the asphalt layer and propagate upward. Once a fatigue crack is visible at the surface, significant damage has already occurred.

At low severity, alligator cracks are evidenced by a series of parallel hairline cracks (usually in a wheel path). Medium-severity alligator cracking is a well-defined pattern of interconnected cracks, and some spalling may be present. High-severity alligator cracks have lost aggregate interlock between adjacent pieces, and the cracks may be severely spalled with FOD potential. Most likely, the pieces will move freely under traffic.

Alligator cracking is a serious structural failure that cannot be repaired with sealant. The proper repair is patching.

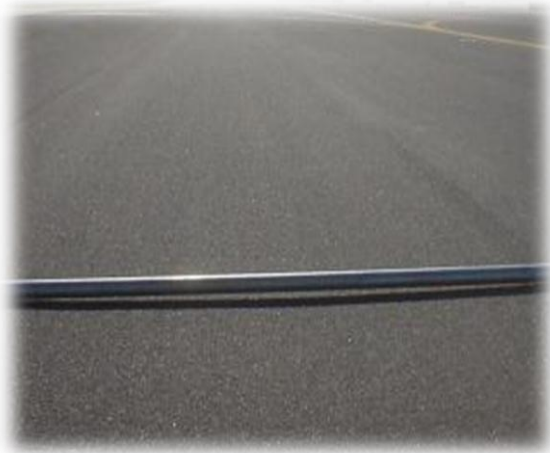
Rutting is due to base and subgrade consolidation caused by excessive wheel loads or poor compaction. Ruts indicate structural failure and can cause hydroplaning.

At low severity, ruts have an average depth of ¼ to ½ inches. At medium severity, ruts have an average depth of ½ to 1 inch. At high severity, ruts have an average depth greater than 1 inch. Patching is the appropriate repair for ruts.
