Pavement Condition Report

Huntington Municipal Airport

Project 15805741

February 2015

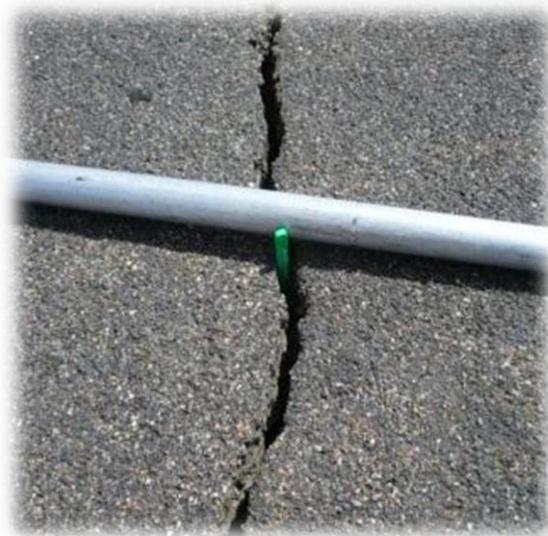
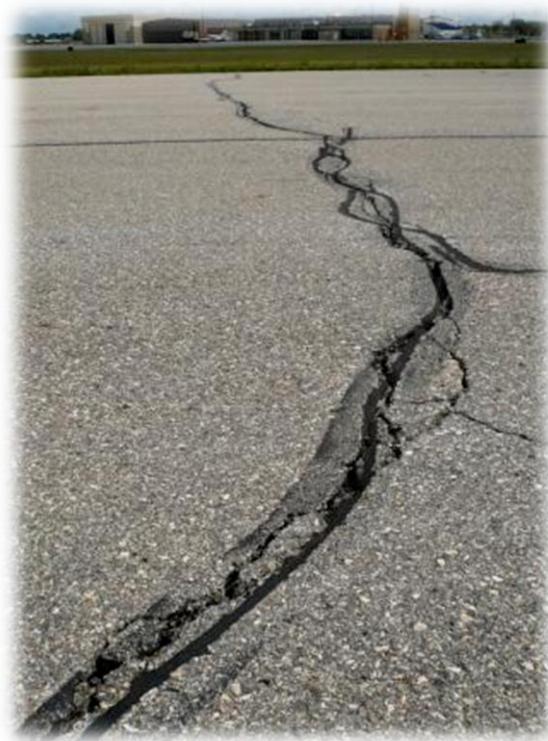
Longitudinal & Trans. Cracking

L&T cracks are caused by age, construction, and subsurface conditions. Age-related cracking occurs as oxidizing pavement loses components to the atmosphere and becomes more brittle. Consistent application of seal coats can help to prevent age-related cracks.

Construction-related cracking often develops along paving joints. Ensuring that joints are made when both sides are still hot, and near the same temperature, is one of the best ways to mitigate this potential problem.

Seasonal movement caused by changes in subsurface moisture or temperature differences also can cause pavement cracking. Asphalt pavement placed over a PCC pavement or cement stabilized base course may evidence reflective cracking from the underlying material. Wheel loads do not cause L&T cracks, although traffic may worsen their condition.

Low-severity L&T cracks are less than ¼ inch wide, or if sealed with suitable filler material in satisfactory condition can be any width less than 3 inches, if they are not spalled. Maintenance usually is not indicated for low-severity cracking. Moderately spalled cracks and cracks wider than ¼ inch which are not satisfactorily sealed are at medium severity. Medium-severity cracks should be sealed with a high-quality crack filling material. Severely spalled cracks and cracks wider than 3 inches are at high severity. High-severity L&T cracks normally require patching.
