Pavement Condition Report

Indianapolis Greenwood Municipal Airport

Project 15805741

February 2015

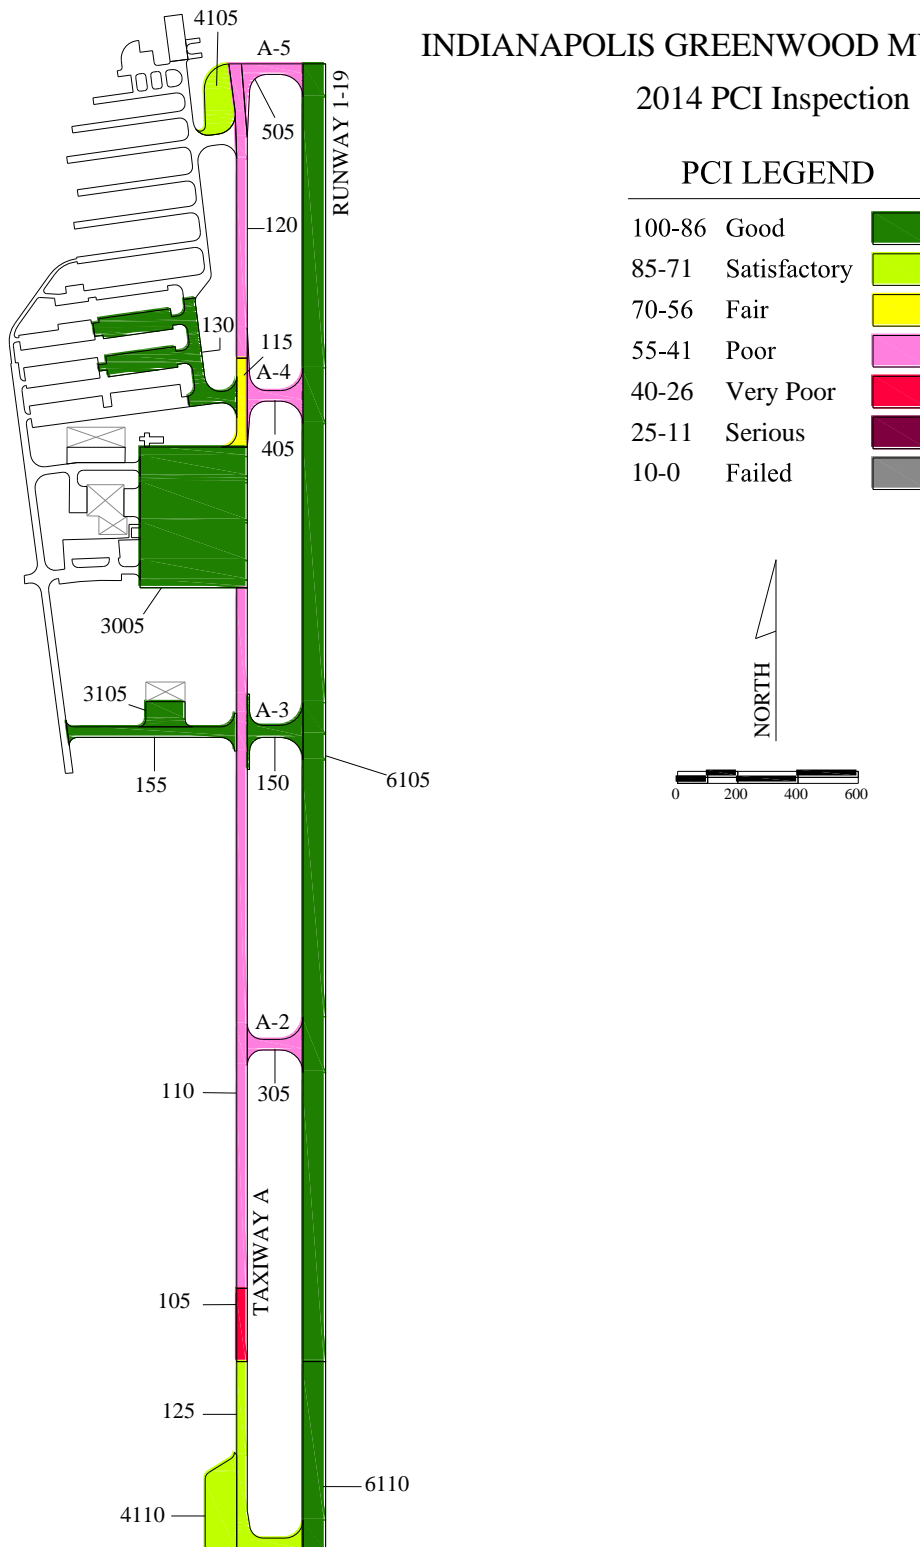
Figure 2-1. Inspected Pavement Condition

The pavement within each of the PCI condition categories is shown in Figure 2-1. The inspected PCI is summarized by branch use in Figure 2-2, and the photographs in Figure 2-3 through Figure 2-5 provide examples of the condition categories.

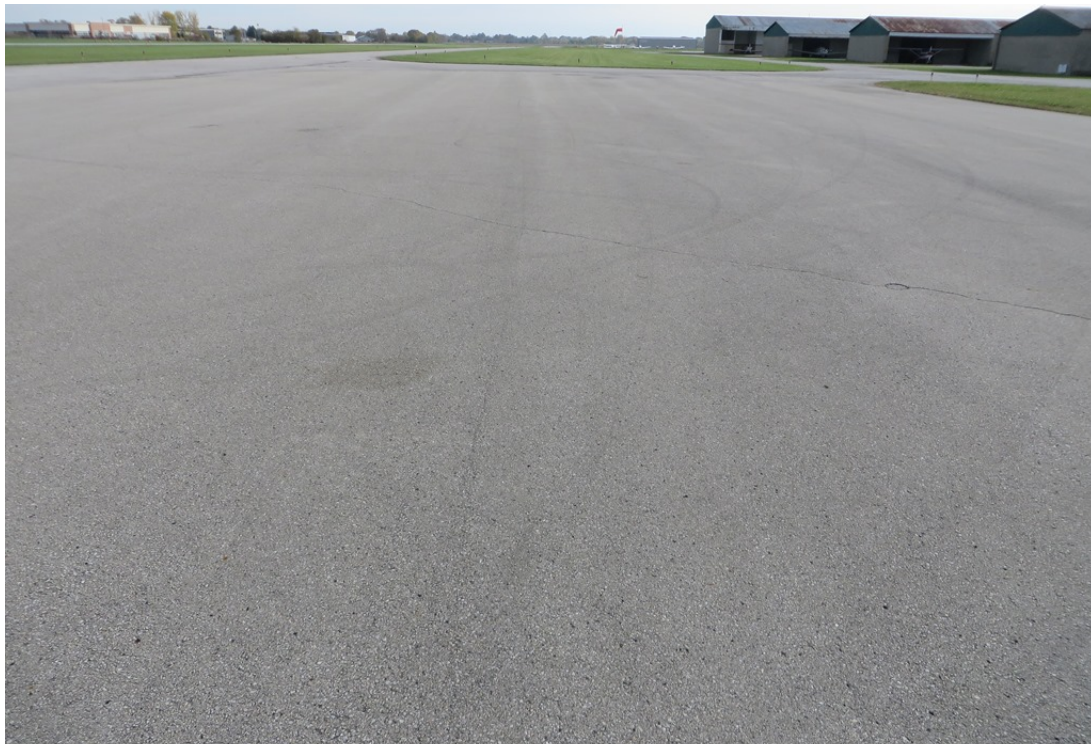
DISTRESS TYPE	SEVERITY	MEASURED QUANTITY	ESTIMATED TOTAL QUANTITY	UNITS	PERCENTAGE OF All DISTRESS
LONG.& TRANS. CRACK	MED	144	317	L.F.	51.8
LONG.& TRANS. CRACK	LOW	75	165	L.F.	16.4
RAVELING	HIGH	3	6	S.F.	14.3
RAVELING	MED	48	105	S.F.	17.2

APPROXIMATE AMOUNT OF DISTRESS RELATED TO LOAD ON THE PAVEMENT IS:	0 %
APPROXIMATE AMOUNT OF DISTRESS RELATED TO MATERIALS PROBLEMS IN THE FEATURE IS:	56 %
APPROXIMATE AMOUNT OF DISTRESS RELATED TO AGE OF PAVEMENT AND TRAFFIC REPETITIONS IS:	44 %

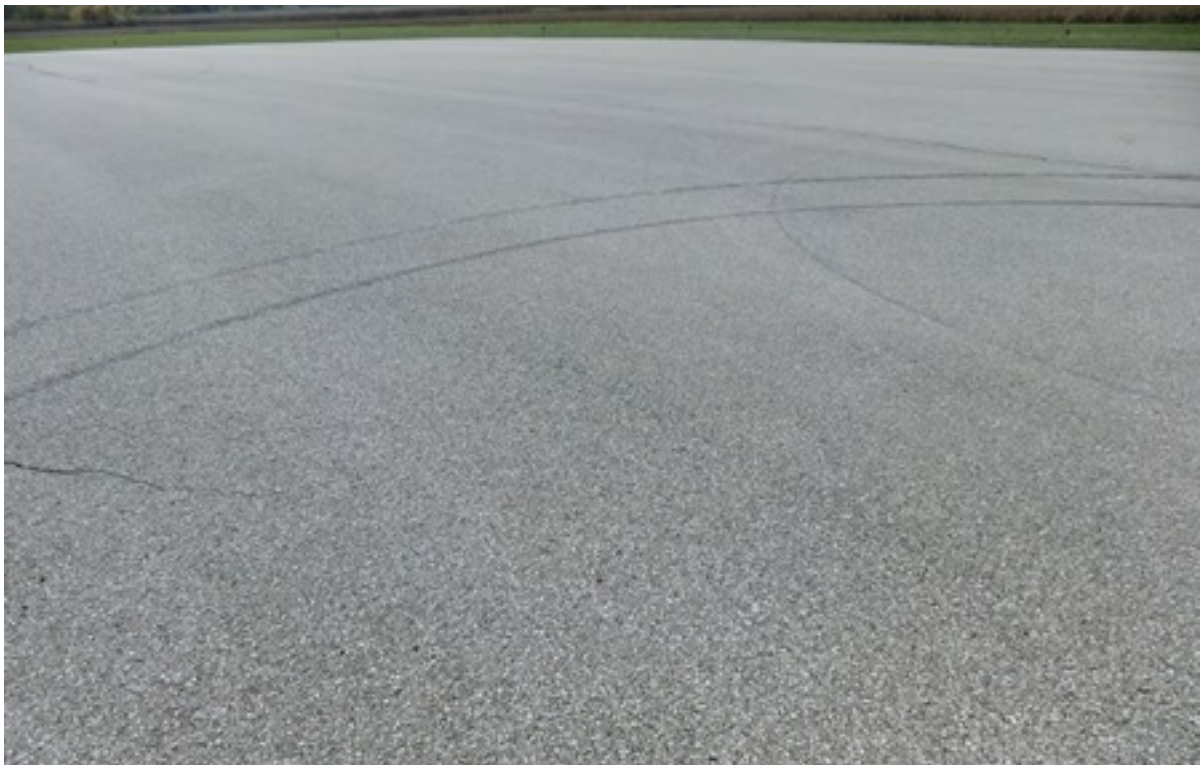
DISTRESS TYPE	SEVERITY	MEASURED QUANTITY	ESTIMATED TOTAL QUANTITY	UNITS	PERCENTAGE OF All DISTRESS
LONG.& TRANS. CRACK	HIGH	6	11	L.F.	11.5
LONG.& TRANS. CRACK	MED	239	455	L.F.	57.7
LONG.& TRANS. CRACK	LOW	325	619	L.F.	30.7

APPROXIMATE AMOUNT OF DISTRESS RELATED TO LOAD ON THE PAVEMENT IS:	0 %
APPROXIMATE AMOUNT OF DISTRESS RELATED TO MATERIALS PROBLEMS IN THE FEATURE IS:	67 %
APPROXIMATE AMOUNT OF DISTRESS RELATED TO AGE OF PAVEMENT AND TRAFFIC REPETITIONS IS:	33 %

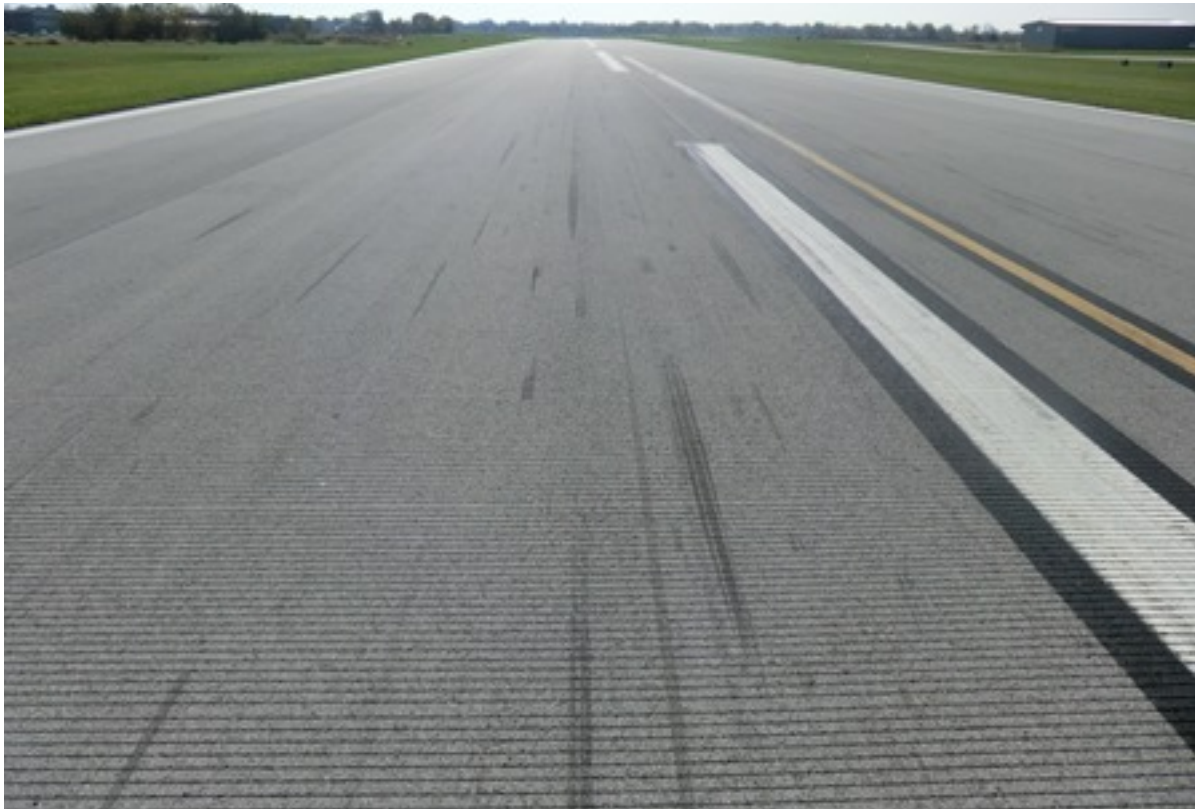
DISTRESS TYPE	SEVERITY	MEASURED QUANTITY	ESTIMATED TOTAL QUANTITY	UNITS	PERCENTAGE OF All DISTRESS
LONG.& TRANS. CRACK	LOW	247	1,634	L.F.	100

APPROXIMATE AMOUNT OF DISTRESS RELATED TO LOAD ON THE PAVEMENT IS:	0 %
APPROXIMATE AMOUNT OF DISTRESS RELATED TO MATERIALS PROBLEMS IN THE FEATURE IS:	67 %
APPROXIMATE AMOUNT OF DISTRESS RELATED TO AGE OF PAVEMENT AND TRAFFIC REPETITIONS IS:	33 %

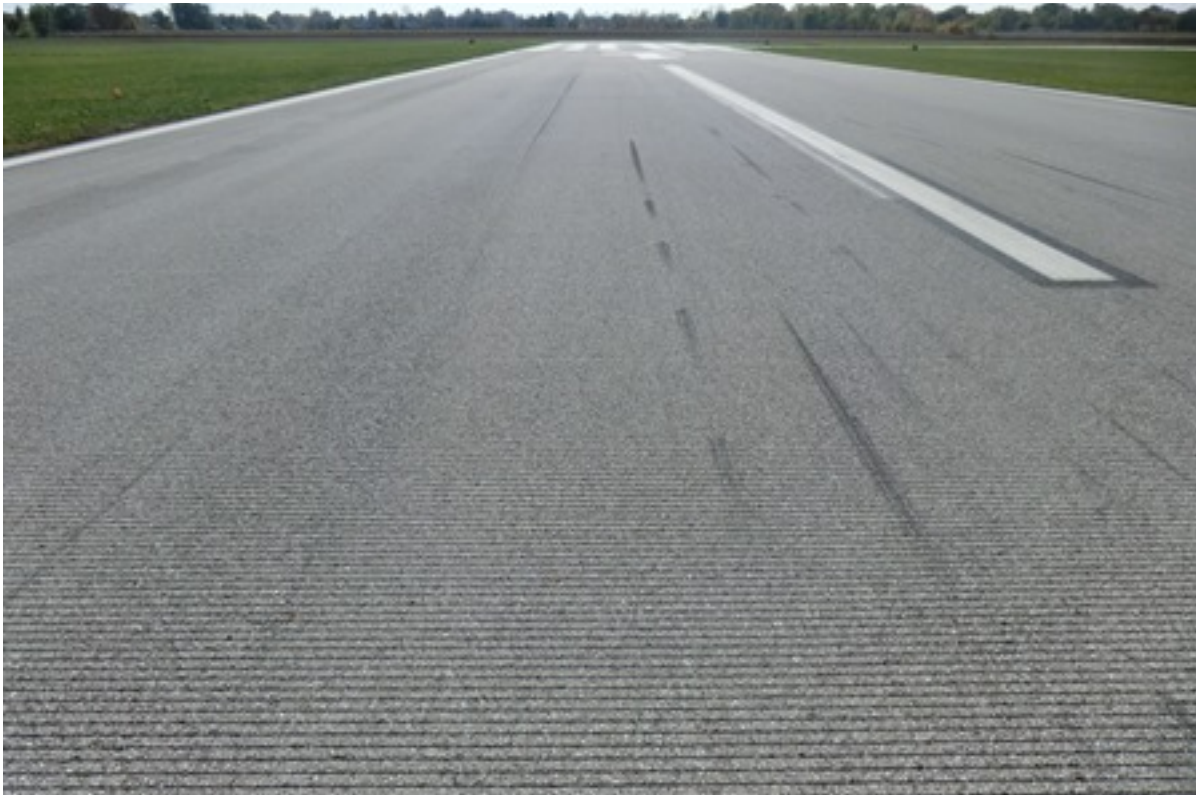
DISTRESS TYPE	SEVERITY	MEASURED QUANTITY	ESTIMATED TOTAL QUANTITY	UNITS	PERCENTAGE OF All DISTRESS
LONG.& TRANS. CRACK	MED	71	177	L.F.	51
LONG.& TRANS. CRACK	LOW	222	555	L.F.	48.9

APPROXIMATE AMOUNT OF DISTRESS RELATED TO LOAD ON THE PAVEMENT IS:	0 %
APPROXIMATE AMOUNT OF DISTRESS RELATED TO MATERIALS PROBLEMS IN THE FEATURE IS:	67 %
APPROXIMATE AMOUNT OF DISTRESS RELATED TO AGE OF PAVEMENT AND TRAFFIC REPETITIONS IS:	33 %
