Pavement Condition Report

Indianapolis Downtown Heliport

Project 15805741

February 2015

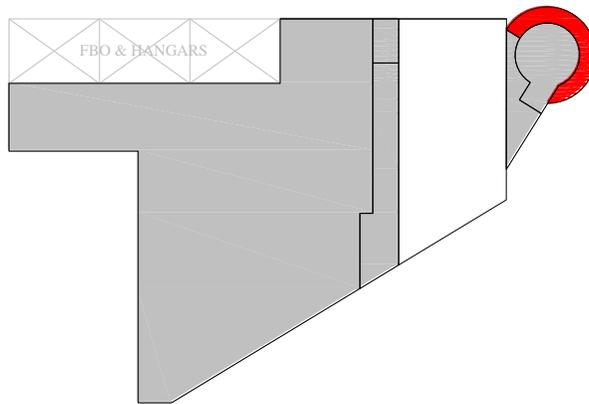
RECOMMENDED MAINTENANCE

Analysis of potential maintenance projects identified approximately 60 linear feet of crack sealing and crack repair needs, at an estimated total cost of approximately \$50.

Work Item	Quantity	Unit	Cost
AC SUSTAINING CRACK REPAIR	55	L.F.	48
Total:			\$48

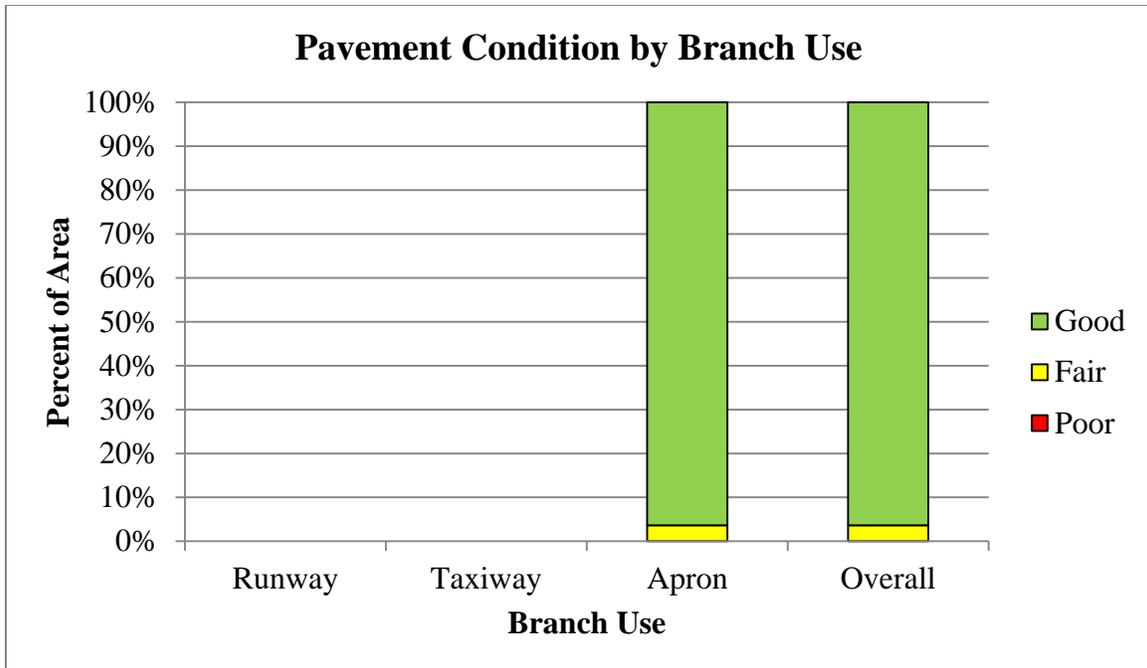
Figure 2-2. Pavement Condition by Branch Use

The pavement within each of the PCI condition categories is shown in Figure 2-1. The inspected PCI is summarized by branch use in Figure 2-2, and the photographs in Figure 2-3 through Figure 2-4 provide examples of the condition categories.
