Pavement Condition Report

Lafayette-Purdue University Airport

Project 15805741

February 2015

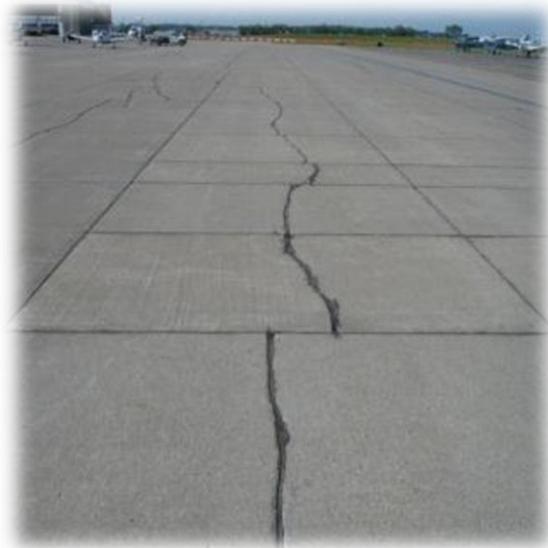
Longitudinal, Transverse & Diagonal Cracking

LTD cracking is often a result of load or temperature deformations. External loads cause flexure. Temperature changes can cause curling. When any of these stresses exceed the slab strength, cracking occurs.

LTD cracking is recorded at low, medium, or high severity, depending on the width of crack opening and degree of deterioration.

At low severity, a crack is less than 1/8 inch wide with little spalling, and no corrective action is indicated. At medium severity, LTD cracks can be up to 1 inch wide with moderate spalling and should be repaired using procedures similar to joint sealing. At high severity, cracks exceed 1 inch in width and may be severely spalled. High-severity LTD cracking is evidence of serious load failure, and correction may require patching or slab replacement. If distress occurs in several adjacent slabs at medium or high severity, major rehabilitation of that area is indicated.

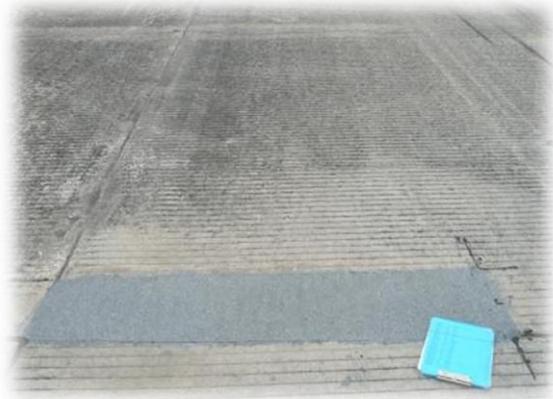
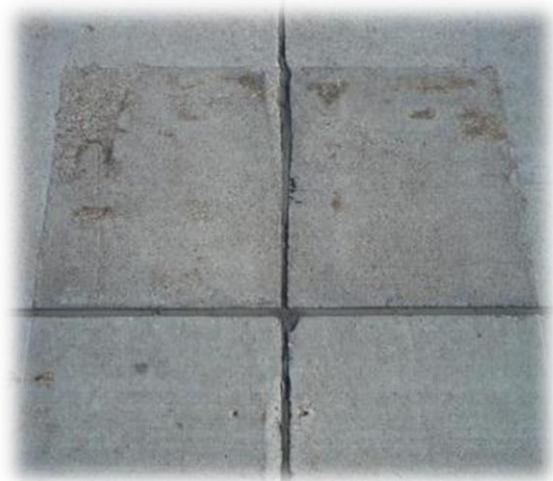
Large and small patches, by PCI inspection criteria, are distress conditions. Patches indicate deterioration and aging of pavement that contributes to shortened service life. However, patching also indicates that pavement is being maintained.

A patch that is performing well and shows no outward distress is recorded at low severity, and no corrective action is required. Medium-severity patches are serviceable but are beginning to deteriorate. Maintenance or replacement is indicated. At high severity, replacement is indicated.

By definition, small patches are smaller than 5 square feet in surface area, and they usually result from spall repair at slab joints and corners.

Large patches also may be the result of spall repair, but they often indicate more serious deficiencies, such as corner breaks or other full-depth failure smaller than panel size.

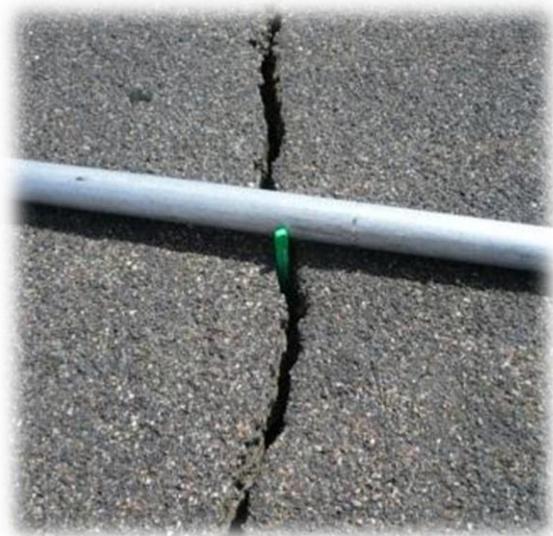
Longitudinal & Trans. Cracking

L&T cracks are caused by age, construction, and subsurface conditions. Age-related cracking occurs as oxidizing pavement loses components to the atmosphere and becomes more brittle. Consistent application of seal coats can help to prevent age-related cracks.

Construction-related cracking often develops along paving joints. Ensuring that joints are made when both sides are still hot, and near the same temperature, is one of the best ways to mitigate this potential problem.

Seasonal movement caused by changes in subsurface moisture or temperature differences also can cause pavement cracking. Asphalt pavement placed over a PCC pavement or cement stabilized base course may evidence reflective cracking from the underlying material. Wheel loads do not cause L&T cracks, although traffic may worsen their condition.

Low-severity L&T cracks are less than $\frac{1}{4}$ inch wide, or if sealed with suitable filler material in satisfactory condition can be any width less than 3 inches, if they are not spalled. Maintenance usually is not indicated for low-severity cracking. Moderately spalled cracks and cracks wider than $\frac{1}{4}$ inch which are not satisfactorily sealed are at medium severity. Medium-severity cracks should be sealed with a high-quality crack filling material. Severely spalled cracks and cracks wider than 3 inches are at high severity. High-severity L&T cracks normally require patching.

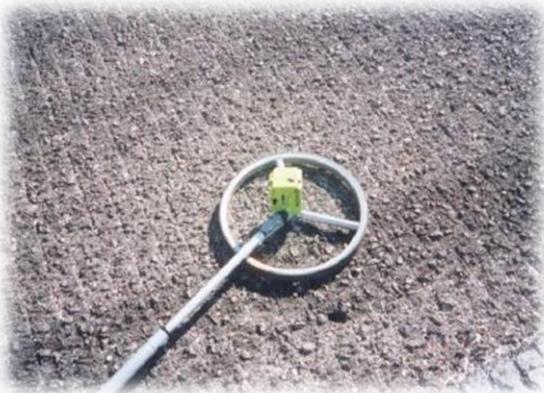
Raveling/Weathering

Raveling and weathering are the wearing away of the pavement surface. Failure can be caused by the dislodging of aggregate particles or the loss of asphalt binder. These distresses are usually evident over large areas and may indicate that the asphalt binder has hardened significantly.

Raveling: At low severity, 5 to 20 coarse aggregate particles are missing per square yard. Medium severity is defined by 20 to 40 missing coarse aggregate particles per square yard. At high severity, more than 40 coarse aggregate particles are missing per square yard, and the top layer of aggregate has eroded away.

Weathering: At low severity, edges of coarse aggregate are exposed less than 1 mm. At medium severity, loss of fine aggregate is noticeable and edges of coarse aggregate are exposed up to 6 mm (1/4 inch). High severity weathering has edges of coarse aggregate exposed > 6 mm, with considerable loss of fine aggregate matrix and potential for loss of coarse aggregate.
