Pavement Condition Report

Rochester-Fulton County Airport

Project 1480370

January 2014

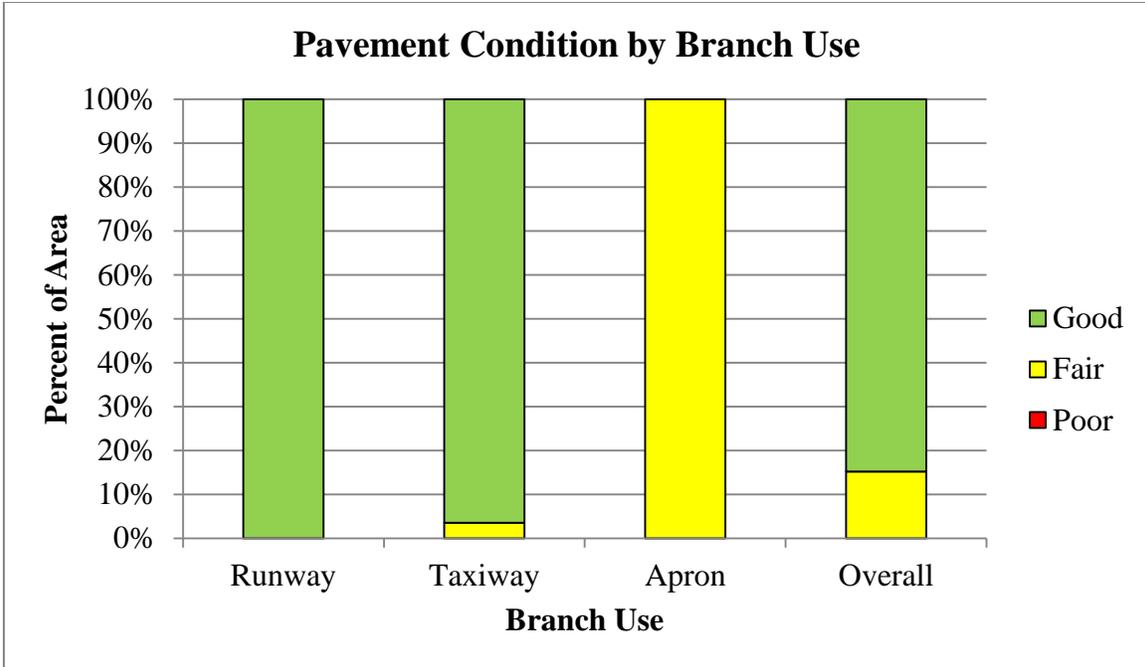
Figure 2-2. Pavement Condition by Branch Use

The overall Pavement Condition Index (PCI) for the airfield pavements was 79. Runways had an average inspected PCI of 76 and were above the desired MSL of 60. Taxiways had an average inspected PCI of 87, and ramps had an average inspected PCI of 70.

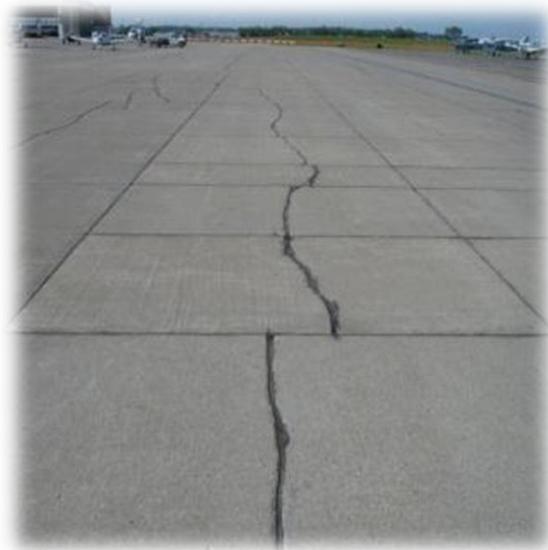
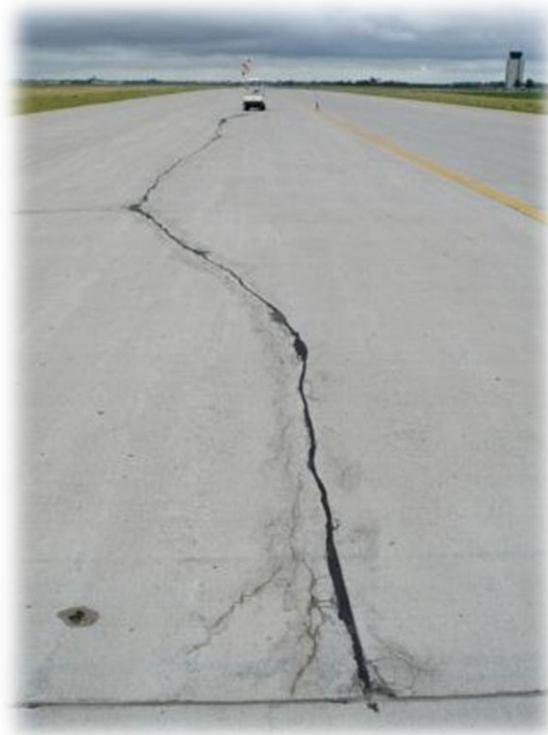
Longitudinal, Transverse & Diagonal Cracking

LTD cracking is often a result of load or temperature deformations. External loads cause flexure. Temperature changes can cause curling. When any of these stresses exceed the slab strength, cracking occurs.

LTD cracking is recorded at low, medium, or high severity, depending on the width of crack opening and degree of deterioration.

At low severity, a crack is less than 1/8 inch wide with little spalling, and no corrective action is indicated. At medium severity, LTD cracks can be up to 1 inch wide with moderate spalling and should be repaired using procedures similar to joint sealing. At high severity, cracks exceed 1 inch in width and may be severely spalled. High-severity LTD cracking is evidence of serious load failure, and correction may require patching or slab replacement. If distress occurs in several adjacent slabs at medium or high severity, major rehabilitation of that area is indicated.

A slab divided into four or more pieces is said to be “divided” or “shattered.” Shattered slab is a separate distress category and indicates a significant structural failure. A shattered slab has lost its ability to distribute loads. Shattered slabs are rated in three severities, but the recommended action in any case is slab replacement.

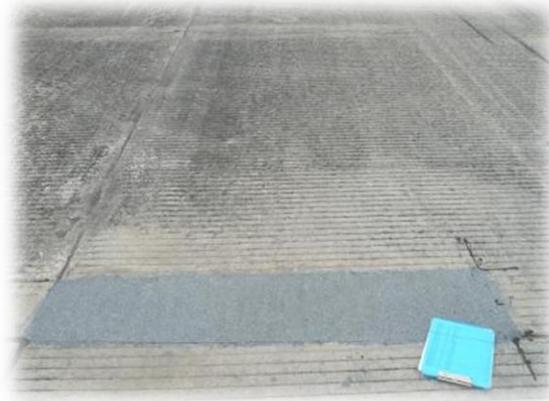
Patches, Large and Small

Large and small patches, by PCI inspection criteria, are distress conditions. Patches indicate deterioration and aging of pavement that contributes to shortened service life. However, patching also indicates that pavement is being maintained.

A patch that is performing well and shows no outward distress is recorded at low severity, and no corrective action is required. Medium-severity patches are serviceable but are beginning to deteriorate. Maintenance or replacement is indicated. At high severity, replacement is indicated.

By definition, small patches are smaller than 5 square feet in surface area, and they usually result from spall repair at slab joints and corners.

Large patches also may be the result of spall repair, but they often indicate more serious deficiencies, such as corner breaks or other full-depth failure smaller than panel size.
