# Pavement Condition Report

## Seymour-Freeman Municipal Airport

Project 1480370

**January 2014**

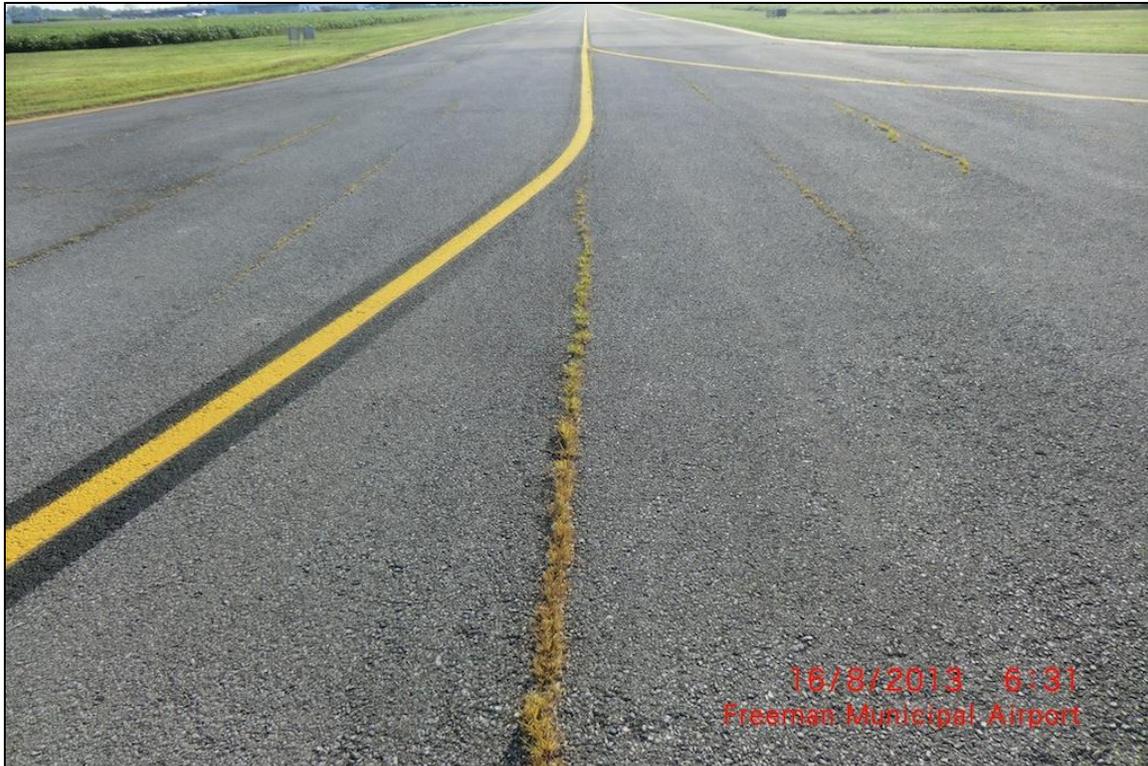
Figure 2-4. Typical Fair AC Pavement (Feature 105)

- Feature 105 had a 15 point PCI drop since the last inspection due largely to the development of medium and high severity L&T cracking.
- Feature 210 had a 13 point PCI drop since the last inspection due to the development of medium severity L&T cracking and high severity ravelling.
- Feature 505 had a 12 point PCI drop since the last inspection, the feature was partially reconstructed and the smaller area of remaining pavement has a higher percentage of medium severity L&T cracking than the in the prior inspections.

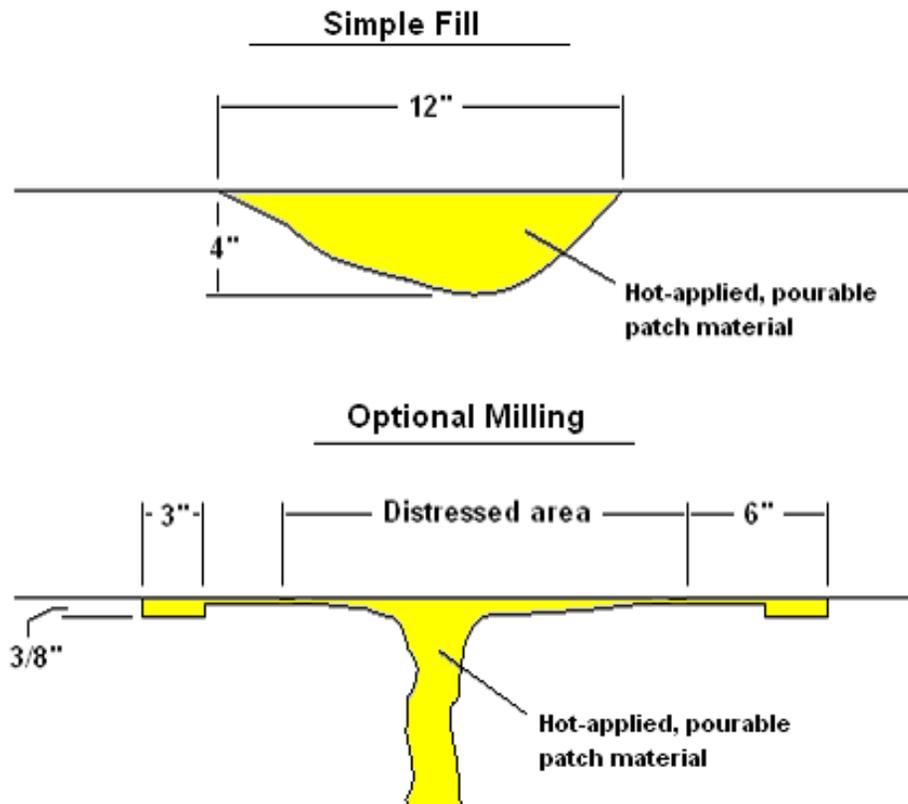
Hot-applied, pourable materials generally are used to repair deficiencies larger than can be repaired by sealants, but smaller than those where traditional techniques would be required. Suggested uses for this type of repair include cracks over 2 inches wide, potholes less than 4 inches deep, as a leveling for small depressions, as a cap for settled utility cuts, and as a skin patch for areas of alligator cracking.

- Examine and mark the patch outline. Boundaries should extend to sound pavement.
- Apply patch material to clean, dry surfaces.
- A heating lance to preheat or dry existing pavement is recommended in cold or wet conditions.
- Patch material should be poured into the area to be repaired and leveled as appropriate.
- Patch edges should be sealed after application to assure good adhesion, preventing surface moisture from migrating under patch edges.
