Pavement Condition Report

Bedford-Grissom Municipal Airport

Project 16801839

January 2016

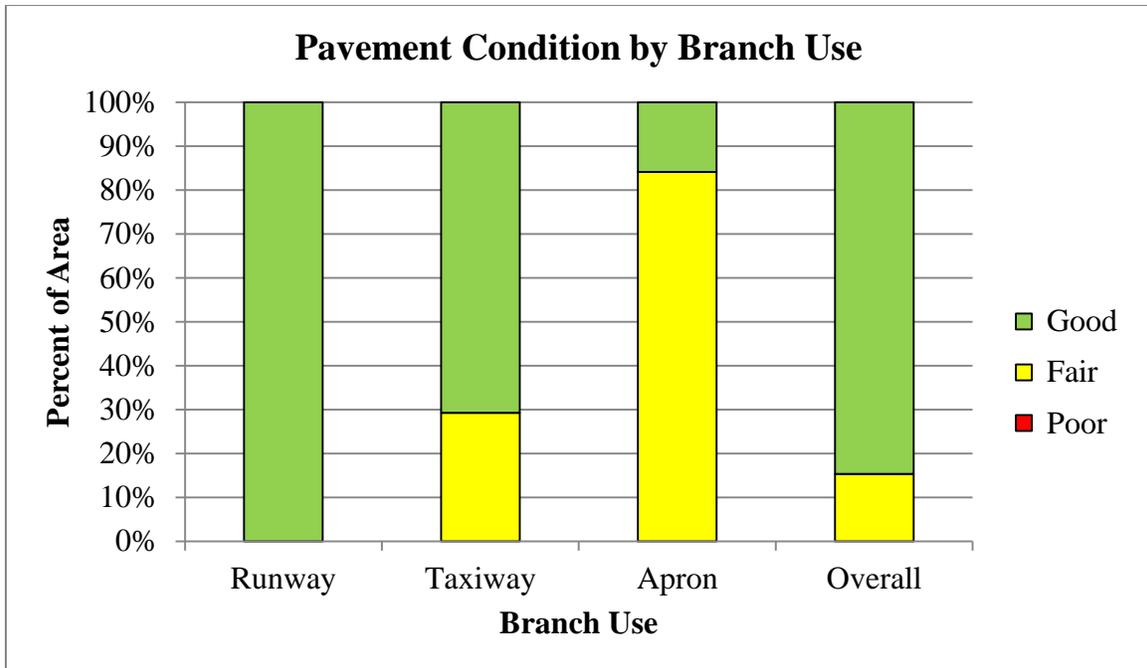
Figure 2-2. Pavement Condition by Branch Use

The pavement within each of the PCI condition categories is shown in Figure 2-1. The inspected PCI is summarized by branch use in Figure 2-2, and the photographs in Figure 2-3 through Figure 2-5 provide examples of the condition categories.

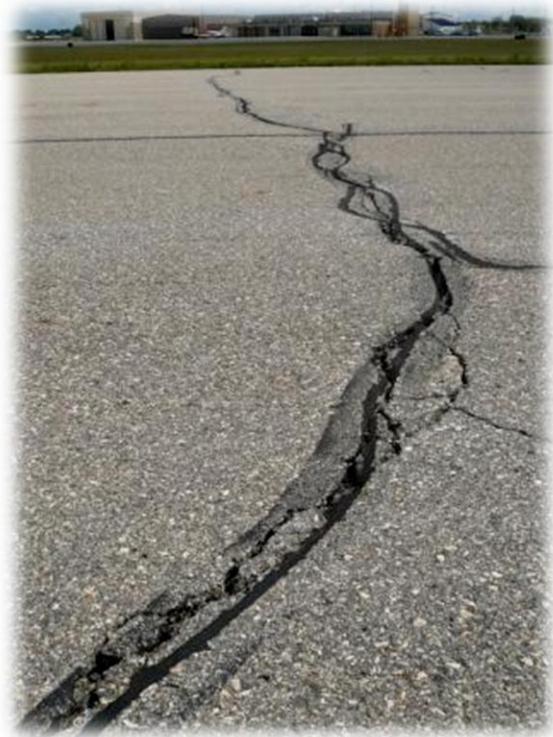
Longitudinal & Transverse Cracking

L&T cracks are caused by age, construction, and subsurface conditions. Age-related cracking occurs as oxidizing pavement loses components to the atmosphere and becomes more brittle. Consistent application of seal coats can help to prevent age-related cracks.

Construction-related cracking often develops along paving joints. Ensuring that joints are made when both sides are still hot, and near the same temperature, is one of the best ways to mitigate this potential problem.

Seasonal movement caused by changes in subsurface moisture or temperature differences also can cause pavement cracking. Asphalt pavement placed over a PCC pavement or cement stabilized base course may evidence reflective cracking from the underlying material. Wheel loads do not cause L&T cracks, although traffic may worsen their condition.

Low-severity L&T cracks are less than ¼ inch wide, or if sealed with suitable filler material in satisfactory condition can be any width less than 3 inches, if they are not spalled. Maintenance usually is not indicated for low-severity cracking. Moderately spalled cracks and cracks wider than ¼ inch which are not satisfactorily sealed are at medium severity. Medium-severity cracks should be sealed with a high-quality crack filling material. Severely spalled cracks and cracks wider than 3 inches are at high severity. High-severity L&T cracks normally require patching.
