# Pavement Condition Report

## Greensburg Municipal Airport

Project 16801839

**January 2016**

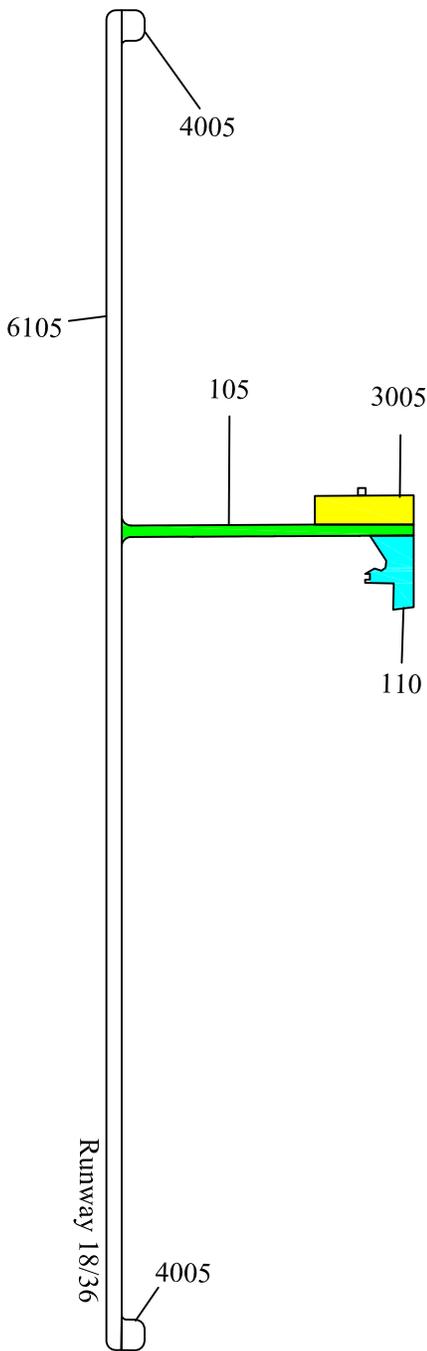
## 2015 PCI Inspection

- Patching

- Crack Sealing

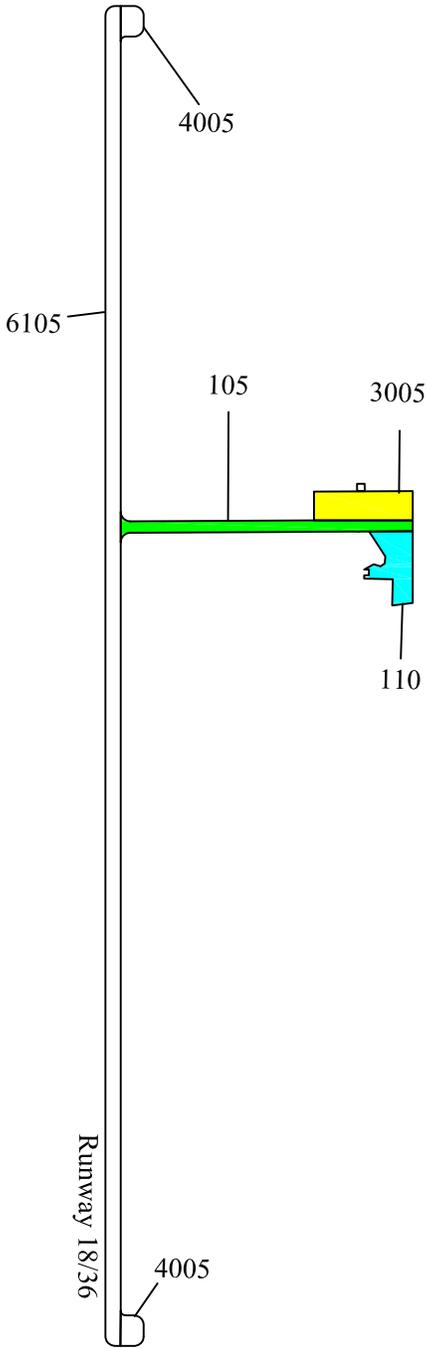
## 2015 PCI Inspection

- Patching
- Crack Sealing
- Both

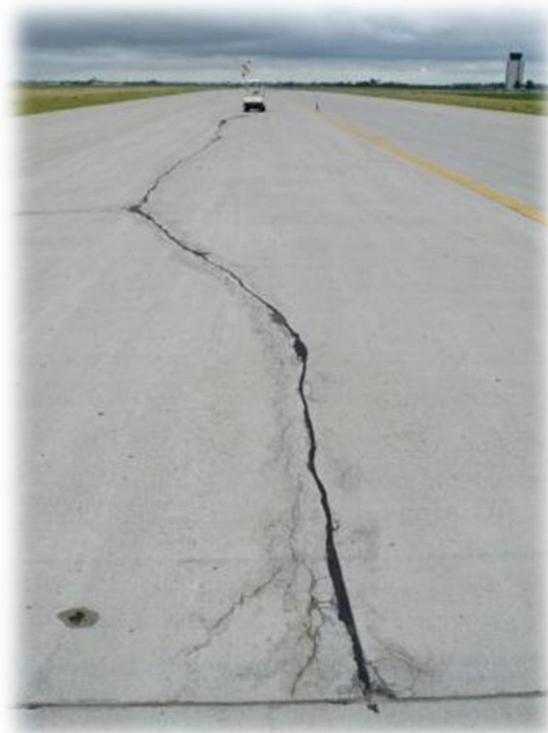
#### *Longitudinal, Transverse & Diagonal Cracking*

LTD cracking is often a result of load or temperature deformations. External loads cause flexure. Temperature changes can cause curling. When any of these stresses exceed the slab strength, cracking occurs.

LTD cracking is recorded at low, medium, or high severity, depending on the width of crack opening and degree of deterioration.

At low severity, a crack is less than 1/8 inch wide with little spalling, and no corrective action is indicated. At medium severity, LTD cracks can be up to 1 inch wide with moderate spalling and should be repaired using procedures similar to joint sealing. At high severity, cracks exceed 1 inch in width and may be severely spalled. High-severity LTD cracking is evidence of serious load failure, and correction may require patching or slab replacement. If distress occurs in several adjacent slabs at medium or high severity, major rehabilitation of that area is indicated.

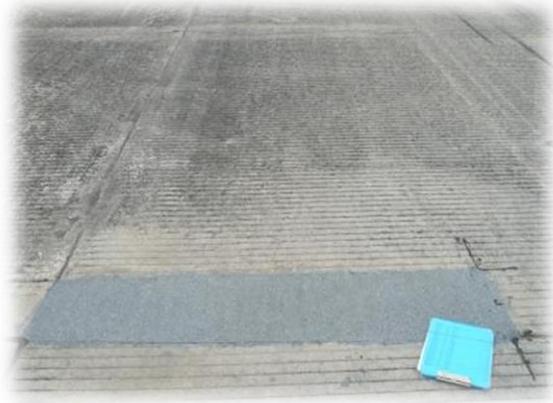
### *Patches, Large and Small*

Large and small patches, by PCI inspection criteria, are distress conditions. Patches indicate deterioration and aging of pavement that contributes to shortened service life. However, patching also indicates that pavement is being maintained.

A patch that is performing well and shows no outward distress is recorded at low severity, and no corrective action is required. Medium-severity patches are serviceable but are beginning to deteriorate. Maintenance or replacement is indicated. At high severity, replacement is indicated.

By definition, small patches are smaller than 5 square feet in surface area, and they usually result from spall repair at slab joints and corners.

Large patches also may be the result of spall repair, but they often indicate more serious deficiencies, such as corner breaks or other full-depth failure smaller than panel size.
