Pavement Condition Report

North Vernon Airport

Project 16801839

January 2016

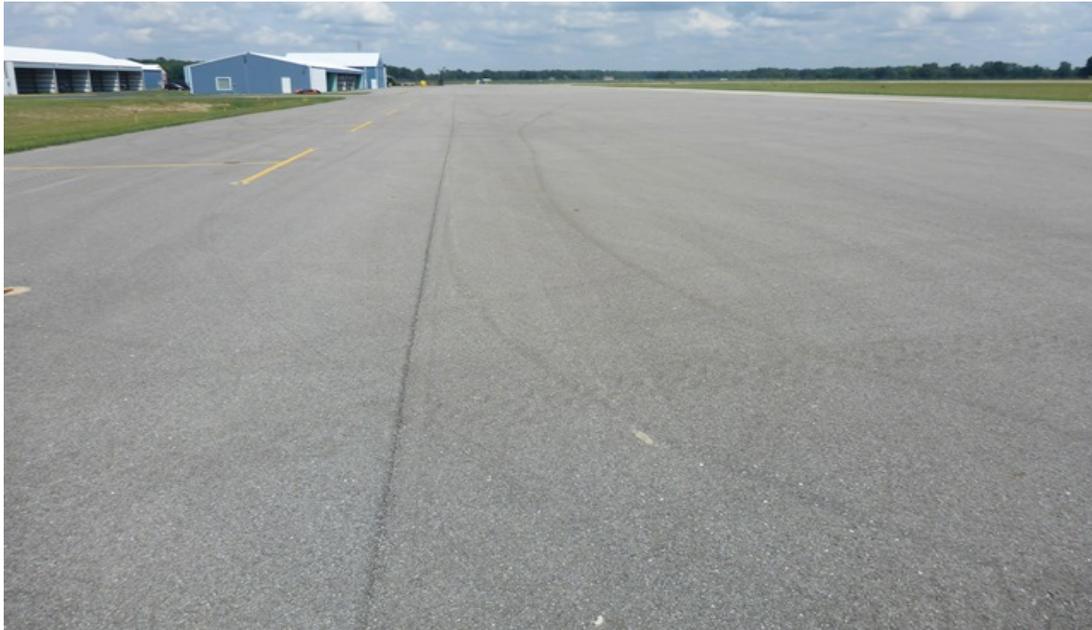
DISTRESS TYPE	SEVERITY	MEASURED QUANTITY	ESTIMATED TOTAL QUANTITY	UNITS	PERCENTAGE OF All DISTRESS
LONG.& TRANS. CRACK	LOW	74	252	L.F.	100

APPROXIMATE AMOUNT OF DISTRESS RELATED TO LOAD ON THE PAVEMENT IS: 0 %
 APPROXIMATE AMOUNT OF DISTRESS RELATED TO MATERIALS PROBLEMS IN THE FEATURE IS: 67 %
 APPROXIMATE AMOUNT OF DISTRESS RELATED TO AGE OF PAVEMENT AND TRAFFIC REPETITIONS IS: 33 %

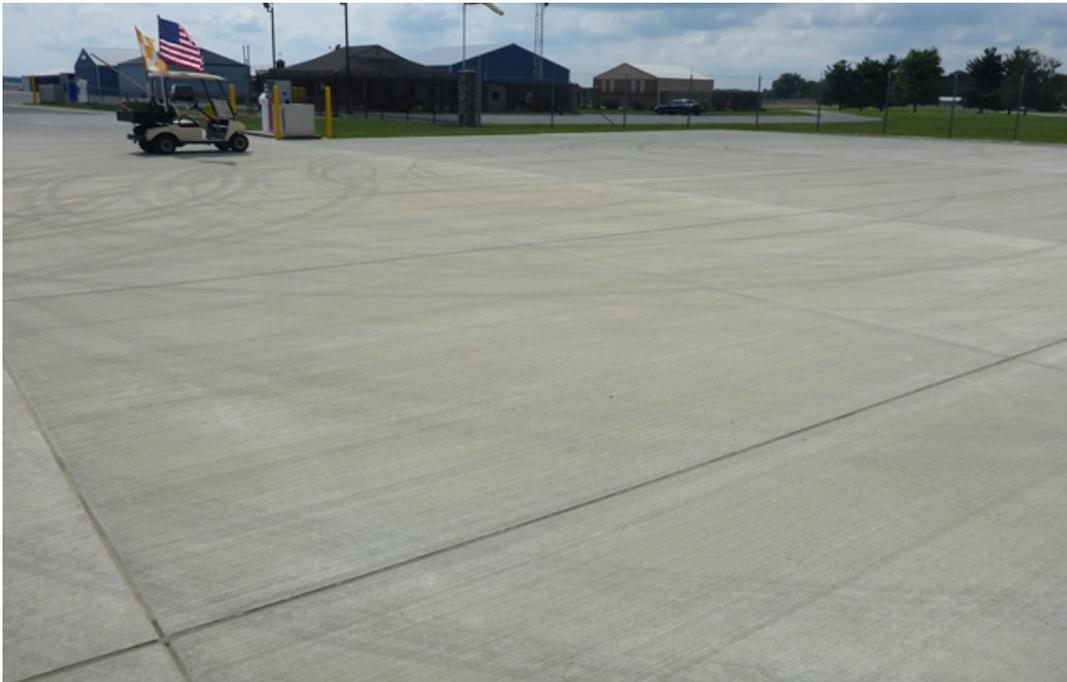
APPROXIMATE AMOUNT OF DISTRESS RELATED TO LOAD ON THE PAVEMENT IS:	0 %
APPROXIMATE AMOUNT OF DISTRESS RELATED TO MATERIALS PROBLEMS IN THE FEATURE IS:	0 %
APPROXIMATE AMOUNT OF DISTRESS RELATED TO AGE OF PAVEMENT AND TRAFFIC REPETITIONS IS:	0 %

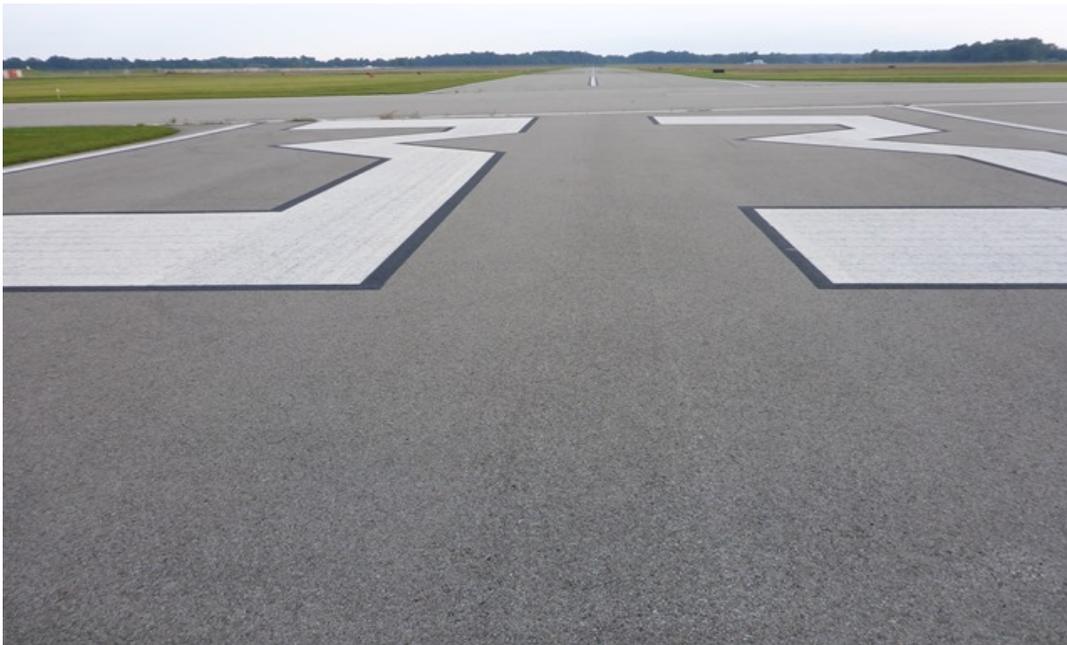
DISTRESS TYPE	SEVERITY	MEASURED QUANTITY	ESTIMATED TOTAL QUANTITY	UNITS	PERCENTAGE OF All DISTRESS
LONG.& TRANS. CRACK	LOW	105	135	L.F.	100

APPROXIMATE AMOUNT OF DISTRESS RELATED TO LOAD ON THE PAVEMENT IS:	0 %
APPROXIMATE AMOUNT OF DISTRESS RELATED TO MATERIALS PROBLEMS IN THE FEATURE IS:	67 %
APPROXIMATE AMOUNT OF DISTRESS RELATED TO AGE OF PAVEMENT AND TRAFFIC REPETITIONS IS:	33 %

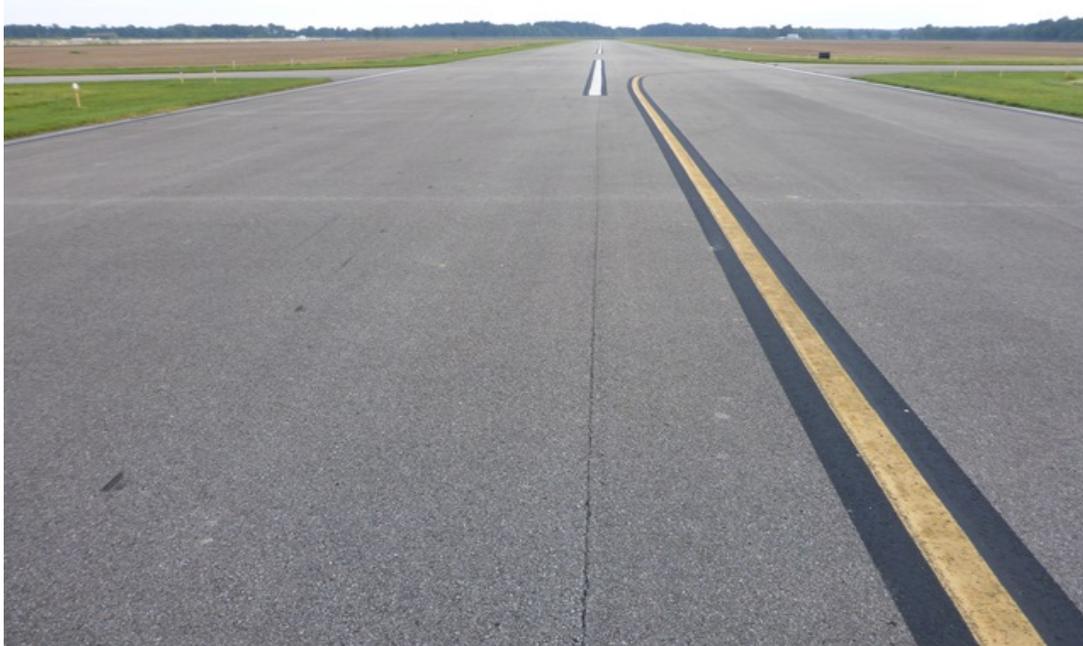
DISTRESS TYPE	SEVERITY	MEASURED QUANTITY	ESTIMATED TOTAL QUANTITY	UNITS	PERCENTAGE OF All DISTRESS
LONG.& TRANS. CRACK	LOW	1,607	4,490	L.F.	98.6
WEATHERING	LOW	500	1,397	S.F.	1.3

APPROXIMATE AMOUNT OF DISTRESS RELATED TO LOAD ON THE PAVEMENT IS:	0 %
APPROXIMATE AMOUNT OF DISTRESS RELATED TO MATERIALS PROBLEMS IN THE FEATURE IS:	66 %
APPROXIMATE AMOUNT OF DISTRESS RELATED TO AGE OF PAVEMENT AND TRAFFIC REPETITIONS IS:	34 %

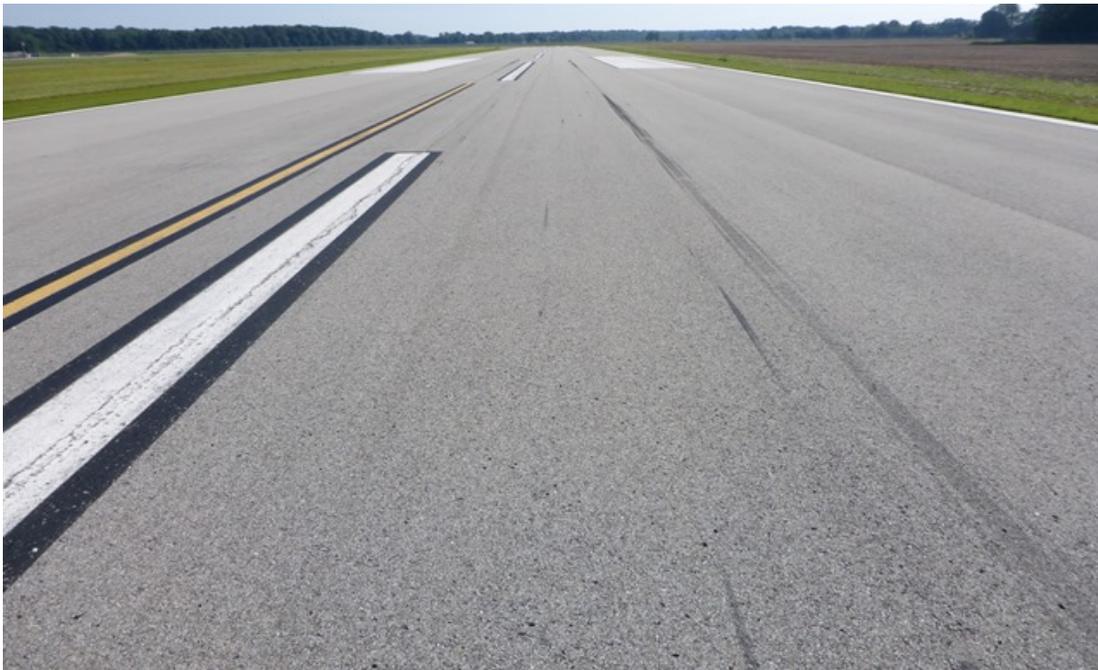
DISTRESS TYPE	SEVERITY	MEASURED QUANTITY	ESTIMATED TOTAL QUANTITY	UNITS	PERCENTAGE OF ALL DISTRESS
LONG.& TRANS. CRACK	LOW	1,680	12,729	L.F.	100

APPROXIMATE AMOUNT OF DISTRESS RELATED TO LOAD ON THE PAVEMENT IS:	0 %
APPROXIMATE AMOUNT OF DISTRESS RELATED TO MATERIALS PROBLEMS IN THE FEATURE IS:	67 %
APPROXIMATE AMOUNT OF DISTRESS RELATED TO AGE OF PAVEMENT AND TRAFFIC REPETITIONS IS:	33 %
