# HAZARDOUS AND REGULATED MATERIALS INSPECTION REPORT

Gordon's Annex  
810 Massachusetts Street  
Parcel ID: 45-08-03-355-005  
Gary, 46402

Northwest Indiana Regional Development Authority  
9800 Connecticut Drive  
Crown Point, Indiana 46307  
Client Reference: Gary Blight Elimination Program

Egis  
48797 Alpha Drive, Suite 130  
Wixom, MI 48393  
Egis Project ID: 240100  
April 22, 2025

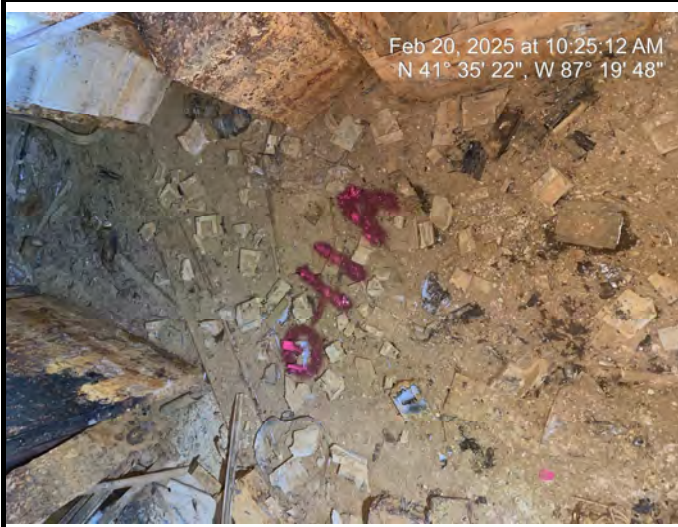
Sample # 11 Insulator - Transite debris, from electrical panels

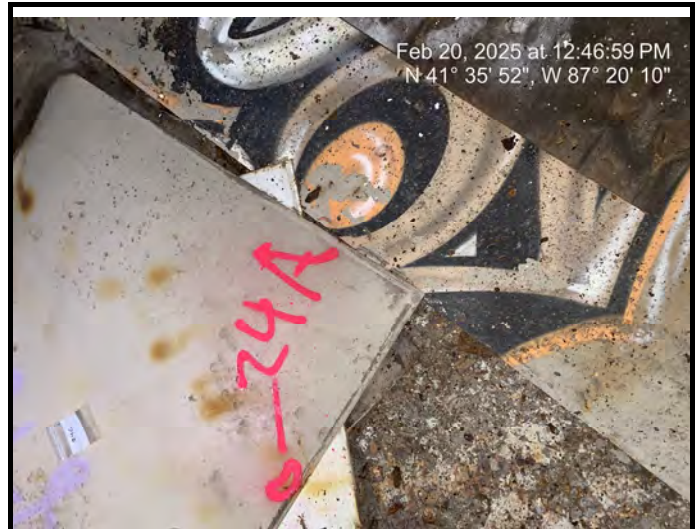
Sample # 24 Interior Caulk - Gray, on metal panels on floor

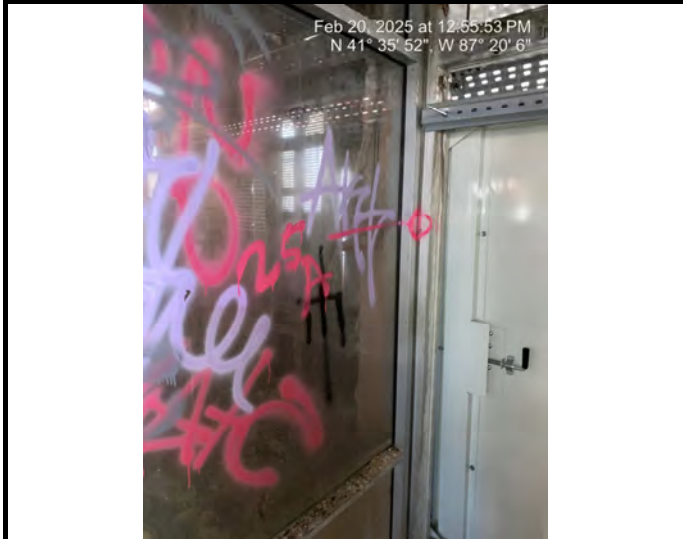
Sample # 25 Interior Caulk - Gray, flexible, on Metal door trim at west vestibule

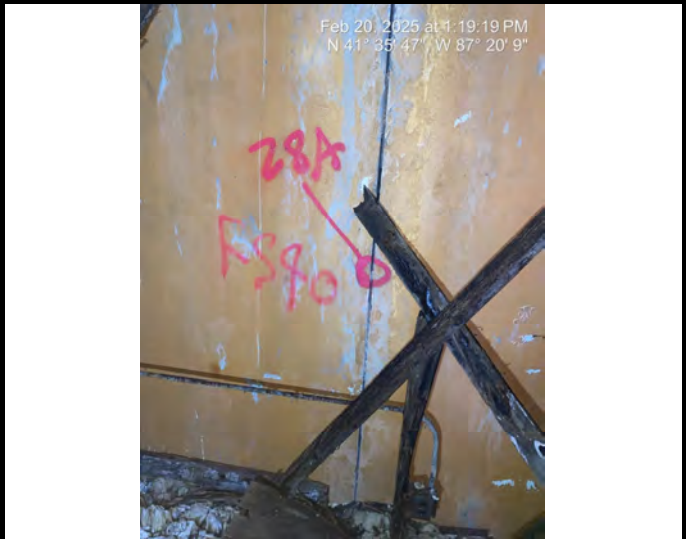
Sample # 28 Interior Caulk - Gray, between concrete slabs along north & east walls

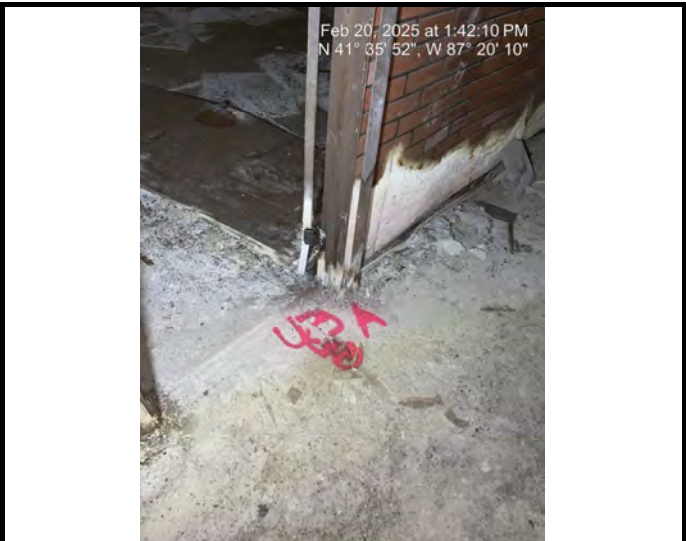
Sample # 43 Flooring - 12X12 Floor Tile with Mastic & Glue

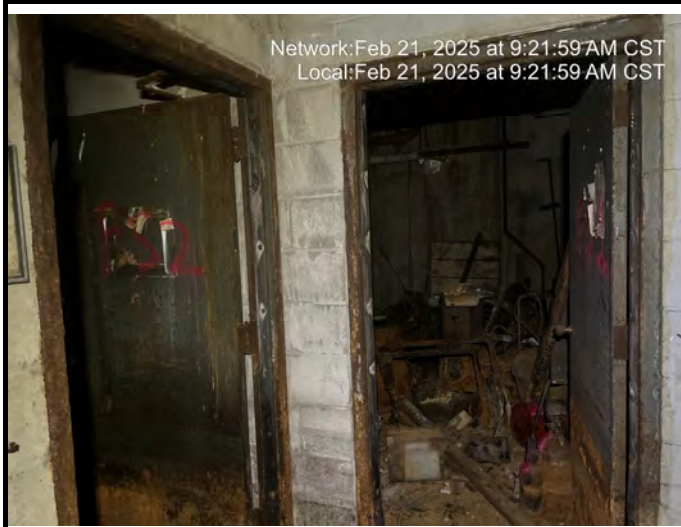
Assumed Material # A-3	Fire Door - Metal
------------------------	-------------------

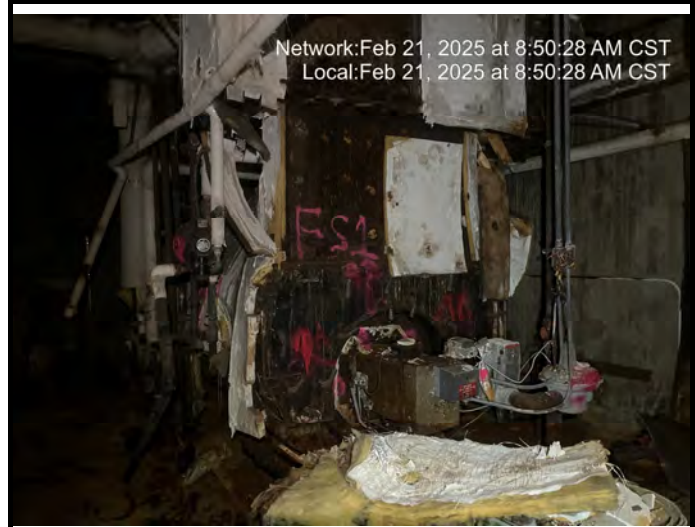
Assumed Material # A-4	Boiler Insulation - Internal boiler components including but not limited to; fire brick, gaskets, insulation, etc.
------------------------	--

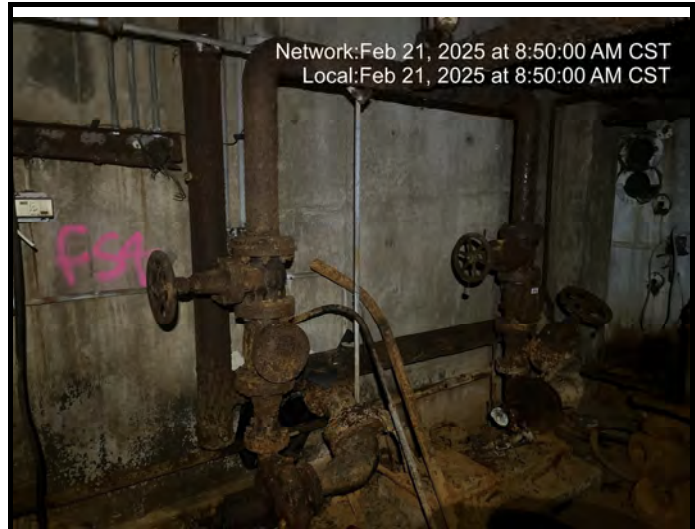
Assumed Material # A-6	Valve Packings - Various size valve packings
------------------------	--

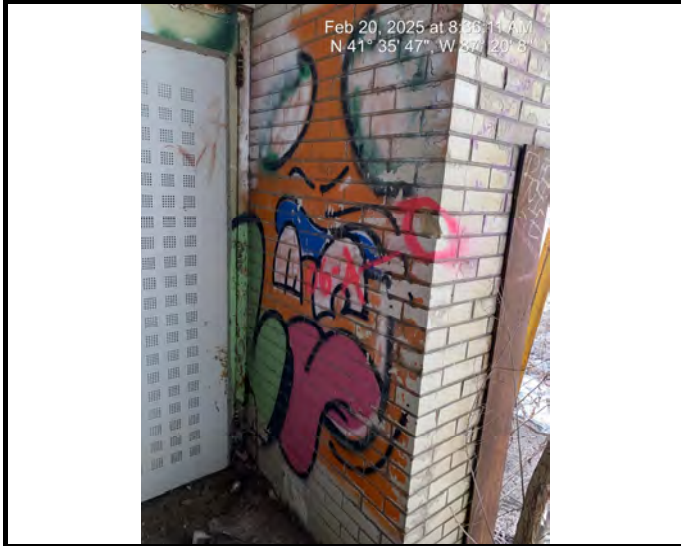
Sample # 6      Brick Mortar - Exterior, gray with white glazed brick

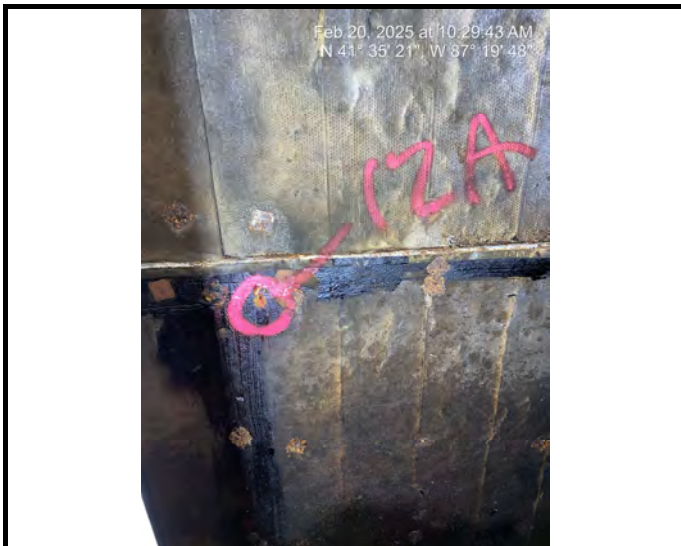
Sample # 12      Construction Adhesive - Black, on fiberglass insulation inside air handler

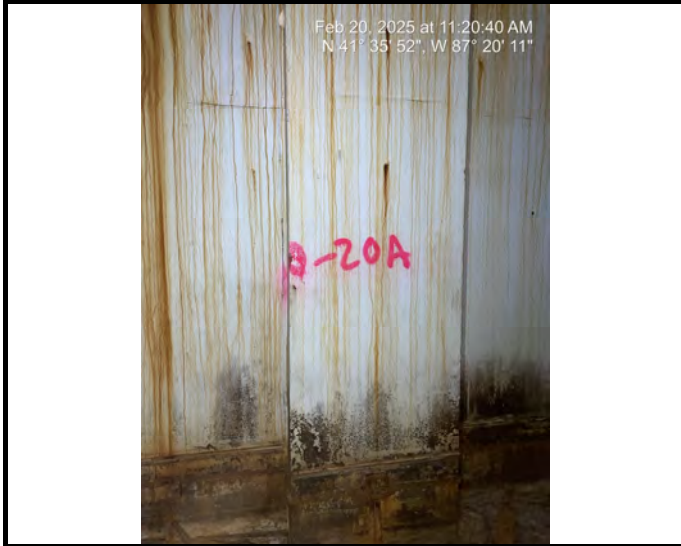
Sample # 20 Concrete - Foundation Walls

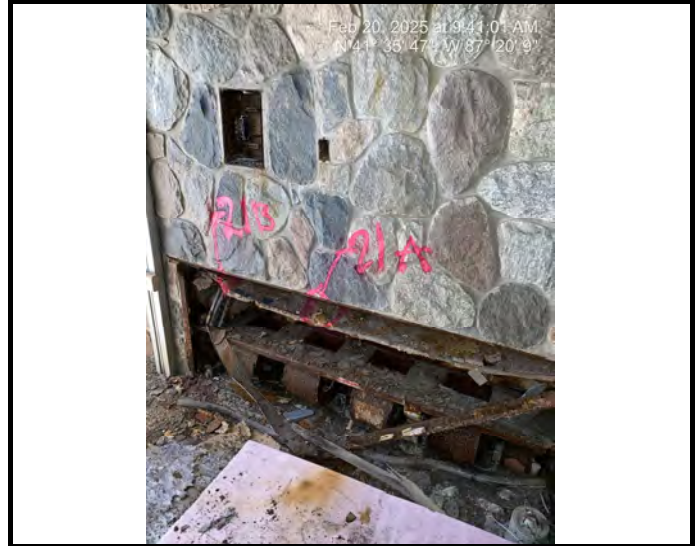
Sample # 21 Rolled In Insulation - Yellow fiberglass with thick tar Paper backing

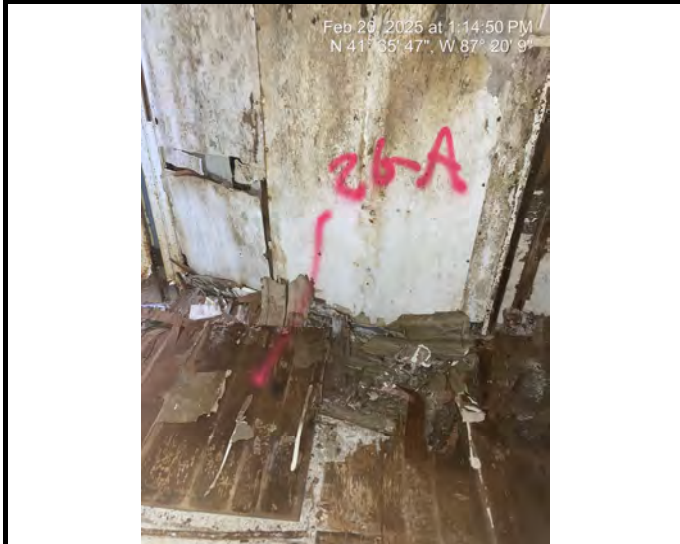
Sample # 26 Construction Adhesive - Yellow, behind wood paneling

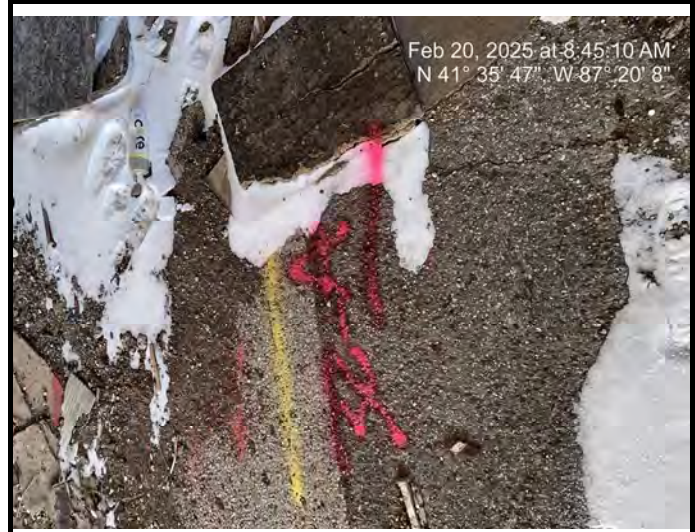
Sample # 32      Exterior Siding - Fiberboard, black, for sound proofing behind plaster

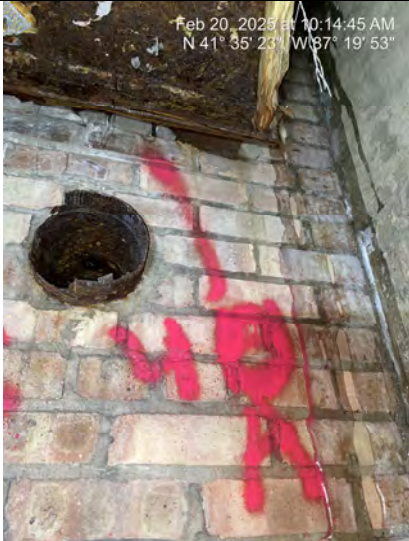
Sample # 40      Stack Cement - Chimney at Mechanical Exhausts

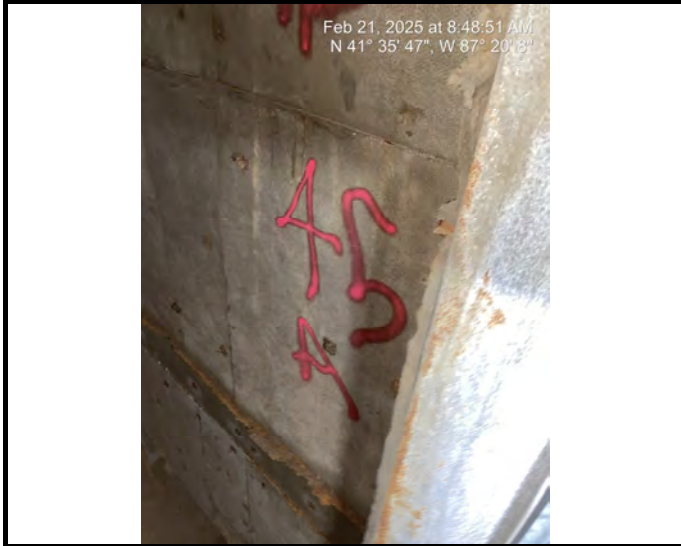
Sample # 45 Duct Insulation - Fiberglass/horse hair w/plastic

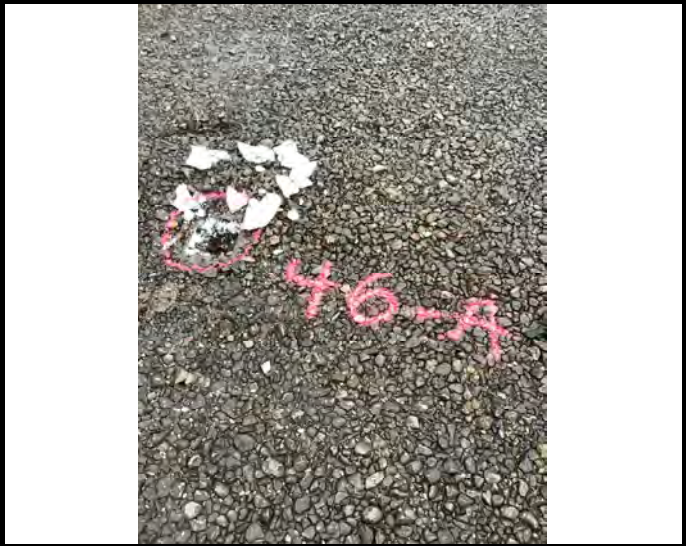
Sample # 46 Roofing Material - Flat Roof Material

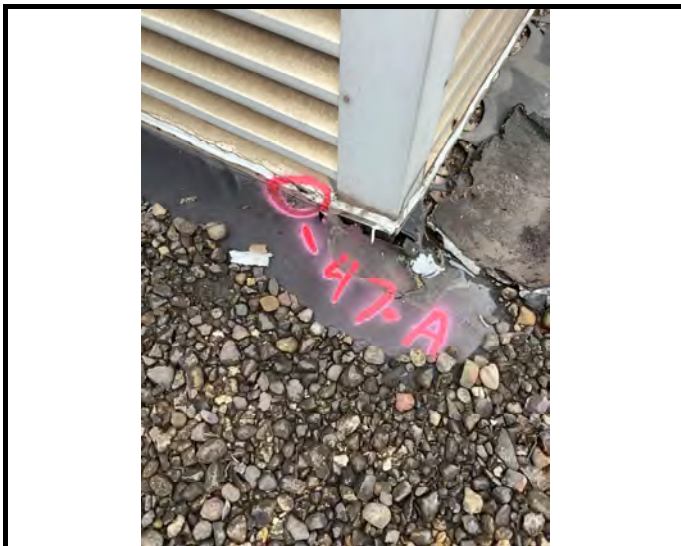
Sample # 47 Exterior Caulk-Light Gray - Around an Air Handling Unit perimeter and used as patching seams, Window

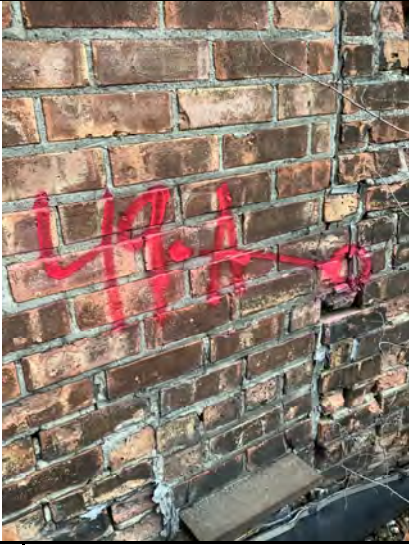
Sample # 49 Exterior Caulk- Brown - Used as a patch for brick mortar
