# HAZARDOUS AND REGULATED MATERIALS INSPECTION REPORT

Former H. Gordon & Sons Department Store  
813 Broadway  
Parcel ID: 45-08-03-355-002  
Gray, IN 46402

Egis  
48797 Alpha Drive, Suite 130  
Wixom, MI 48393  
Egis Project ID: 240100  
April 22, 2025

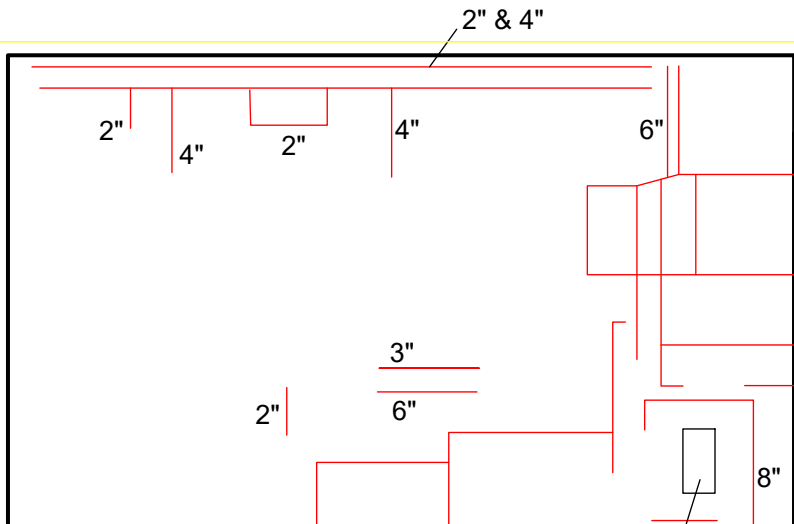
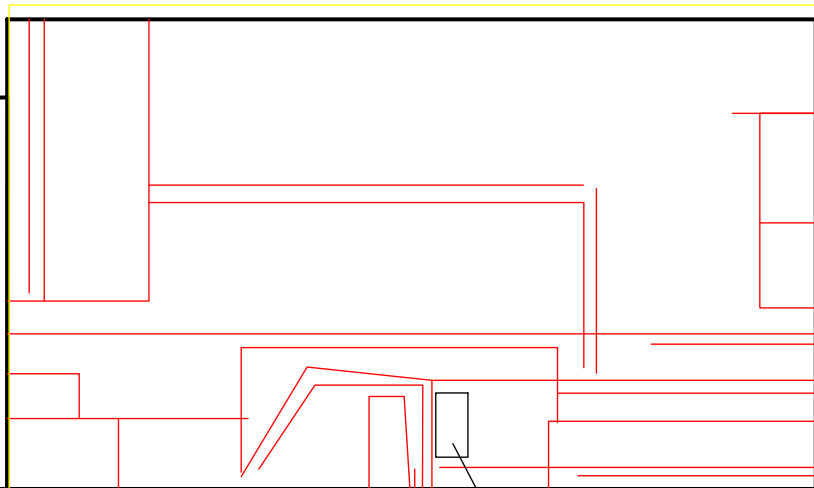
FIGURE 3  
BASEMENT LAYOUT W/ TSI LOCATIONS

Based on the results of this inspection, friable RACMs in the form of TSI pipe wrap on horizontal and vertical pipe chases and pipe fittings (mudded joints) cladded on the elbows of pipe chases were identified throughout the site building, primarily within the basement and within vertical pipe chases on each floor. Layouts depicting TSI locations within the basement and the upper floors are provided as Figure 3 and Figure 4, respectively.

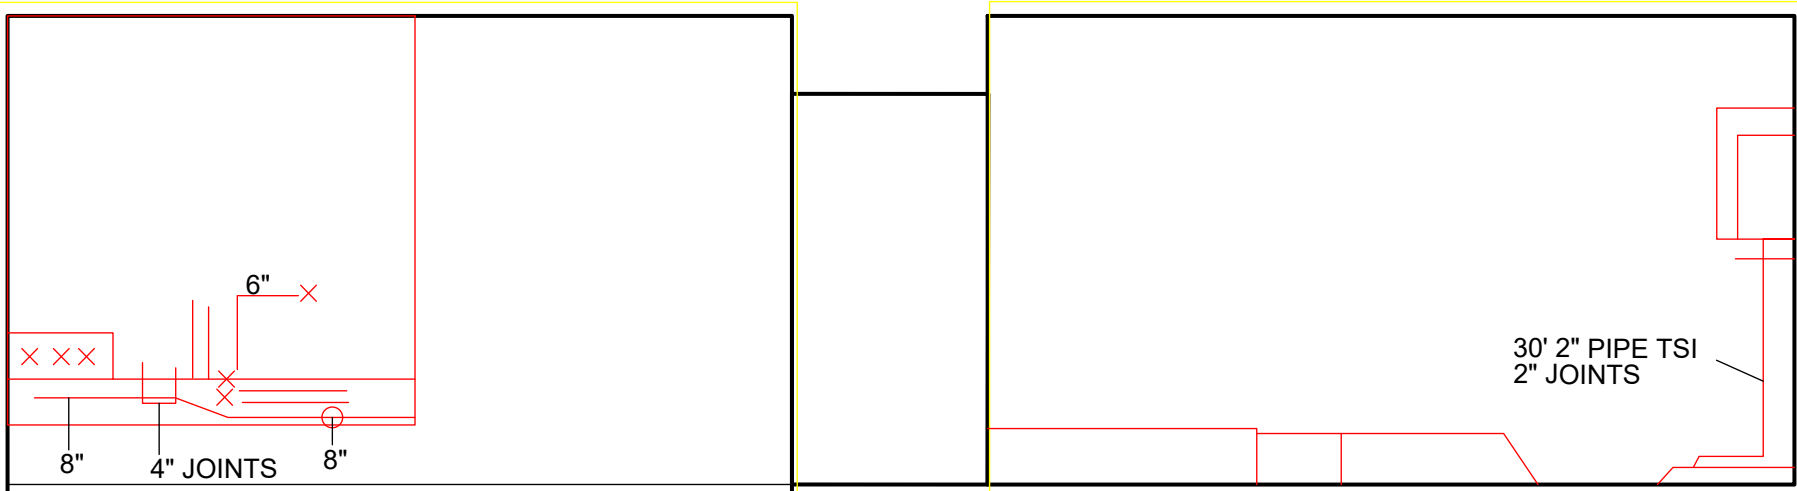
FIGURE 4  
UPPER FLOOR LAYOUTS W/ TSI LOCATIONS

8' x 4" JOINTS  
5' X 8" PIPE TSI  
15' X 6" PIPE TSI

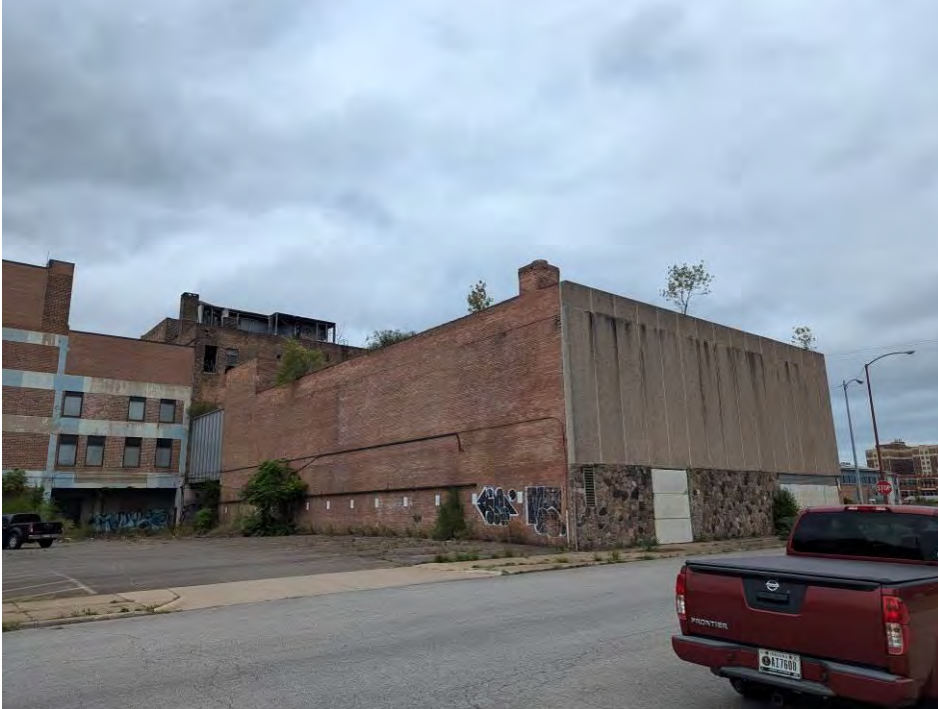
DATE: September 23, 2024  
LOCATION: 801-811 Broadway Street in Gary, Indiana  
SUBJECT: View of southeast side of site building  
PHOTOGRAPHER: Ryan M. Orzechowicz (Heartland)  
PHOTO: 1

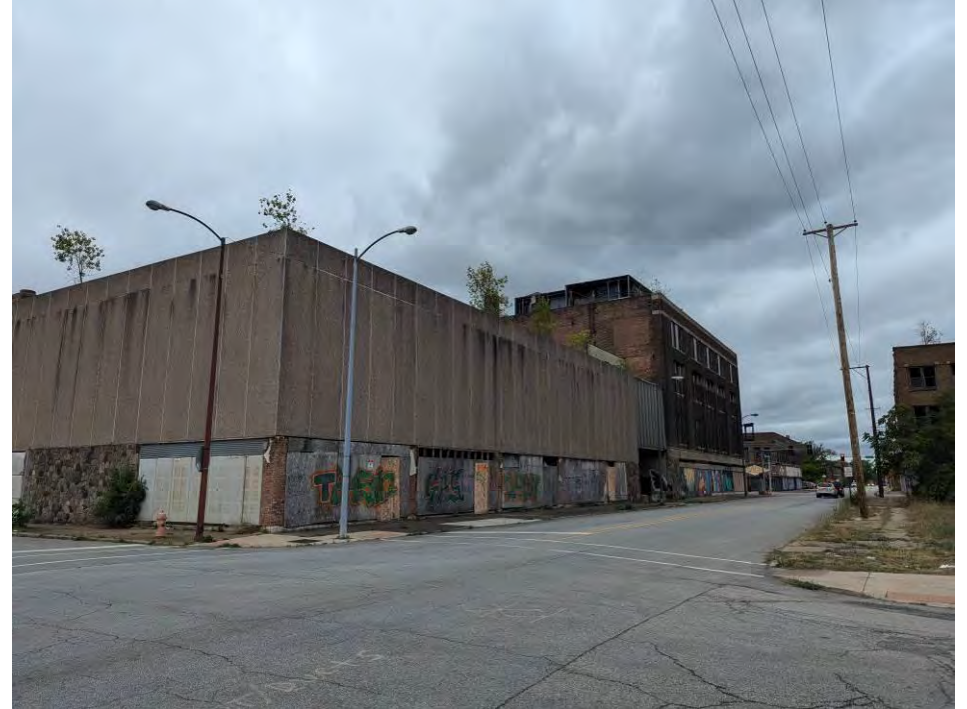
DATE: September 23, 2024  
LOCATION: 801-811 Broadway Street in Gary, Indiana  
SUBJECT: View of north and east faces of site building  
PHOTOGRAPHER: Ryan M. Orzechowicz (Heartland)  
PHOTO: 2

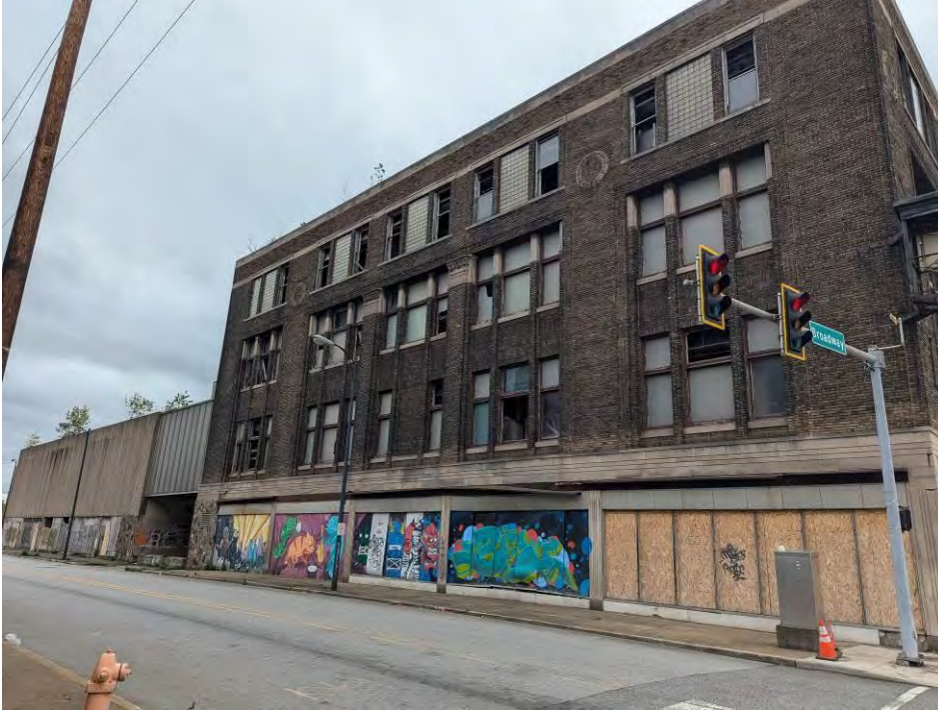
DATE: September 23, 2024  
LOCATION: 801-811 Broadway Street in Gary, Indiana  
SUBJECT: View of north face of site building  
PHOTOGRAPHER: Ryan M. Orzechowicz (Heartland)  
PHOTO: 3

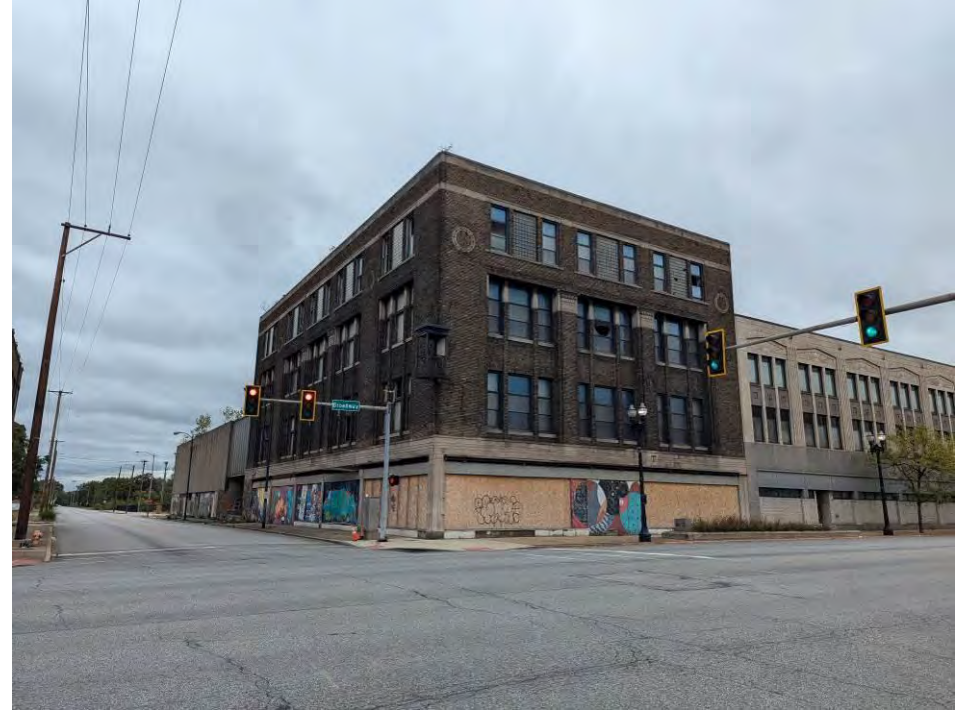
DATE: September 23, 2024  
LOCATION: 801-811 Broadway Street in Gary, Indiana  
SUBJECT: View of north and west faces of site building  
PHOTOGRAPHER: Ryan M. Orzechowicz (Heartland)  
PHOTO: 4

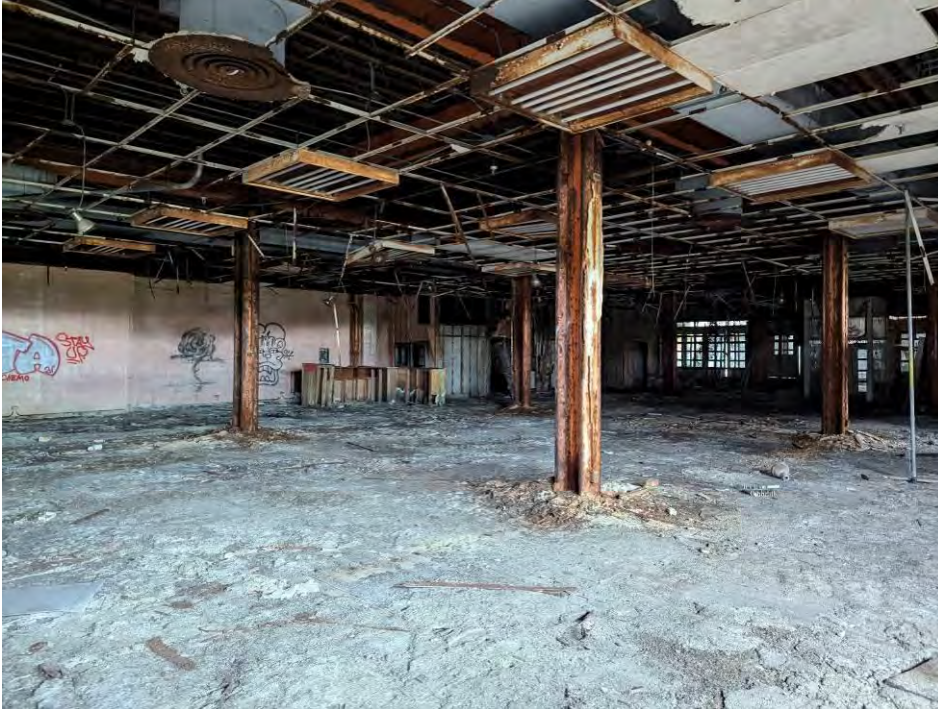
DATE: September 23, 2024  
LOCATION: 801-811 Broadway Street in Gary, Indiana  
SUBJECT: View of first floor of eastern portion of site building  
PHOTOGRAPHER: Ryan M. Orzechowicz (Heartland)  
PHOTO: 5

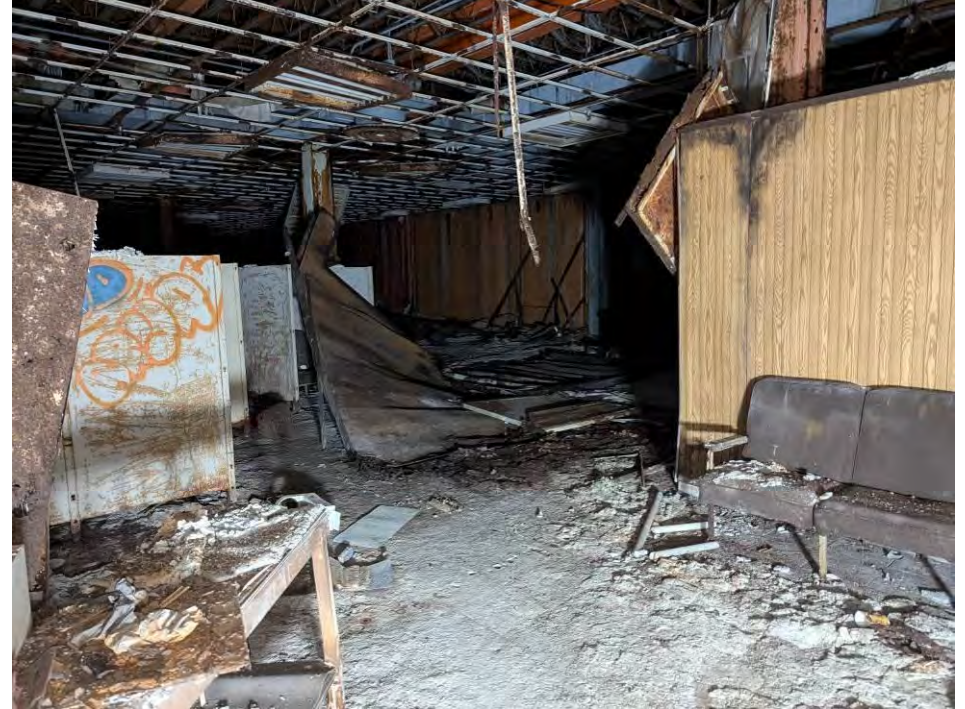
DATE: September 23, 2024  
LOCATION: 801-811 Broadway Street in Gary, Indiana  
SUBJECT: View of second floor of eastern portion of site building  
PHOTOGRAPHER: Ryan M. Orzechowicz (Heartland)  
PHOTO: 6

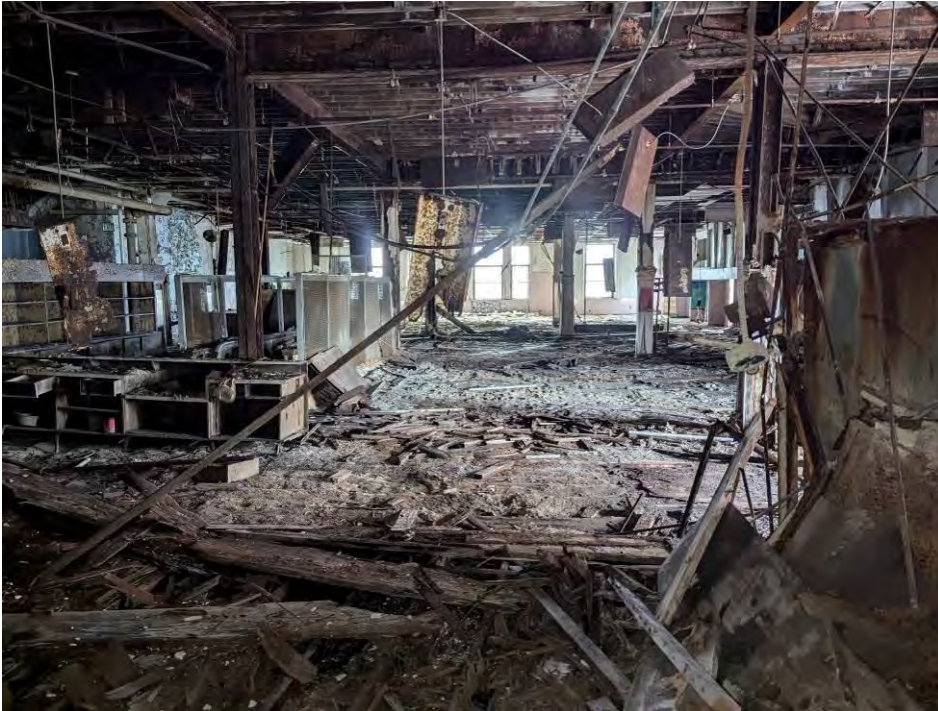
DATE: September 23, 2024  
LOCATION: 801-811 Broadway Street in Gary, Indiana  
SUBJECT: General view of interior of western portion of site building  
PHOTOGRAPHER: Ryan M. Orzechowicz (Heartland)  
PHOTO: 7

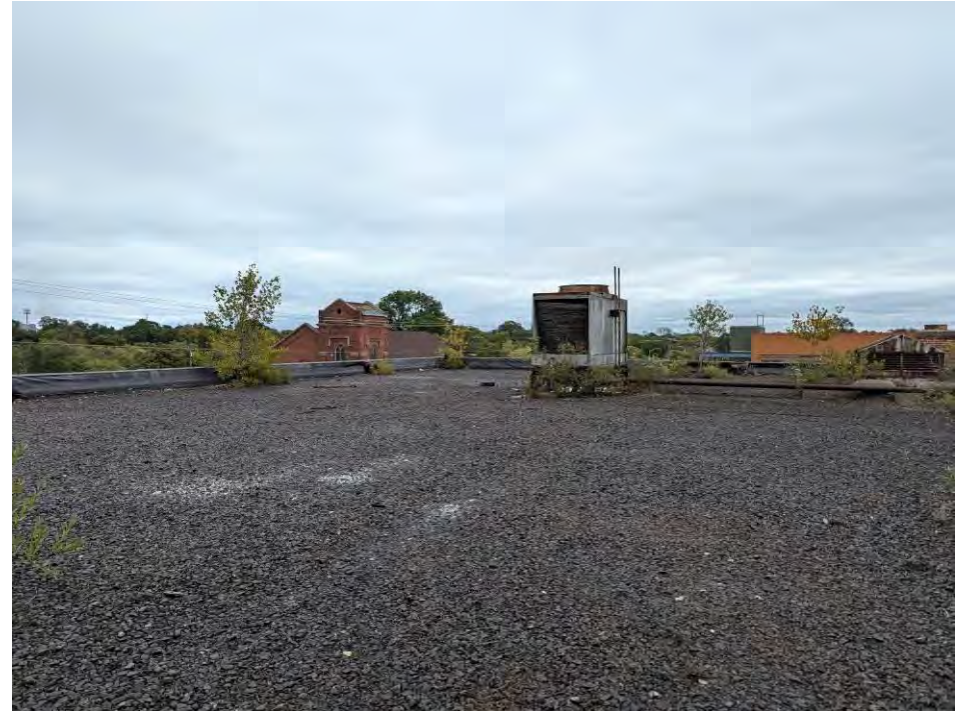
DATE: September 23, 2024  
LOCATION: 801-811 Broadway Street in Gary, Indiana  
SUBJECT: View of roof  
PHOTOGRAPHER: Ryan M. Orzechowicz (Heartland)  
PHOTO: 8

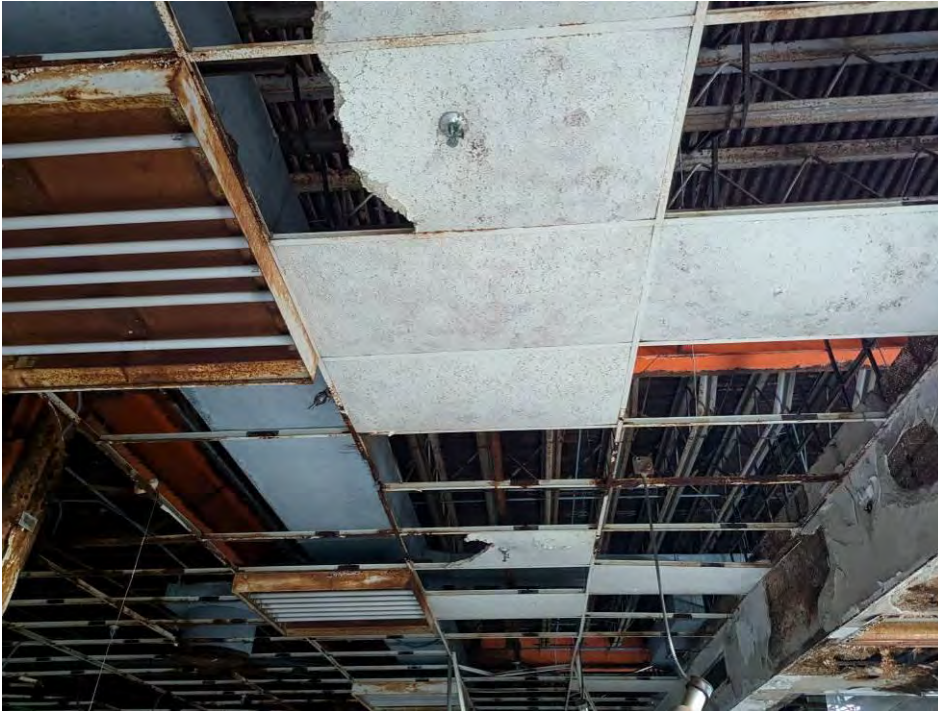
DATE: September 23, 2024  
LOCATION: 801-811 Broadway Street in Gary, Indiana  
SUBJECT: View of sampled ceiling tile (CT-1)  
PHOTOGRAPHER: Ryan M. Orzechowicz (Heartland)  
PHOTO: 11

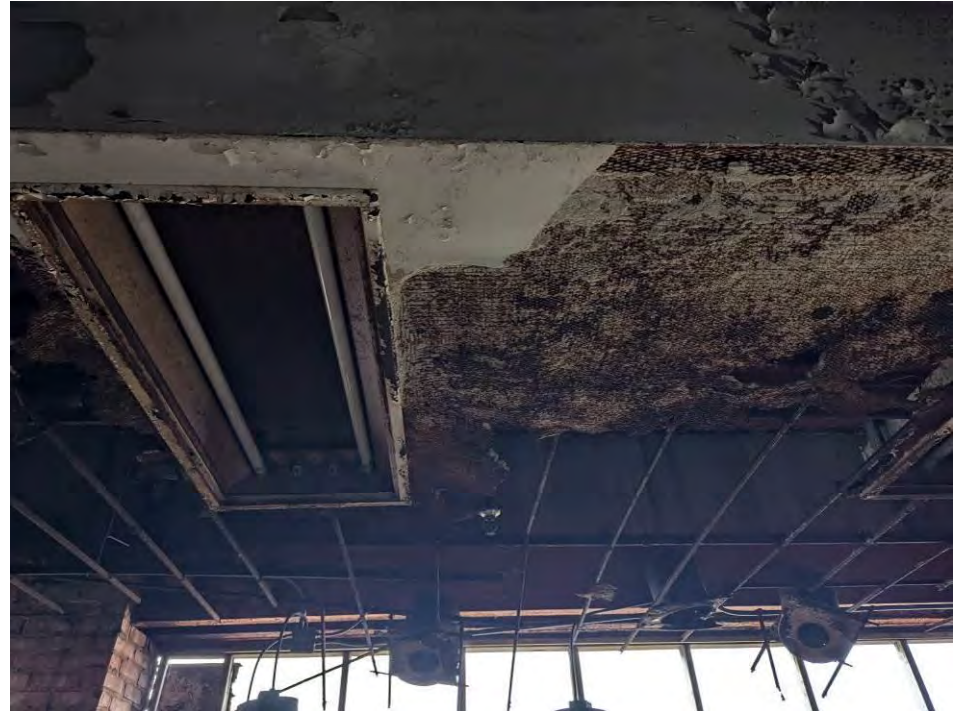
DATE: September 23, 2024  
LOCATION: 628 Western Avenue in South Bend, Indian  
SUBJECT: View of sampled plaster (PL-1)  
PHOTOGRAPHER: Ryan M. Orzechowicz (Heartland)  
PHOTO: 12

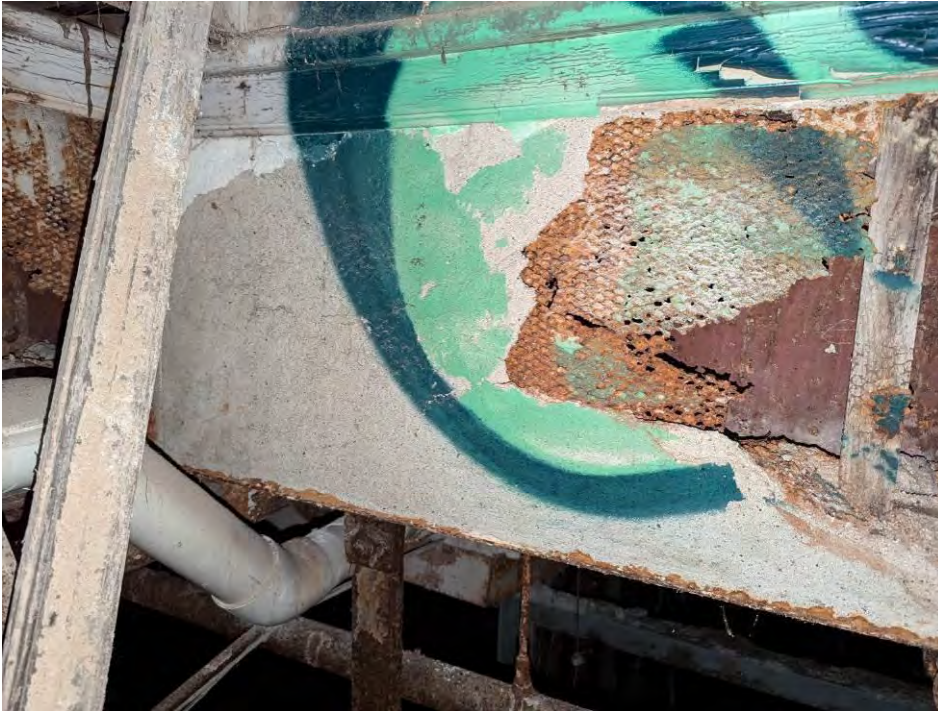
DATE: September 23, 2024  
LOCATION: 801-811 Broadway Street in Gary, Indiana  
SUBJECT: View of sampled plaster (PL-2)  
PHOTOGRAPHER: Ryan M. Orzechowicz (Heartland)  
PHOTO: 13

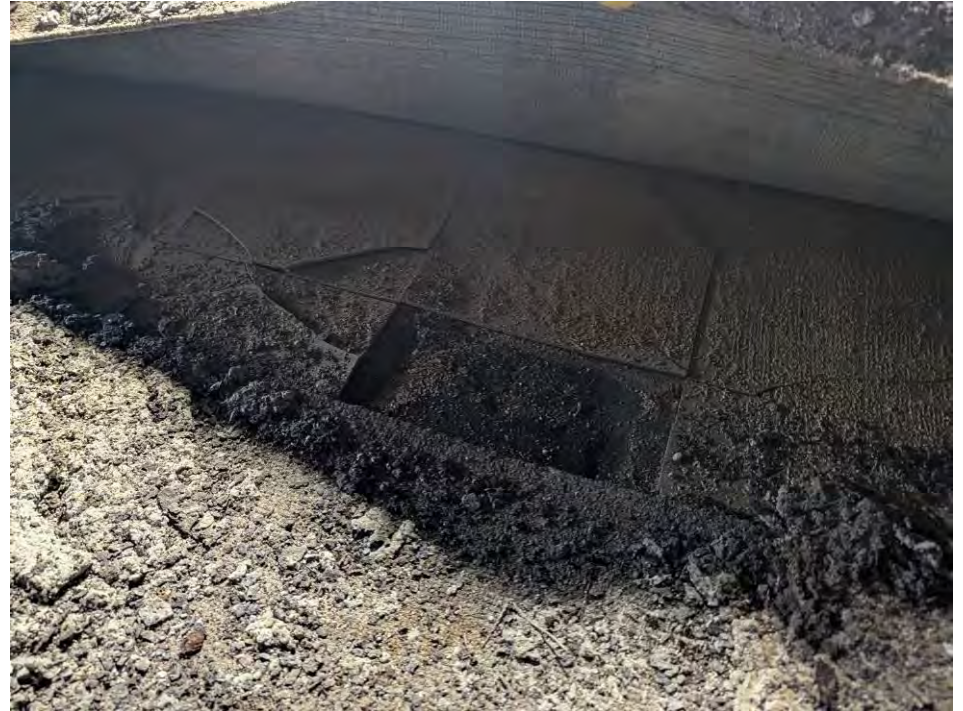
DATE: September 23, 2024  
LOCATION: 801-811 Broadway Street in Gary, Indiana  
SUBJECT: View of sampled floor tile (FT-1)  
PHOTOGRAPHER: Ryan M. Orzechowicz (Heartland)  
PHOTO: 14

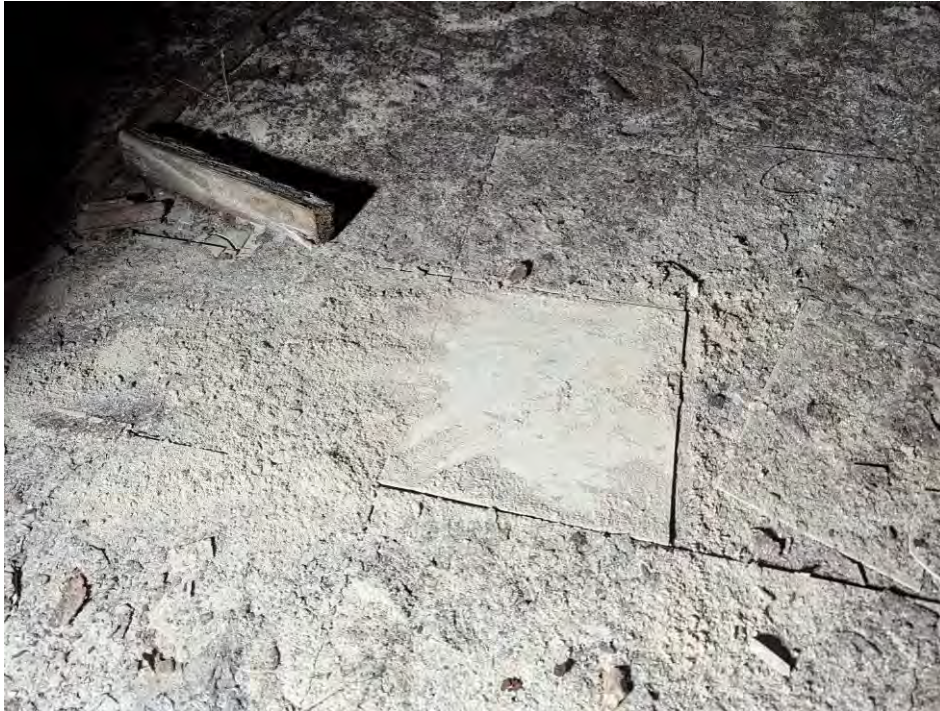
DATE: September 23, 2024  
LOCATION: 801-811 Broadway Street in Gary, Indiana  
SUBJECT: View of sampled floor tile (FT-2)  
PHOTOGRAPHER: Ryan M. Orzechowicz (Heartland)  
PHOTO: 15

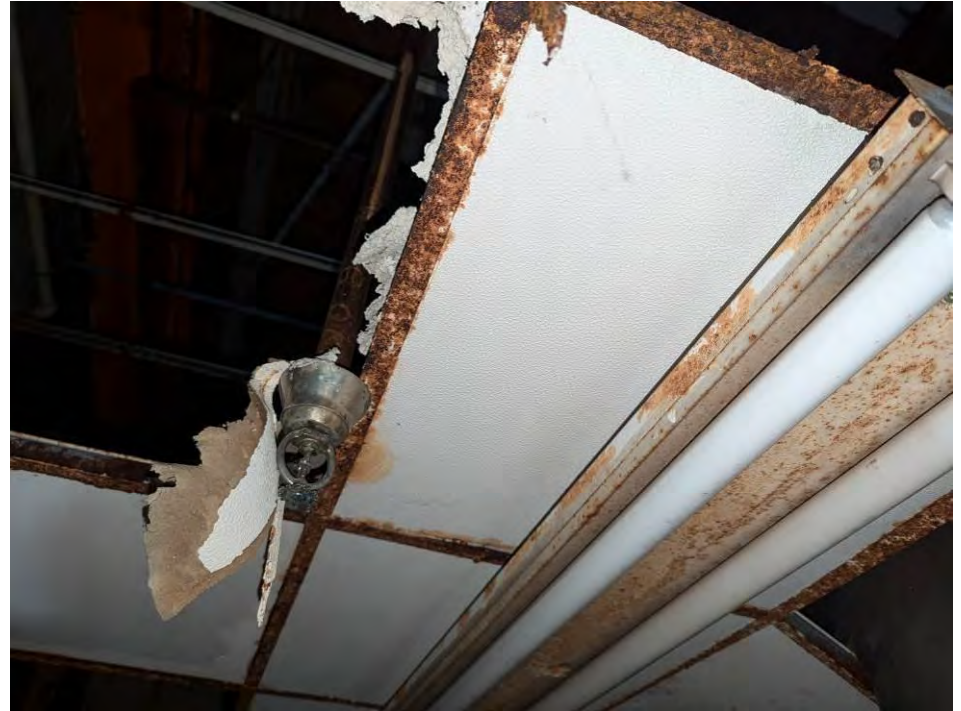
DATE: September 23, 2024  
LOCATION: 801-811 Broadway Street in Gary, Indiana  
SUBJECT: View of sampled ceiling tile (CT-2)  
PHOTOGRAPHER: Ryan M. Orzechowicz (Heartland)  
PHOTO: 16

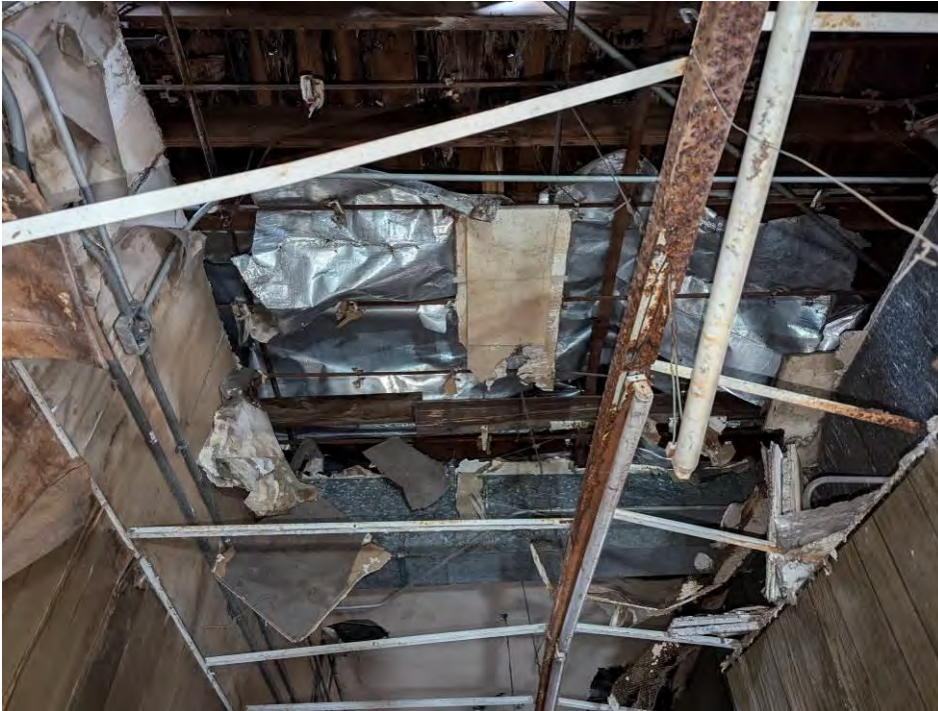
DATE: September 23, 2024  
LOCATION: 801-811 Broadway Street in Gary, Indiana  
SUBJECT: View of sampled ceiling tile (CT-3)  
PHOTOGRAPHER: Ryan M. Orzechowicz (Heartland)  
PHOTO: 17

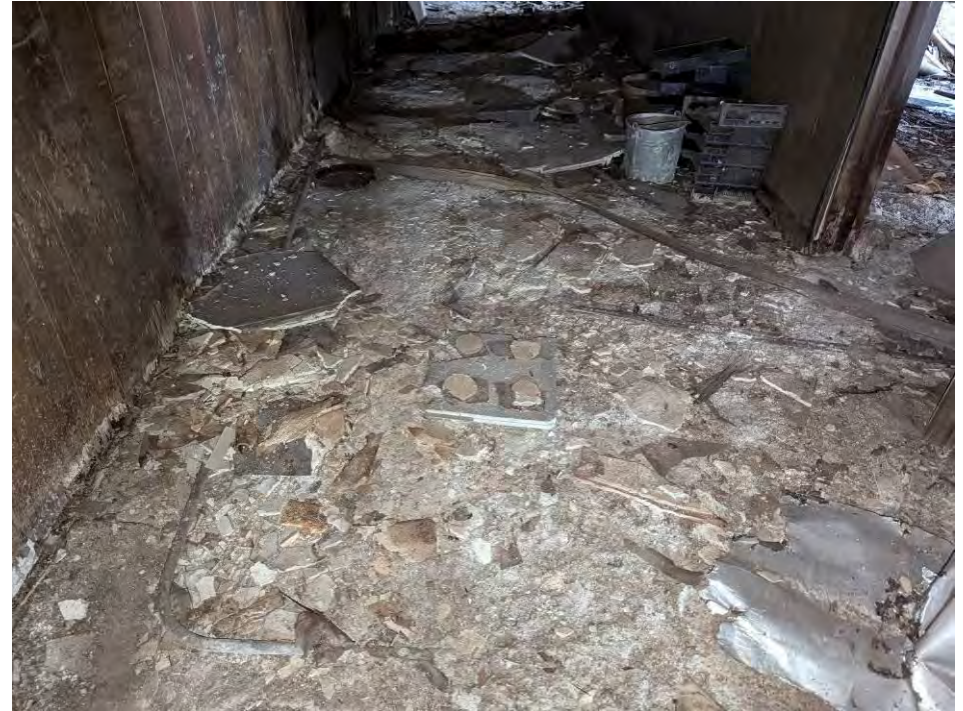
DATE: September 23, 2024  
LOCATION: 801-811 Broadway Street in Gary, Indiana  
SUBJECT: View of sampled glue pods (GP-1)  
PHOTOGRAPHER: Ryan M. Orzechowicz (Heartland)  
PHOTO: 18

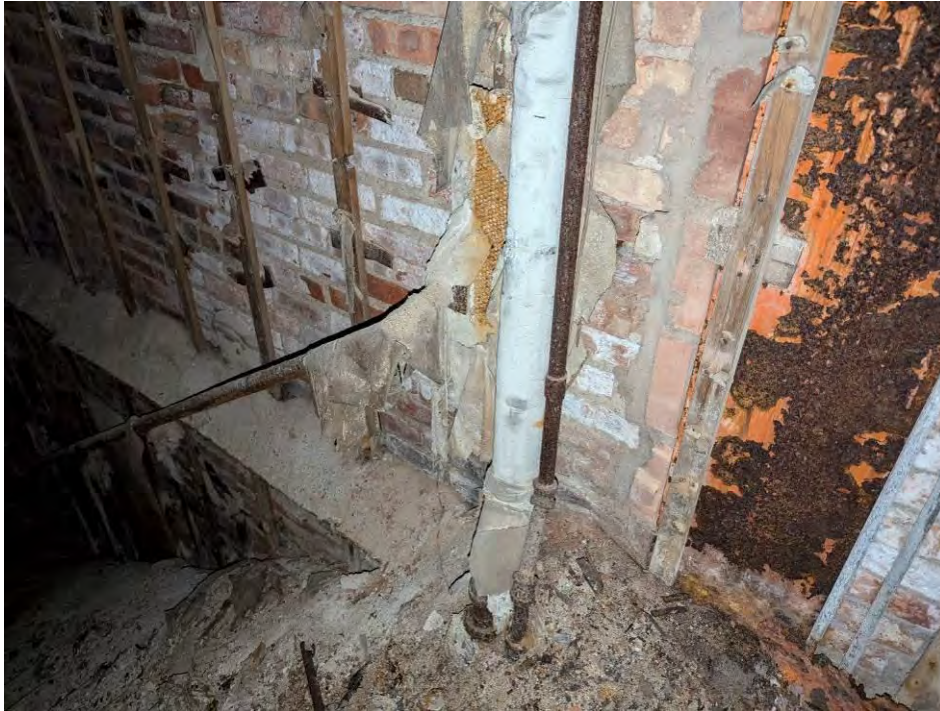
DATE: September 23, 2024  
LOCATION: 801-811 Broadway Street in Gary, Indiana  
SUBJECT: View of sampled backing paper (BP-1)  
PHOTOGRAPHER: Ryan M. Orzechowicz (Heartland)  
PHOTO: 19

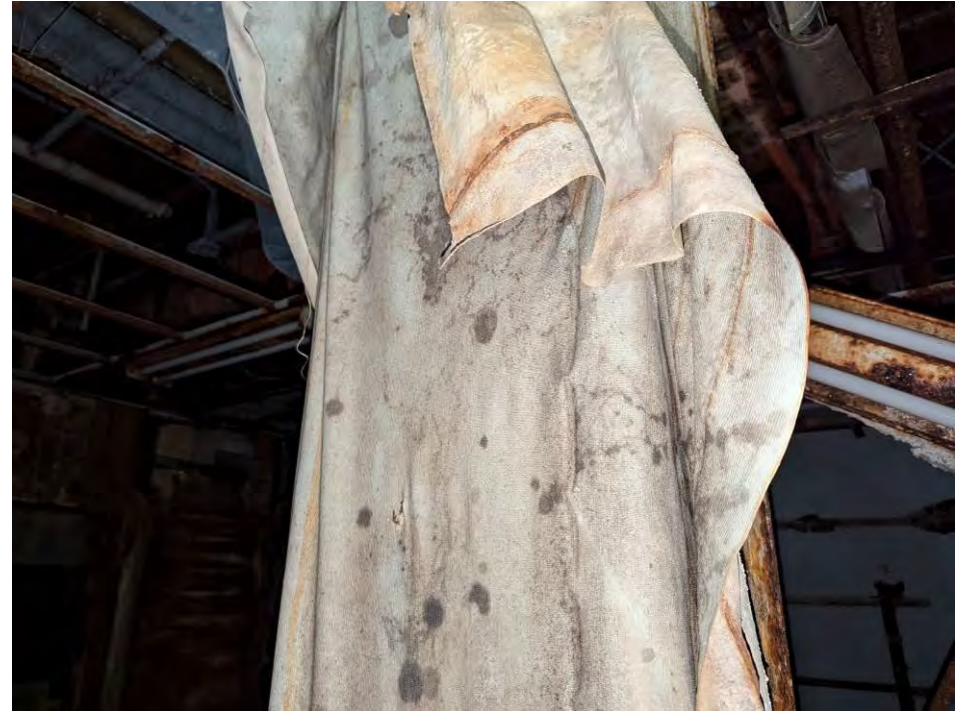
DATE: September 23, 2024  
LOCATION: 801-811 Broadway Street in Gary, Indiana  
SUBJECT: View of sampled column wrap (CW-1)  
PHOTOGRAPHER: Ryan M. Orzechowicz (Heartland)  
PHOTO: 20

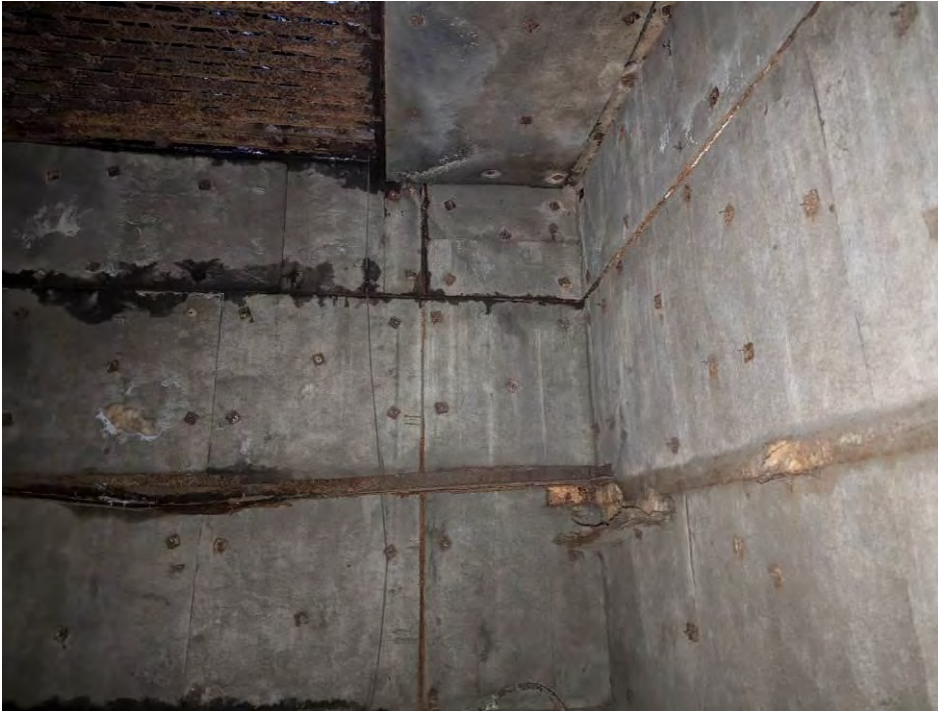
DATE: September 23, 2024  
LOCATION: 801-811 Broadway Street in Gary, Indiana  
SUBJECT: View of sampled insulation within air handling ducts (IN-1)  
PHOTOGRAPHER: Ryan M. Orzechowicz (Heartland)  
PHOTO: 21

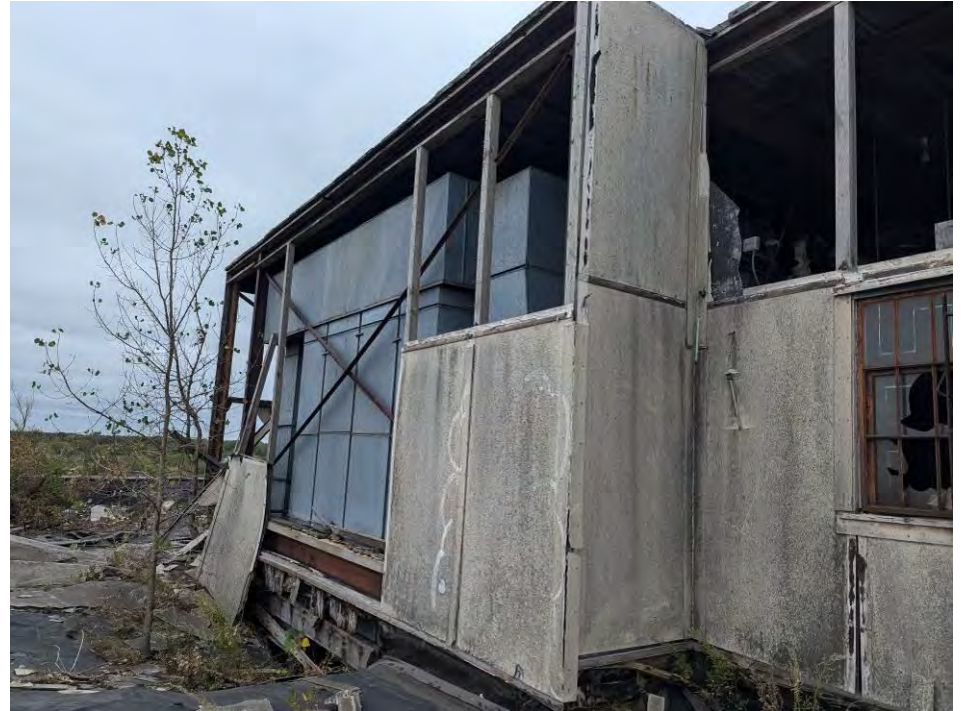
DATE: September 23, 2024  
LOCATION: 801-811 Broadway Street in Gary, Indiana  
SUBJECT: View of sampled exterior wallboard (SD-1)  
PHOTOGRAPHER: Ryan M. Orzechowicz (Heartland)  
PHOTO: 22

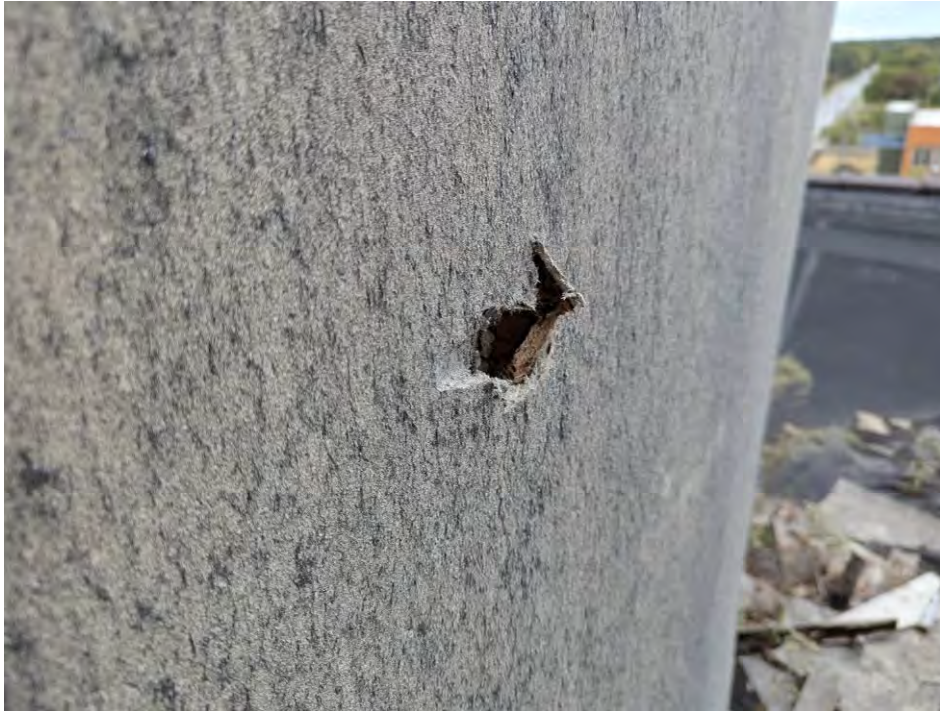
DATE: September 23, 2024  
LOCATION: 801-811 Broadway Street in Gary, Indiana  
SUBJECT: View of sampled exterior wallboard behind SD-1 (WB-1)  
PHOTOGRAPHER: Ryan M. Orzechowicz (Heartland)  
PHOTO: 23

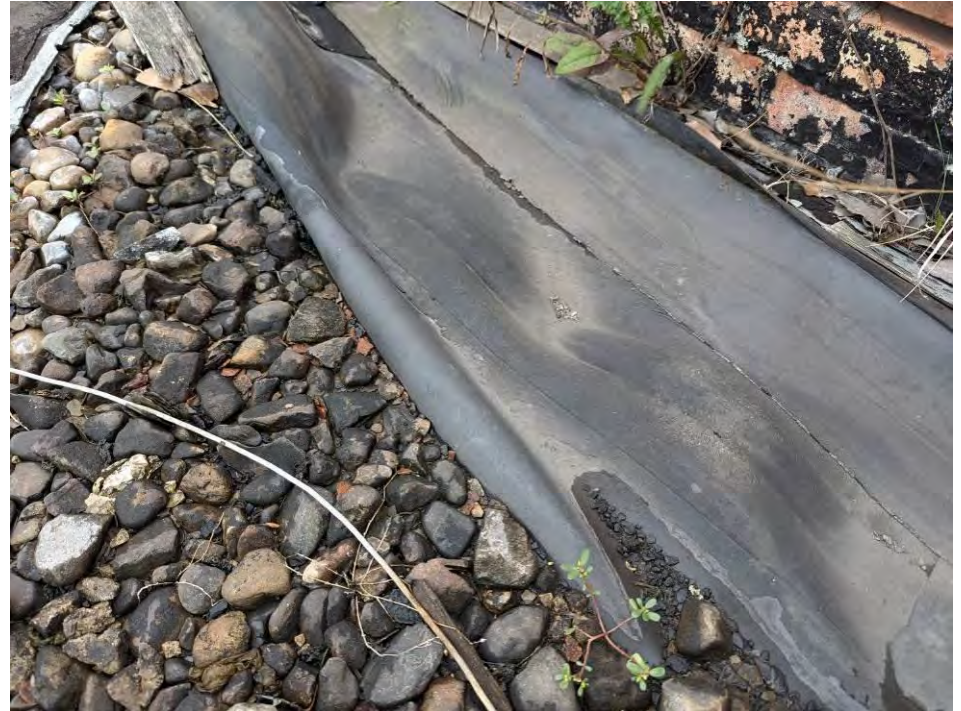
DATE: September 23, 2024  
LOCATION: 801-811 Broadway Street in Gary, Indiana  
SUBJECT: View of sampled rubberized roofing (RF-1)  
PHOTOGRAPHER: Ryan M. Orzechowicz (Heartland)  
PHOTO: 24

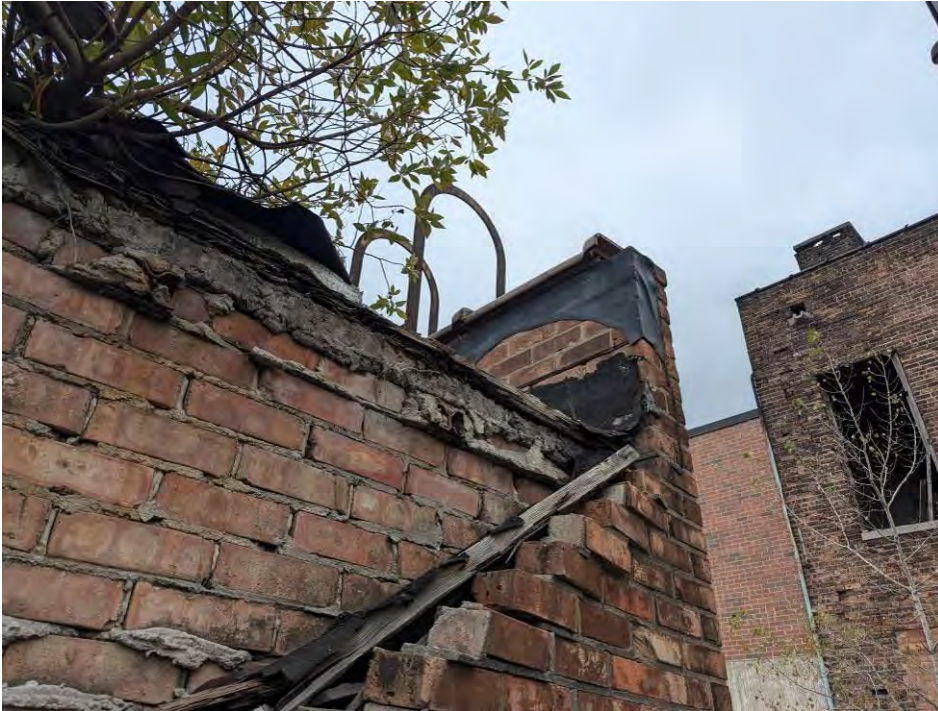
DATE: September 23, 2024  
LOCATION: 801-811 Broadway Street in Gary, Indiana  
SUBJECT: View of sampled asphalt roofing (RF-2)  
PHOTOGRAPHER: Ryan M. Orzechowicz (Heartland)  
PHOTO: 25

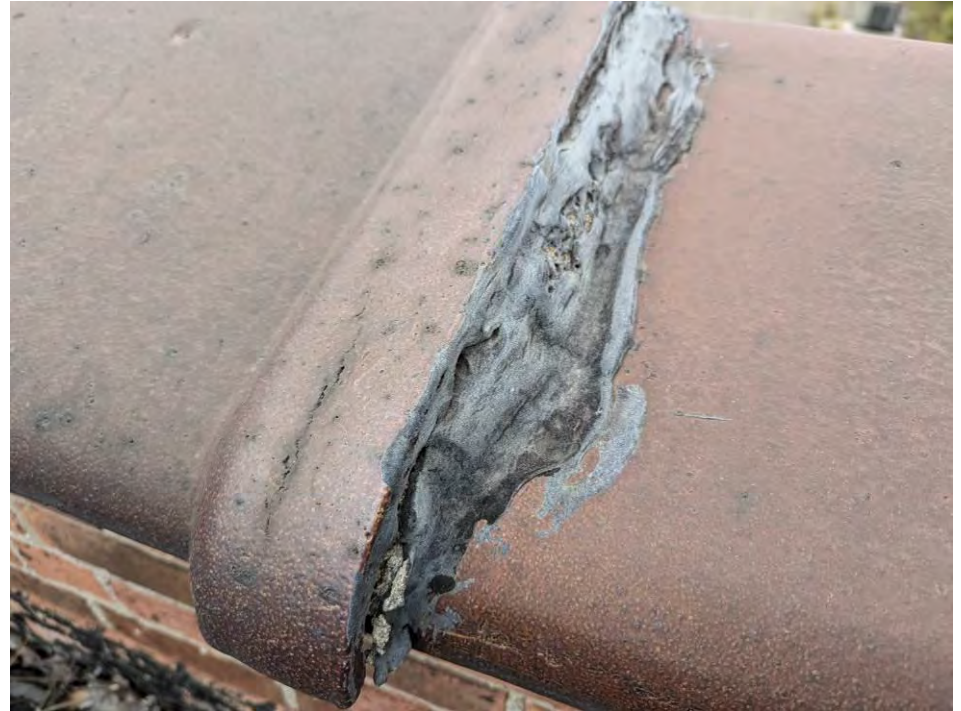
DATE: September 23, 2024  
LOCATION: 801-811 Broadway Street in Gary, Indiana  
SUBJECT: View of sampled roof flashing (FL-1)  
PHOTOGRAPHER: Ryan M. Orzechowicz (Heartland)  
PHOTO: 26

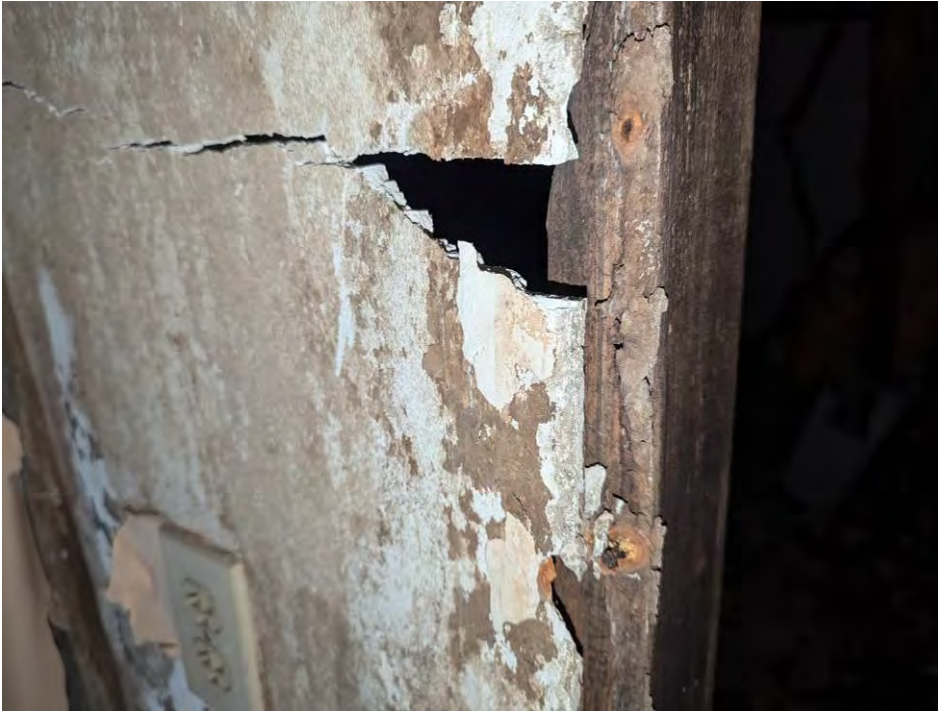
DATE: September 23, 2024  
LOCATION: 801-811 Broadway Street in Gary, Indiana  
SUBJECT: View of sampled drywall (DW-1)  
PHOTOGRAPHER: Ryan M. Orzechowicz (Heartland)  
PHOTO: 27

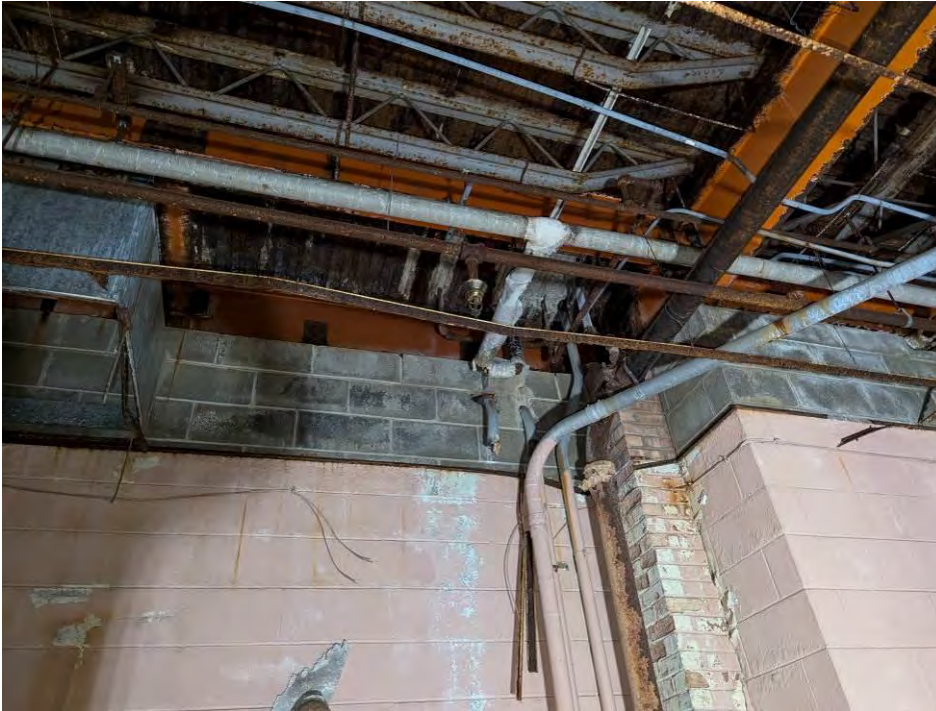
DATE: September 23, 2024  
LOCATION: 801-811 Broadway Street in Gary, Indiana  
SUBJECT: View of sampled TSI pipe wrap (PW-1)

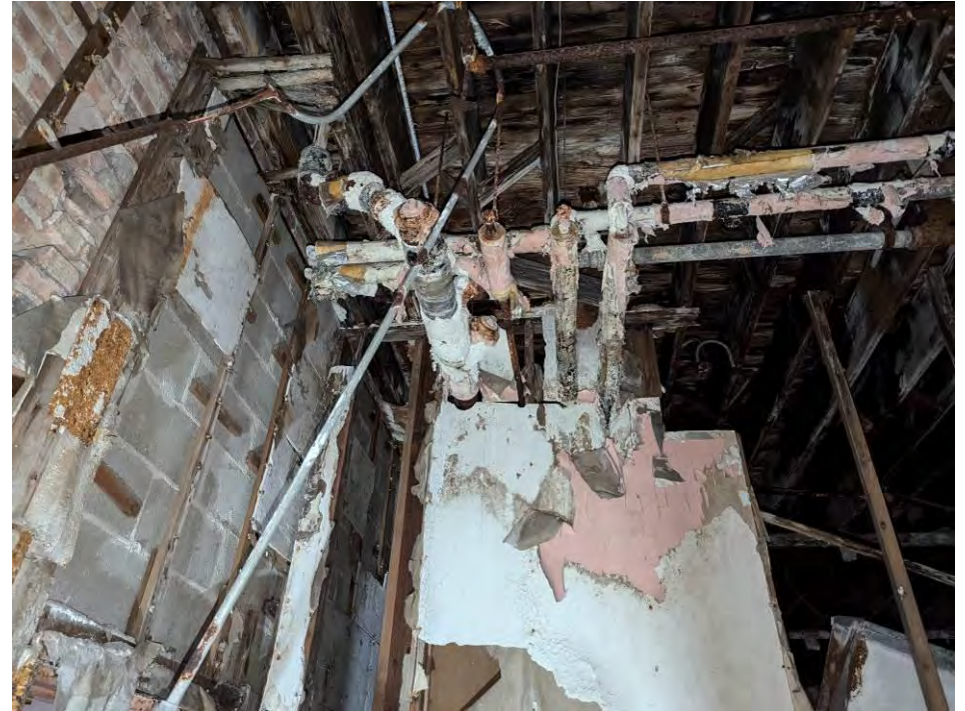
DATE: September 23, 2024  
LOCATION: 801-811 Broadway Street in Gary, Indiana  
SUBJECT: View of sampled TSI pipe wrap and TSI mudded joints (PW-1 & MJ-1)

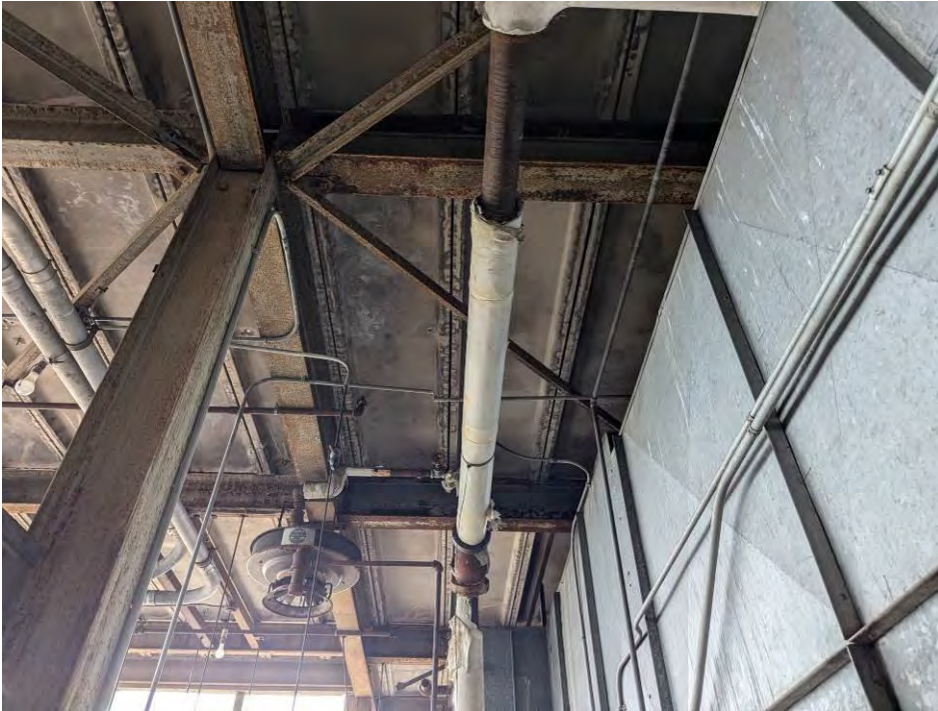
DATE: September 23, 2024  
LOCATION: 801-811 Broadway Street in Gary, Indiana  
SUBJECT: View of sampled TSI pipe wrap (PW-1)  
PHOTOGRAPHER: Ryan M. Orzechowicz (Heartland)  
PHOTO: 31

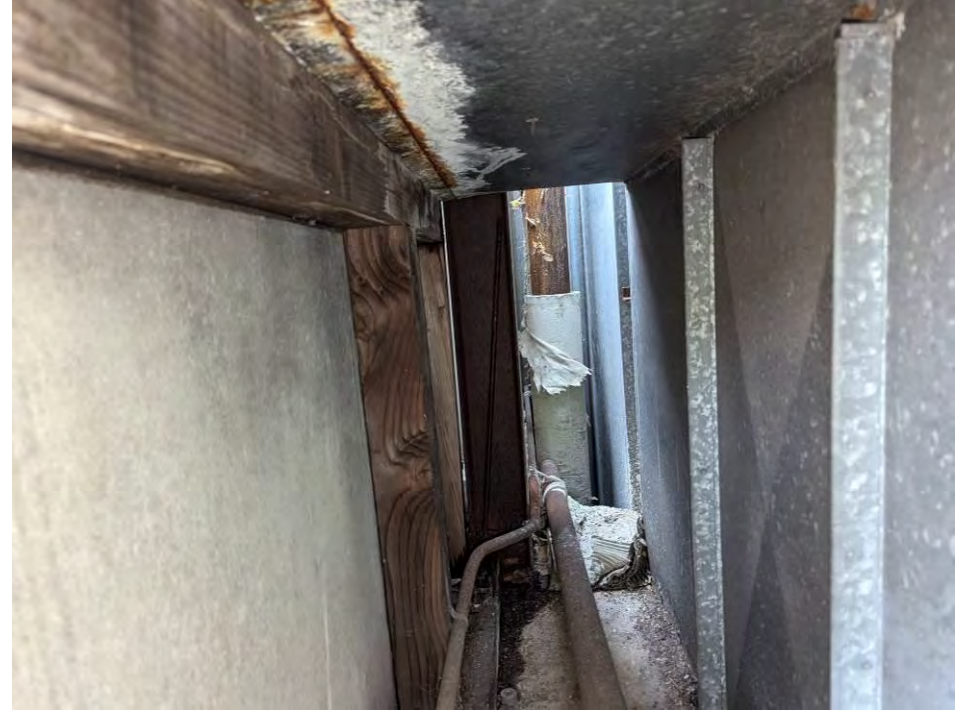
DATE: September 23, 2024  
LOCATION: 801-811 Broadway Street in Gary, Indiana  
SUBJECT: View of sampled TSI pipe wrap (PW-1)  
PHOTOGRAPHER: Ryan M. Orzechowicz (Heartland)  
PHOTO: 34
