# HAZARDOUS AND REGULATED MATERIALS INSPECTION REPORT

Former H. Gordon & Sons Department Store  
813 Broadway  
Parcel ID: 45-08-03-355-002  
Gray, IN 46402

Egis  
48797 Alpha Drive, Suite 130  
Wixom, MI 48393  
Egis Project ID: 240100  
April 22, 2025

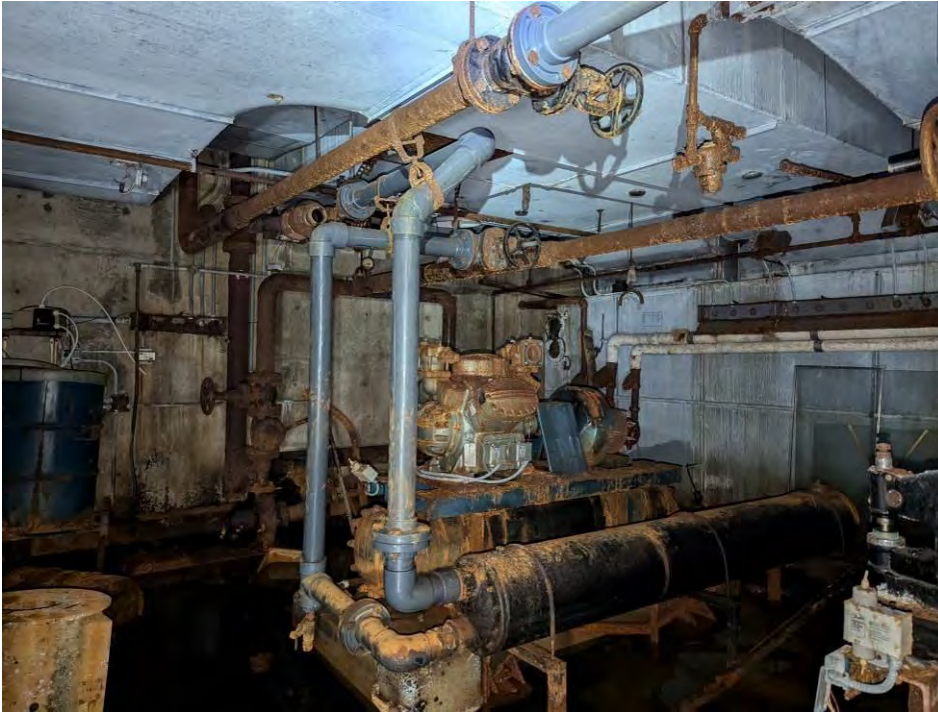
DATE: September 23, 2024  
LOCATION: 801-811 Broadway Street in Gary, Indiana  
SUBJECT: View of basement water pumping station  
PHOTOGRAPHER: Ryan M. Orzechowicz (Heartland)  
PHOTO: 39

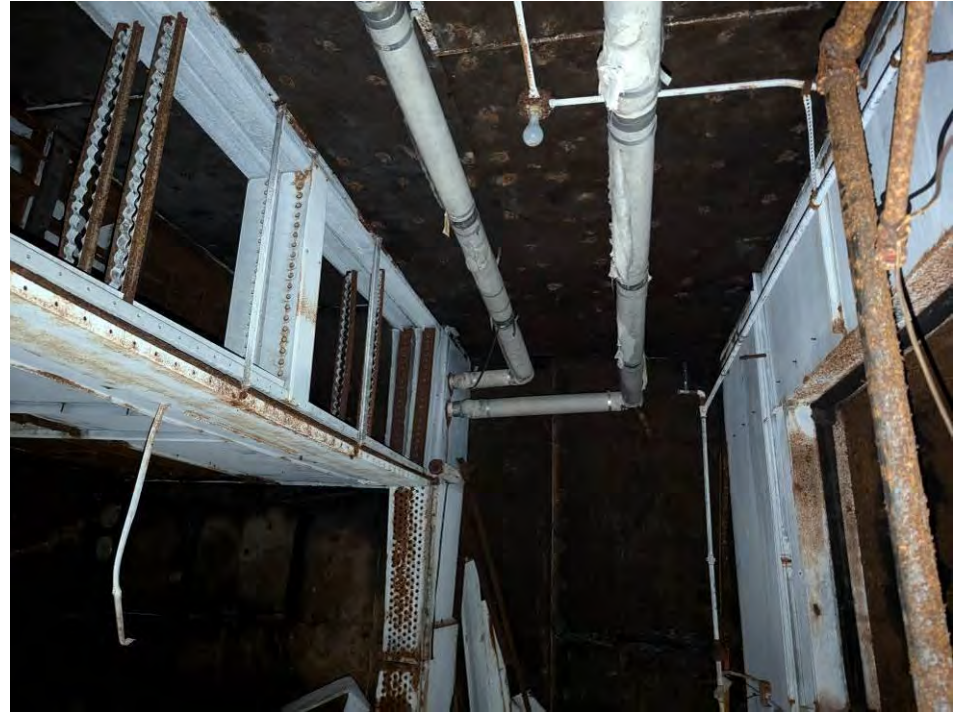
DATE: September 23, 2024  
LOCATION: 801-811 Broadway Street in Gary, Indiana  
SUBJECT: View of sampled TSI pipe wrap (PW-1)  
PHOTOGRAPHER: Ryan M. Orzechowicz (Heartland)  
PHOTO: 40

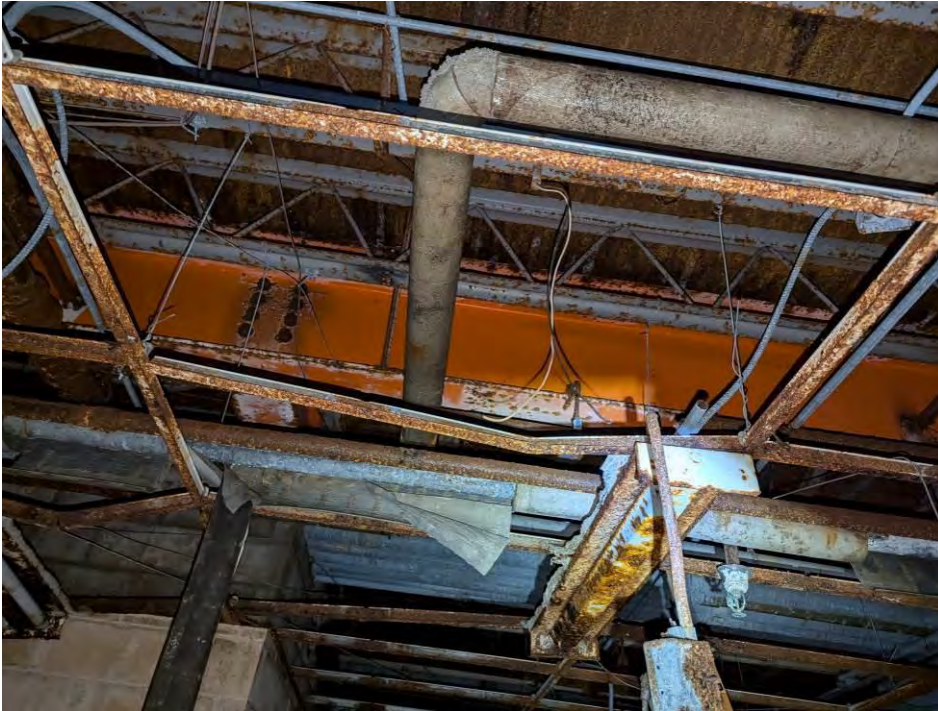
DATE: September 23, 2024  
LOCATION: 801-811 Broadway Street in Gary, Indiana  
SUBJECT: View of sampled TSI mudded joint (MJ-1)  
PHOTOGRAPHER: Ryan M. Orzechowicz (Heartland)  
PHOTO: 41

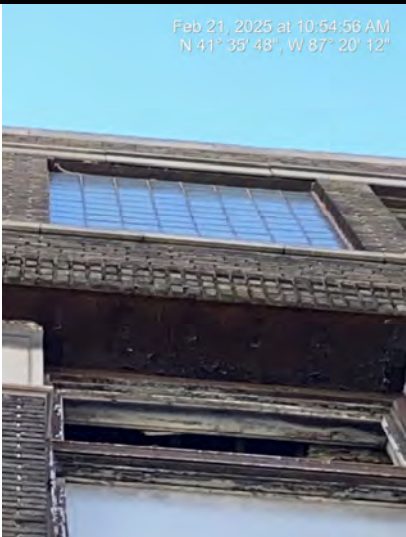
Assumed Material # A-3	Glass Block - Grout & Mortar

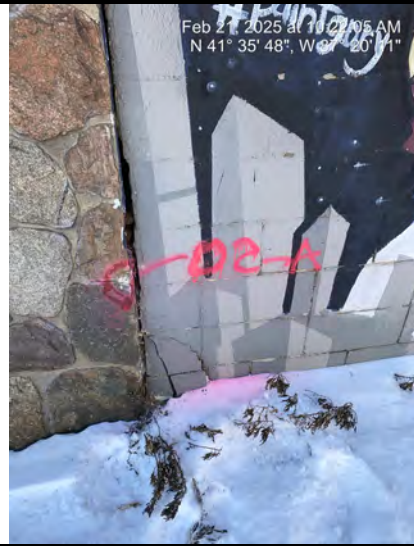
Sample # 1 Brick Mortar - Exterior glazed brick with mortar

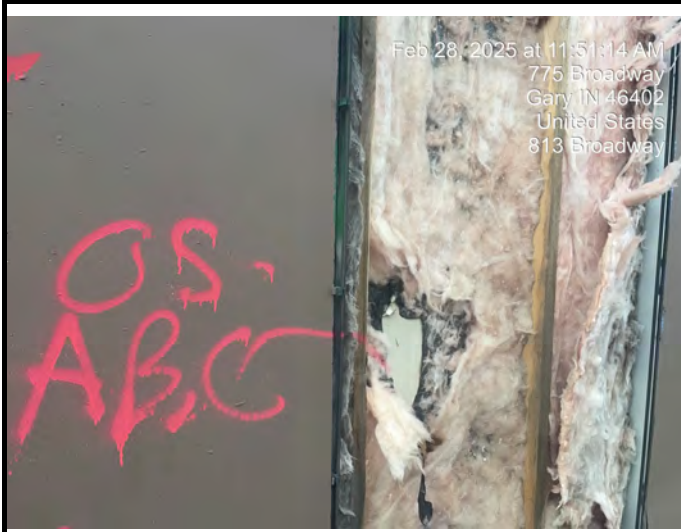
Sample # 5

Rolled In Insulation - Pink with Paper

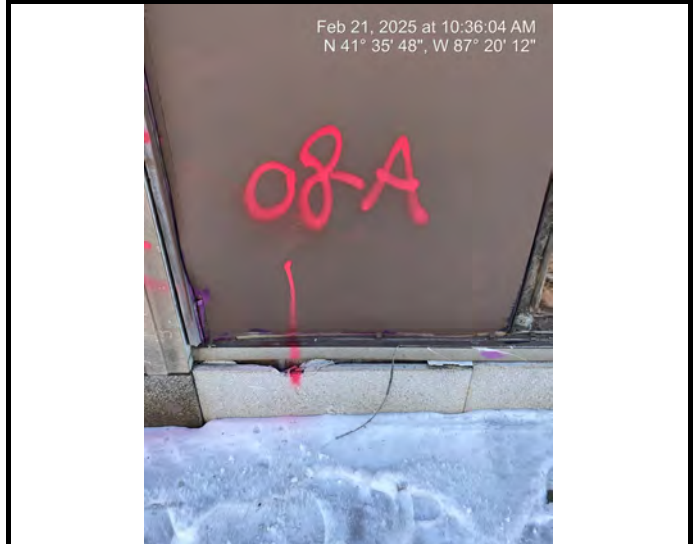
Sample # 8

Exterior Siding - Terrazzo panels, cream colored

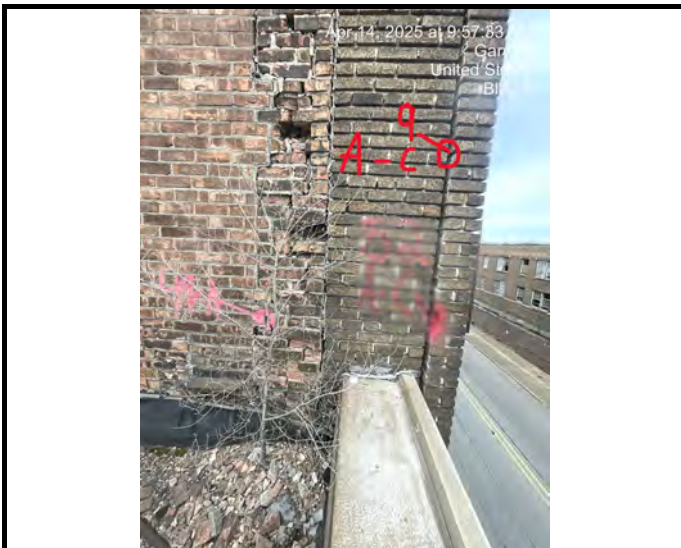
Sample # 9

Brick Mortar - Exterior brown brick with gray mortar
