# INDIANA DAM SAFETY INSPECTION MANUAL

## PART 5 DAM SAFETY FACT SHEETS

## Preface – Part 5

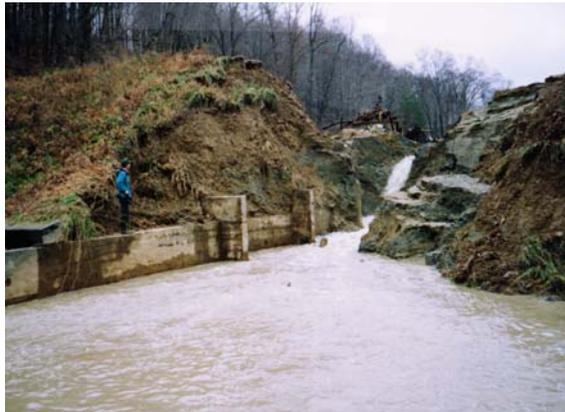
Figure 1 – Earth dam failure

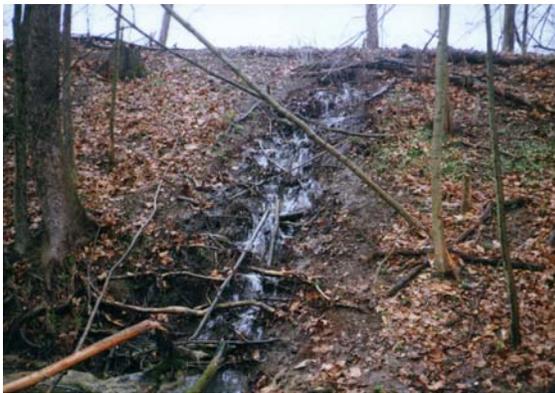
Figure 2 – Seepage through tree roots

Seepage must be controlled in both velocity and quantity. If uncontrolled, it can progressively erode soil from the embankment or its foundation, resulting in rapid failure of the dam. Erosion of the soil begins at the downstream side of the embankment, either in the dam proper or the foundation, progressively works toward the reservoir, and eventually develops a "pipe" or direct conduit to the reservoir. This phenomenon is known as "piping." Piping action can be

recognized by an increased seepage flow rate, the discharge of muddy or discolored water, sinkholes on or near the embankment, and a whirlpool in the reservoir. Once a whirlpool (eddy) is observed on the reservoir surface, complete failure of the dam will probably follow in a matter of minutes. As with overtopping, fully developed piping is virtually impossible to control and will likely cause failure. Seepage can cause slope failure by creating high pressures in the soil pores or by saturating the slope. The pressure of seepage within an embankment is difficult to determine without proper instrumentation. A slope which becomes saturated and develops slides may be showing signs of excessive seepage pressure.

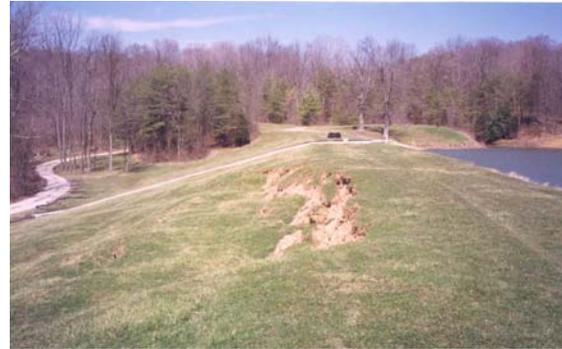
Figure 3 – Structural failure resulting in a slump condition

Structural failures can occur in either the embankment or the appurtenances. Structural failure of a spillway, lake drain, or other appurtenance may lead to failure of the embankment. Cracking, settlement, and slides are the more common signs of structural failure of embankments. Large cracks in an appurtenance or the embankment, major settlement, and major slides will require emergency measures to ensure safety, especially if these problems occur suddenly. If this type of situation occurs, the lake

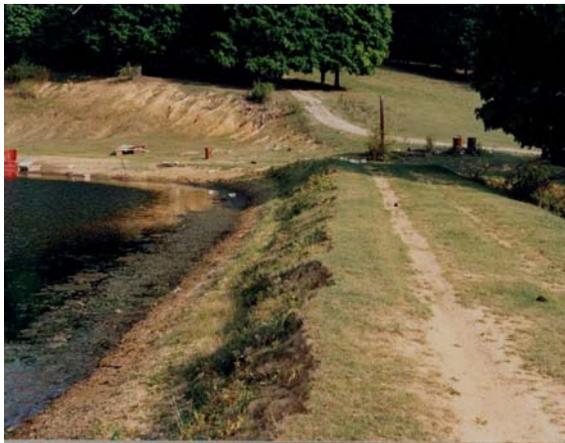
Figure 1 – Beaching

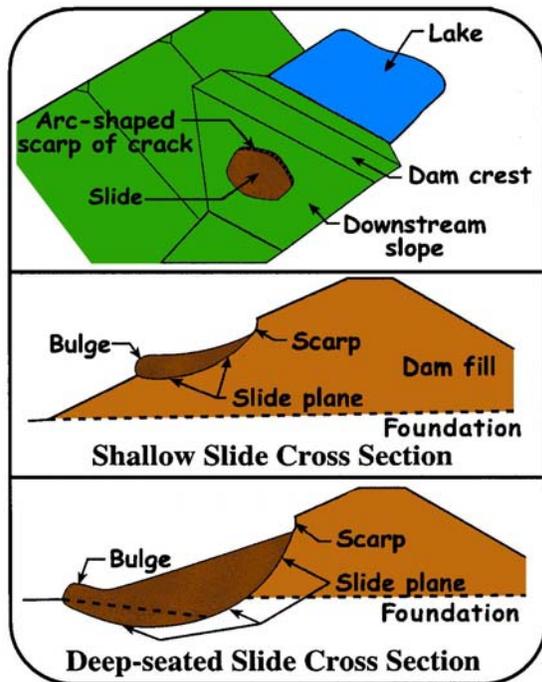
A slide in an embankment or in natural soil or rock is a mass movement of material. Some typical characteristics of a slide are an arc-shaped crack or scarp along the top and a bulge along the bottom of the slide (see drawing). Slides may develop because of poor soil compaction, the gradient of the slope being too steep for the embankment material, seepage, sudden

Figure 2 – Slide cross-sections

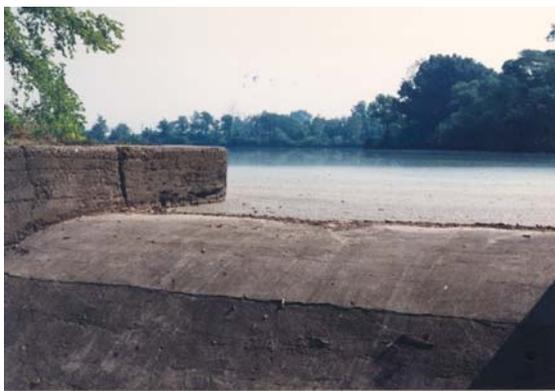
Concrete surfaces should be visually examined for spalling and deterioration due to weathering, unusual or extreme stresses, alkali or other chemical attack, erosion, cavitation, vandalism, and other destructive forces. Structural problems

Figure 1 – Concrete spalling and cracking

are indicated by cracking, exposure of reinforcing bars, large areas of broken-out concrete, misalignment at joints, undermining and settlement in the structure. Rust stains that are noted on the concrete may indicate that internal corrosion and deterioration of reinforcement steel

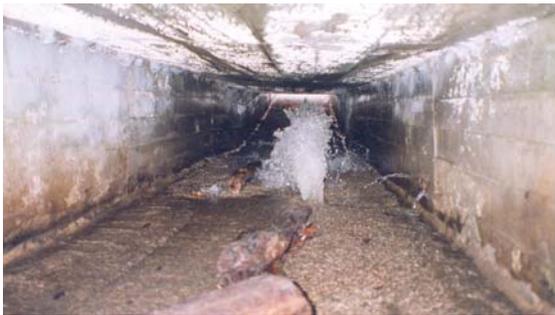
Structural cracking of concrete is usually identified by long, single or multiple diagonal cracks with accompanying displacements and misalignment. Cracks extending across concrete slabs which line open channel spillways or provide upstream slope wave protection can indicate a loss of foundation support resulting from settlement, piping, undermining, or erosion of foundation soils. Piping and erosion of foundation soils are the result of inadequate underdrainage and/or cutoff walls. Items to consider when evaluating a suspected structural crack are the concrete thickness, the size and location of the reinforcing steel, the type of foundation, and the drainage provision for the structure.

Figure 2 - Rupture of concrete spillway conduit

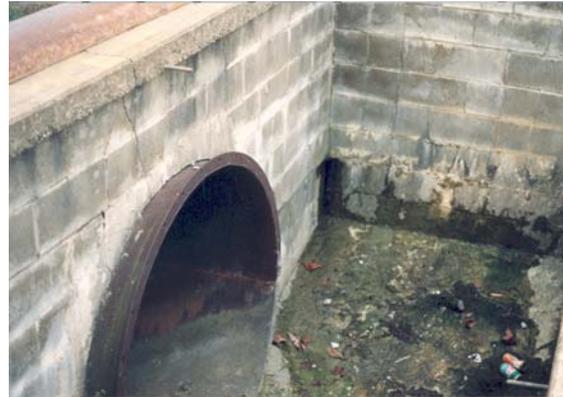
Inspection of intake structures, trashracks, upstream conduits, and stilling basin concrete surfaces that are below the water surface is not readily feasible during a regularly scheduled inspection. Typically, stilling basins require the most regular monitoring and major maintenance because they are holding ponds for rock and

debris, which can cause extensive damage to the concrete surfaces during the dissipation of flowing water. Therefore, special inspections of these features should be performed at least once every five years by either dewatering the structure or when operating conditions permit. Investigation of these features using experienced divers is also an alternative.

Figure 3 – Stilling basin

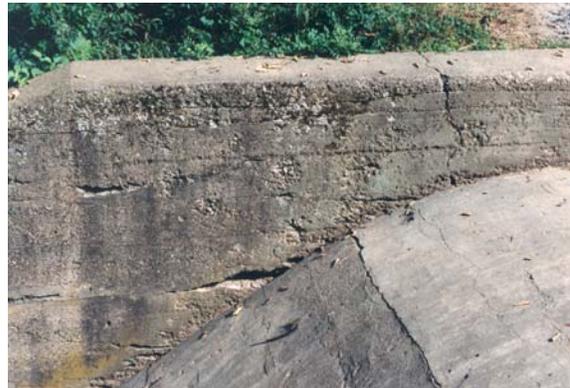
deterioration of the concrete into small fragments and individual aggregates. Scaling is a milder form of disintegration where the surface mortar flakes off. Large areas of crumbling (rotten) concrete, areas of deterioration which are more than about 3 to 4 inches deep (depending on the wall/slab thickness), and exposed rebar indicate serious concrete deterioration. If not repaired, this type of concrete deterioration may lead to structural instability of the concrete structure. A registered professional engineer must prepare plans and specifications for repair of serious concrete deterioration. For additional information,

Figure 1 – Scaling

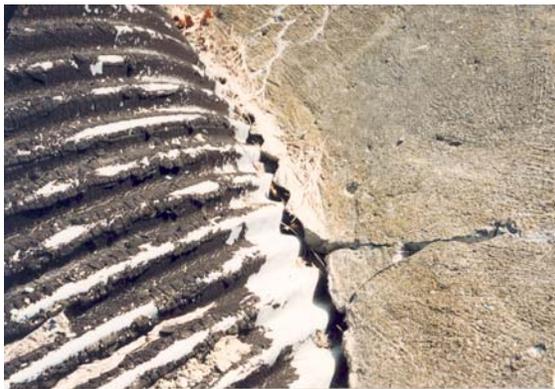
Cracks in the concrete may be structural or surface cracks. Surface cracks are generally less than a 0.2 inches wide and deep. These are often called hairline cracks and may consist of single, thin cracks, or cracks in a craze/map-like pattern. A small number of surface or shrinkage cracks is common and does not usually cause any problems. Surface cracks can be caused by freezing and thawing, poor construction practices, and alkali-aggregate reactivity. Alkali-aggregate reactivity occurs when the aggregate reacts with the cement causing crazing or map cracks. The placement of new concrete over old may cause surface cracks to develop. This occurs because the new concrete will shrink as it cures. Surface cracks in the spillway should be monitored and will need to be repaired if they deteriorate further.

Figure 2 – Cracking

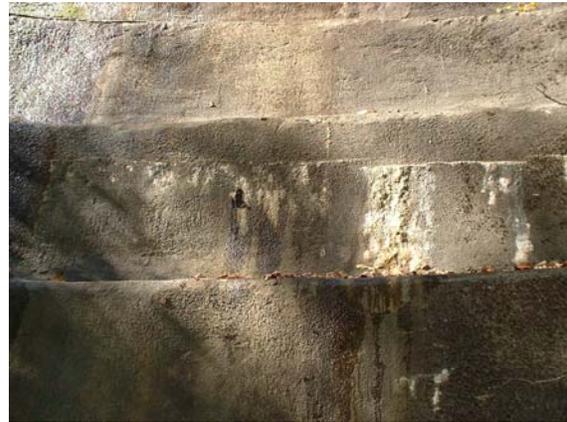
A white, crystallized substance, known as efflorescence, may sometimes be noted on concrete surfaces, especially spillway sidewalls. It is usually noted near hairline or thin cracks. Efflorescence is formed by water seeping through the pores or thin cracks in the concrete. When the water evaporates, it leaves behind some minerals that have been leached from the soil, fill, or

Figure 3 – Efflorescence

concrete. Efflorescence is typically not a structural problem. Efflorescence should be monitored because it can indicate the amount of seepage finding its way through thin cracks in the concrete and can signal areas where problems (i.e. inadequate drainage behind the wall or deterioration of concrete) could develop. Also, water seeping through thin cracks in the wall will make the concrete more susceptible to deterioration due to freezing and thawing of the water.

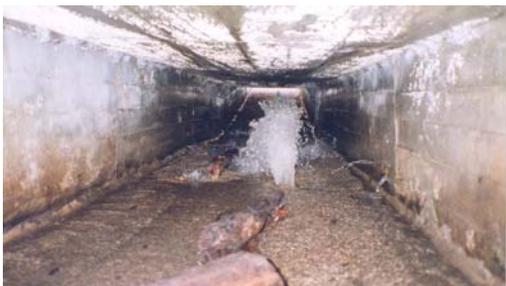
Regular inspection and monitoring is essential to detect problems with concrete materials. Concrete structures should be inspected a minimum of once per year. The inspector should also look at the interior condition of concrete spillway conduit. Proper ventilation and confined space precautions

**Figure 4 – Rupture of concrete spillway conduit**

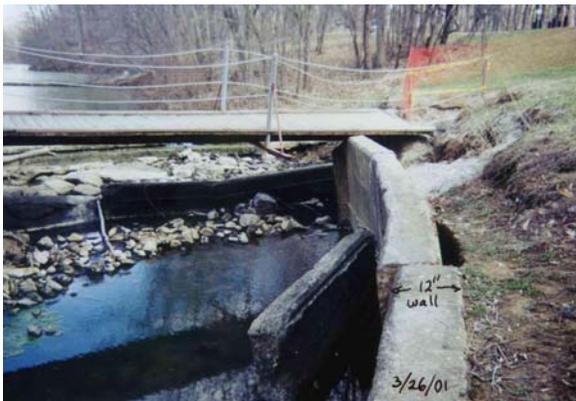
Figure 1 – Concrete Wall Displacement

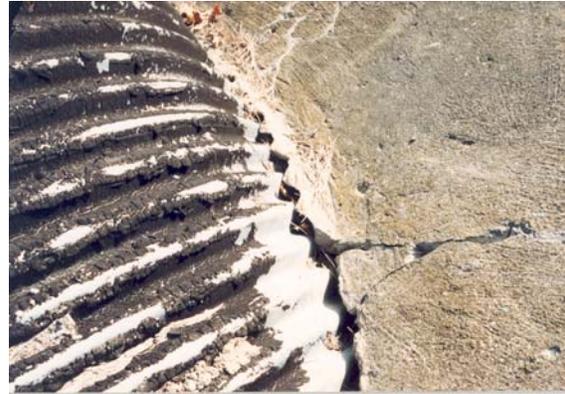
The two main objectives when repairing cracks in concrete are structural bonding and stopping water flow. For a structural bond, epoxy injection can be used. This process can be very expensive since a skilled contractor is needed for proper installation. The epoxy is injected into the

**Figure 3 – Crack Repair**

concrete under pressure, welding the cracks to form a monolithic structure. This method of repair should not be considered if the crack is still active (moving). For a watertight seal, a urethane sealant can be used. This repair technique does not form a structural bond; however, it can be used on cracks that are still active. Cracks should be opened using a concrete saw or hand tool prior to placing the sealant. A minimum opening of 1/4 inch is recommended since small openings are hard to fill. Urethane sealants can be reapplied since they are flexible materials and will adhere to older applications. As previously noted, all of the factors causing cracking must be identified and addressed before repairing the concrete to prevent the reoccurrence of cracks.

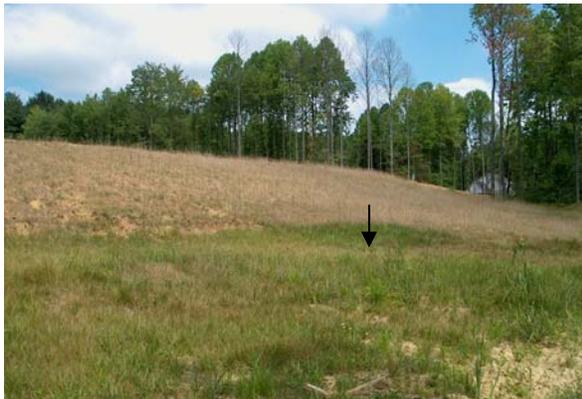
Figure 1 - Seepage at embankment toe caused sloughing

In this case, the vegetation on the face of the embankment is dormant while that at the toe is growing vigorously. The seepage has caused minor sloughing with a resultant scarp formation (at the arrow). If the seepage forces are large enough, soil can be eroded from the embankment or foundation resulting in piping or boils. Figure 2 shows a boil near the toe of an embankment. In this case, it appears seepage is flowing under the embankment in the foundation soils. Piping is often associated with “muddy flows” as sediment is

Seepage can emerge anywhere on the downstream face, embankment toe, or abutments at or below the normal pool level. Seepage will appear as soft wet areas, areas with flowing water, areas where the vegetation is noticeably lush and green, areas where the embankment is sloughing or bulging, or areas containing ponded water. Cattails, reeds, mosses, and other marsh vegetation are often present in seep areas. Rust-colored iron bacteria are another indication of water seeping from the ground. Figure 1 shows extensive seepage at the toe of an embankment.

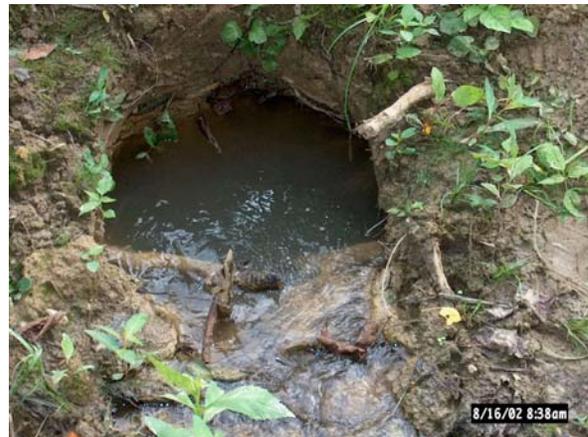
Figure 2 - Boil near toe of embankment (12-inches diameter)

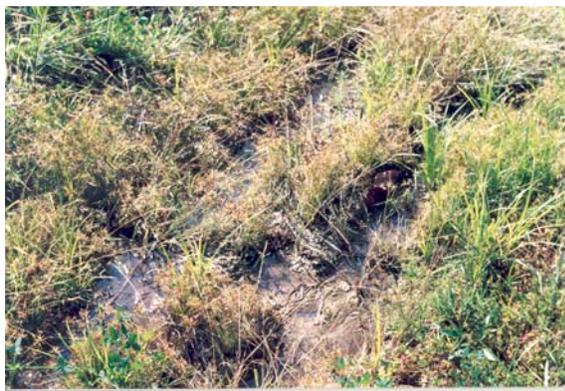
Figure 3 – Seepage flows on vegetated embankment

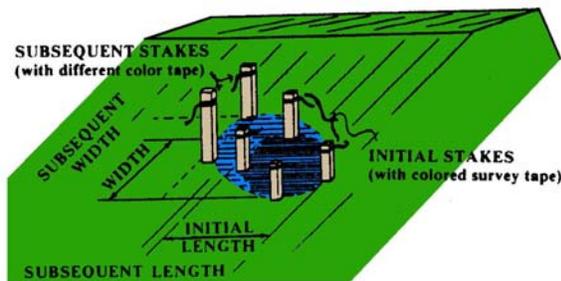
Figure 4 – Staking wet area to record changes

If seepage is detected on a dam embankment or foundation, it should be closely monitored on a regular basis until it is corrected. Seepage flows should be measured if possible and photographed to track its progression. If piping or boils are present, the size and the depth of the exit opening should be measured and recorded at each inspection, and the turbidity of the water should be noted. If the seepage is causing sloughing, sliding, or settlement, the affected area should be measured and recorded. The length, width, and depth of these conditions should be measured and photographed at each inspection. Sketches of the location of the seepage or instabilities should be prepared for the dam records.

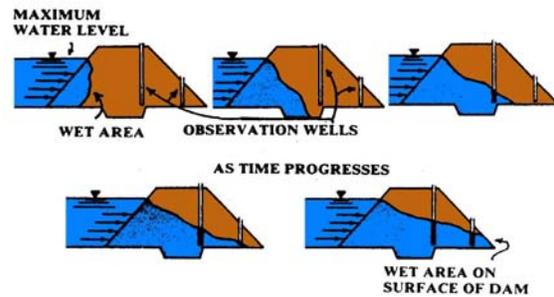
Figure 5 – Progression of seepage through dam embankment

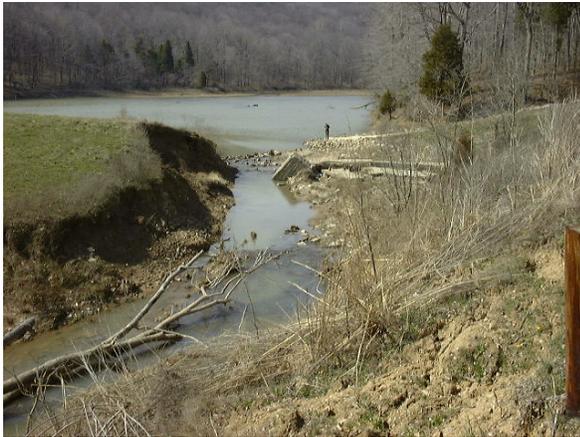
**Figure 6 - Apparent seepage along this concrete spillway caused total erosion of the structure.**

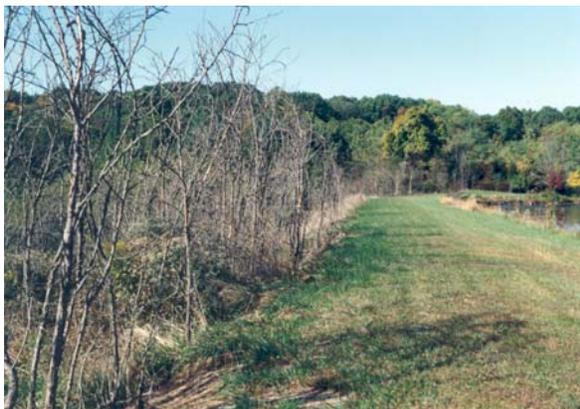
Figure 1 – Trees and brush on dam embankment

Trees and brush should not be permitted on embankment surfaces or in vegetated earth spillways. Extensive root systems can provide seepage paths for water. Trees that blow down or fall over can leave large holes in the embankment surface that will weaken the embankment and can lead to increased erosion. Brush obscures the surface limiting visual inspection, provides a haven for burrowing animals, and retards growth of grass vegetation. Tree and brush growth adjacent to concrete walls and structures may

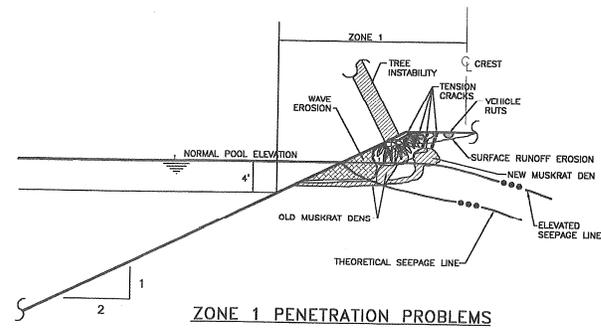
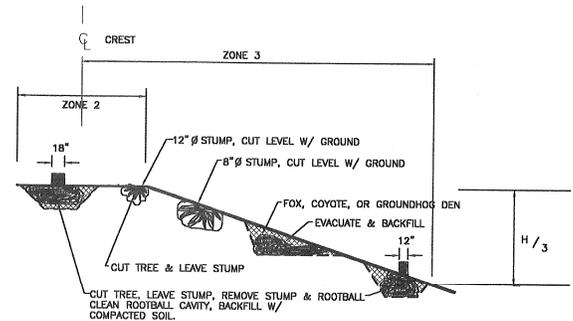
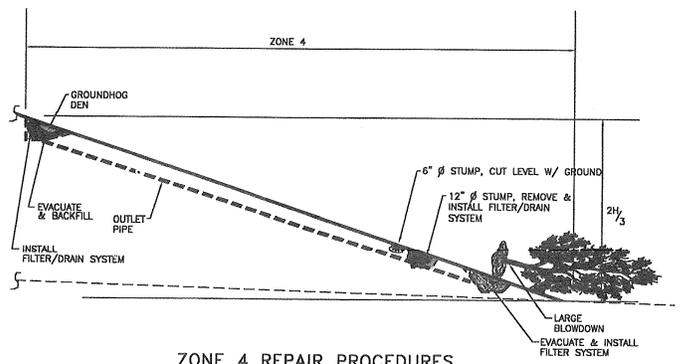
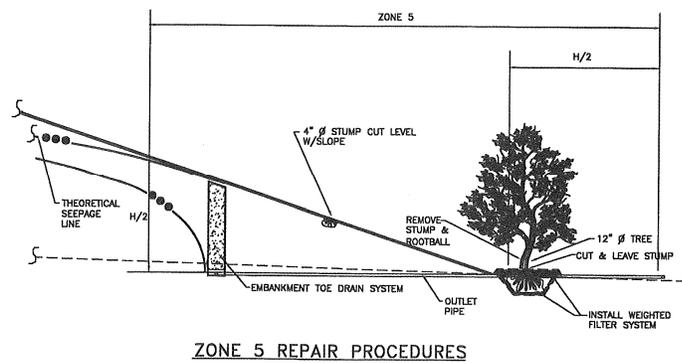
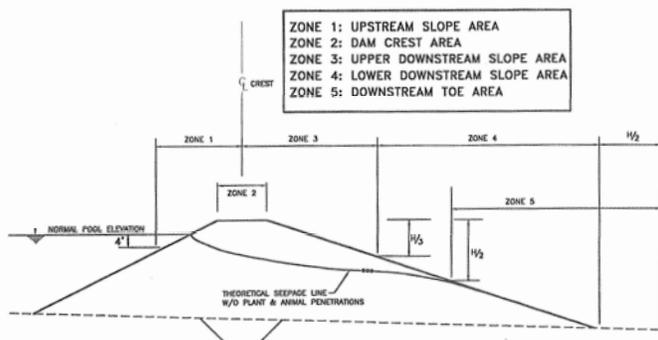
Figure 2 – Embankment Zones Related to Tree Removal

Figure 3 – Repair Procedures for Embankment Zones

The following guidelines are recommended when removing trees from dams (see Figures 2 and 3):

**Zone 2:** Cut trees in overlap area of Zone 2 and Zone 3 having stump diameters of twelve inches or less flush with the ground and treat the stump with a waterproof sealant to prolong stump decay.

**Zone 3:** Cut trees having stump diameters of about eight inches and less level with the ground and treat the stump with a waterproof sealant to prolong stump and rootball decay.

**Zone 4:** Cut all trees having stump diameters of six inches or less flush with the ground and treat the stump with a waterproof sealant to prolong stump and rootball decay.

**Zone 5:** Cut all trees having stump diameters of about four inches and smaller flush with the ground and treat the stump to prolong stump and rootball decay.

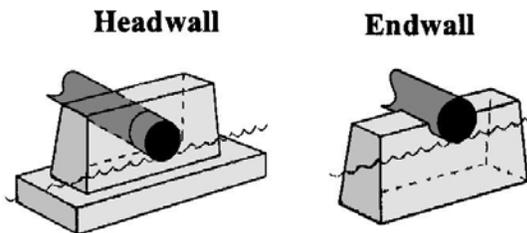
Figure 1 – Headwall/Endwall

A headwall/endwall located at or close to the end of the discharge conduit will provide support and reduce the potential for undermining. A headwall/endwall is typically constructed of concrete, and it should be founded on bedrock or have an adequate foundation footing to provide support for stability. A headwall/endwall can become displaced if it is not adequately designed and is subject to undermining. Displacement of the headwall/endwall can lead to separation of the spillway conduit at the joints which could affect the integrity of the spillway conduit. If a concrete structure develops the structural defects mentioned in the opening paragraphs, or if the discharge spillway conduit does not have a headwall/endwall, then a qualified dam safety professional with expertise in hydraulic and structural engineering should be contacted to evaluate the stability of the outlet.

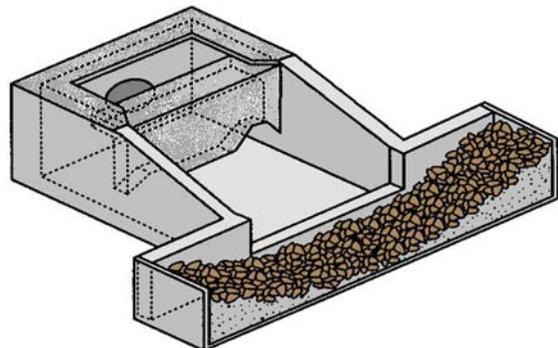
Figure 2 - Impact basin

A concrete impact basin is an energy dissipating device located at the outlet of the spillway in which flow from the discharge conduit strikes a vertical hanging baffle. Discharge is directed upstream in vertical eddies by the horizontal portion of the baffle and by the floor before flowing over the endsill. Energy dissipation occurs as the

discharge strikes the baffle, thus, performance is not dependent on tailwater. Most impact basins were designed by the United States Department of Agriculture, Natural Resources Conservation Service and the United States Department of Interior, Bureau of Reclamation. If any of the severe defects that are referenced in the opening paragraphs are observed, a qualified dam safety professional should be contacted to evaluate the stability of the outlet.

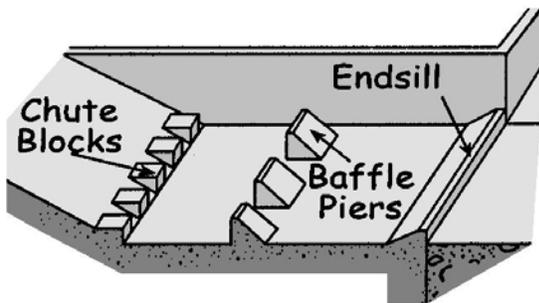
Figure 3 – Type III basin

Type III energy dissipaters can be used if the entrance velocity of the water is not high. They contain baffle piers which are located on the stilling basin apron downstream of the chute blocks. Located at the end of both the Type II and Type III basins is an endsill. The endsill may be level or sloped, and its purpose is to create the tailwater which reduces the outflow velocity. If any of the severe defects associated with concrete structures are observed, a registered professional engineer should be contacted to evaluate the stability of the basin.

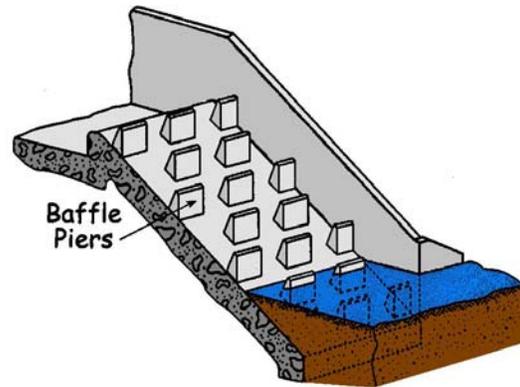
Figure 4 – Baffled chute

Baffled chutes require no initial tailwater to be effective and are located downstream of the control section. Multiple rows of baffle piers on the chute prevent excessive acceleration of the flow and prevent the damage that occurs from a high discharge velocity. A portion of the baffled chute

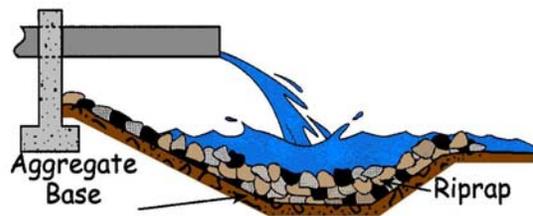
Figure 5 – Plunge pool

A plunge pool is an energy dissipating device located at the outlet of a spillway. Energy is dissipated as the discharge flows into the plunge pool. Plunge pools are commonly lined with rock riprap or other material to prevent excessive erosion of the pool area. Discharge from the plunge pool should be at the natural streambed elevation. Typical problems may include movement of the riprap, loss of fines from the bedding material and scour beyond the riprap and

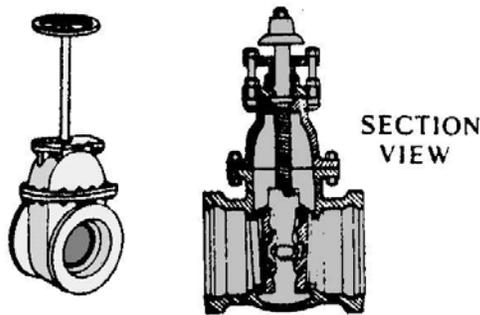
Figure 1 – Gate valve

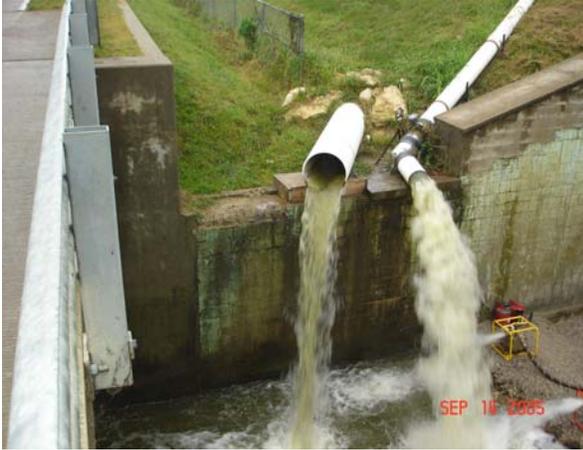
Figure 2 – Lake drain consisting of a pipe with control valve (left) and a siphon drain (right).

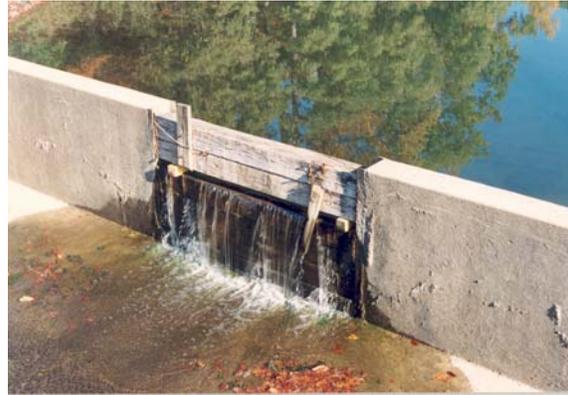
Figure 3 – Stoplog drain

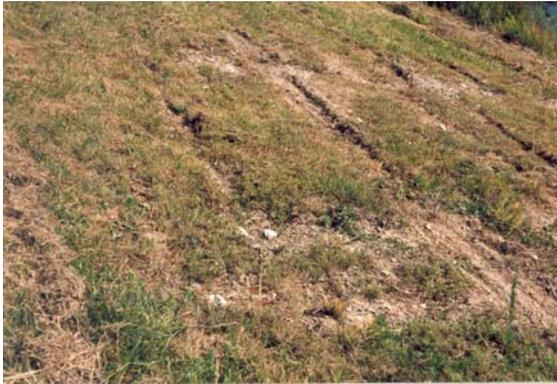
Figure 1 – Rill and gully erosion

Embankment slopes are normally designed and constructed so that the surface drainage will be spread out in a thin layer as "sheet flow" over the grass cover. When the sod is in poor condition or flow is concentrated at one or more locations, the resulting erosion will leave rills and gullies in the embankment slope. The erosion will cause loss of material and make maintenance of the embankment difficult. Prompt repair of the erosion is required to prevent more serious damage to the embankment. If erosion gullies are extensive, a registered professional engineer may be required to design a more rigid repair such as riprap or concrete. Minor rills and gullies can be repaired by filling them with compacted cohesive material. Topsoil should be a minimum of 4 inches deep. The area should then be seeded and mulched. Not only should the eroded areas be

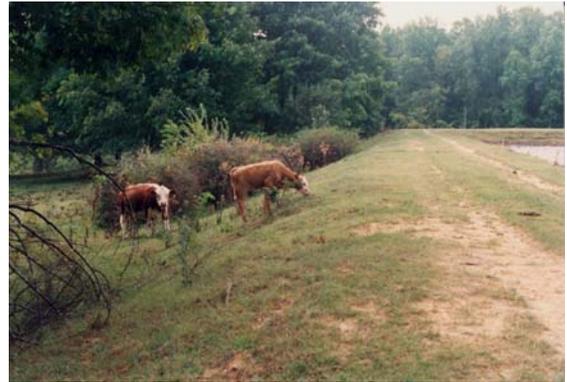
Figure 2 – Animal footpaths and vehicular ruts

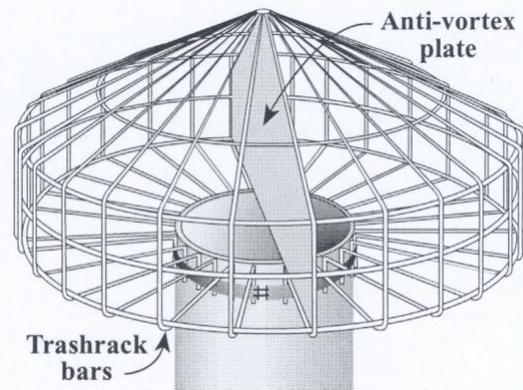
Figure 1 – Trash rack design

A well-designed trash rack will stop large debris that could plug the conduit but allow unrestricted passage of water and smaller debris. The larger the outlet conduit, the larger the trashrack opening should be. In the design of a trashrack, the openings should be sized so that they measure

one-half the nominal dimension of the outlet conduit. For example, if the outlet pipe is 18 inches in diameter, the trashrack openings should be the effective equivalent of 9 inches by 9 inches; if the outlet conduit is 3 feet by 5 feet, the trashrack openings should be the effective equivalent of 18 inches by 18 inches. This rule applies up to a maximum trashrack opening of two

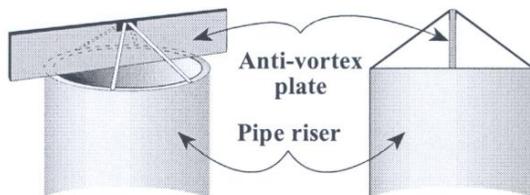
Figure 2 – Basic anti-vortex plate design

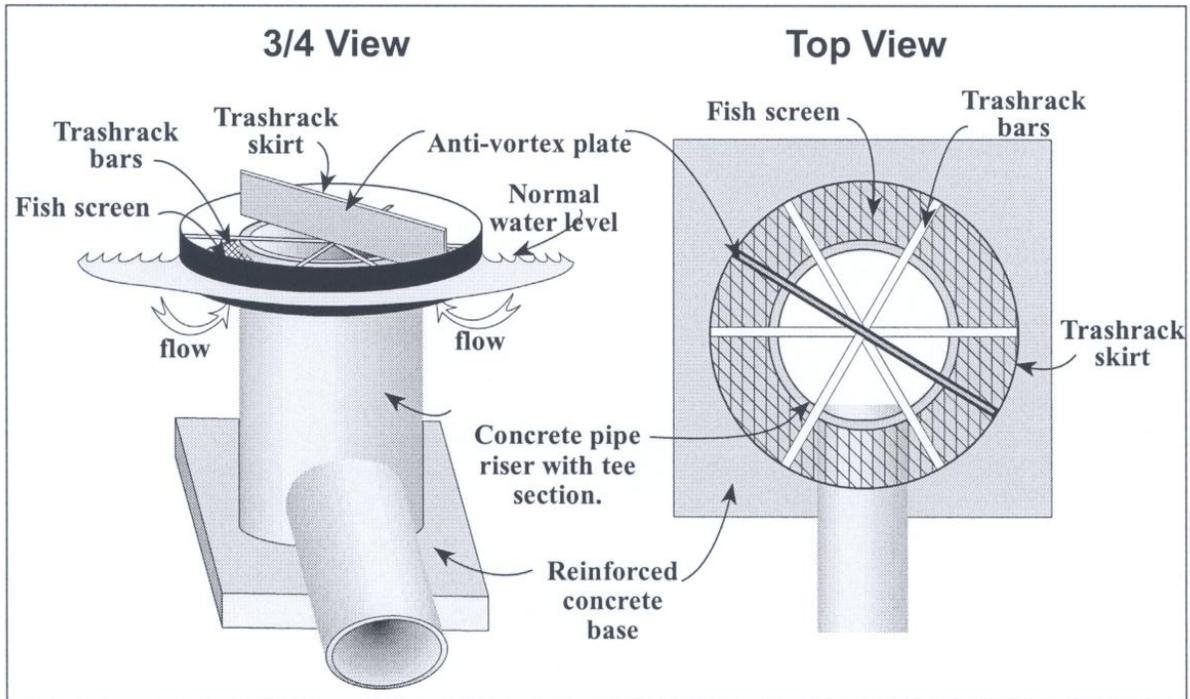
Figure 3 – Trash rack design with fish protector screen

Many owners are concerned about losing fish through trashracks that have large openings. If this is a concern, a metal plate surrounding the riser or drop inlet which extends above and below the normal pool level should be installed (see Figure 3). On the bottom of the plate, a metal screen should be attached and connected to the riser pipe. The solid plate at the water level will prevent the fish and floating debris from passing over the crest of the riser. The underwater screen will keep the fish from moving under the metal plate and through the spillway. The underwater screen will not become blocked because most of the debris floats on the water surface. If this design is used, the area between the inside of the cylinder and the outside of the riser must be equal to or greater than the area inside the riser.

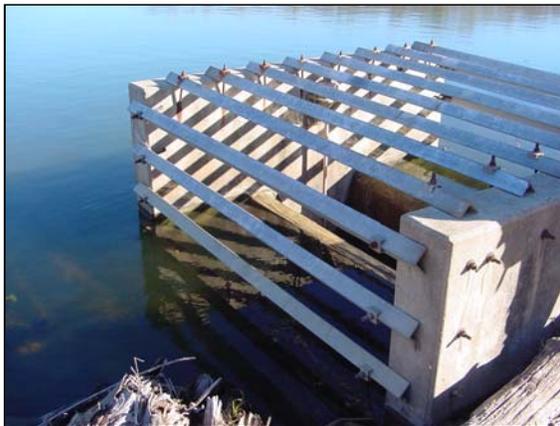
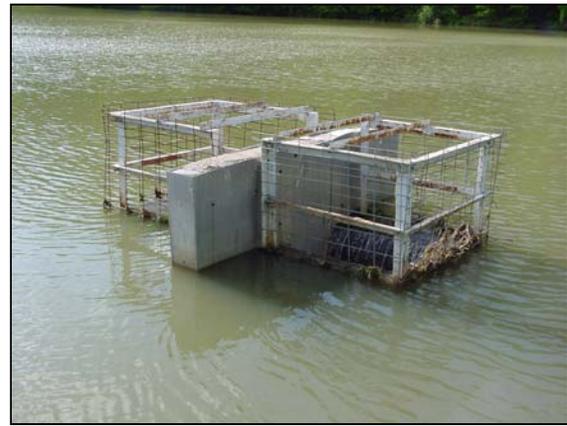
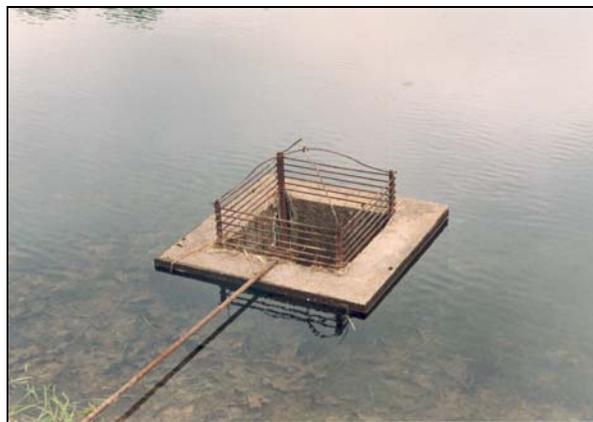
Figure 4 – Examples of trash racks used in Indiana

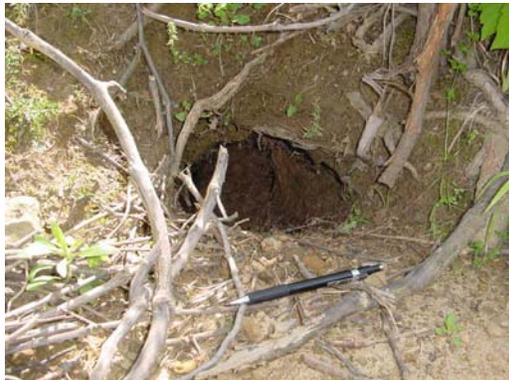
Figure 1 – Groundhog burrow

Occupied groundhog burrows are easily recognized in the spring due to the groundhog’s habit of keeping them “cleaned out.” Fresh dirt is generally found at the mouth of active burrows. Half-round mounds,

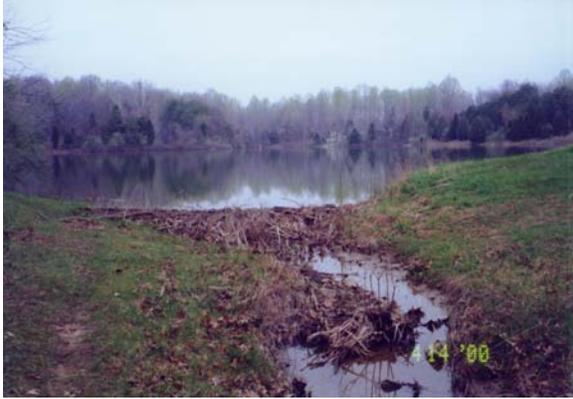
Figure 4 – Beaver dam

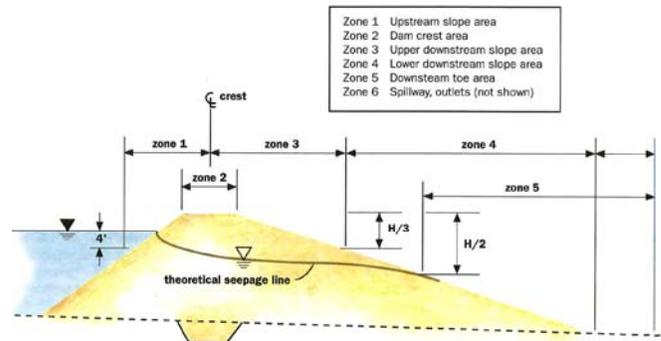
Figure 5 – Repair Zones for Dam Embankments

One method of evaluating and performing repairs on the dam embankment is based on dividing the embankment into 5 zones and applying specific techniques to each zone (see Figure 5).

**Repair Zone 1** begins on the upstream slope at a point approximately 4 vertical feet below the normal pool elevation and extends to the center of the crest. A 4-foot vertical distance was recommended by Marks, et al. (ASDSO, 2001) to account for average fluctuations in the abnormal pool and typical underwater animal burrows. The size of Zone 1 can vary significantly from dam to dam because it depends upon the distance between the crest elevation and the normal pool elevation. This distance is often referred to a freeboard.

**Repair Zone 2** corresponds to the limits of the dam crest and, therefore, overlaps with Zone 1 by one-half of the crest width. Overlapping a portion of Zone 1 with Zone 2 emphasizes the importance and critical nature of both zones. This overlap essentially suggests that both zones be inspected twice during a dam safety inspection.

**Repair Zone 3** begins at the crest centerline and extends to a point on the downstream slope equivalent to one-third the structural height of the dam below the dam crest elevation. As with Zone 2, Zone 3 overlaps Zone 2 by one-half of the crest width to emphasize the importance of the dam crest area. However, the remaining portion of Zone 3 is typically considered the least critical dam repair zone relative to dam safety issues (ASDSO, 2001). The phreatic surface and zone of saturation within the embankment are generally below the depths of average animal burrows and should not interfere with restoration activities.

**Repair Zone 4** extends from the point on the downstream slope that is one-third the dam's structural height below the crest to the toe of the downstream slope. Zone 4 is one of the two most critical dam repair zones relative to dam safety issues because of the proximity of the phreatic surface and zone of saturation to the embankment slope.

**Repair Zone 5** begins at the mid-height of the downstream slope and extends to a distance of one-half of the dam's structural height horizontally beyond the downstream toe. Zone 5 overlaps a large portion of Zone 4 to emphasize the most critical portions of both zones and heighten scrutiny during inspection. Zone 5 is typically considered the most critical zone relative to dam safety issues (ASDSO, 2001) because the interception of the phreatic surface and

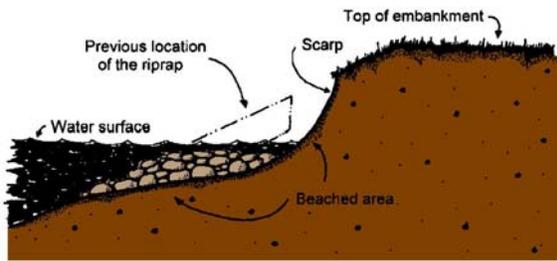
Figure 1 – Beaching

Slope protection is usually needed to protect the upstream slope against erosion due to wave action. Without proper slope protection, a serious erosion problem known as “beaching” can develop on the upstream slope. The repeated action of waves striking the embankment surface

erodes fill material and displaces it farther down the slope, creating a “beach.” The amount of erosion depends on the predominant wind direction, the orientation of the dam, the steepness of the slope, water level fluctuations, boating activities, and other factors. Further erosion can lead to cracking and sloughing of the slope which can extend into the crest, reducing its width. When erosion occurs and beaching develops on the upstream slope of a dam, repairs should be made as soon as possible. However, an erosion scarp less than 1 foot high may be stable and not require repair.

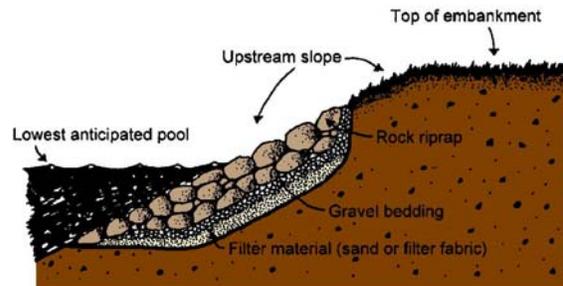
Figure 2 – Rock riprap

smaller rocks help to fill the spaces between the larger pieces forming an interlocking mass. The filter prevents soil particles on the embankment surface from being washed out through the spaces (or voids) between the rocks. The maximum rock size and weight must be large enough to break up the energy of the maximum anticipated wave action and hold the smaller stones in place. If the rock size is too small, it will eventually be displaced and washed away by wave action. If the riprap is sparse or if the filter or bedding material is too small, the filter material will wash out easily, allowing the embankment material to erode. Once the erosion has started, beaching will develop if remedial measures are not taken. Technical Release No. 69 developed by the USDA, Natural Resources Conservation Service can be used to help design engineers develop a preliminary or detailed design for riprap slope protection.

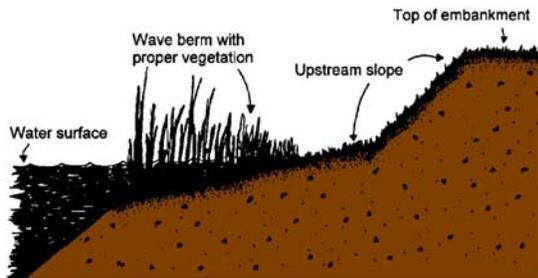
Figure 3 – Vegetated wave berm

Vegetated wave berms dissipate wave energy and protect the slope from erosion. Berms are constructed on the upstream slope at the normal pool level and should be no less than 20 feet wide. This method of slope protection will not work well where the water surface fluctuates regularly from normal pool. If improper or sparse vegetation is present, the wave berm may not adequately dissipate the wave energy, allowing erosion and beaching to develop on the upstream slope. Technical Release No. 56 developed by the USDA, Natural Resources Conservation Service provides design and layout information.

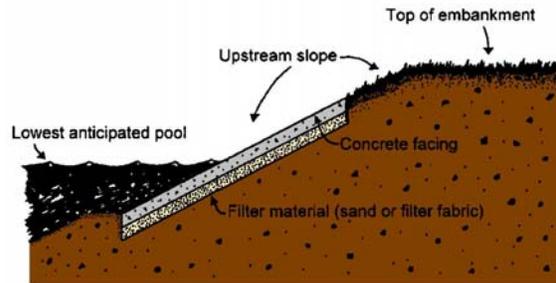
Figure 4 – Concrete facing

adequate support for the concrete facing. A properly designed and constructed concrete facing can be expensive. This slope protection should extend several feet above and below the normal pool level. It should terminate on a berm or against a concrete curb or header. Granular filter or filter fabric (geotextile) is required under the concrete facing to help reduce the risk of undermining.

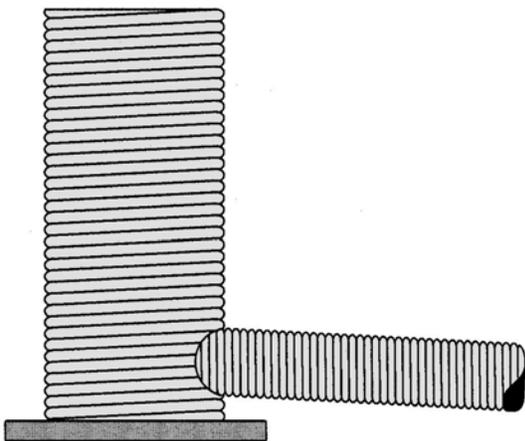
Figure 1 – Example of a corrugated metal pipe and riser spillway

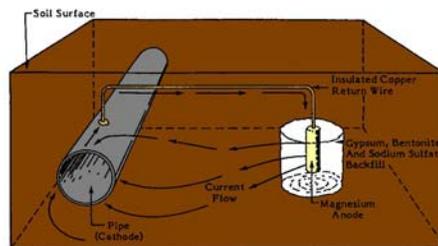
Figure 2 – Cathodic protection

Corrosion can also be controlled or arrested by installing cathodic protection. A metallic anode such as magnesium (or zinc) is buried in the soil and is connected to the metal conduit by wire. Natural voltage current flowing from the magnesium (anode) to the conduit (cathode) will cause the magnesium to corrode and not the conduit. However, sufficient maintenance funds should be allocated for the regular inspection of this active system.

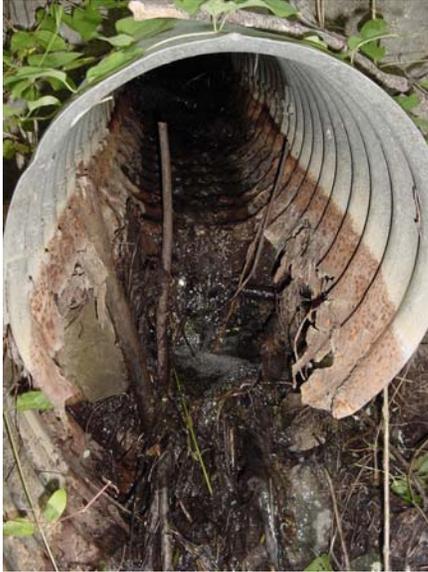
Figure 3 – Corrosion of corrugated metal pipe

If corrosion is allowed to continue, metal conduits will rust out. The spillway must be repaired before water flows through the rusted out portion of the conduit and erodes the fill material of the embankment. Continued erosion can lead to failure of the dam. Sliplining can be an economical and effective method of permanently restoring deteriorated spillways. During sliplining, a smaller

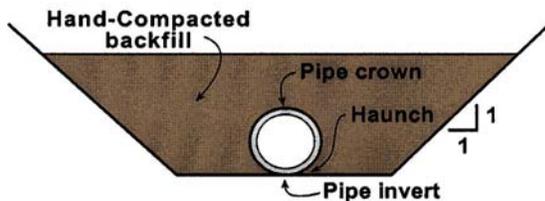
Figure 1 – Cross-section of plastic pipe in trench

Plastic pipes are considered flexible, and they get their strength from the material and the surrounding backfill whereas rigid pipes, such as concrete, get their strength from the material and the pipe structure. Backfill around plastic pipes must be properly compacted and in full contact with the pipe. It is important to take special care in the haunch area to prevent the pipe from lifting off the subgrade and disrupting vertical alignment. Symmetric backfilling is also required to prevent the pipe from being out of lateral alignment.

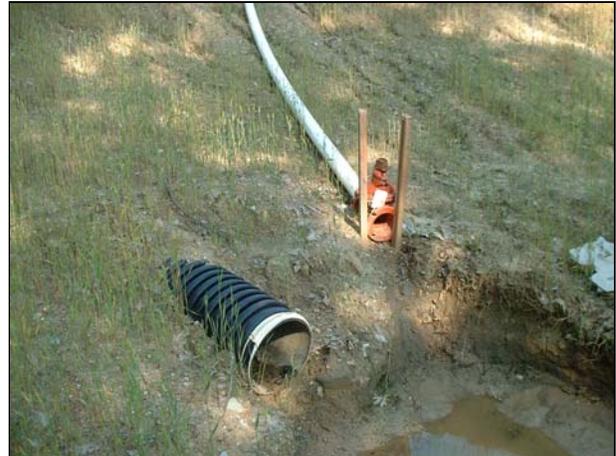
Figure 2 - Plastic pipe used as the principal spillway; the use of this type of plastic pipe is not recommended

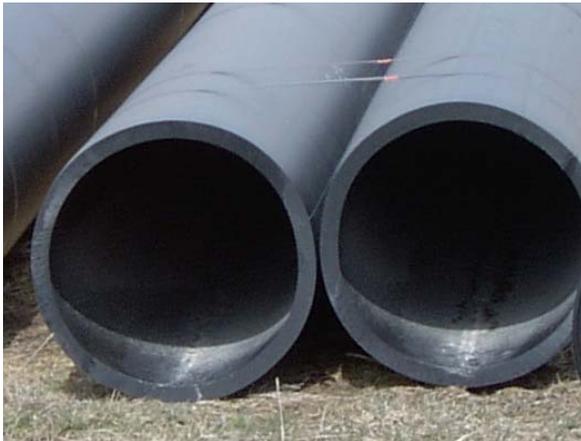
**Figure 3 – “Thick-walled” small diameter HDPE pipe.**

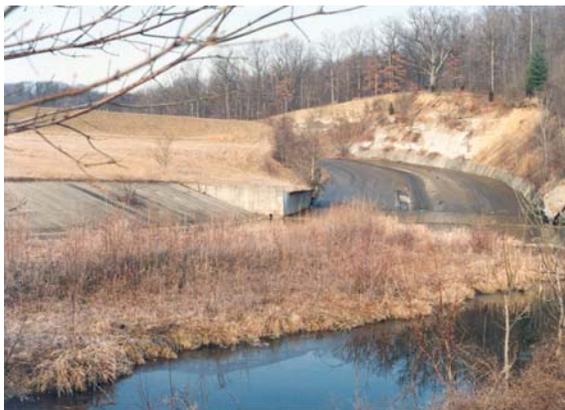
Figure 1 – Concrete chute spillway

The main components of a concrete chute spillway are the inlet structure, control section, discharge channel, and outlet erosion control structure. The inlet structure conveys water to the control section. The control section is the highest point in the channel and regulates the outflow from the reservoir. It is usually located on or near the crest of the dam. The control section may consist of a concrete weir or may simply be the most elevated slab in the floor of the chute. The discharge channel is located downstream of the control section and conveys flow to the outlet

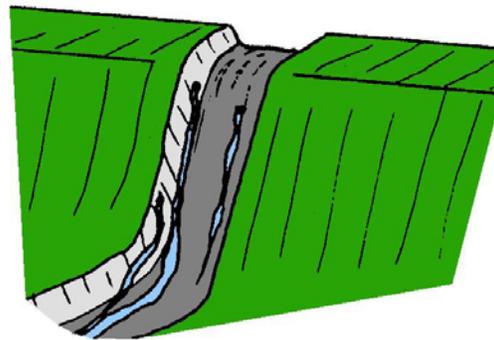
Figure 2 – Spillway leakage

The rate and content of flow from weep holes and relief drains must be monitored and documented regularly. Muddy flow may indicate erosion of fill material along the spillway or piping through the embankment. The presence of soil particles or muddy flow from the drains indicates that the filter or under-drainage is not functioning properly and is allowing the migration of soil particles from the embankment. Sudden increases in flow, or muddy flow from the drains should be immediately

investigated by a qualified dam safety professional with experience in geotechnical issues in order to determine the cause and severity of the problem. Plans and specifications to properly control the seepage and repair the drain(s) and embankment should also be developed and carried out under the direction of a registered professional engineer.

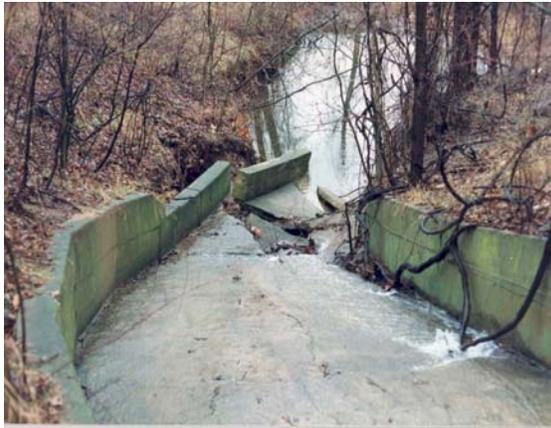
**Figure 3 – Concrete spillway cracking and undermining**

gravel. Seepage can occur through the dam, along the contact between the embankment and the concrete chute, or through open joints and cracks. Uncontrolled seepage flow along the structure can erode the underlying fill material (undermining) which may cause cracking or buckling of the slabs. Excessive pressure behind the walls and floor of the chute can cause cracking and heaving of the concrete. The freeze-thaw cycle can increase the amount of stress and strain on the concrete and can also cause heaving, cracking and additional serious damage to the structure. Weep holes, relief drains, and underdrainage for a concrete chute spillway should be designed by a registered professional engineer.

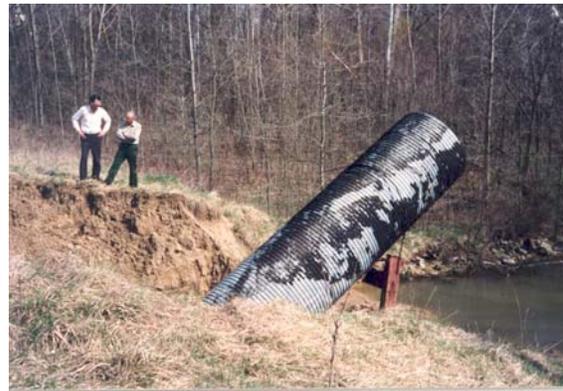
Figure 1 – Undermining of principal spillway conduit

Undermining is the removal of foundation material surrounding a conduit system. Any low areas or unexplained settlement of the earthfill in line with the conduit may indicate that undermining has occurred within the embankment. As erosion continues, undermining of a conduit can lead to displacement and collapse of the pipe sections and cause sloughing, sliding or other forms of instability in the embankment. As the embankment is weakened, a complete failure of the conduit system and, eventually the dam may occur.

Seepage along the conduit from the reservoir can occur as a result of poor compaction around the conduit. If seepage control devices have not been installed, the seepage may remove foundation

material from around the conduit and eventually lead to undermining.
