Draft Feasible Alternatives Selection Report

US-20 @ US-35

Interchange (Ramp) Modification

Des No.: 0014050

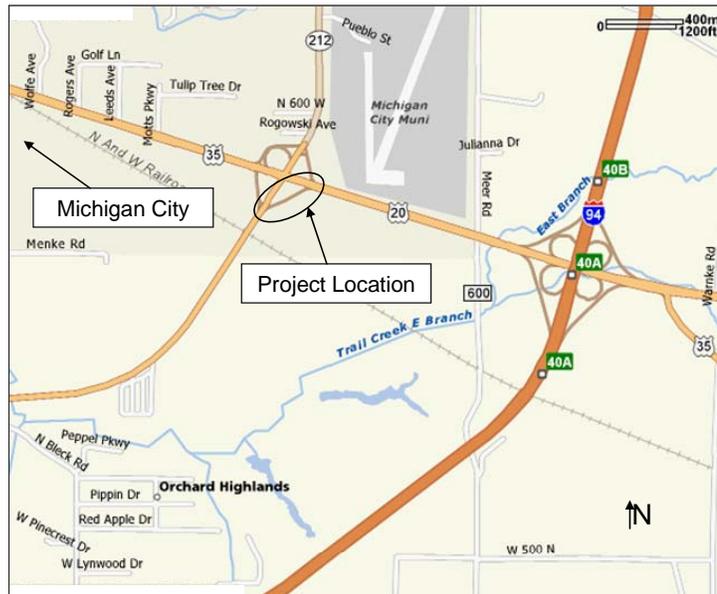
Figure 1: Project Location Map, US-20 @ US-35 Interchange

The existing configuration at the US-20 and US-35 interchange is an old/archaic style cloverleaf interchange. As can be seen in Figure 1 to the right, the interchange only has one somewhat traditional loop ramp in the northwest quadrant. The ramps in the northeast, southeast, and southwest quadrants combine with the diagonal connector ramps to form two lane ramps that carry two-way traffic. The lanes on these ramps are separated by a double yellow line. As a result of the odd looking configuration, left turn movements act as they would in a traditional full cloverleaf interchange but since there are not true loop ramps the cars have to decelerate rapidly to make the sharp right turn of 115 degrees to 150 degrees depending on the ramp. Furthermore there are not any auxiliary lanes; therefore, traffic is required to stop at the end of each of these pseudo look ramps.
