## INDIANA DEPARTMENT OF TRANSPORTATION

# MSE WALL MAINTENANCE MANUAL

**Prepared by**  
**Geotechnical Engineering Division**  
**120 S Shortridge Rd, Indianapolis, IN 46219**  
**August, 2025**

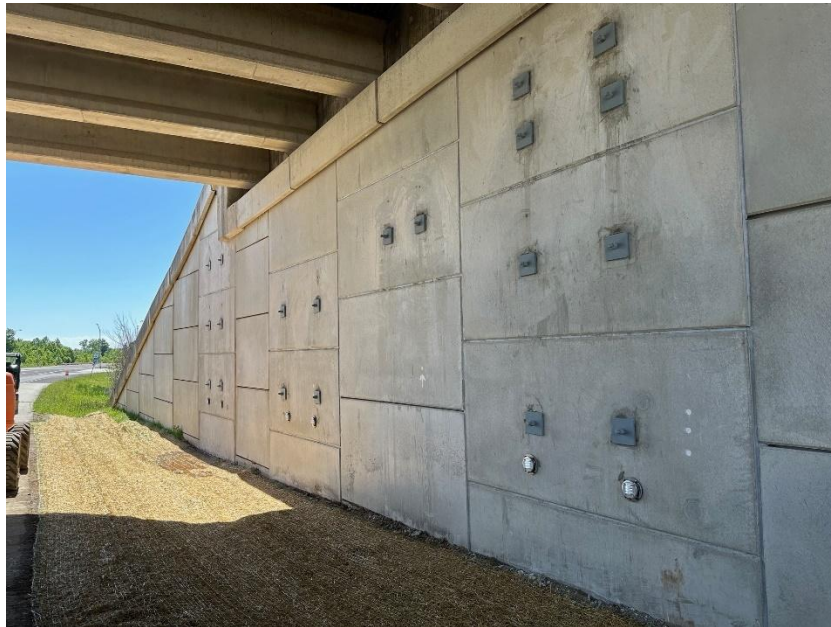
- Fill the void up to a depth of 12 inches from the surface with No. 8 aggregate. The maximum loose lift thickness shall not exceed 5 inches. Compaction should be done by means of a minimum of five passes with a lightweight mechanical tamper, roller, or an alternative vibratory system. If such equipment is not available, use manual tamping for compaction.
- Cover the compacted aggregate surface with geotextile Type 2B.
- Encase the remaining top 12 inches with either silty clay or silty clay loam.
- Do the necessary adjustment of the final finished grade to ensure drainage away from the wall.
- Install the appropriate erosion control product (e.g., rolled straw matting and seeding) on top of the finished grade to stabilize the area, as shown in Figure 1.

**Figure 1: Rolled straw matting on the bench of the MSE wall**

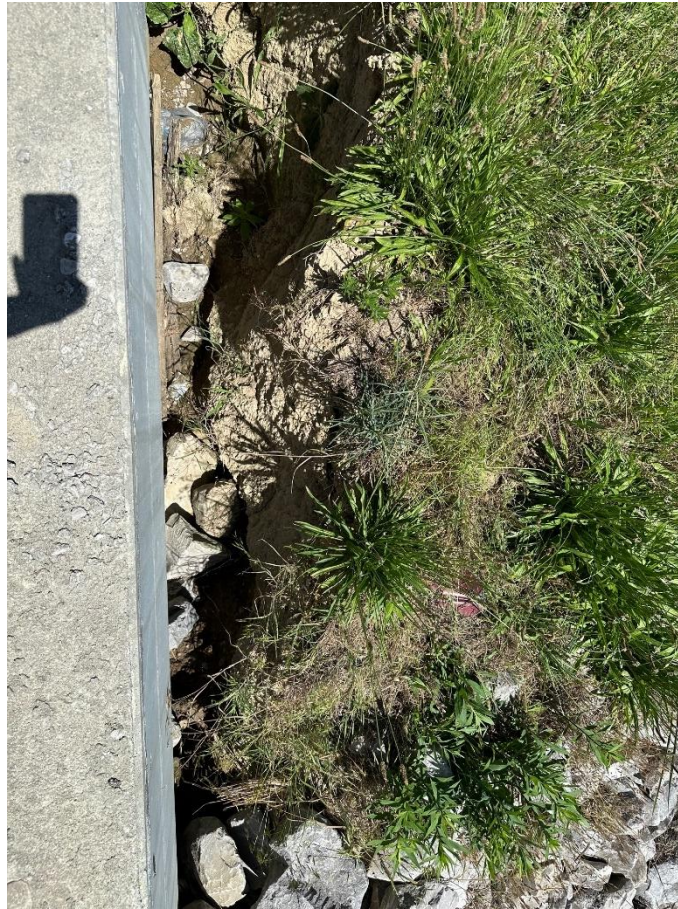
If erosion occurs in the area at the back face of the wall, as shown in Figure 2, water can accumulate and weaken the backfill soil, which compromises the overall stability of the MSE wall. After observing erosion, it should be properly addressed. The following actions should be taken to prevent further damage:

**Figure 2: Erosion at the back face of the wall**

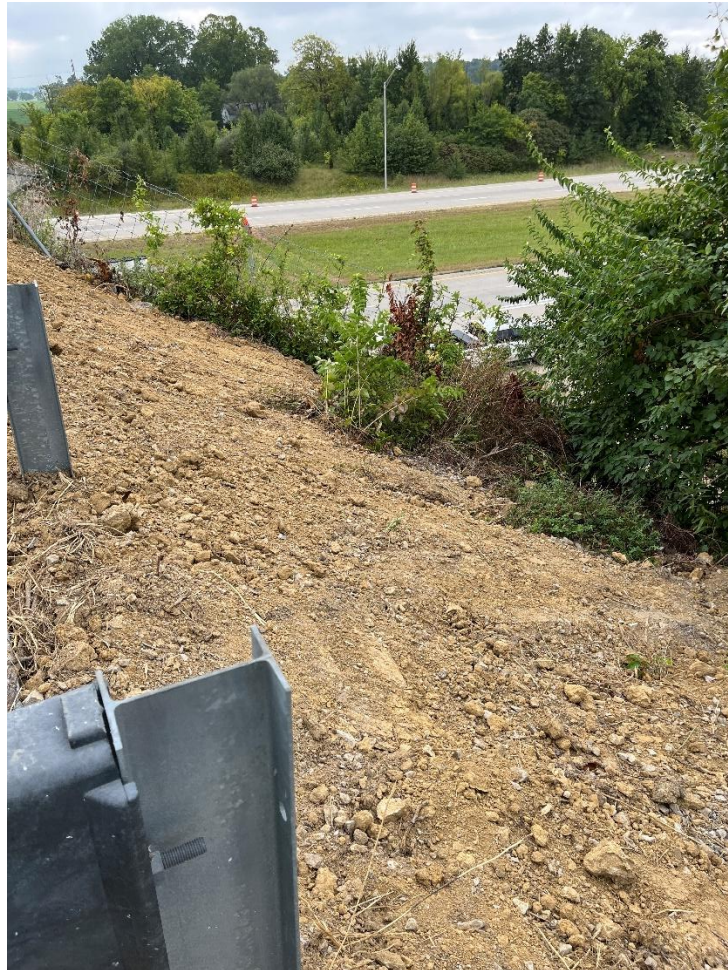
- Encase the remaining top 12 inches with either silty clay or silty clay loam, as shown in Figure 3.
- Do the necessary adjustment of the final finished grade to ensure drainage away from the wall.

**Figure 3: Recompacted eroded backfill of MSE wall**

Erosion in the reinforced and retained backfill zones can hinder the stability of the MSE wall. After observing erosion (Figure 3), the following strategy can be used to correct existing issues and minimize the likelihood of future erosion:

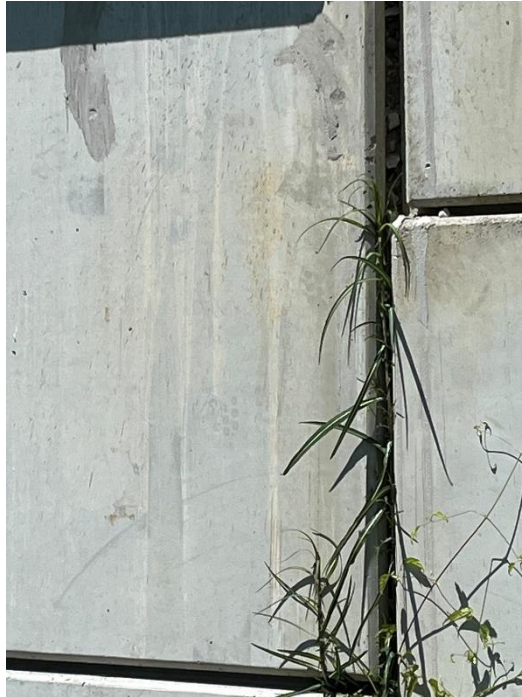
Vegetation growing through panel joints, as shown in Figure 4, indicates poor performance of an MSE wall's overall drainage system. Roots damage the geotextile fabric that lines the backside of the panel joints, leading to potential leakage of backfill material. Additionally, as the roots grow, they may cause harm to the panels. Therefore, addressing vegetative growth promptly is crucial to the longevity of MSE walls. The following strategies should be taken to prevent further damage:

**Figure 4: Vegetation growing through panel joints**

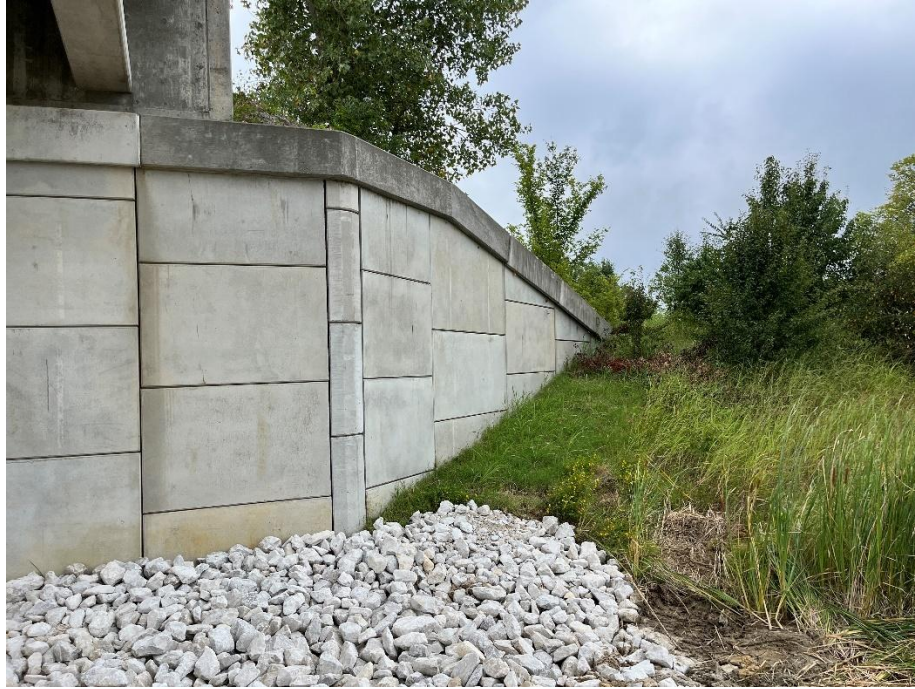
Woody vegetation (Figure 5) should not be allowed to grow on top of the reinforced or retained backfill zones as the roots can damage the MSE wall reinforcement. No pulling or hoeing of woody vegetation is permitted in these zones as damage to the reinforcement may occur. Grassy and other herbaceous vegetation is permitted to grow in this area and is preferred over bare ground conditions to minimize topsoil erosion potential. The following actions must be taken to manage the vegetation in the backfill zones.

**Figure 5: Grown tree on top of the MSE wall**

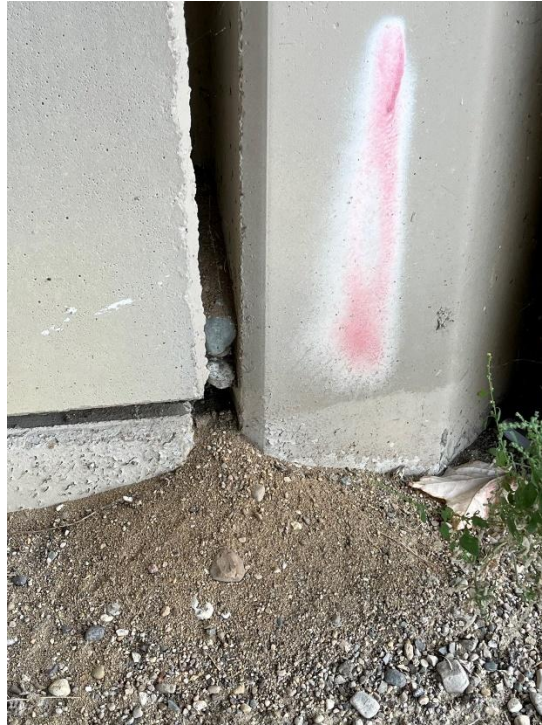
If any panel joint is wider than 3/4 inch (Figure 6), it needs to be sealed to prevent damaging of the geotextile layer behind the panel and to prevent soil leakage through the joints. Therefore, the wide joints should be filled with a durable and flexible joint filler (e.g., free drainage seal or baker rod) and sealed with silicon sealant to prevent soil leaking. Periodic monitoring should be conducted to evaluate if the joints are widening. The INDOT Geotechnical Engineering Division should be notified if the movement is progressive.

**Figure 6: Soil leaking through wide panel joints**

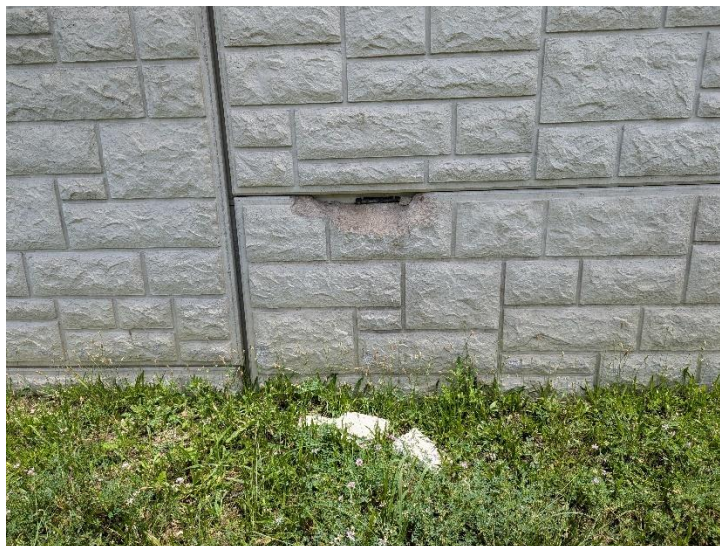
Cracked or spalled corners of the face panels (Figure 7) can be a path through which backfill soil can be leaked upon failure of the geotextile layer. Therefore, the cracked or spalled corners of the face panels need to be fixed with epoxy injection or concrete patching depending on the extent of the damage.

**Figure 7: Spalling in the concrete panel**

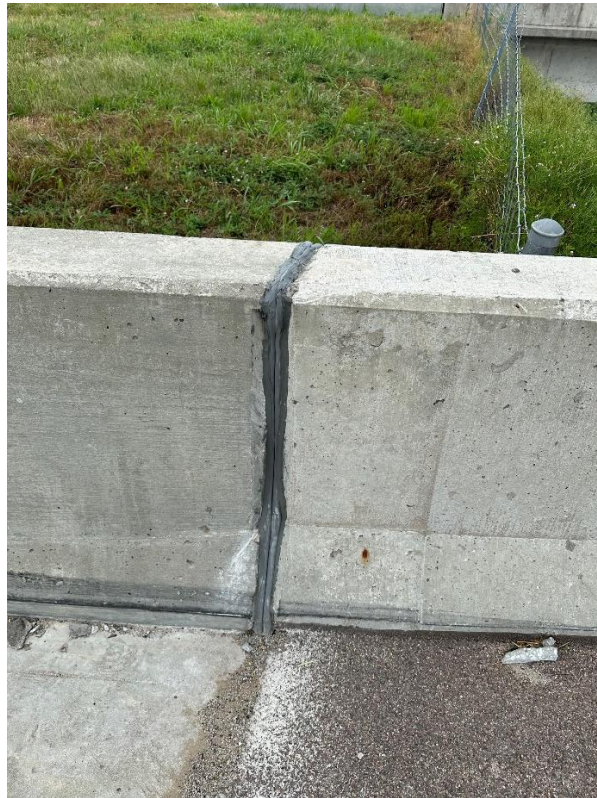
The sealing between expansion joints of concrete bridge railing degrades over time. When the seal is broken, water from the bridge can be directed to the top of the MSE wall reinforced zone. Therefore, periodic monitoring should be done to check if any joint seal is broken. The broken joint seals need to be resealed with pre-compressed foam joint sealer, as shown in Figure 8.

**Figure 8: Pre-compressed foam sealer for bridge rail joints**

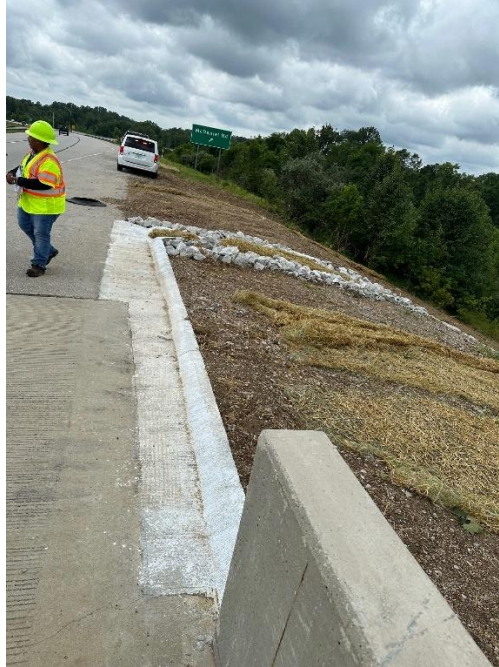
Drainage curb, as shown in Figure 9, is used to direct the surface water away from the reinforced backfill. Any broken curb needs to be repaired with concrete patching to prevent water from draining on the reinforced backfill zone.

**Figure 9: Drainage curb to direct rainwater away from backfill zone**

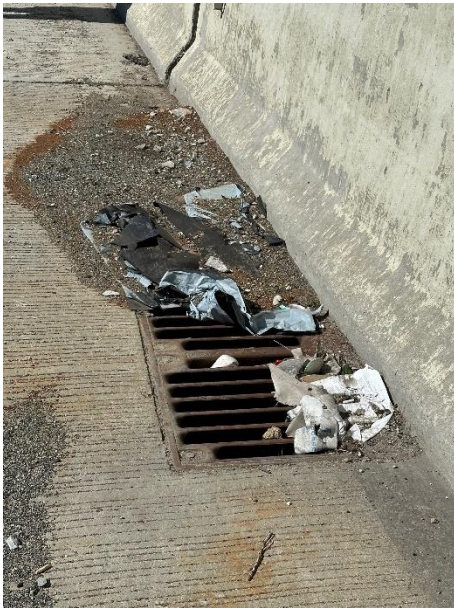
a) Clogged manhole

**Figure 10: Clogged drainage inlet and pipe**

The drainage inlets and pipes should be inspected periodically to investigate if they are working properly. If any of the inlets and drainage pipes are clogged (Figure 10) or disconnected, they need to be cleaned or reattached.

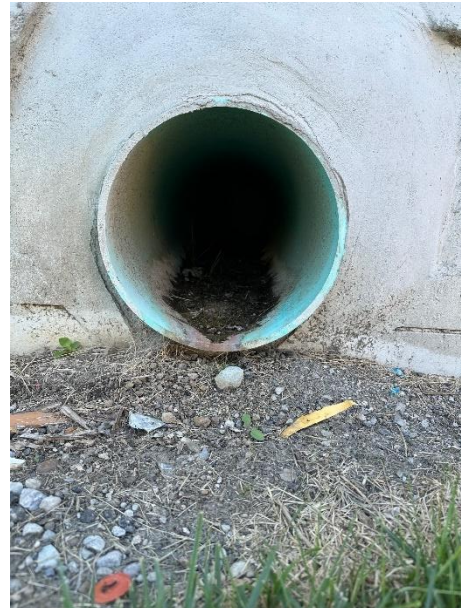
b) Clogged pipe

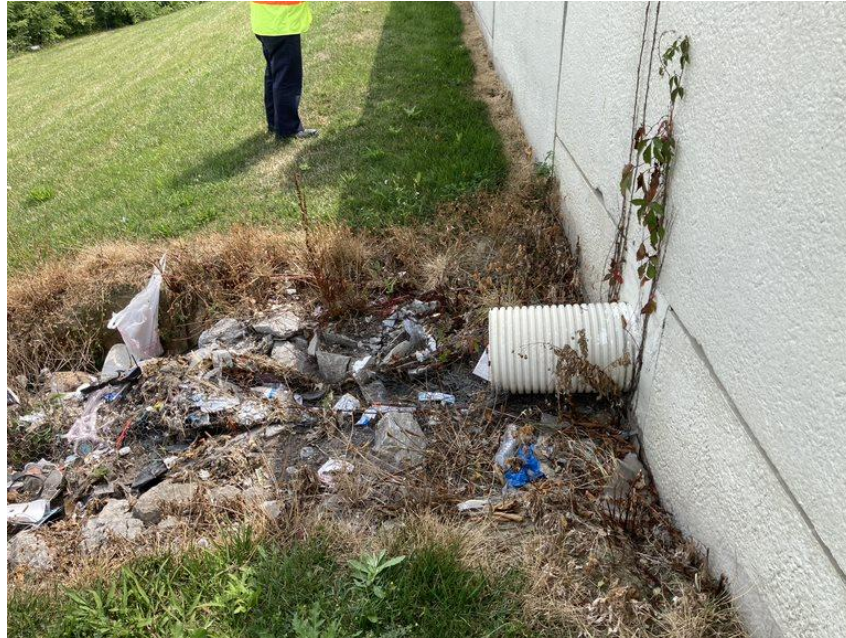
Periodic grubbing and cleaning should be done to improve the overall drainage performance of the MSE wall.

**Figure 11: Blocked MSE wall drain**
