INDIANA DEPARTMENT OF ADMINISTRATION (IDOA)
INDIANA DEPARTMENT OF NATURAL RESOURCES (IDNR)

PROJECT No. ENG2403889284
NASBY DAM REHABILITATION
BLOOMFIELD TOWNSHIP, LAGRANGE COUNTY, INDIANA

December 2023

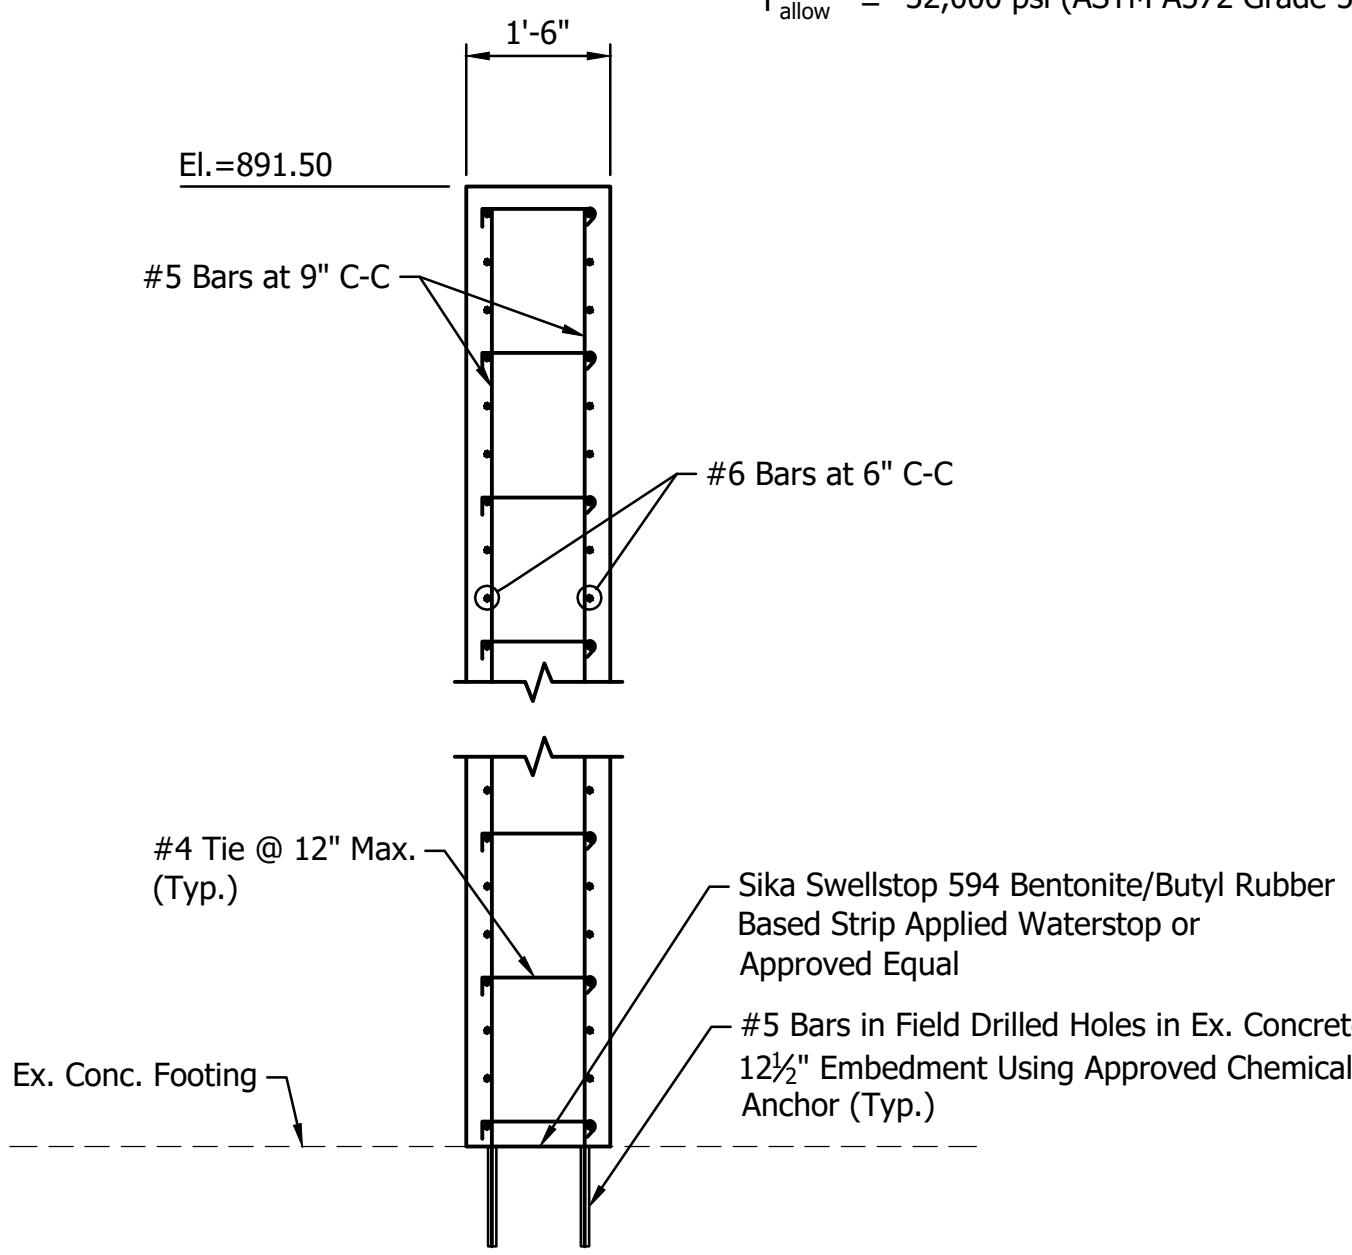
SECTION B-B
WALL REPLACEMENT #1

f_c = 3,500 psi (Wall Stem)
 f_c = 4,000 psi (Concrete Cap and Slab)
 f_y = 60,000 psi (Reinforcement)
 F_y = 50,000 psi (ASTM A572 Grade 50, Structural Steel)
 F_y = 50,000 psi (ASTM A572 Grade 50, Steel Sheet Pile)
 F_{allow} = 32,000 psi (ASTM A572 Grade 50, Steel Sheet Pile)

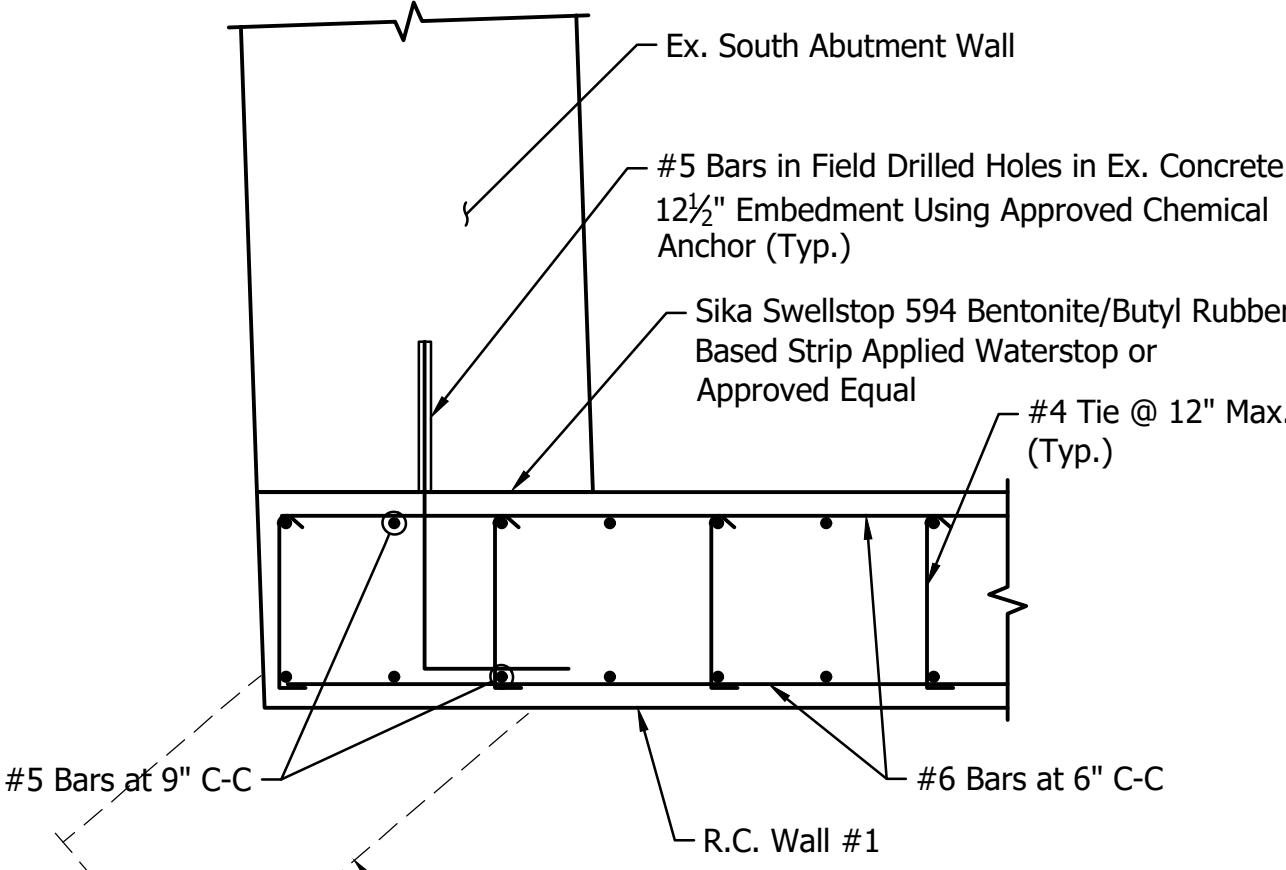
DETAIL 1
(PLAN VIEW SHOWING R.C. WALL AND SOUTH ABUTMENT WALL REINFORCEMENT CONNECTION DETAIL)

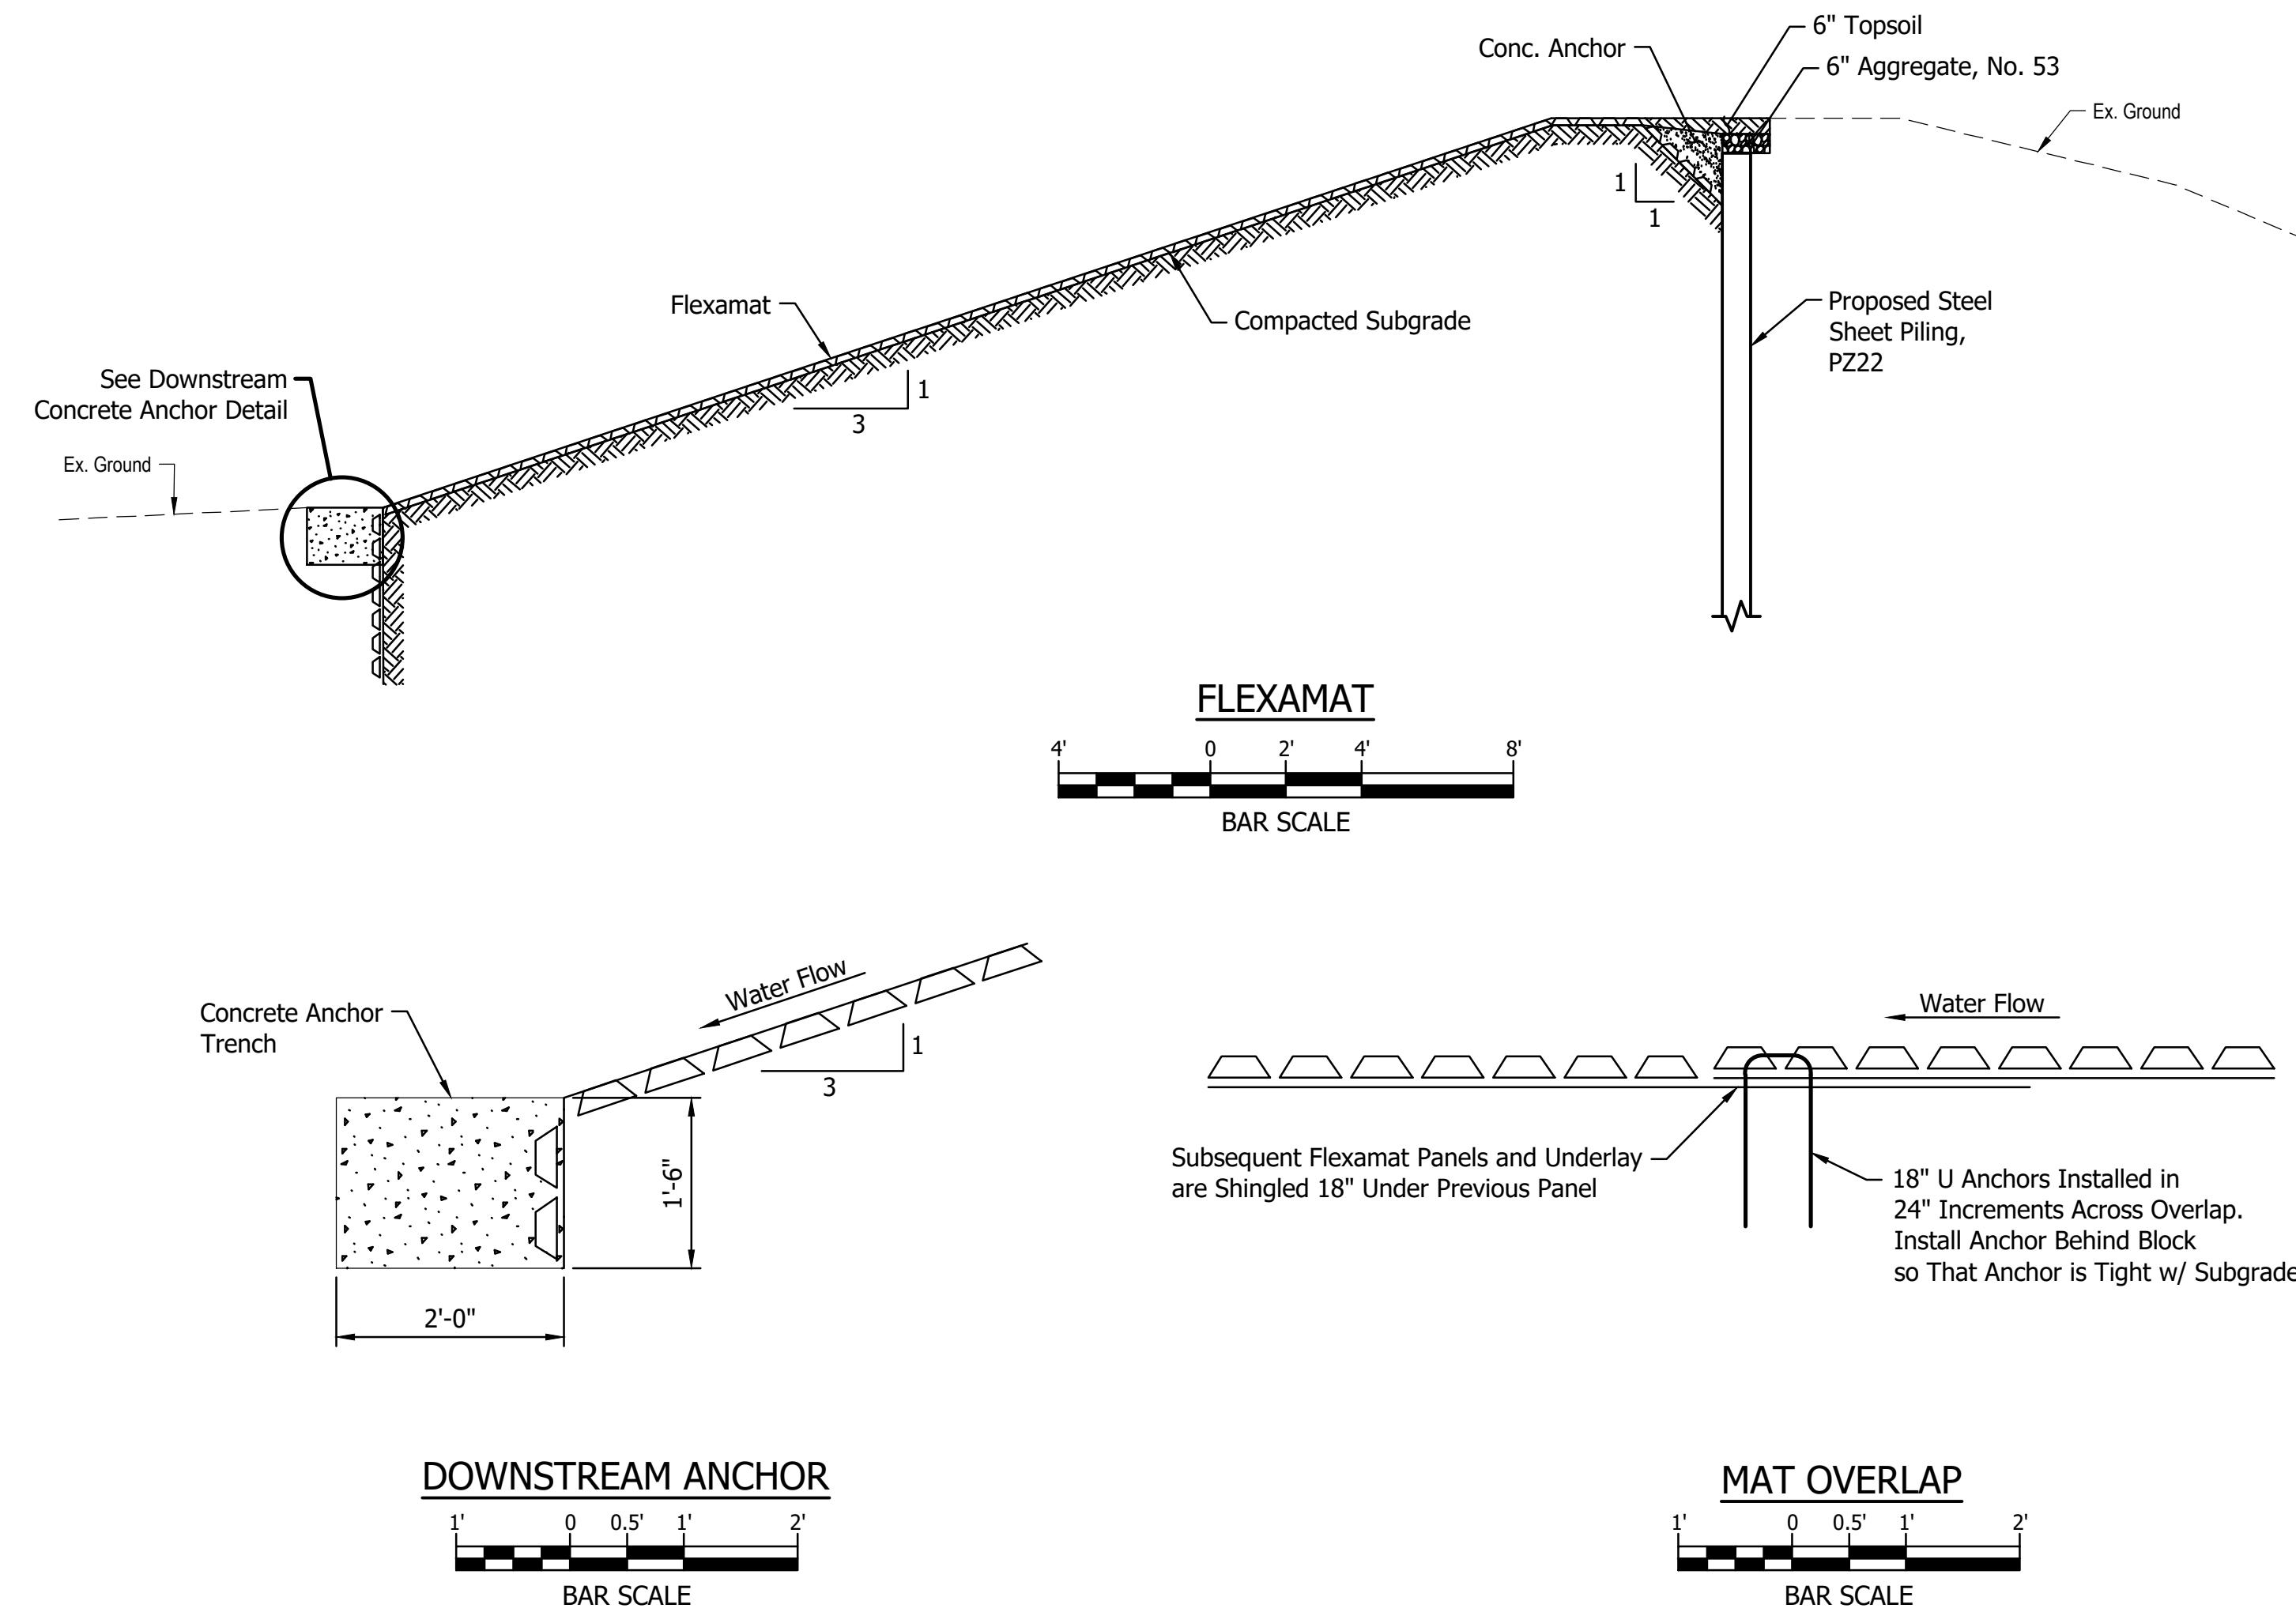
MAT OVERLAP
BAR SCALE

- An Engineer or manufacturers representative shall be onsite for the start of the installation.
- All subgrade surfaces prepared for placement of mats shall be smooth and free of all rocks, sticks, roots, other protrusions, or debris of any kind. The prepared surface shall provide a firm, unyielding subgrade for the mats.

- Install Flexamat plus rolls. Manufacturer recommends installing the widest mat possible for spillway applications.
- Installation starts at the down channel end and moves up the channel, towards the start of channel.

- Install 18" u-anchors in 2' increments or stainless steel zip ties in 1' increments across mat abutment seams. Install u-anchors and zip ties perpendicular to flow directly behind first block of the up-channel mat. U-anchors shall encompass two cords of geogrid on each mat. Zip ties shall encompass 3 cords of geogrid from each mat.

- For edge of Flexamat, recess the outside two blocks into the slope at 45° angle.
