INDIANA DAM SAFETY INSPECTION MANUAL

UPDATED 2007

PART 3 DAM SAFETY INSPECTIONS

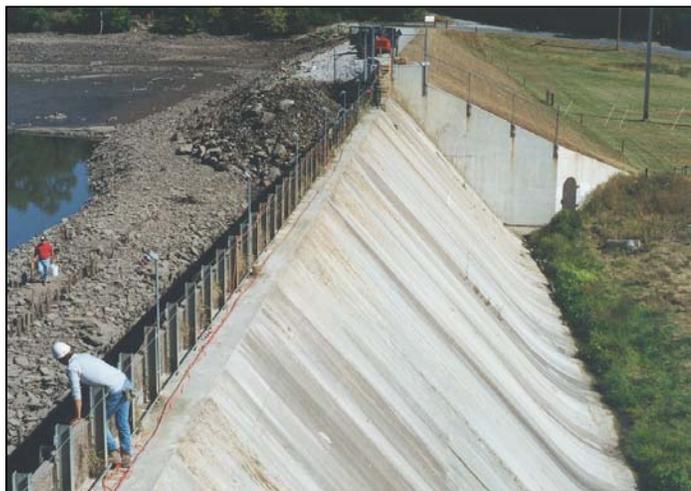
Figure 1-1 Knowledge of concrete and earth structures is required here.

Personnel that perform dam inspections must be knowledgeable in dam design, construction, and operation to effectively evaluate the dam conditions. The inspector should be an experienced, or trained, dam safety professional with expertise in the technical issues encountered at the dam. For instance, the inspector must have knowledge or expertise in structures if the dam has a significant concrete spillway structure, or knowledge or expertise in soils and geotechnical engineering if the dam has an earth embankment (see Figure 1-1). This

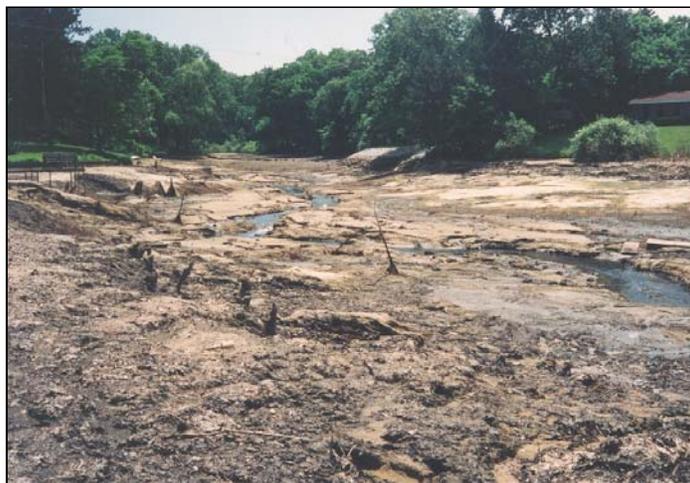
Figure 1-3 Dam breach failures cause significant downstream damage.

intended to provide a guide and reference to all individuals performing and reporting dam safety inspections. Chapters 5 through 8 provide a quick reference to be used in assessing observed conditions, their probable cause and possible consequences, and remedial actions that may solve the observed problems or deficiencies. The dam owner or inspector can use the results of inspections to help identify any changes in previously noted conditions that may indicate a safety concern. Quick corrective action to conditions requiring attention will promote the safety and extend the useful life of the dam while possibly preventing costly future repairs (see Figure 1-3).

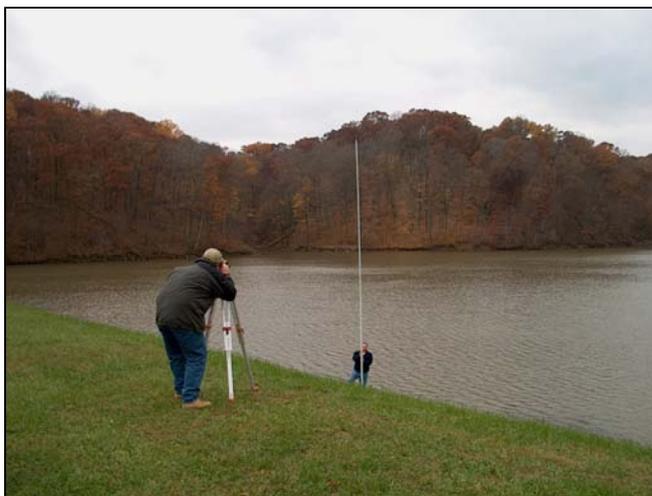
Figure 2-2 These inspectors are checking freeboard with a level and stadia rod.

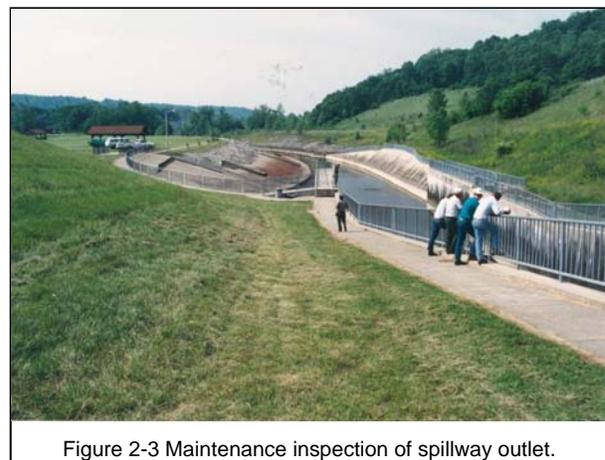
Figure 2-3 Maintenance inspection of spillway outlet.

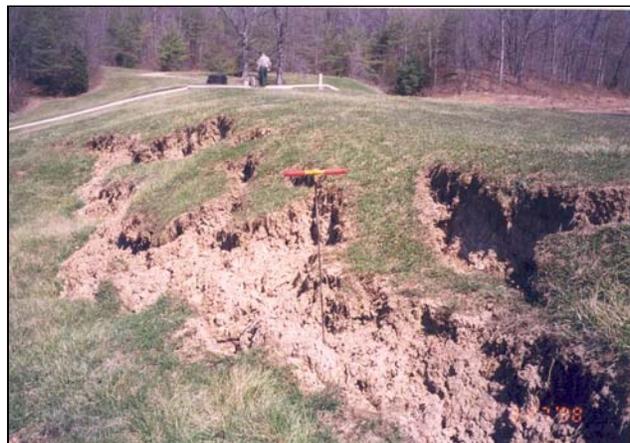
Figure 2-4 Photographic documentation of embankment slide.

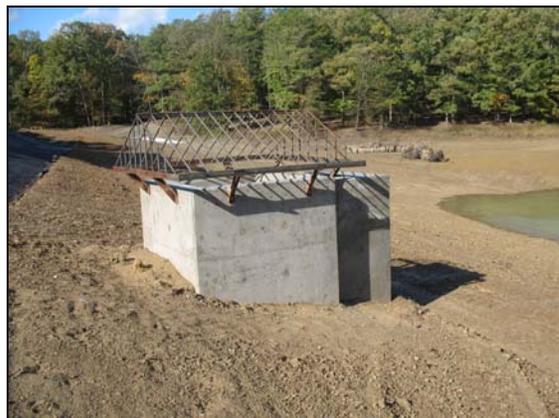
Figure 3-6 Construction photograph of spillway and embankment rehab.

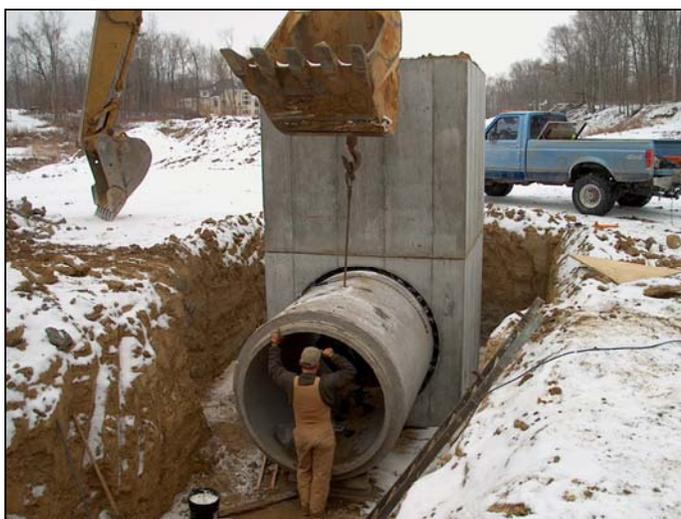
Figure 3-7 Installation of a riser pipe during winter weather.

understand an observed condition. [Figure 3-7](#) shows a dam's riser structure being installed during cold weather conditions. Troubleshooting potential future seepage problems along the discharge pipe may be aided if such photographs are available in the dam owner's project files.

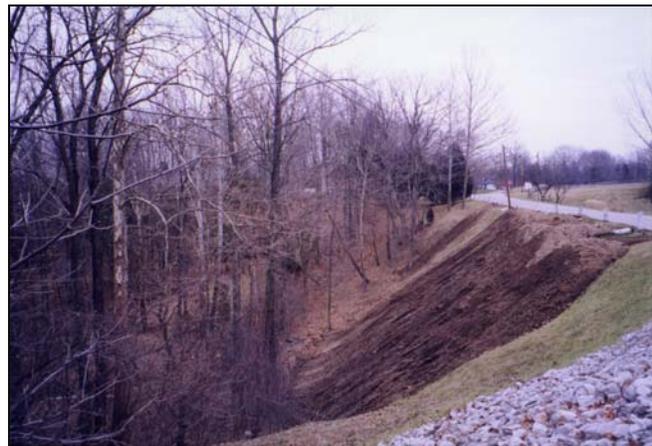
Figure 3-8 Loose fill inappropriately added to embankment slope.

Alterations or modifications may occur to a dam at any time after construction is completed. In some cases, an older structure such as a wood crib dam may have been reconstructed by adding earthfill or concrete, completely covering the original dam. Additional soil fill may have been placed on embankment dams to reduce the slopes or to repair defects such as settlement or erosion. Spillways may have been replaced or upgraded if the original structures were deteriorating or damaged. The design and construction

records of these subsequent changes, and whether they followed applicable agency requirements, should be reviewed, if available. Dam owners should beware of performing un-designed and un-permitted modifications to their structures. Such modifications can subject the owner to potential legal and liability issues, and could result in regulatory fines, damage payments to downstream property owners, or prison when lives are lost if the dam fails as a result of the modifications. The inspector should note any unapproved modifications in the inspection report or the Suggested Dam Inspection Report.

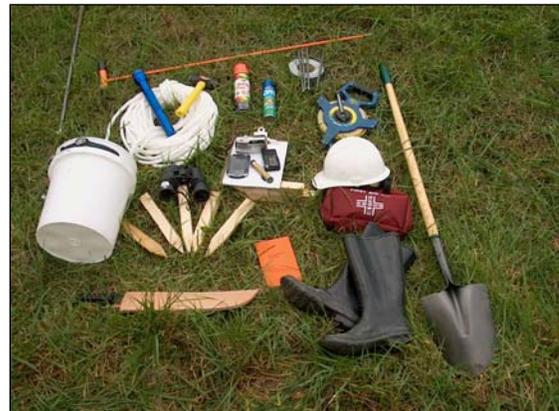
Figure 3-9 A typical inspection field kit.

A wide range of equipment may be required by the team to satisfactorily perform the safety inspection. The equipment needs depend on many parameters such as weather conditions, type of dam, complexity of design, condition of the dam, instrumentation, and purpose of the inspection. Below is a listing of general equipment, specialized equipment, and safety equipment and protective clothing which may be useful to the inspection team.

Equipment should be maintained properly and stored securely when not in use. Instruments should be adjusted properly, inspected often, and calibrated regularly. Misplaced or damaged equipment can reduce the effectiveness of or even alter the outcome of the inspection. Personal equipment items include clipboards, field notebooks, pencils, pocket rulers, proper clothing, and pocket knives. Also, a reduced copy of the drawings for the dam being inspected is a convenient means to have design data readily available during the inspection.

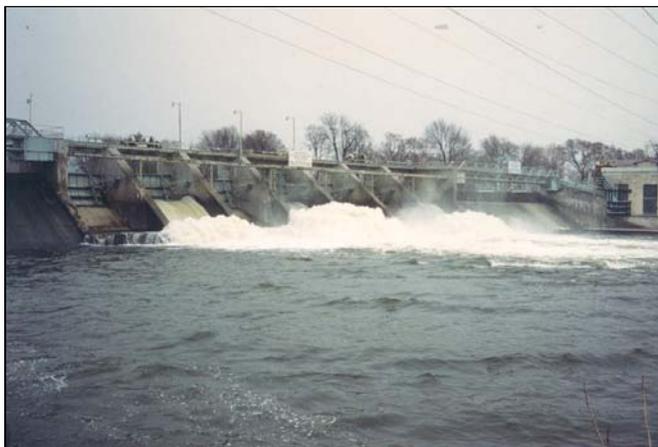
Figure 4-8 Dam with significant concrete spillway structures.

Although concrete dams comprise less than 1% of the total number of dams within the state, they are potentially more dangerous than embankment dams. Some embankment dams have significant concrete structures (composite dams), making inspection of them similar to inspection of both concrete and embankment dams. Basic procedures for inspection of a concrete dam are similar to those of embankment dams, except that the

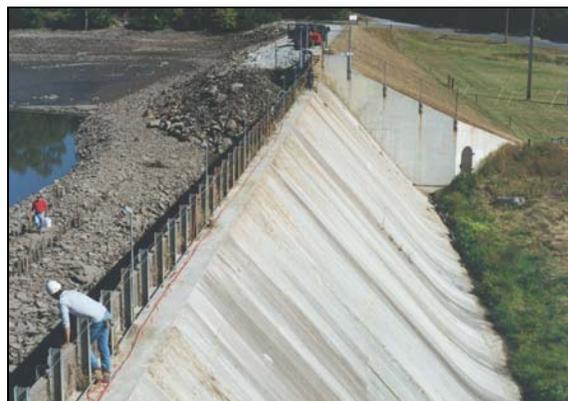
Figure 4-9 Dam requiring extensive concrete inspection.

crest and faces of the dam may be very difficult to access. Therefore, inspector access and safety should be a primary concern on concrete dams. The faces of concrete dams are often near vertical, and the upstream slope is usually damp and slippery. Access to the downstream face, toe area, and abutments may be difficult and require special safety equipment such as safety ropes, or a boatswain's chair. Close inspection of the

upstream face may also require a boatswain's chair or a boat. Without this equipment, inspection of all surfaces of the dam and abutments may not be possible. Another method of inspection that may be used consists of videotaping the dam faces from a safe point using a high power magnification on the camera. The inspector can zoom in on the surface areas and get a close up view and recording of the dam. The inspector should start filming at a discernable point, such as the top or toe of the dam face at the point of contact with the abutment. The

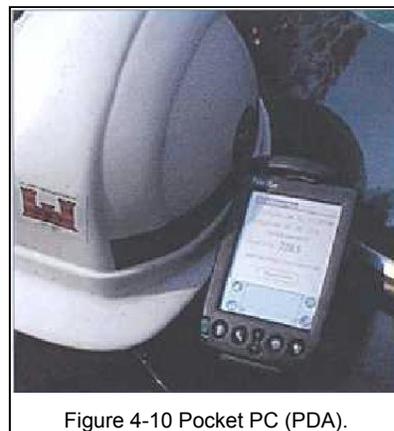
Figure 4-10 Pocket PC (PDA).

Pocket PC's and Laptop Computers – Pocket PC's (also referred to as "PDA's") and laptop computers are convenient tools for entering field inspection data in reports being prepared in the office. While laptop or notebook computers have

traditionally been used for data collection, advances in Pocket PC's make them an excellent choice for the field. Pocket PC's have a variety of peripherals available and can operate for weeks between charging or battery replacement. One of the biggest advantages and potential for Pocket PC's lies in their capabilities for customization. Inspection checklist software has been developed as part of the Dam Safety Program Management Tools (DSPMT). Plug-in software applications are available for a variety of dam specific inspection checklists, including Fill Dams, Concrete Dams, Spillways, Powerhouses, Instrumentation, etc. Using a Standard ACCESS database interface, users can easily configure the Pocket PC-based application to only present the inspection checklists utilized by the user's organization. Inspection checklist reports can be beamed directly to an IR-enabled printer; synchronized with Outlook Notes and edited in Word, or synchronized with the DSPMT Desktop. The Pocket PC's must be synchronized with a desktop system to incorporate the inspection data into a compatible inspection report.

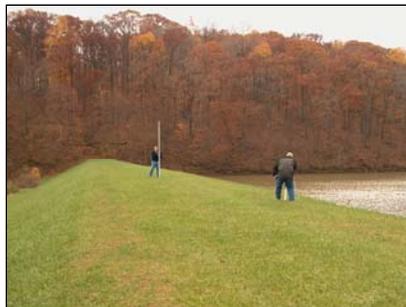
Figure 4-12 Picture with shutter speed controlled by the treeline.

One other factor that should be taken into consideration when choosing camera position is the quality of available light. Poor lighting obviously will result in poor pictures. Choose the camera position so as to make the most of angle and lighting. Also, watch out for shadows that will block out important details or sun in the camera lens. Figure 4-12 shows an example of picture quality when an automatic digital camera shutter speed is controlled by including the trees in the background rather than the sky; the result is a brighter picture. Figure 4-13 shows a photograph of the same scene at about the same time, but with more of the sky included in the background; the result is a shutter speed adjustment based on the sky. A darker picture is the result.

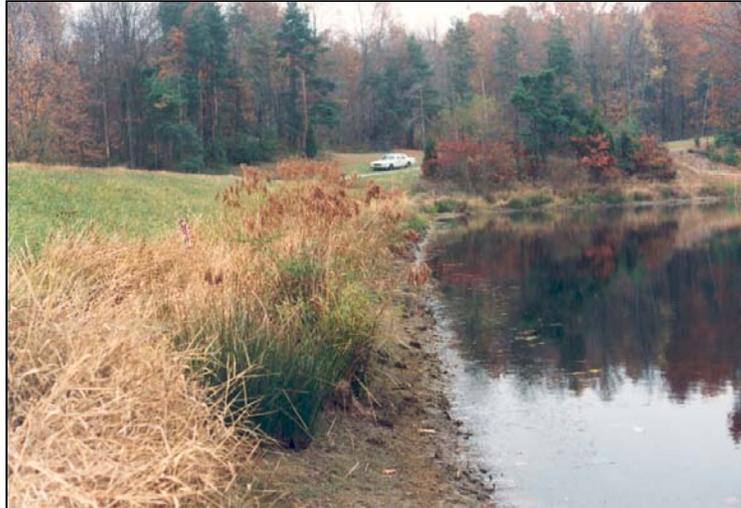
The upstream slope needs a thorough visual inspection, since the slope protection, vegetation, debris, and reservoir water can hide problems. Anytime the reservoir is emptied, the slope should be thoroughly inspected for settlement areas, animal burrows, sinkholes, or slides. Also, the reservoir basin (bottom of the reservoir) should be inspected for sink holes or settlement anytime the reservoir is emptied.

Figure 5-2 Embankment slope inspection can be hindered with excessive vegetation.

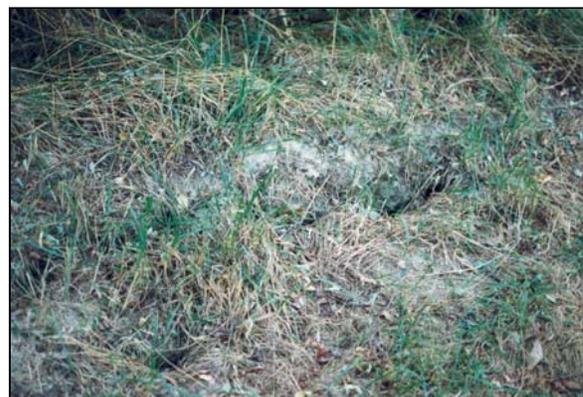
Figure 5-3 Longitudinal cracks on embankment slope.

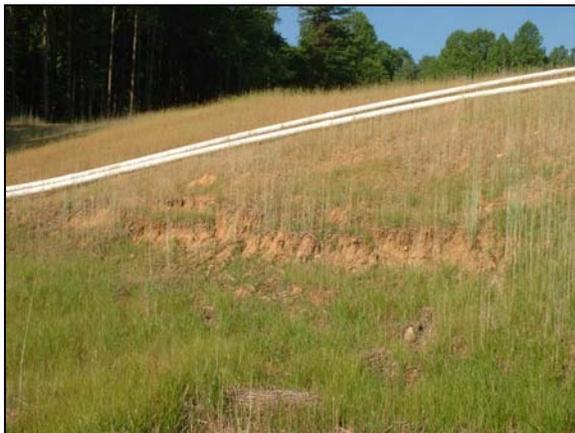
Figure 5-11 Shallow slide at toe of embankment resulting from excessive seepage and poor compaction.

slides may be difficult to spot if a scarp has not developed. Their appearance may be subtle, since there may be very little settlement or bulging out from the normal slope. A good familiarity with how the slope looked at the end of construction will help identify any new slides. Figures 5-11 and 5-14 illustrate slides on the downstream slope, with vertical and horizontal movement and the formation of a scarp.

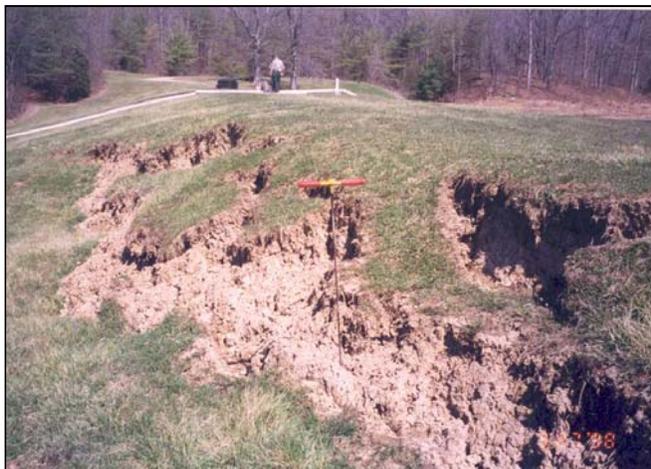
Figure 5-14 Large slide on embankment with prominent scarp.

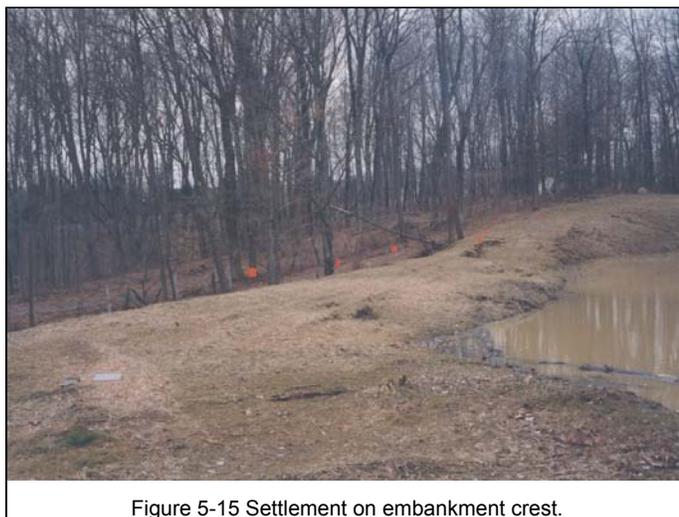
Figure 5-15 Settlement on embankment crest.

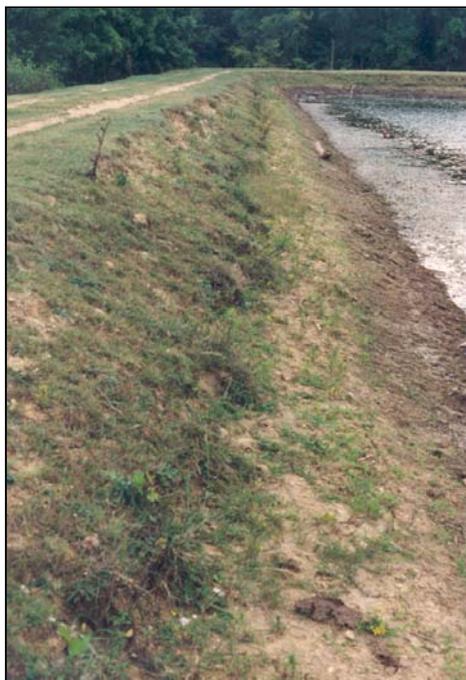
provides excellent protection against erosion caused by rainfall and runoff. Deep-rooted grass that can tolerate repeated wetting and drying cycles should be used on embankments. Figure 5-19 shows an embankment experiencing shoreline erosion as a result of inadequate slope protection. The shoreline has no riprap and insufficient vegetative cover.

Figure 5-19 Inadequate slope protection resulting in shoreline erosion.

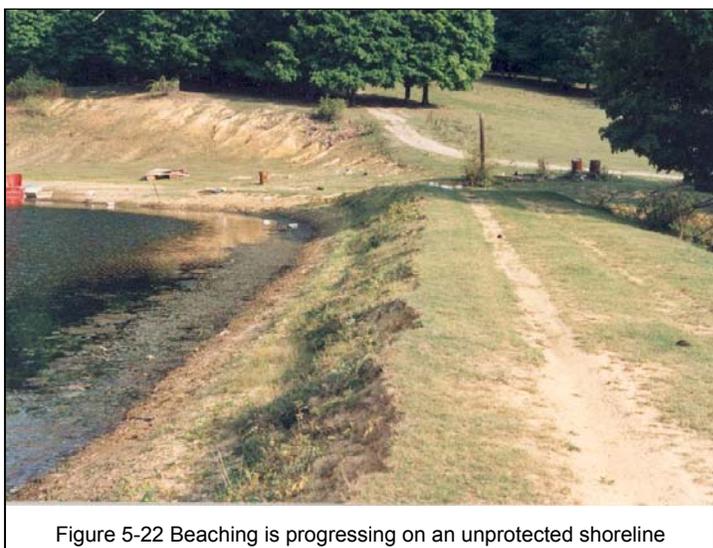
Beaching is the removal of a portion or portions of the upstream slope of the embankment by wave action. Figures 5-21 and 5-22 show the effects of erosion and beaching on the upstream slope of a dam. When beaching occurs, embankment material is deposited farther down the slope. In this extreme form of erosion, the slope protection (i.e., riprap or vegetative cover) and underlying material are removed. A relatively flat beach area with a steep back slope, or scarp, is formed. Scarps should be monitored regularly for additional deterioration and repaired if conditions get worse.

Severe beaching could lessen the width, and possibly height of the embankment, leading to increased seepage, instability, or overtopping of the dam. Riprap installations in areas exposed to numerous freeze-thaw cycles or high winds are most likely to experience problems. The inspector should be alert for riprap problems if the dam is exposed to these conditions.

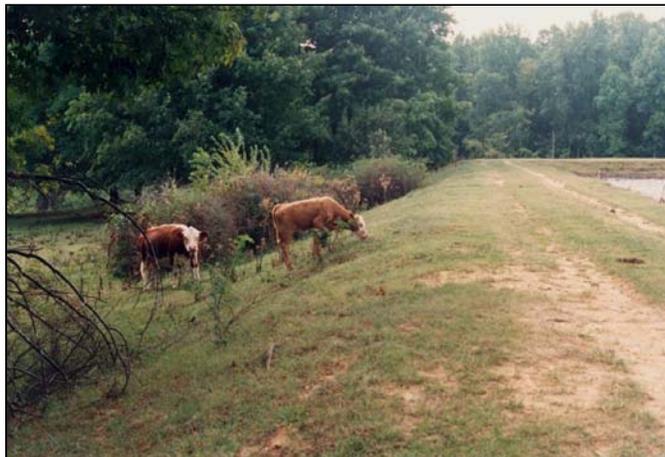
Figure 5-23 Cattle grazing on a dam embankment can lead to erosion problems.

There are a number of special circumstances that can contribute to or initiate surface erosion of the crest and downstream slope. In some areas, livestock may establish trails on the embankment. Livestock traffic can damage the slope's vegetative cover. Recreational vehicles can cause ruts in the crest and can damage the slope protection. The inspector should be aware of any unique problems that may be common in a particular location or past problems that were noted on previous dam inspections.

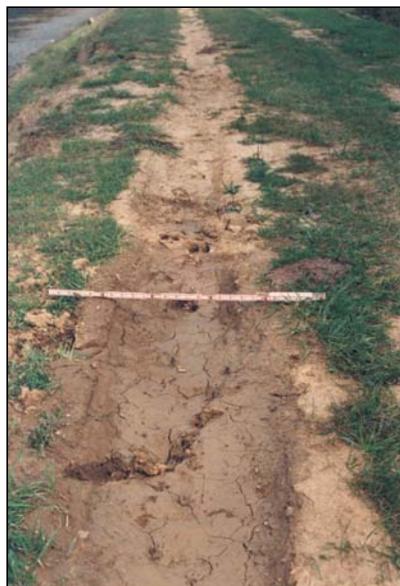
Figure 5-24 Vehicle traffic can kill vegetation and result in erosion.

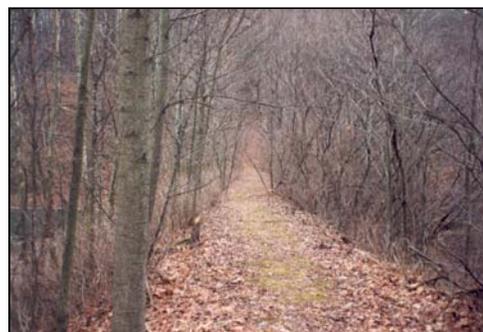
Figure 5-25 Trees and brush on an embankment pose a stability risk and can impede visual inspection.

Although a healthy cover of grass is desirable as slope protection, the growth of deep-rooted vegetation, such as large shrubs and trees, is undesirable. Large trees could be blown over and uprooted during a storm. The resulting cavity left by the root system could reduce the embankment top elevation, breach the dam or shorten the seepage path and initiate piping. Accelerated soil erosion will also develop in the cavity left by an uprooted tree due to the exposed soil surfaces. The cavity left by the uprooting of a tree should be repaired immediately. The method of cavity repair will depend on the size of the tree and the location of the tree on the embankment.

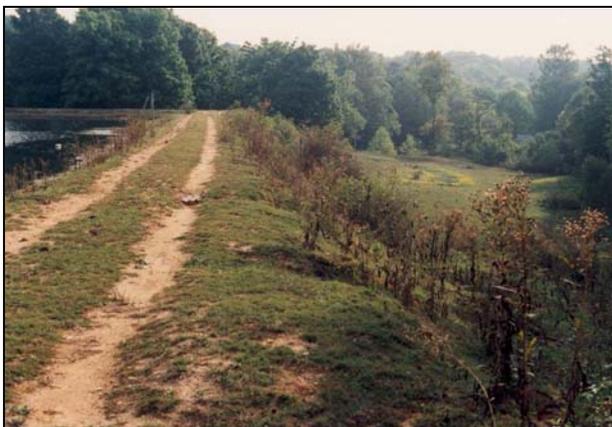
Figure 5-26 Insufficient vegetation on embankment crest and slopes will result in accelerated erosion.

Insufficient vegetation on the embankment slopes can progress to serious problems if left uncorrected for extended periods of time. These conditions should be recorded during a visual inspection along with recommendations for corrective action. The recommendations should also include a proposed timeframe for completing the repairs.

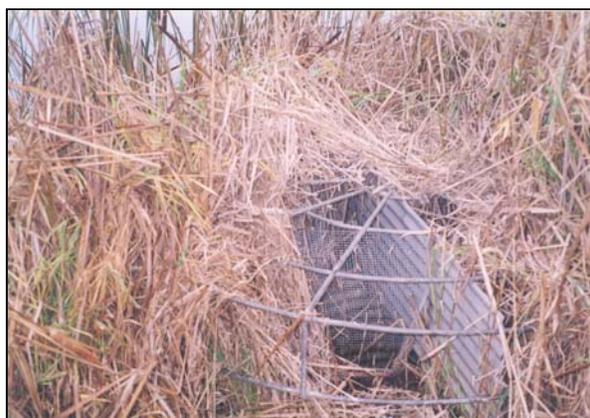
Figure 5-27 Excessive vegetation around this riser and trash rack makes visual inspection almost impossible.

Excessive vegetation is a problem wherever it occurs on an embankment dam. Excessive vegetation can obscure large portions of the dam, preventing adequate visual inspection. Problems that threaten the integrity of the dam can develop and remain undetected if they are obscured by vegetation. Excessive vegetation can also prevent access to the dam and surrounding areas. Limited access is an obvious problem both for visual inspection and maintenance, and especially during emergency situations, when access is crucial. Excessive vegetation can provide a habitat for

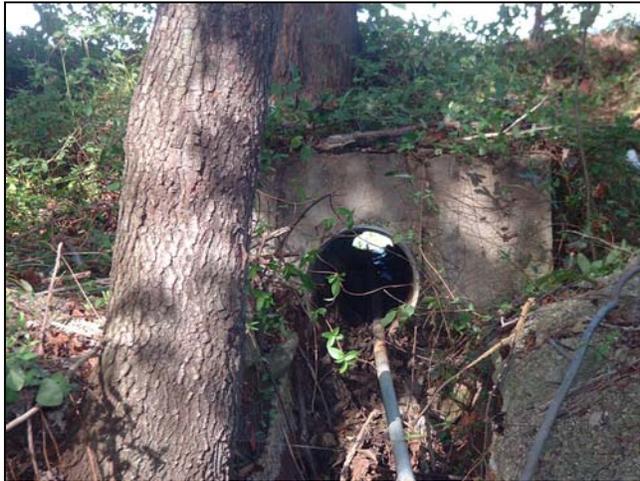
Figure 5-28 A tree is growing over the top of this spillway conduit.

structures. When the vegetation dies, the decaying root system can provide paths for seepage and cause piping to occur. Even healthy root systems of large vegetation can pose a threat by providing seepage paths. These seepage paths eventually can lead to internal erosion and threaten the integrity of the embankment. Generally, trees and shrubs more than 2 feet in height are undesirable growing on or adjacent to embankment dams. The best approach to trees on the crest, slopes, and adjacent to the dam is to cut them down or pull them out before they reach significant size. When

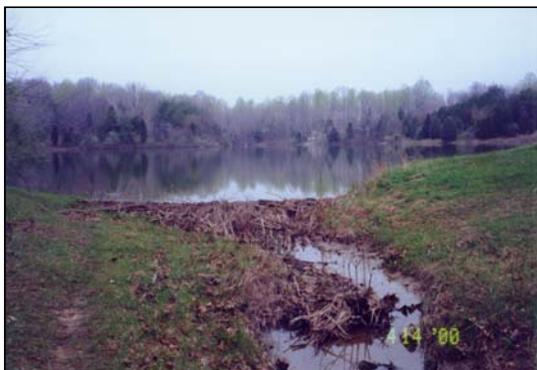
Figure 5-30 A beaver has blocked the spillway on this dam.

Beaver will try to plug spillways with their cuttings. Typical signs of beaver at a dam are tooth-marked trees and stumps. Routinely removing the cuttings is one way to alleviate the problem. Another successful remedy is the placement of electrically charged wire or wires around the spillway inlet. Trapping beaver may be done by the owner during the appropriate season.

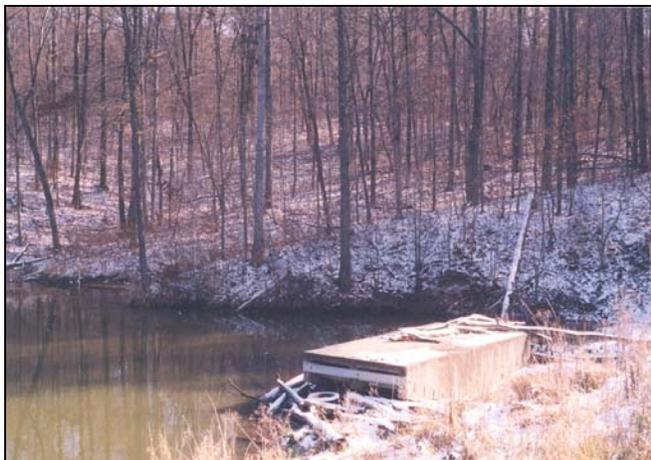
Figure 5-29 Excessive debris around the riser trash rack can reduce discharge capacity and increase water levels.

Debris can clog or block spillway and outlet systems, resulting in potential dam overtopping hazards. Woody debris can become waterlogged and sink, possibly blocking an outlet works, inlet, or spillway inlets. Floating debris can also clog trash racks on spillways with riser conduits. The blocking of these inlet structures can cause overtopping of the dam in the event of a flood.

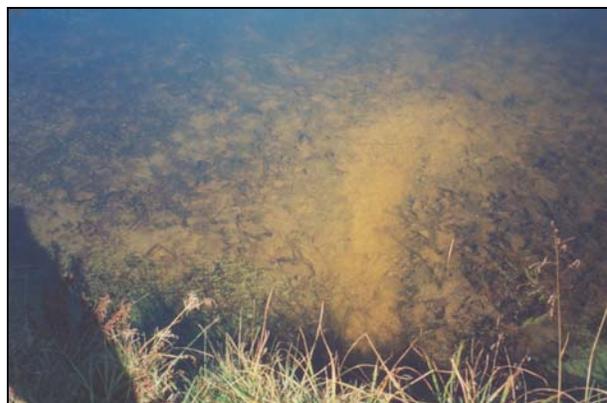
Figure 5-31 Telltale signs of a muskrat burrow.

The muskrat is a stocky rodent with a broad head, short legs, small eyes, and rich dark brown fur. Muskrats are chiefly nocturnal. Muskrats can be found wherever there are marshes, swamps, ponds, lakes, and streams having calm or very slowly moving water with vegetation in the water and along the banks. Muskrats make their homes by burrowing into the banks of lakes and streams or by building "houses" of rushes and other plants. Their burrows begin from 6 to 18 inches below the water surface and penetrate the embankment on an upward slant. At distances up to 15 feet from the entrance, a dry chamber is hollowed out above the water level. Once a muskrat den is occupied, a rise in the water level will cause the muskrat to dig farther and higher to excavate a new dry chamber. Damage (and the potential for problems) is compounded where groundhogs or other burrowing animals construct their dens in the embankment opposite muskrat dens.

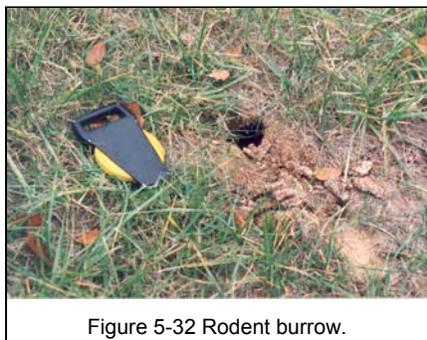
Figure 5-32 Rodent burrow.

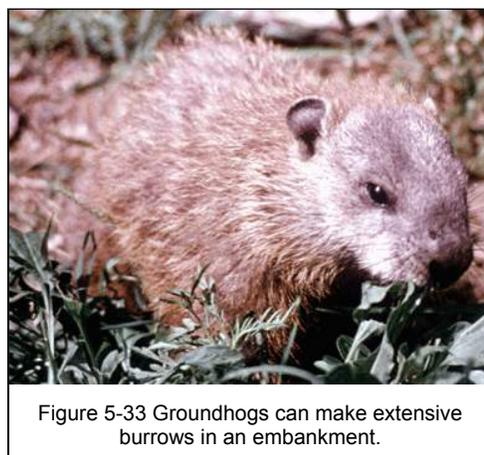
Figure 5-33 Groundhogs can make extensive burrows in an embankment.

The groundhog is the largest member of the squirrel family. Occupied groundhog burrows are easily recognized in the spring due to the groundhog's habit of keeping them "cleaned out." Fresh dirt is generally found at the mouth of active burrows. Half-round mounds, paths leading from the den to nearby fields, and clawed or girdled trees and shrubs also help identify inhabited burrows and dens. When burrowing into an embankment, groundhogs stay above the phreatic surface (upper surface of seepage or saturation) to stay dry. The groundhog usually burrows into the embankment from the downstream slope; the burrow is rarely a single tunnel. It is usually forked, with more than one entrance and with several side passages or rooms from 1 to 12 feet long. Groundhogs can be controlled by using fumigants or by removal from the site. Fumigation is the most practical method of controlling groundhogs. Removal may be preferable around buildings or other high fire hazard areas. Groundhogs will be discouraged from inhabiting the embankment if the vegetal cover is kept mowed.

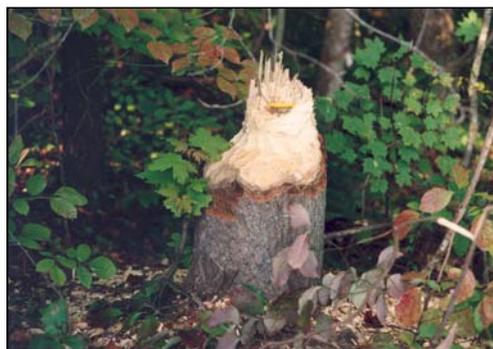
Figure 5-34 Telltale signs of a beaver.

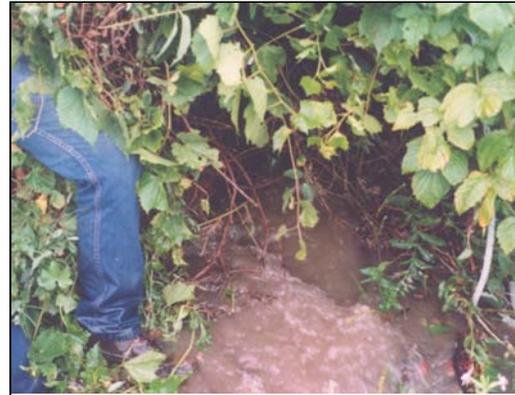
Figure 5-37 Piping through the foundation; notice the turbid discharge.

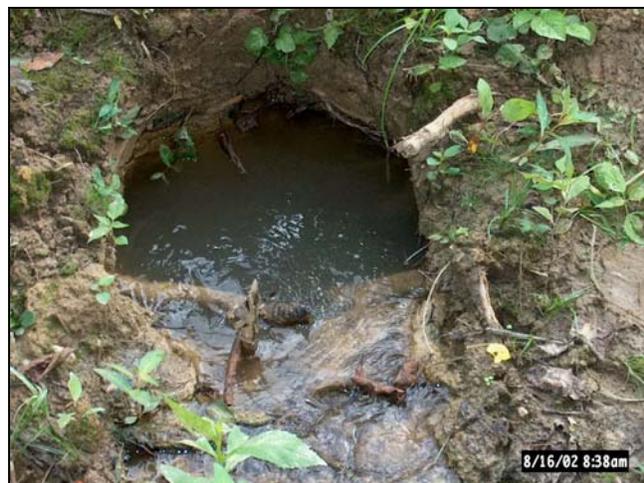
Figure 5-40 Piping with clear discharge may indicate that no additional soil is being removed from the foundation.

It can be difficult to determine the source of seepage, since the exit may be the only visible condition observed. The seepage pipe shown in Figure 5-40 was observed a few feet below the toe of an earth embankment, and it was not clear whether the water was flowing through the embankment or under it.

No sand or other soil was being carried by the seeping water, and the reservoir level was slowly getting lower, so the pipe was probably already formed. Seepage may originate in the bottom of the reservoir, upstream of the embankment, and travel through porous soil strata in the foundation of the dam.

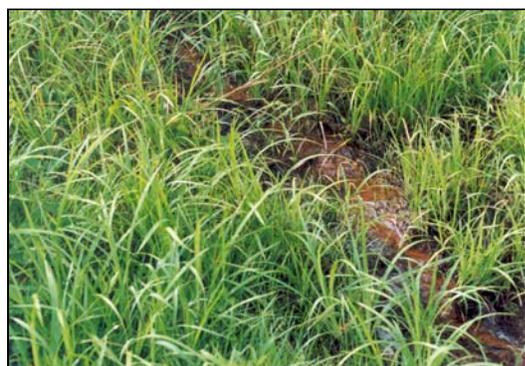
Figure 5-41 This seepage has produced iron oxide stains.

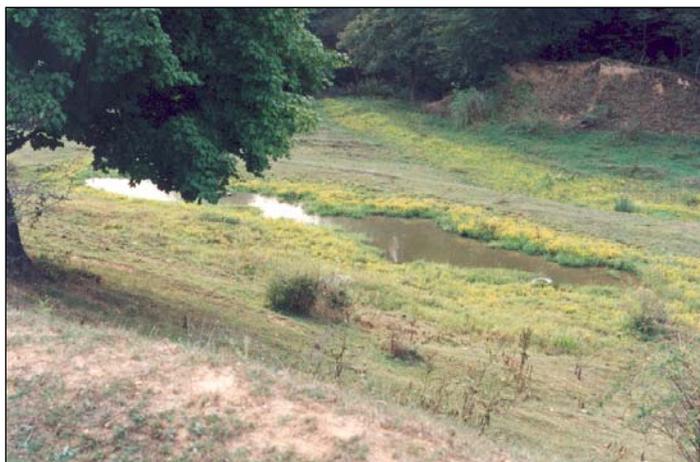
Figure 5-42 Excessive seepage near embankment toe.

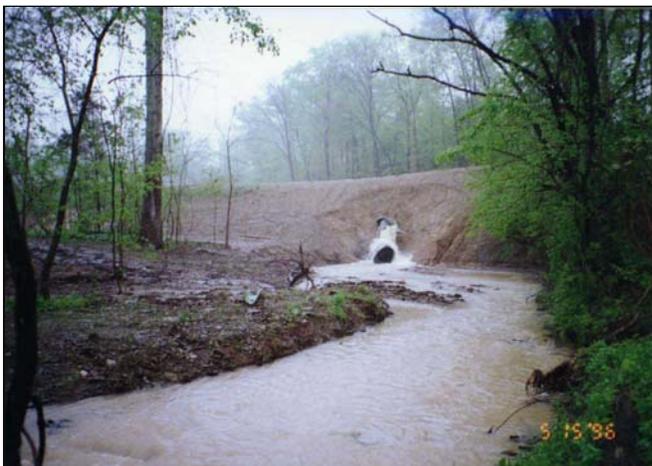
Figure 5-43 Seepage along the spillway in this dam has resulted in piping and a serious leak.

under pressure into the embankment. Rapid erosion and an eventual breaching of the dam can result from seepage around conduits. [Figure 5-43](#) shows serious piping along a spillway conduit. This type of seepage is excessive and will continue to erode the soils around the conduit.

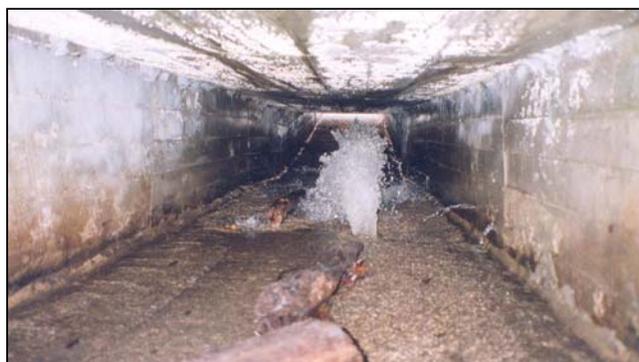
Figure 5-44 Seepage under this spillway conduit has caused piping, allowing a significant leak through conduit deficiencies.

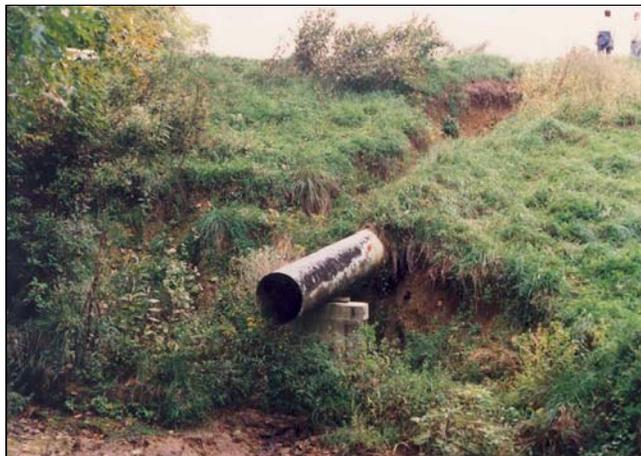
Figure 5-45 Seepage along this spillway conduit has caused piping, sinkholes, and eventual erosion of all the soil over the conduit.

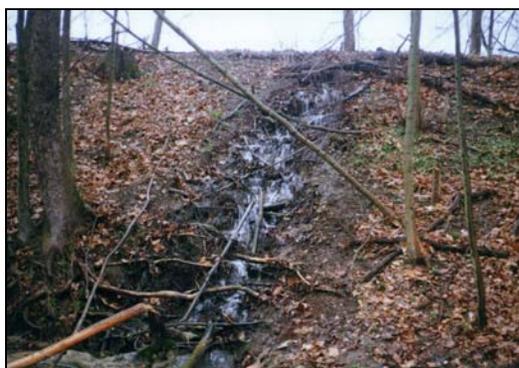
Figure 5-46 Seepage caused by tree roots through the embankment.

Seepage can be caused by deep-rooted vegetation on embankments, such as trees. Tree roots can penetrate the embankment and create passageways for water. Seepage along root systems will usually start off at a very slow rate and get progressively greater with time. This is another example of the importance of early detection of seeps. As discussed earlier in this chapter, uprooted trees can also cause seepage problems.

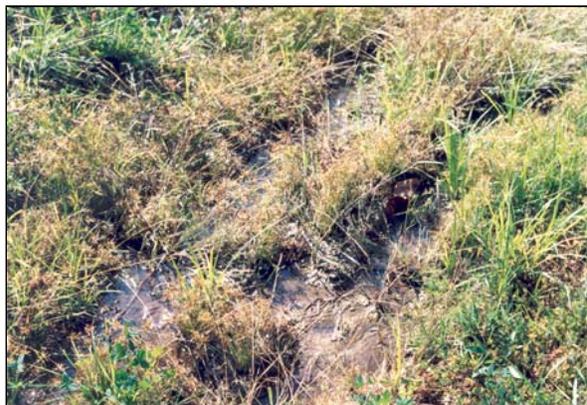
Figure 5-47 Typical photograph of seepage accumulating in low areas.

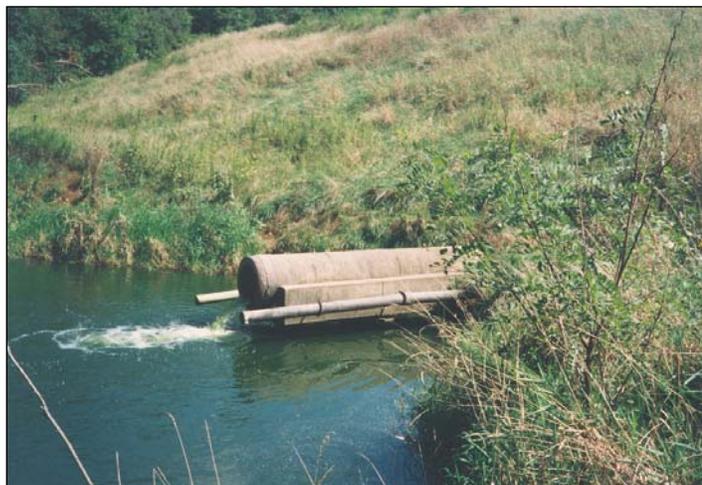
Figure 5-48 Collector pipes (beside spillway conduit) can be used to help monitor seepage through the embankment.

Many **toe drains** have collector pipes that discharge the embankment and foundation seepage at accessible locations. Before conducting a visual inspection of an embankment dam that has toe drains, the inspector should review the site plan to determine the location of the toe drains and outfalls. Previous data on both the reservoir level and flow rate from the drain(s) should be reviewed. Data on drain flow must be looked at in conjunction with reservoir-level data. Correlating the reservoir level with the drain flow can help to determine if there is a problem. If a drain flow is observed that is atypical for the given reservoir level, more investigation is essential.

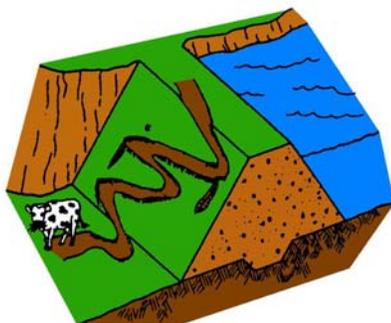
LIVESTOCK/CATTLE TRAFFIC

Excessive travel by livestock especially harmful to slope when wet.

Creates areas bare of erosion protection and causes erosion channels. Allows water to stand. Area susceptible to drying cracks.

1. Fence livestock outside embankment area.
2. Repair erosion protection, i.e., riprap, grass.

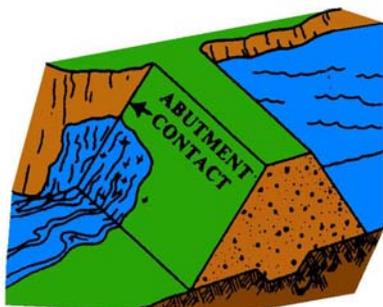
SEEPAGE EXITING AT ABUTMENT CONTACT

1. Water flowing through pathways in the abutment.
2. Water flowing through the embankment.

Can lead to erosion of embankment materials and failure of the dam.

1. Investigate leakage area to determine quantity of flow and extent of saturation.
2. Inspect daily for developing slides.
3. Water level in reservoir may need to be lowered to assure the safety of the embankment.
4. A qualified engineer should inspect the conditions and recommend further actions to be taken.

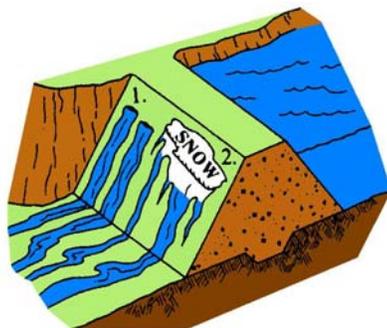
LARGE AREA SATURATED FROM ABOVE

1. Water flowing through the embankment.
2. Snowdrifts melting slowly during mild spring temperatures.

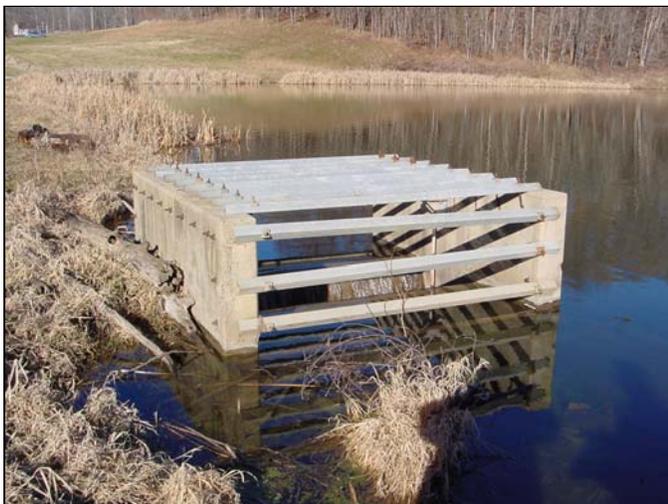
Figure 6-1 Principal spillway utilizing a riser as the control; this is the most common type of spillway in Indiana. The riser has a trash rack over the top constructed with concrete and steel bars.

The spillway system consists of the structures over or through which base inflows and flood flows are safely discharged. If the flow is controlled by gates, it is a **controlled spillway**; if the elevation of the spillway crest is the only control, it is an **uncontrolled spillway**. Uncontrolled spillways are the most commonly used type in Indiana. Figure 6-1 shows an uncontrolled spillway; the control section is the crest of a riser pipe.

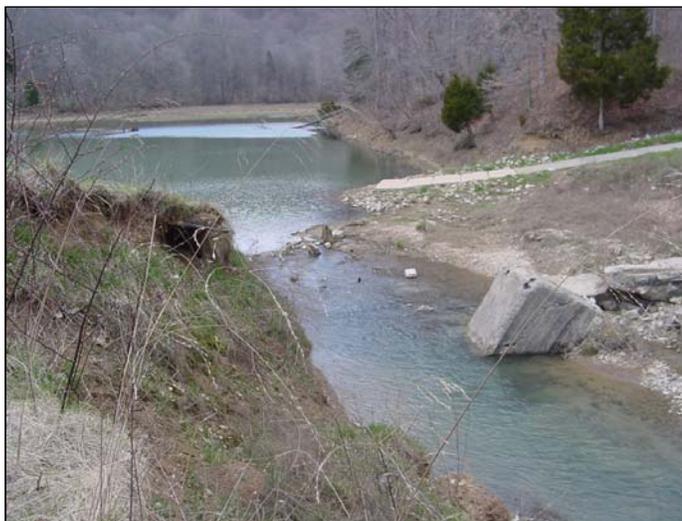
Figure 6-5 This dam's open channel spillway used a concrete control section; note that it failed and was almost totally washed away.

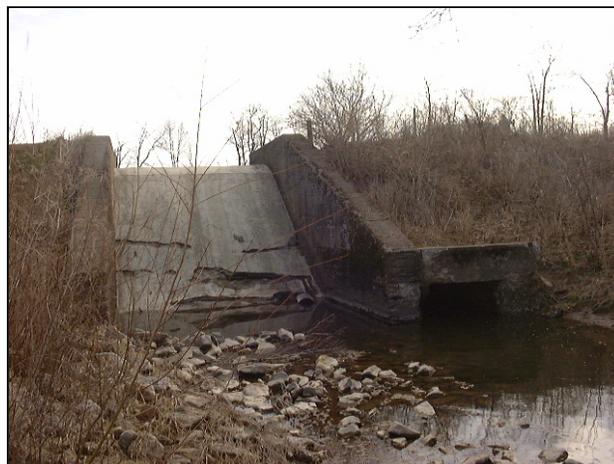
Figure 6-7 Concrete spillway showing extensive cracking and general deterioration, most likely a result of freeze-thaw effects.

Cracks are commonly encountered defects for concrete spillways; cracks are less common in outlets, although they still occur. Cracks may be caused by foundation problems, water pressure, concrete expansion, freeze-thaw effects, poor concrete mix design, poor construction practices, and chemical reactions. The discussion of cracks in this section applies to both spillways and outlets. The open, concrete spillway in Figure 6-7 has extensive cracking and deterioration and should be repaired immediately.

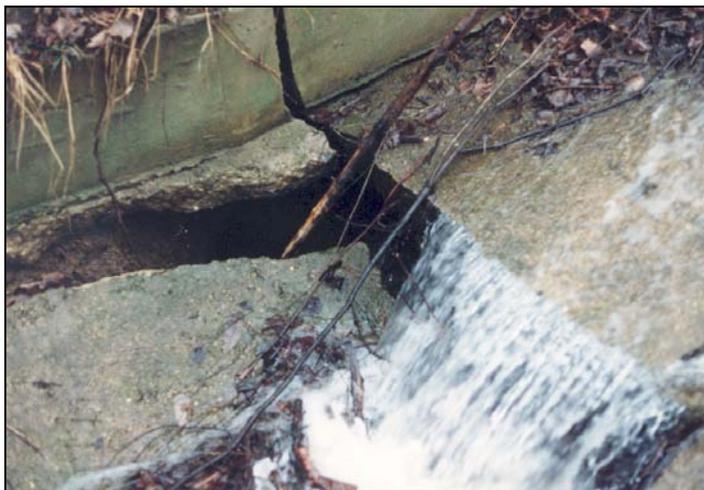
Figure 6-8 Concrete spillway with structure damage.

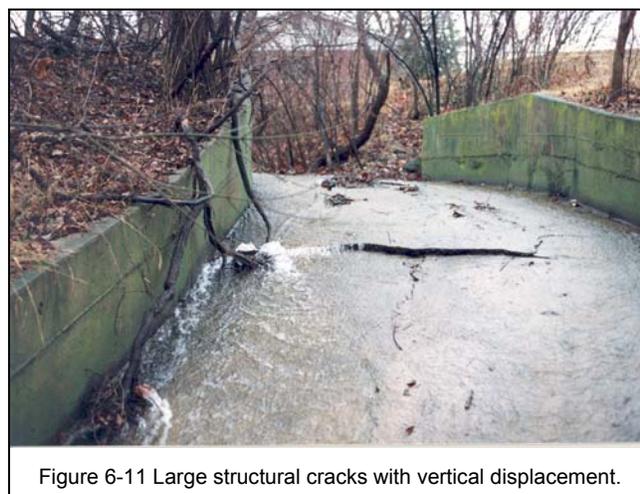
Figure 6-11 Large structural cracks with vertical displacement.

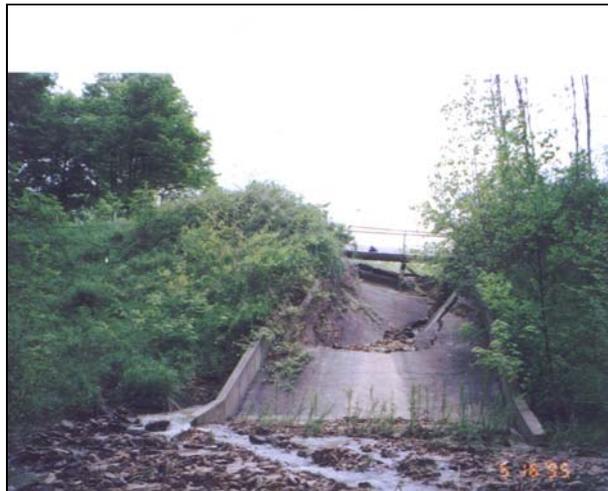
Figure 6-12 Serious structural damage requires replacement of spillway.

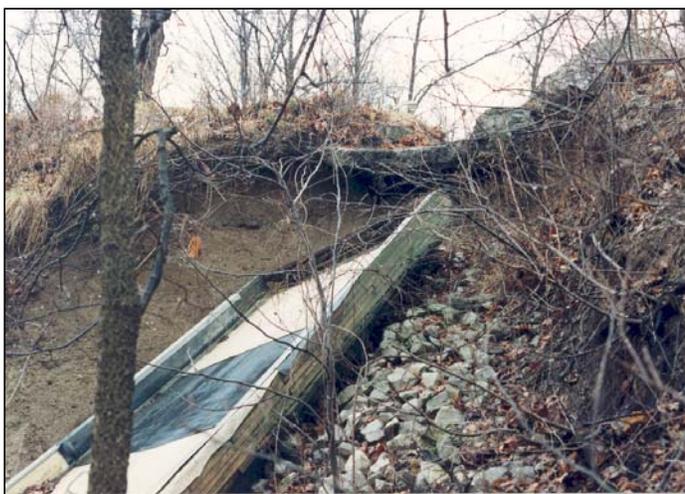
Figure 6-13 This concrete spillway was completely destroyed as a result of foundation erosion.

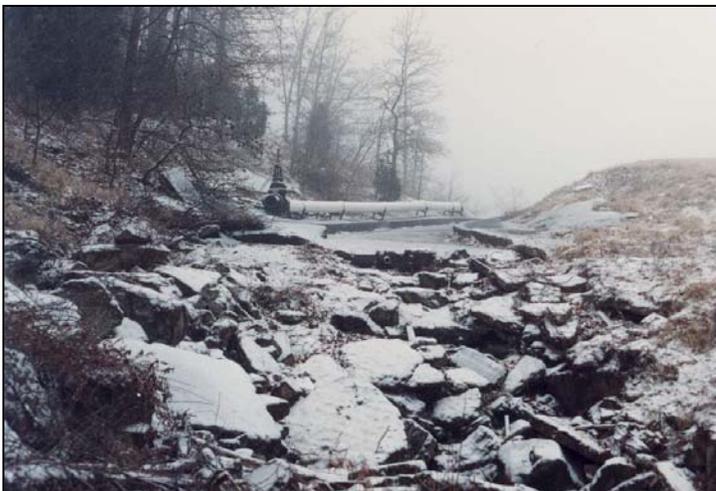
Figure 6-16 Poor spillway lining.

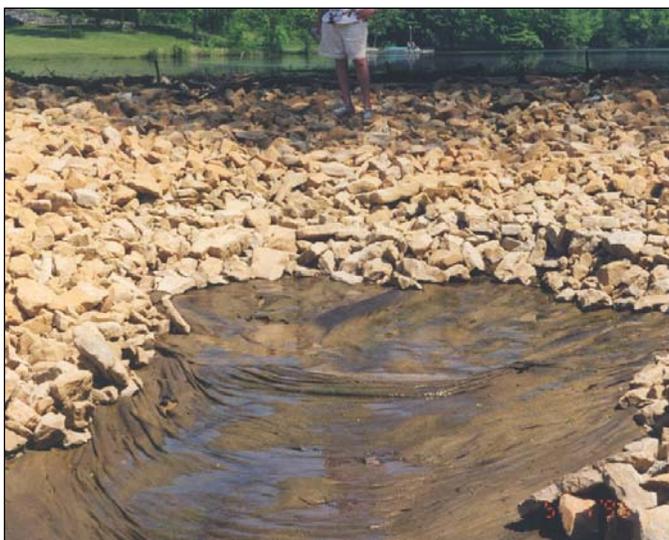
Figure 6-17 Riprap lining was completely washed away during a significant storm event, exposing the geotextile filter.

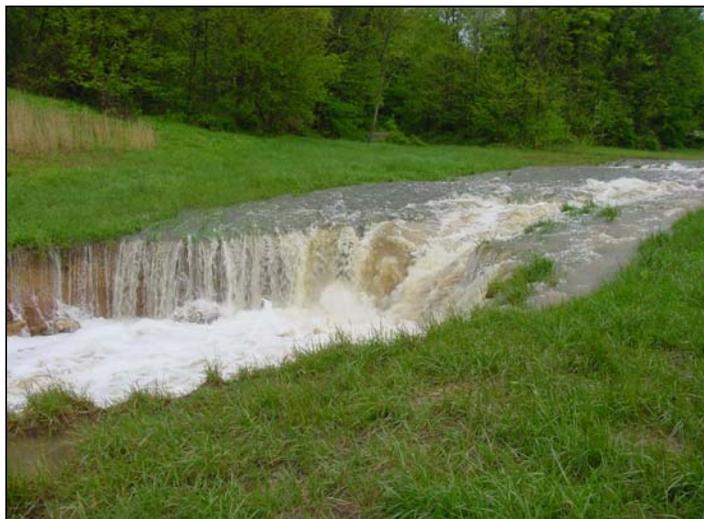
Figure 6-19 Grass lined outlet channel that was not designed for the flows it experienced, resulting in severe erosion.

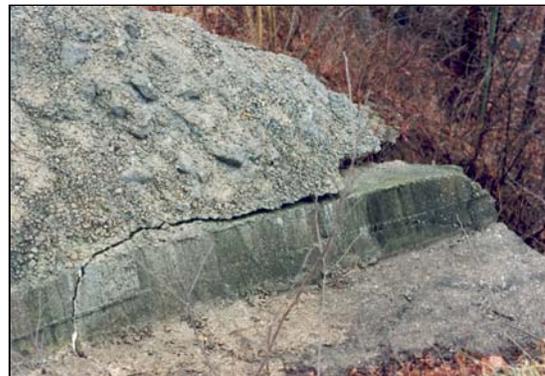
Figure 6-21 General deterioration of a concrete spillway as a result of multiple causes.

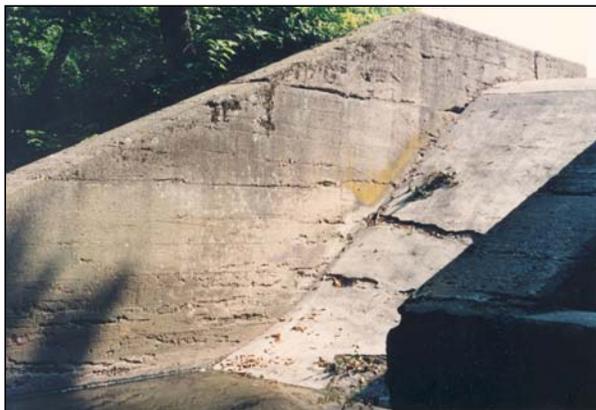
Figure 6-22 Deterioration (cracking and spalling) of a concrete spillway from weathering and freeze-thaw effects.

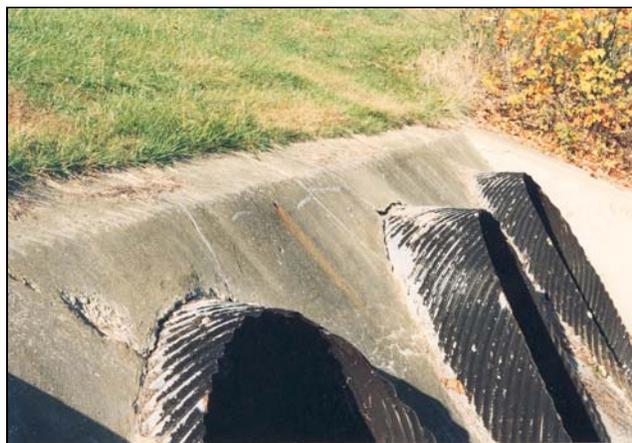
Many times concrete that is cast around corrugated spillway conduits creates problems due to differential expansion and contraction. The two different materials expand and contract at different rates which may result in cracks in the concrete. Another problem

Figure 6-23 Concrete is deteriorating where these metal pipes enter a spillway riser as a result of differential expansion rates.
