INDIANA DAM SAFETY INSPECTION MANUAL

UPDATED 2007

PART 3 DAM SAFETY INSPECTIONS

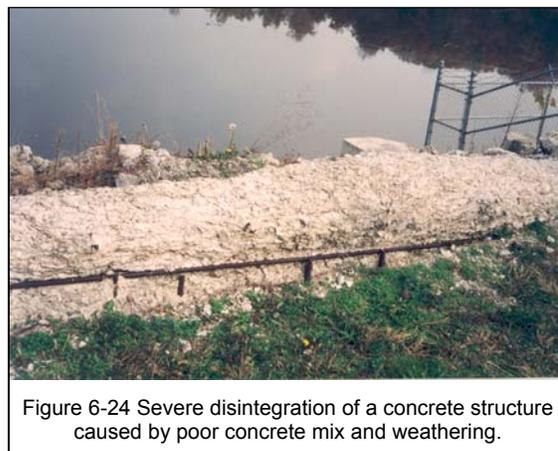
Figure 6-24 Severe disintegration of a concrete structure caused by poor concrete mix and weathering.

Disintegration is the crumbling or deterioration of concrete into small particles. Disintegration may result in possible failure of a concrete element or structure. Disintegration is one of the most serious forms of concrete deterioration. Disintegration can be a result of many causes such as freezing and thawing, chemical attack, and poor construction practices. All exposed concrete is subject to freeze-thaw, but the concrete's resistance to weathering is determined by the concrete mix and the age of the concrete. Concrete with the proper amounts of air, water, and cement, and a properly sized aggregate, will be much more durable. In addition, proper drainage is essential in preventing freeze-thaw damage. When critically saturated concrete (when 90% of the pore space in the concrete is filled with water) is exposed to freezing temperatures, the water in the pore spaces within the concrete freezes and expands, damaging the concrete. Repeated cycles of freezing and thawing will result in surface scaling and can lead to disintegration of the concrete. Hydraulic structures are especially susceptible to freeze-thaw damage since they are more likely to be critically saturated. Older structures (pre-1940) are also more susceptible to freeze-thaw damage since the concrete probably was not air entrained. In addition, acidic substances in the surrounding soil and water can cause disintegration of the concrete surface due to a reaction between the acid and the hydrated cement. The inspector should record visible signs of deterioration and try to determine the cause while at the site.

Large areas of crumbling (rotten) concrete, areas of deterioration which are more than about 3 to 4 inches deep (depending on the wall/slab thickness), and exposed rebar indicate serious concrete deterioration. If not repaired, this type of concrete deterioration may lead to structural instability of the concrete structure. A registered professional engineer should prepare plans and specifications for repair of serious concrete deterioration.

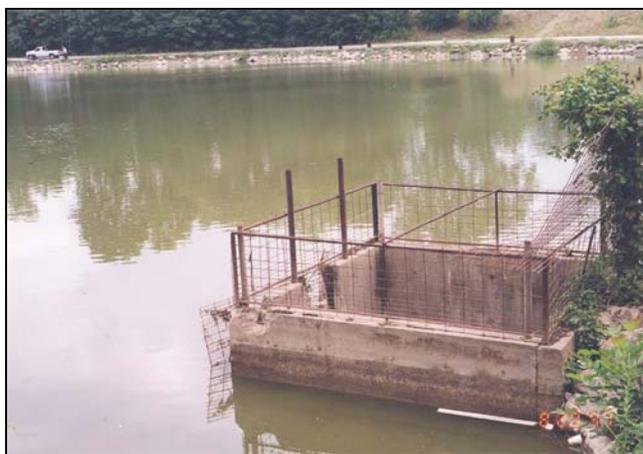
Figure 6-25 Concrete riser is spalling, exposing rebar and experiencing loss of concrete.

Spalling is the loss of larger pieces of concrete (usually flakes or wedge-shaped pieces) from a surface, often at edges, caused by a sudden impact, external pressure, weathering, internal pressure (e.g., corroded rebar near the surface), expansion within the concrete mass, or fires built on or against structures. It often occurs in concrete on exposed surfaces at corners or at joints. Concrete spalling could be the result freeze-thaw action, a repair which has deteriorated, or stresses on a concrete structure which exceed the design. In spillways or outlets, it may be due to the impact of rocks or other debris against the flow surface. Joint spalling is usually due to erosion, weathering and ice damage but can also be due to structure movement. Other causes include reinforcing deterioration, chemical reactivity of aggregates, and vandalism. When observed, the particular structure should be checked for additional deterioration, displacements, and structural damage.

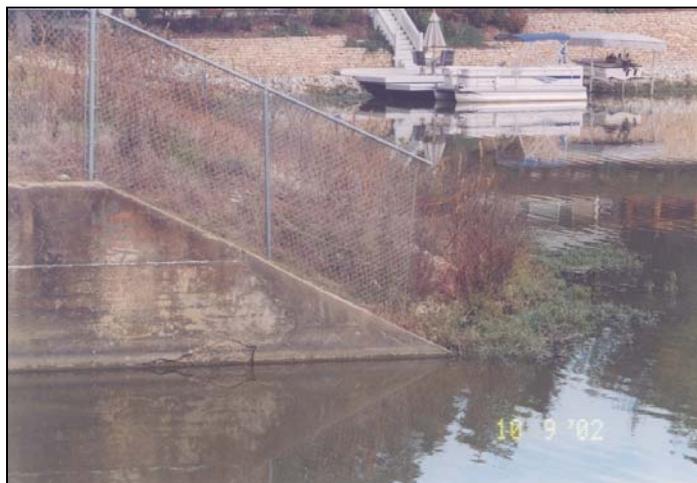
Figure 6-26 Side wall of spillway is spalling.

Spalling usually affects only the surface of the structure, so it is not ordinarily considered dangerous. However, if allowed to continue, spalling will cause structural damage, particularly if the structure is of thin cross section. Spalling often results in exposed reinforcing, leakage paths opened around embedded waterstops at joints, offsets on flow surfaces, and development of points of structural weakness. Repair is necessary when reinforcing becomes exposed

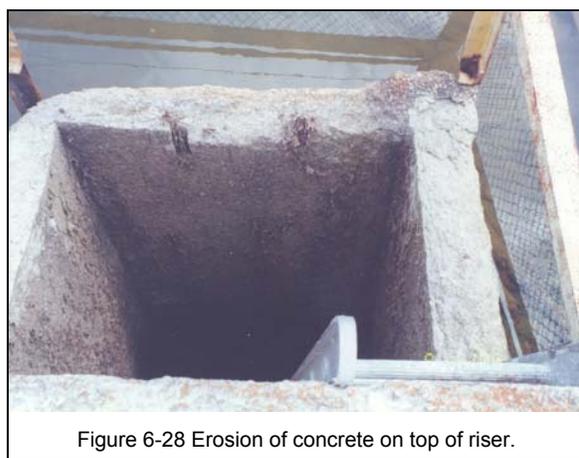
Figure 6-28 Erosion of concrete on top of riser.

Erosion of concrete is caused by fast-moving water containing abrasive material such as sand and gravel, debris, and ice. Ballmilling is a form of erosion which is the grinding away of a surface, usually in a circular pattern, especially in stilling basins. Erosion results in the wearing away of softer aggregates, or of the matrix material around the aggregates. The inspector should also look for abrasion erosion at points of abrupt change in flow channels or at corners, and the loss of concrete from the surface. Erosion in its worst form may result in severe destruction of concrete.

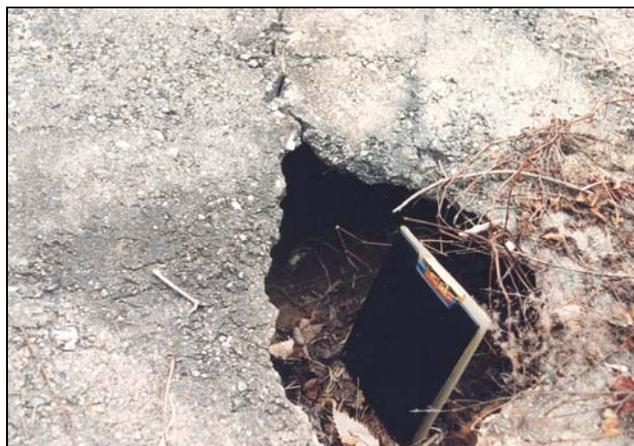
Figure 6-29 Erosion of foundation soil caused this concrete section to fail.

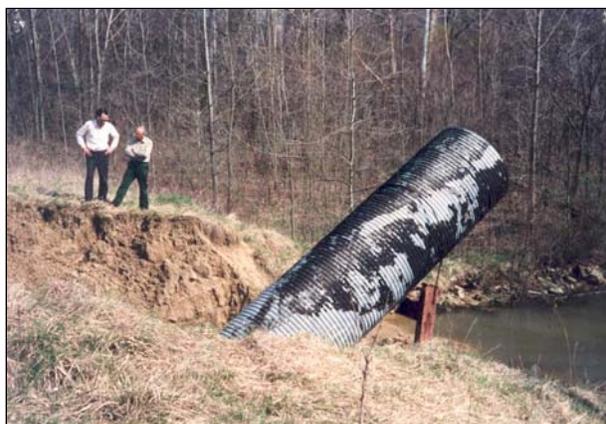
Figure 6-30 Soil erosion under this metal spillway caused the outlet end to settle, resulting in the inlet end tilting upward.

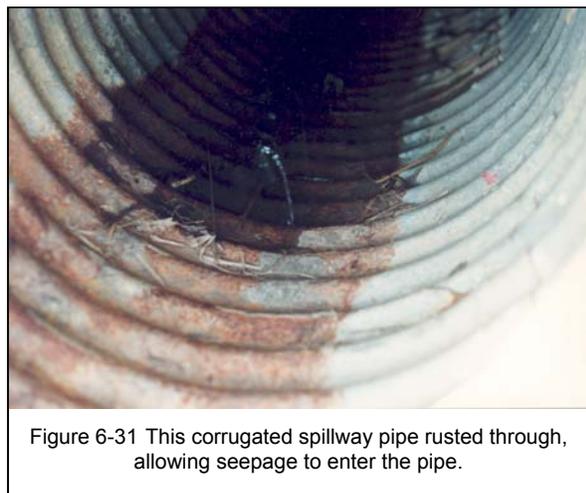
Figure 6-31 This corrugated spillway pipe rusted through, allowing seepage to enter the pipe.

Corrugated metal pipes that are used as spillway structures can have other serious problems besides corrosion. These problems are usually associated with installation practices, and include foundation or backfill erosion, and pipe buckling and crushing. These problems are usually caused by poor compaction in the haunching zone, poor compaction of backfill material beside and over the pipe, and heavy equipment traffic over the pipe. Because of these problems, corrugated metal pipes are not recommended for initial placement, upgrades, or replacements in any dam.

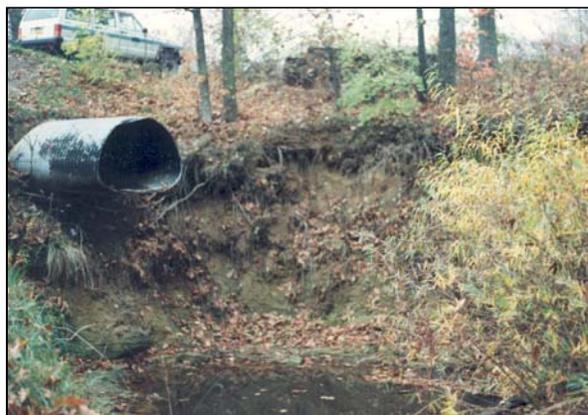
Figure 6-34 The outlet of this spillway has been undermined from the erosive forces of the discharge water.

In addition, undermining can occur as the result of erosion due to inadequate energy dissipation or inadequate erosion protection at the outlet. This undermining can be visually observed at the outlet of a pipe system and can extend well into the embankment. In this case, undermining can lead to other conduit problems such as misalignment, separated joints and pipe deterioration.

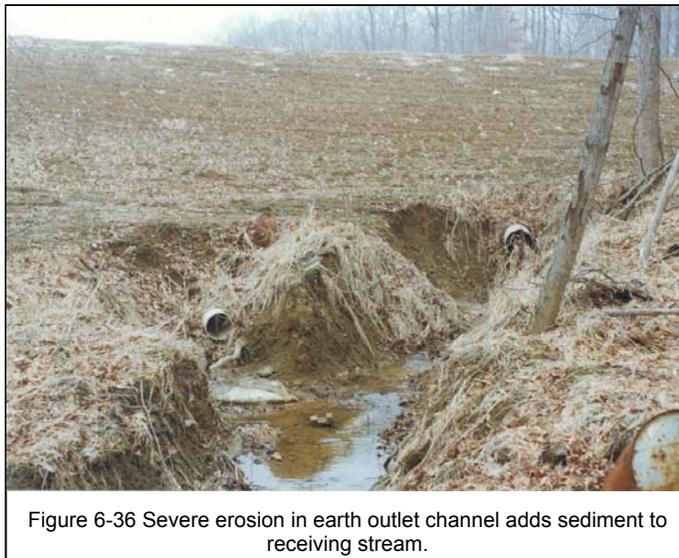
Figure 6-36 Severe erosion in earth outlet channel adds sediment to receiving stream.

When inspecting an earth spillway, the inspector should determine whether side slopes have sloughed, or whether there is excessive vegetative growth in the channel. The entrance and exit of the spillway should be unobstructed by trees, brush, or general vegetative overgrowth; during severe flooding, accumulation of drift in these areas can significantly reduce spillway capacity, increase erosion and contribute to overtopping of the dam and possible failure. The inspector also should look for signs of erosion and rodent activities. Use a probe to

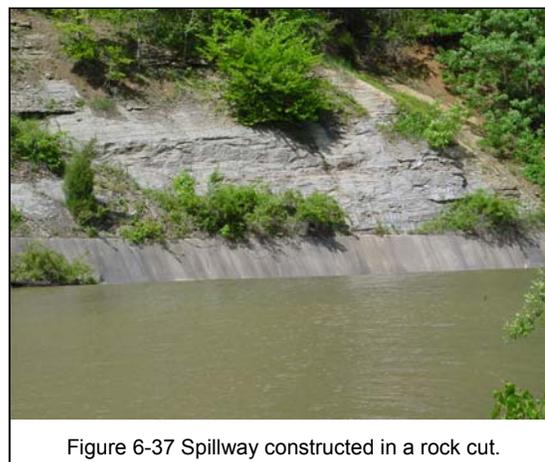
Figure 6-37 Spillway constructed in a rock cut.

Dams built in areas where rock is at or near the surface may include outlet works and spillway channels and tunnels constructed in or through the rock. Fallen rock may block discharges through a tunnel or channel, or rock falling into the reservoir immediately upstream from the dam could render outlet works, penstocks, or spillways inoperable. Abutment movement may restrict or prevent operation of appurtenances located in or on the abutment. Loosened rock could block or

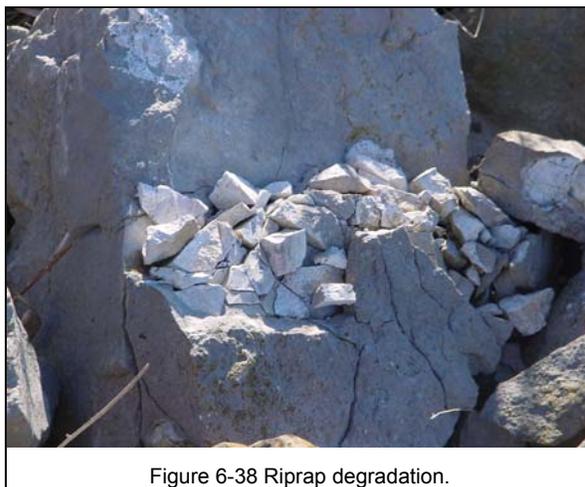
Figure 6-38 Riprap degradation.

Riprap is deficient when it fails to protect the underlying earth from erosion. Many riprap deficiencies can be dealt with through routine maintenance, such as adding rock to areas where riprap has started to become displaced. More severe riprap deficiencies may threaten the safety of the dam. Undercutting by wave action, slides, and slope failure can lead to failure of a spillway channel, a plunge pool, or, if erosion continues unchecked, even the breaching of an embankment dam or dike.

Riprap may suffer from displacement or rock degradation. These deficiencies may be related, with degradation often leading to displacement.

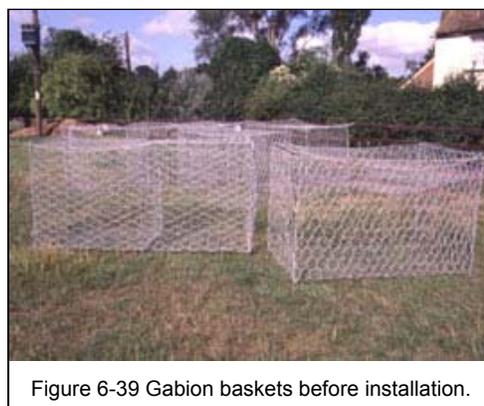
Figure 6-39 Gabion baskets before installation.

Gabions may be used as lining and support in spillways, stilling basins, and other dam outfall structures. A gabion is a prefabricated rectangular wire cage or basket filled in place with rocks. Gabions are free-draining and capable of being stacked for erosion protection. The term "gabion wall" may be used to refer to stacked gabions, while "gabion mattress" refers to a layer of gabions used to protect a chute or basin floor.

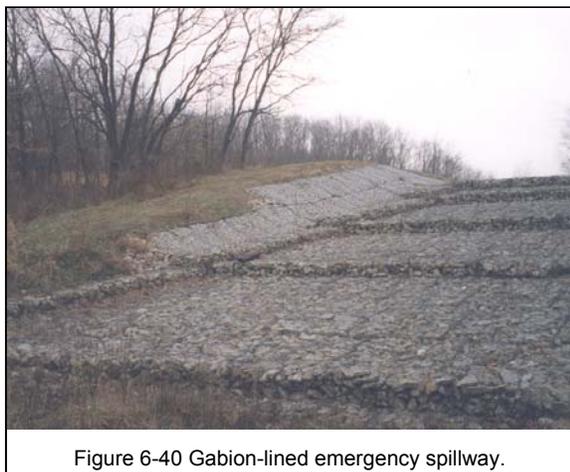
Figure 6-40 Gabion-lined emergency spillway.

Gabions are usually subject to various deficiencies that may cause deformation and possible toppling of gabion walls. These deficiencies include inadequate foundation support, foundation erosion, settlement of the rock within the basket, rock degradation, and failure of the wire baskets. Settlement and possible displacement of gabions can result from inadequate foundation support or from erosion of the subgrade. Foundation soils may be eroded when gabions are used because water flow can occur at the bottom of the basket. Proper foundation treatment is essential when gabions are

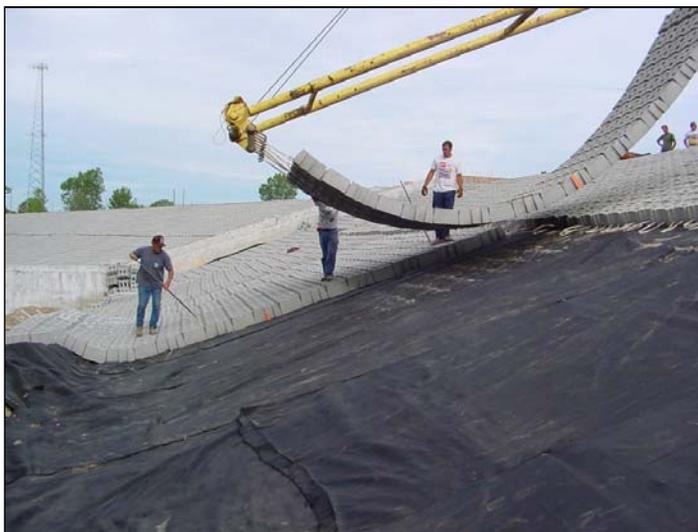
Figure 6-41 Articulating blocks are being placed over a geotextile filter on a dam embankment.

Geotextiles serve to control or prevent the movement of soil fines under riprap or similar materials used for slope protection and for lining spillways and plunge pools. Punctures and other deficiencies may result in loss of bedding material and erosion of foundation material beneath the geotextile, leading to sunken areas and voids under the riprap.

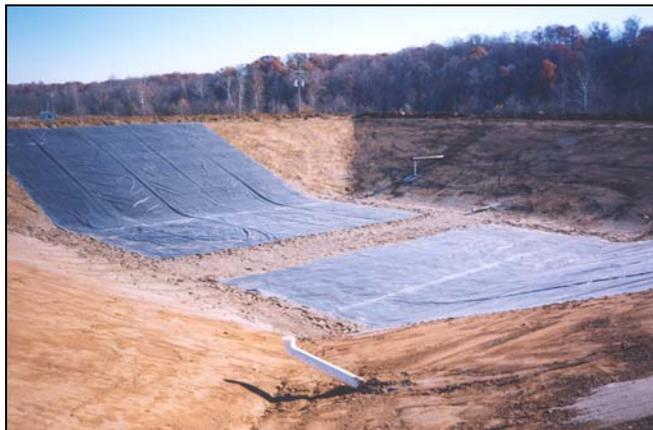
Figure 6-42 A geomembrane liner being installed in a waste water reservoir.

For reservoirs sealed with a geomembrane liner, unaccountable losses from the reservoir may be the first clue that the liner is leaking. Seepage around the reservoir rim is another indicator. The inspector should examine the reservoir floor with the reservoir drawn down if possible. Examine the protective layer over the membrane liner for gaps, plant growth, animal burrows, damage from vandalism, and piercing of the liner.

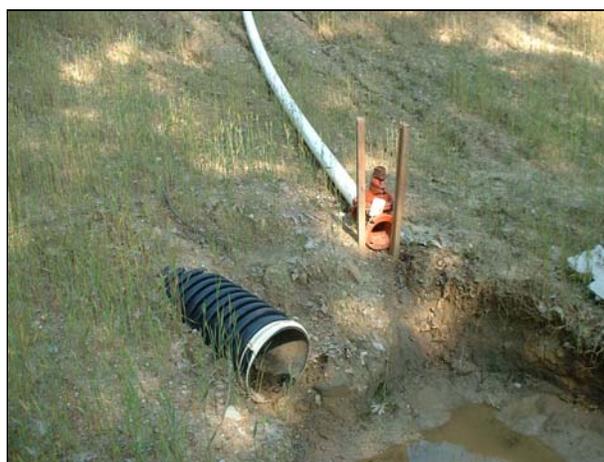
Figure 6-43 Plastic pipe used as the principal spillway; the use of this type of pipe is not recommended

If plastic pipes are used in any application at a dam or reservoir, a detailed engineering analysis of the application must be performed and installation techniques must be carefully specified. Only “thick-walled” plastic pipe should be considered for use, and IDNR or a qualified dam safety professional should be consulted prior to its use. In general, the use of plastic pipe for spillway discharge conduits is not recommended.

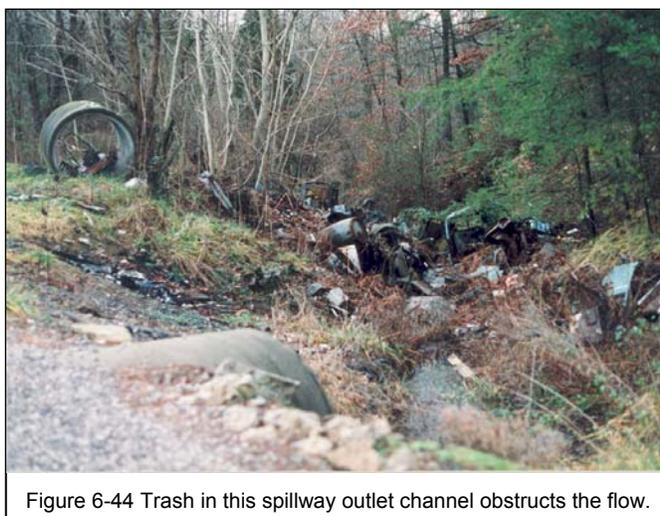
Figure 6-44 Trash in this spillway outlet channel obstructs the flow.

Earthen emergency spillways are particularly prone to excessive vegetative growth. There should be no trees, shrubs, or brush in any emergency spillway. Man-made structures, unless considered in the original design for spillway adequacy, should not be built in emergency spillways. The inspector should always recommend the removal of trees, shrubs, and other obstructions in the emergency spillway. Figure 6-44 shows a spillway discharge channel with excessive trash. Figure 6-45 shows a building constructed in an emergency spillway.

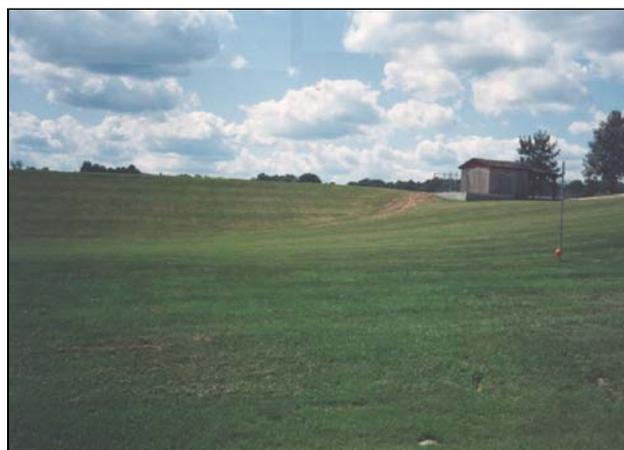
Figure 6-45 A building constructed in the emergency spillway obstructs flow and poses a safety risk to the building.

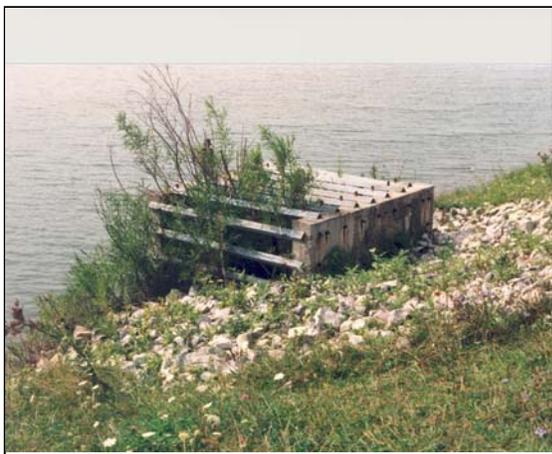
Figure 6-46 Excessive vegetation obstructs this riser structure.

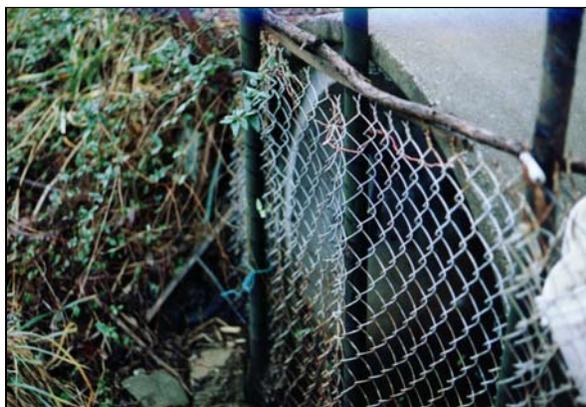
Figure 6-47 Inappropriate trash rack over end of a culvert spillway.

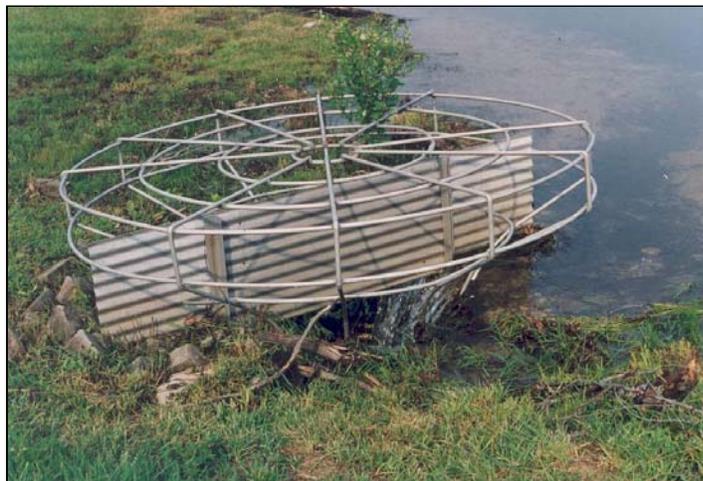
Figure 6-48 Poorly constructed trash rack has openings that are too large at the riser crest.

A well-designed trash rack will stop large debris that could plug the discharge pipe but allow unrestricted passage of water and smaller debris. Some of the most effective racks allow flow to pass beneath the trash into the riser inlet as the pool level rises. Racks usually become plugged because the openings are too small, or the head loss at the rack causes material and sediment to settle out and accumulate. Small openings will stop small debris such as twigs and leaves, which in turn cause a progression of larger items to build

up, eventually completely blocking the inlet. Trash rack openings should be at least 6 inches across regardless of the pipe size. The larger the principal spillway conduit, the larger the trash rack opening should be. The largest possible openings should be used, up to a maximum size of about 2 feet.

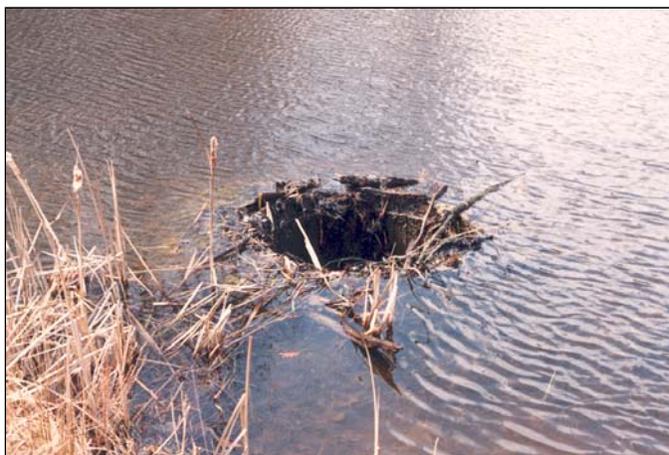
Figure 6-49 Riser lacking a trash rack can clog and cause dam overtopping.

The lack of a trash rack is unacceptable, and creates the potential for an extremely hazardous condition. Trash racks constructed from very thin wire, such as “chicken wire,” that can be easily damaged or destroyed is also unacceptable. Trash racks that are “flat” and cover only the opening of a riser (i.e. constructed similar to a grate over a drop inlet on streets) are also safety concerns because of the potential for clogging. In either case, the inspector should recommend the installation of a proper trash rack.

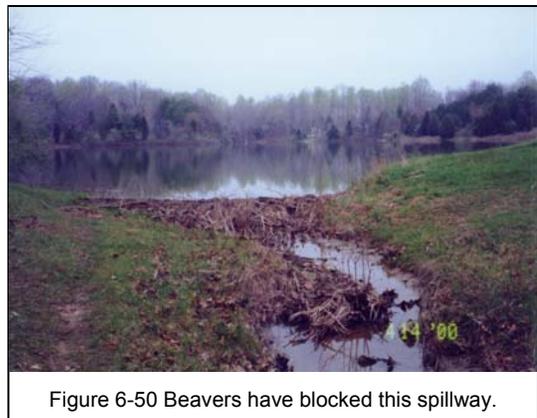
Figure 6-50 Beavers have blocked this spillway.

Beavers may present problems at dams where they may live since they have a natural tendency to block off spillways with brush and sticks. Beavers are attracted to the sound of running water and tend to build dams where they hear this sound. Beavers should be eliminated or relocated if they become a problem, or a control device should be constructed at the spillway to prevent their approach.

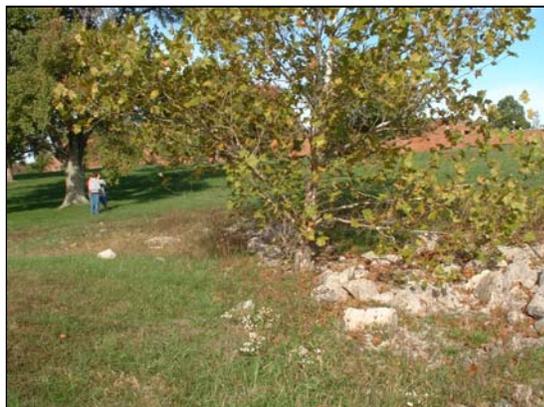
Figure 6-51 Trees growing in emergency spillway.

Periodic mowing in the grass-lined spillways is required to prevent trees, brush, and weeds from becoming established, and to encourage the growth of grass. Poor vegetal cover will usually result in extensive, rapid erosion when the spillway flows, and will require more costly repairs. Trees and brush may reduce the discharge capacity of the spillway. The inspector should evaluate the degree of vegetative growth in the earthen spillways. Tree and shrub removal should always be recommended if these plants are present.

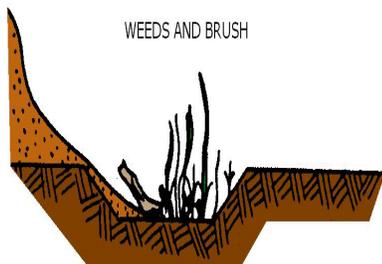
DEBRIS OR OTHER OBSTRUCTIONS

Accumulation of slide materials, dead trees, excessive vegetative growth, etc., in spillway channel.

Reduced discharge capacity; overflow of spillway; overtopping of dam. Prolonged overtopping can cause failure of the dam.

Clean out debris periodically; control vegetative growth in spillway channel. Install log boom in front of spillway entrance to intercept debris.

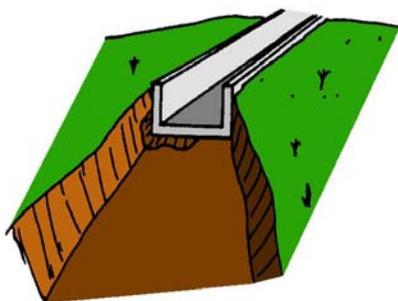
END OF SPILLWAY CHUTE UNDERCUT

Poor configuration of stilling basin area. Highly erodible materials. Absence of cutoff wall at end of chute.

Structural damage to spillway structure; collapse of slab and wall; leads to costly repair. Higher velocity flows can cause erosion of drain, then embankment materials.

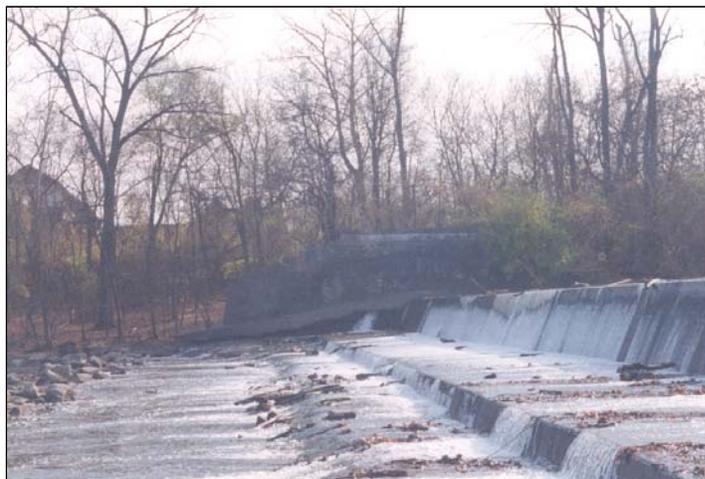
Figure 7-2 Most concrete dams in Indiana are in-channel structures that are difficult to inspect.

difficult to inspect because they are continuously inundated with overflow, and typically have a lot of debris on the structure (see Figures 7-2 and 7-3). Sometimes these concrete structures are contained in or along earth embankments.

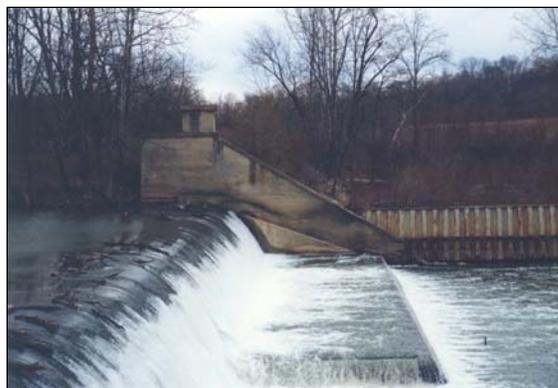
Figure 7-3 Low head, in-channel concrete dams are very dangerous due to the whirlpools, hydraulic jumps, and eddies on the discharge side.

drowning accidents that have occurred in such areas. It can be very difficult or impossible for swimmers and boats to escape from this area, especially during periods of increased flow following precipitation events. For this reason, these dams are often referred to as “drowning machines.”

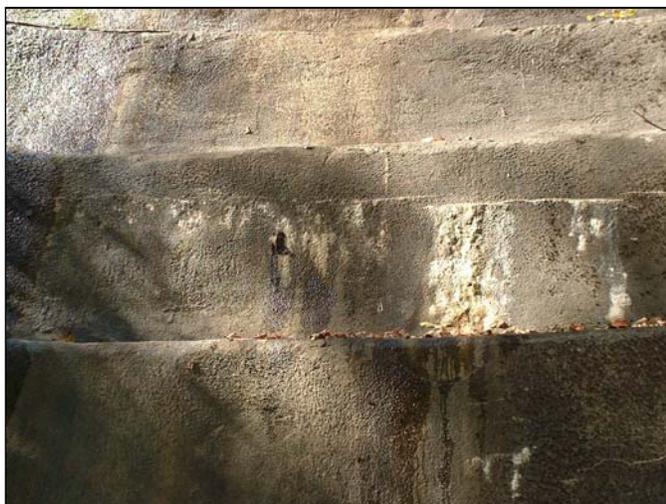
Figure 7-11 Calcium carbonate deposits on the downstream face of a concrete dam as a result of water seepage.

Deterioration of concrete may be caused by many factors, including weathering, mechanical impacts, internal pressure, drying shrinkage, thermal stress, chemical action, leaching by water seepage, poor concrete mixes, poor concrete design, and freeze-thaw action. Water seeping through cracks in concrete usually leaches calcium from the concrete and forms white, calcium carbonate deposits on the concrete

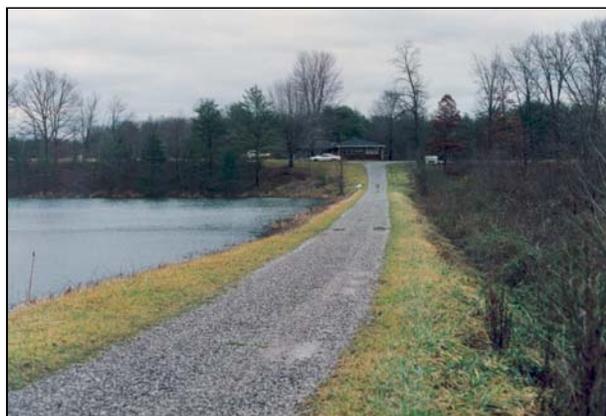
Figure 8-2 This dam has access to and over the embankment, however it may not be able to support heavy equipment.

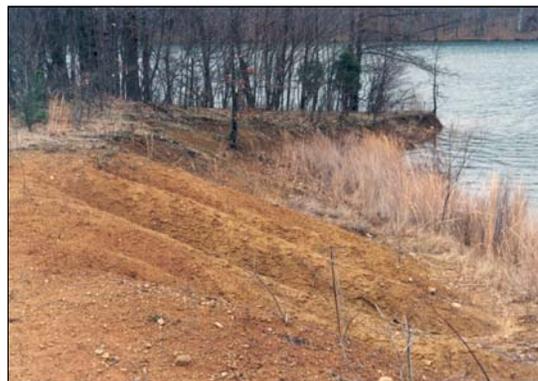
Figure 8-3 This reservoir has severe shoreline erosion due to inadequate vegetation.

seepage from slope areas. Whirlpools may indicate leaks or piping in the bottom of reservoir or along submerged outlets. Burrowing animals should be monitored because they may migrate to the embankment area where they may cause serious harm. Erosion along the shoreline will result in additional sediment entering the reservoir and filling up water space, as well as reducing the available reservoir area.

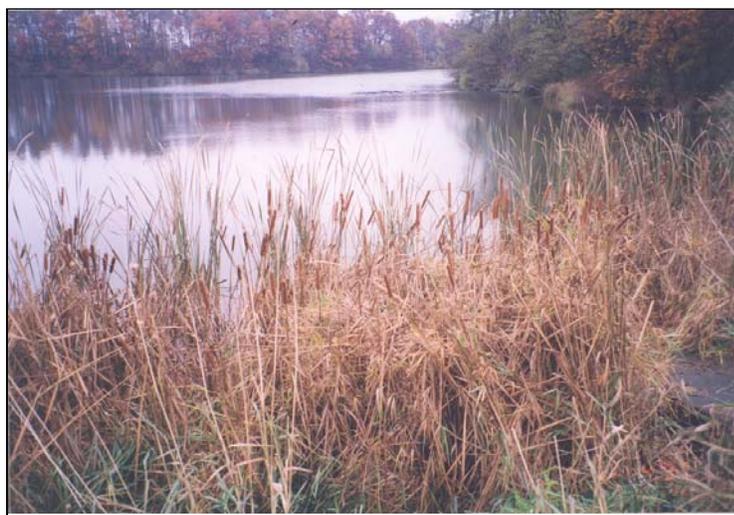
Figure 8-4 Excessive vegetation in reservoir almost completely conceals the spillway riser.

The reservoir submerged areas should be checked for sediment (when possible), debris, and excessive vegetative growth, including algae. Sediment from upstream areas is an ongoing problem in most reservoirs, and is very difficult, if not impossible to stop. When sediment deposits become severe, they should be removed; the usual method is dredging. Although sediment buildup is a concern because it diminishes the value and use of the reservoir, it normally does not affect the dam's stormwater

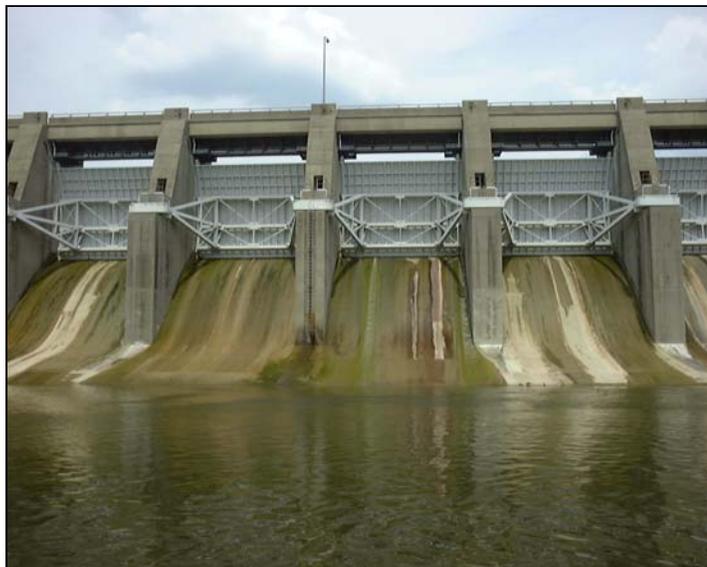
Figure 8-5 Downstream view of gates on a central-Indiana dam.
