# REHABILITATION RETROFITTS

Michael Wenning, PE  
GAI Consultants, Inc.

INDOT Bridge Conference | February 16, 2017

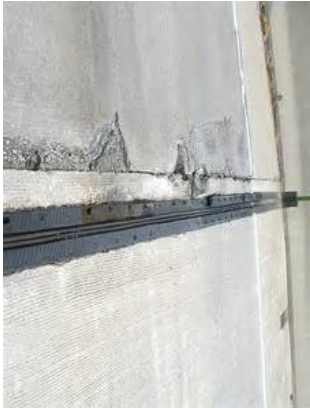
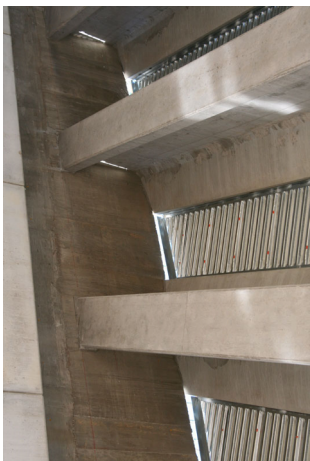
- Purpose to eliminate problematic joints.
- Stephanie discussed currently preferred joints to use
- Lifespan less than rehabilitation cycle of 20± years.
- Jeremy discussed preferred integral and semi-integral end bent details.
- Works at end bents only.

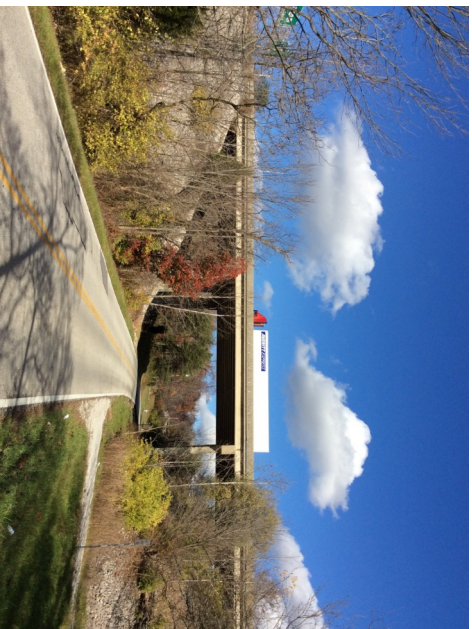
- I-64 over Captain Frank Road
- Built 1965
- Simple Span Prestressed I-beam bridge
- Reconstructed 1992
- Overlay and joint elimination

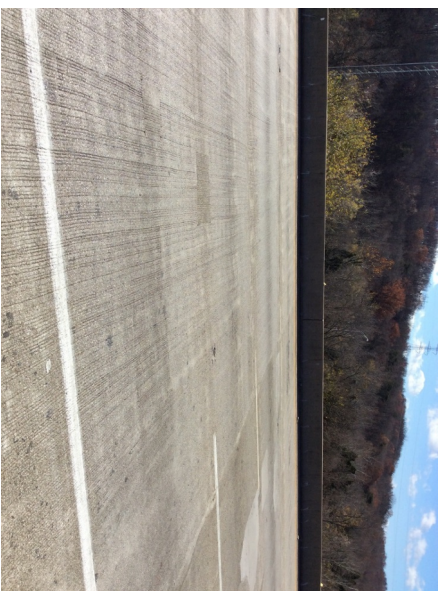
- I-64 over Captain Frank Road
- From 11/19/2015 SI&A

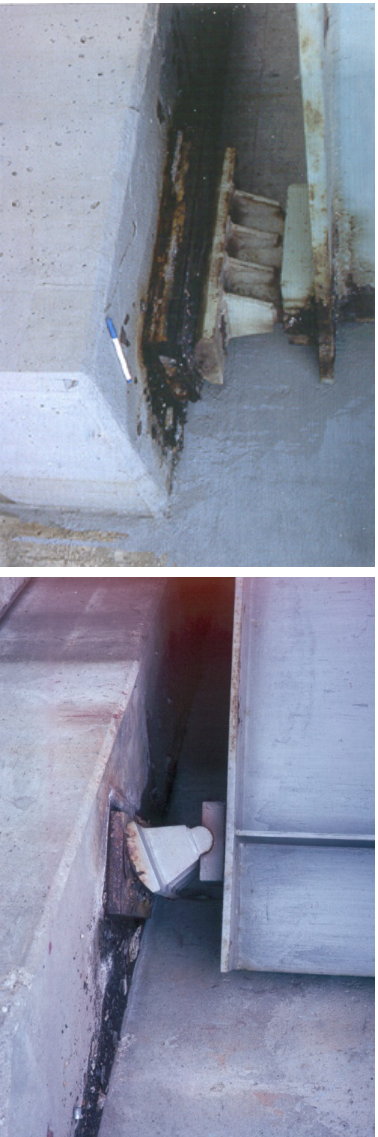
- Found throughout Indiana on Steel Beam / Girder Bridges.

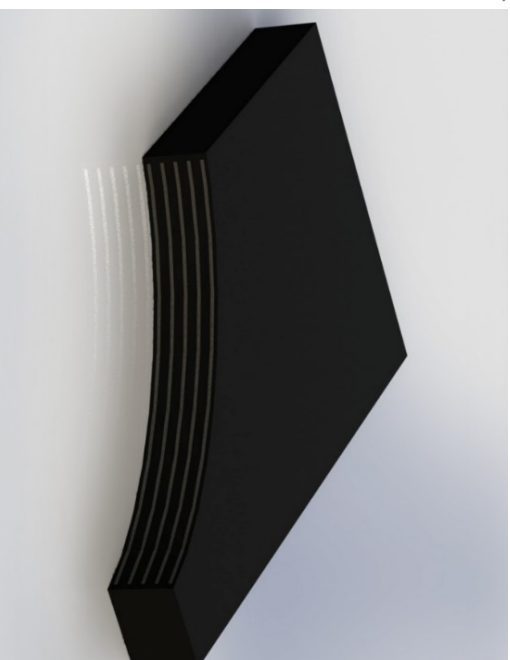
- Elastomeric Bearings don't rust
- Low Profile
- Less Expensive
- Easy to Install

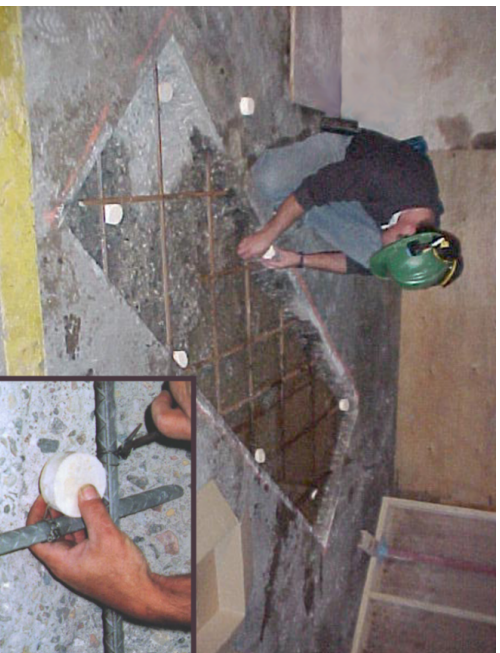
- Amount of zinc dependent on a number of factors such as current, rebar density, etc
- Normally pucks spaced 18-24" are sufficient for decks and most areas
- See presentation from 2016 conference for more information

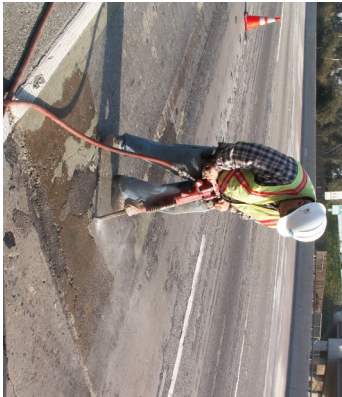
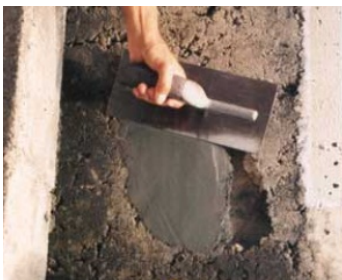
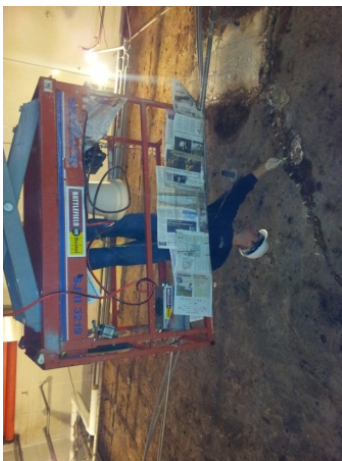
- Not all patching is created equal.
- Class A Patching Spec getting a major overhaul today.

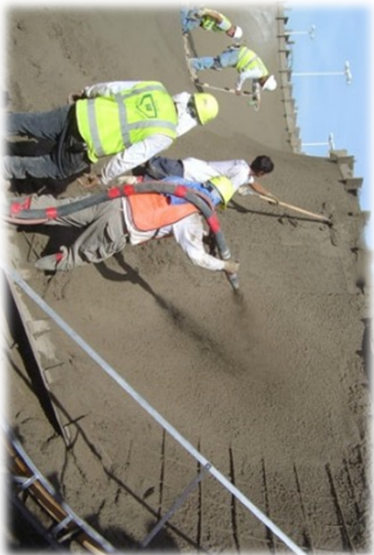
- **Pneumatically Placed Mortar**
  - “Stickier” than Class A Patching and sometimes works better.
  - More Expensive due to equipment mobilization.
  - \$100 - \$200 per SFT, higher for small quantities.
  - Rule of thumb, don't use for under 500 SFT areas.
  - Don't forget WW Mesh
- **INDOT knows the current specifications do not represent the best current practices and intend to update them in the future.**

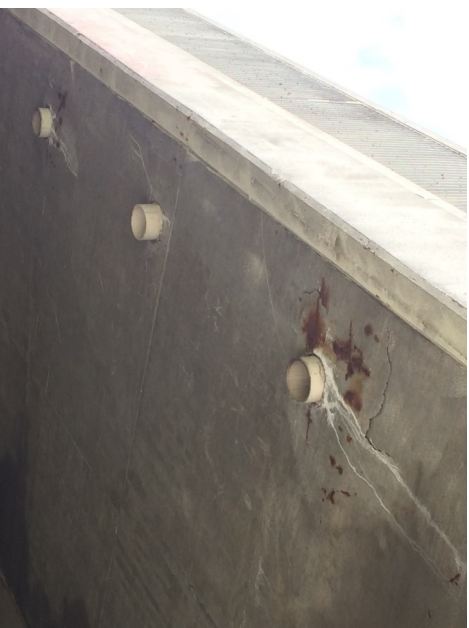
- The Problem:
  - Water and Chlorides Leak around PVC joint
    - Concrete Shrinkage
    - Differential Expansion
  - Chlorides Collect Near Bottom Reinforcing
  - Corrosion and Spalling around Drain
