INDEX	
SHEET NO.	SUBJECT
1	Joint Repair Index and General Notes
2	Longitudinal Joint Repair, Partial Depth
3	Transverse Joint Repair, Partial Depth
4	Joint Repair, Bottom-Half

INDIANA DEPARTMENT OF TRANSPORTATION	
JOINT REPAIR INDEX AND GENERAL NOTES	
EFFECTIVE FOR LETTINGS ON OR AFTER 06-01-21	
RECURRING PLAN DETAIL NO.	509-R-722d
Sheet 1 of 4

<b>INDIANA DEPARTMENT OF TRANSPORTATION</b>	
<b>LONGITUDINAL JOINT REPAIR, PARTIAL DEPTH</b>	
<b>EFFECTIVE FOR LETTINGS ON OR AFTER 06-01-21</b>	
RECURRING PLAN DETAIL NO.	509-R-722d
Sheet 2 of 4

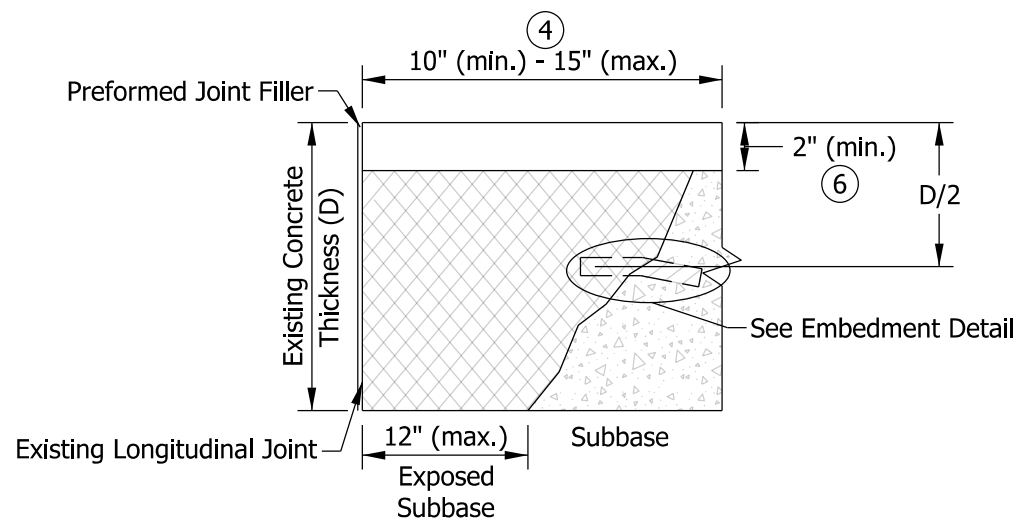
**SECTION A-A**

(showing concrete removal)
