January 2020 to December 2020
ANNUAL STATE OF THE ITR REPORT

This 2020 Indiana Toll Road (ITR) *Annual State of the ITR Report* has been prepared in accordance with the Amended and Restated *Concession and Lease Agreement* (“*CLA*”) for the Indiana Toll Road.

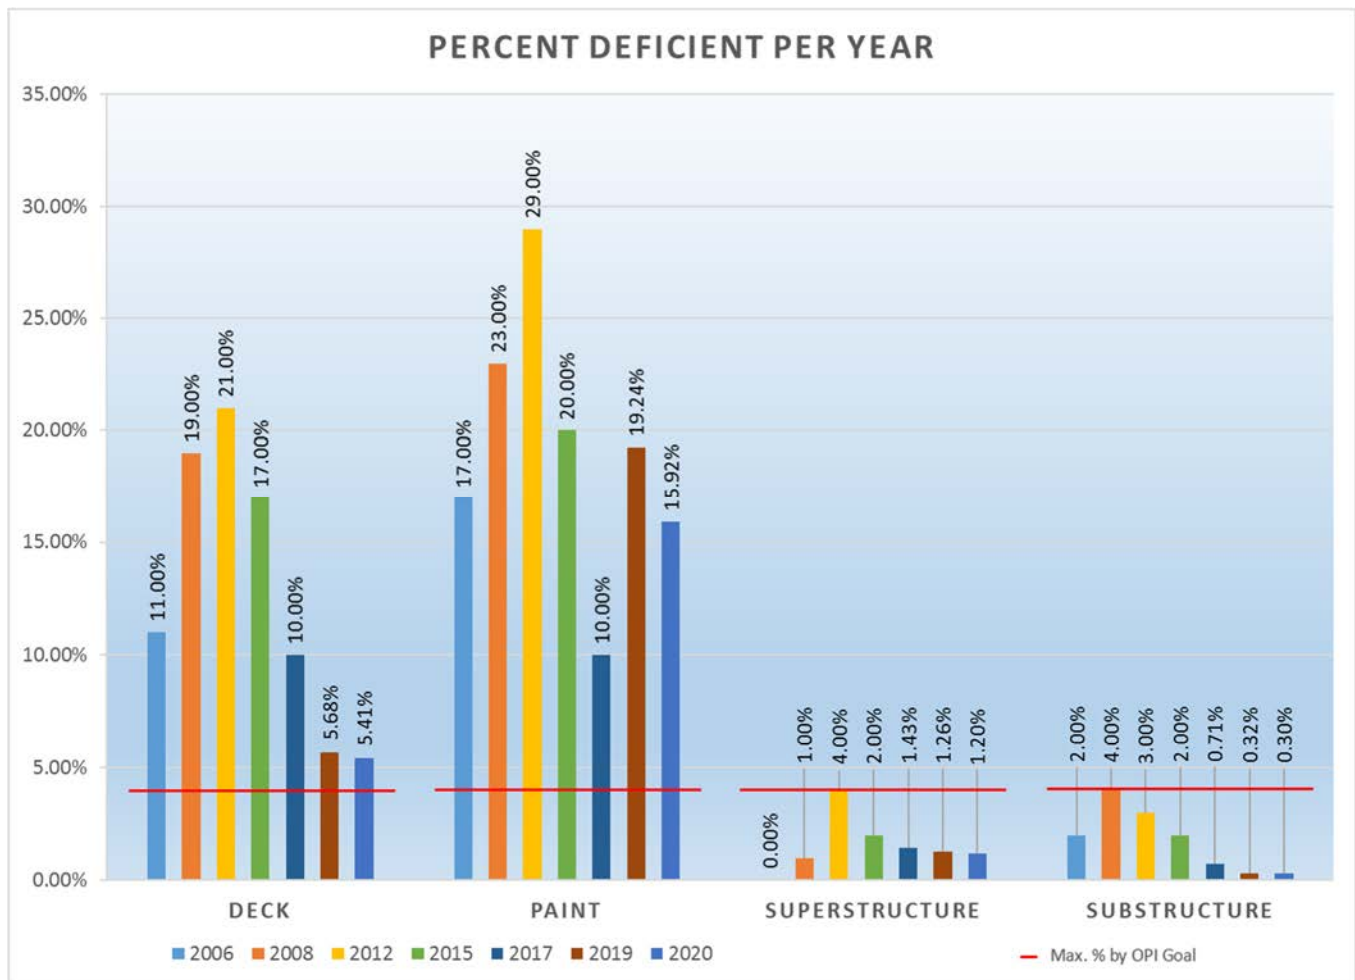
Figure 3.1: Bridge Condition Ratings illustrates that there has been a decrease in the percent deficiencies of the individual items compared to the previous years. This decrease is due to the implementation of the PUSH 1.0 and PUSH 2.0 projects as well as other structure specific contracts the ITR has procured since 2015. The PUSH projects have addressed over 25% of the structures within the ITR corridor.

It should be noted that the ITR is the closest it has ever been, since the initial lease in 2006, to achieving OPI compliance ratings greater than 0 in the Wearing Surface and Deck categories. Per the CLA and the OPI charts, the ITR will be in compliance once the Wearing Surface and Deck ratings reach a percentage of 4% or less of structures being deficient (ratings less than or equal to 5).
