Indiana **TOLL ROAD**

August 2018 to December 2019

ANNUAL STATE OF THE ITR REPORT

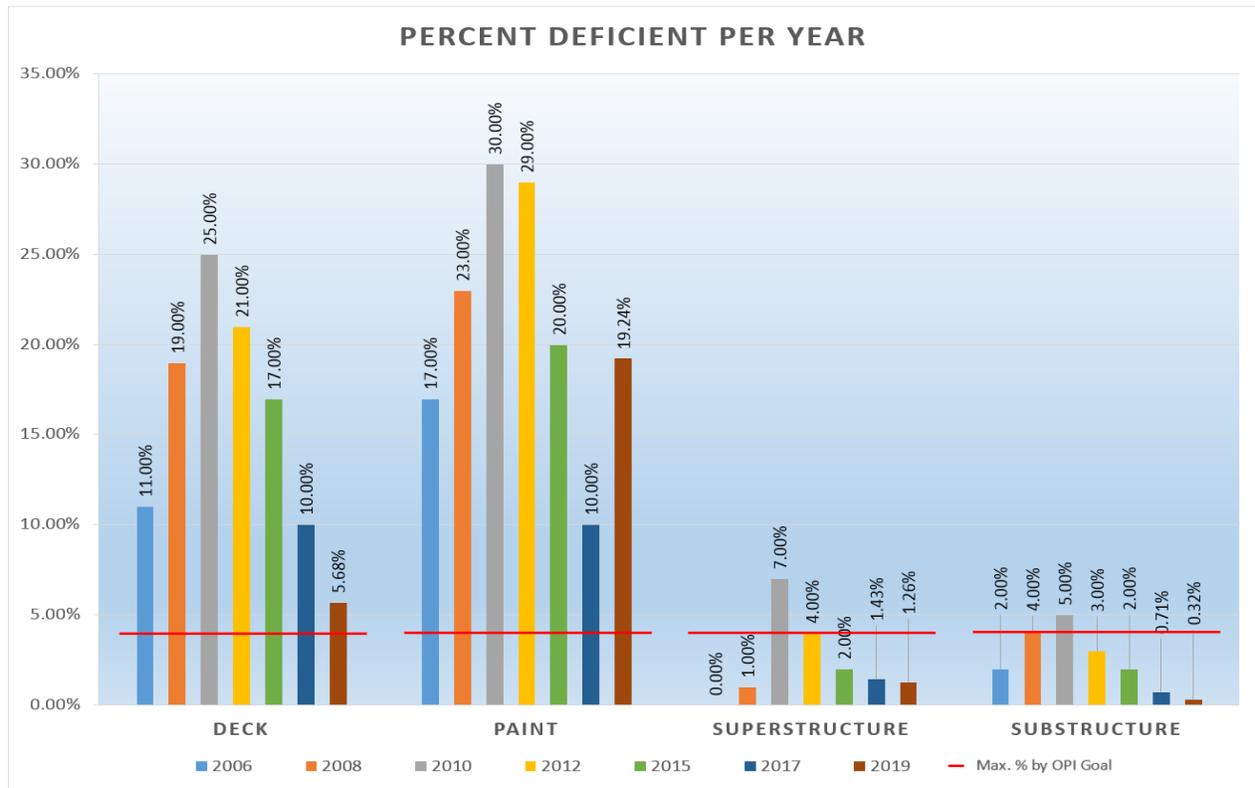
Figure 1.1: Bridge Condition Ratings

Note: To address the upward trend for paint ratings, compared to 2017, the ITRCC is working on new strategic procurement process with the issuance of job order contracts to address superstructure painting across the corridor. Current preliminary plans are to implement these job order contracts in 2020. Further narrative is provided in the Bridge Report Section.

The state of the ITR structures in general have increased in their overall percentages of satisfactory and greater condition ratings, which is the result of lower deficiencies discovered during inspections. Wearing surface and deck deficiencies have improved as well, due to rehabilitation projects outside that of the PUSH I and PUSH 2.0 project. The rehabilitations and new construction applied to many structures have increased the Deck, Superstructure, and Substructure ratings. In 2017 ITRCC implemented a complete reevaluation of the 10 year capital improvement program for all bridge assets. Using the 2015/2016 bridge inspection data and the advanced asset planning system of VUEWorks, a new budget and plan was generated to help lower the amount of deficiencies and further increase the overall condition of the ITR structures.

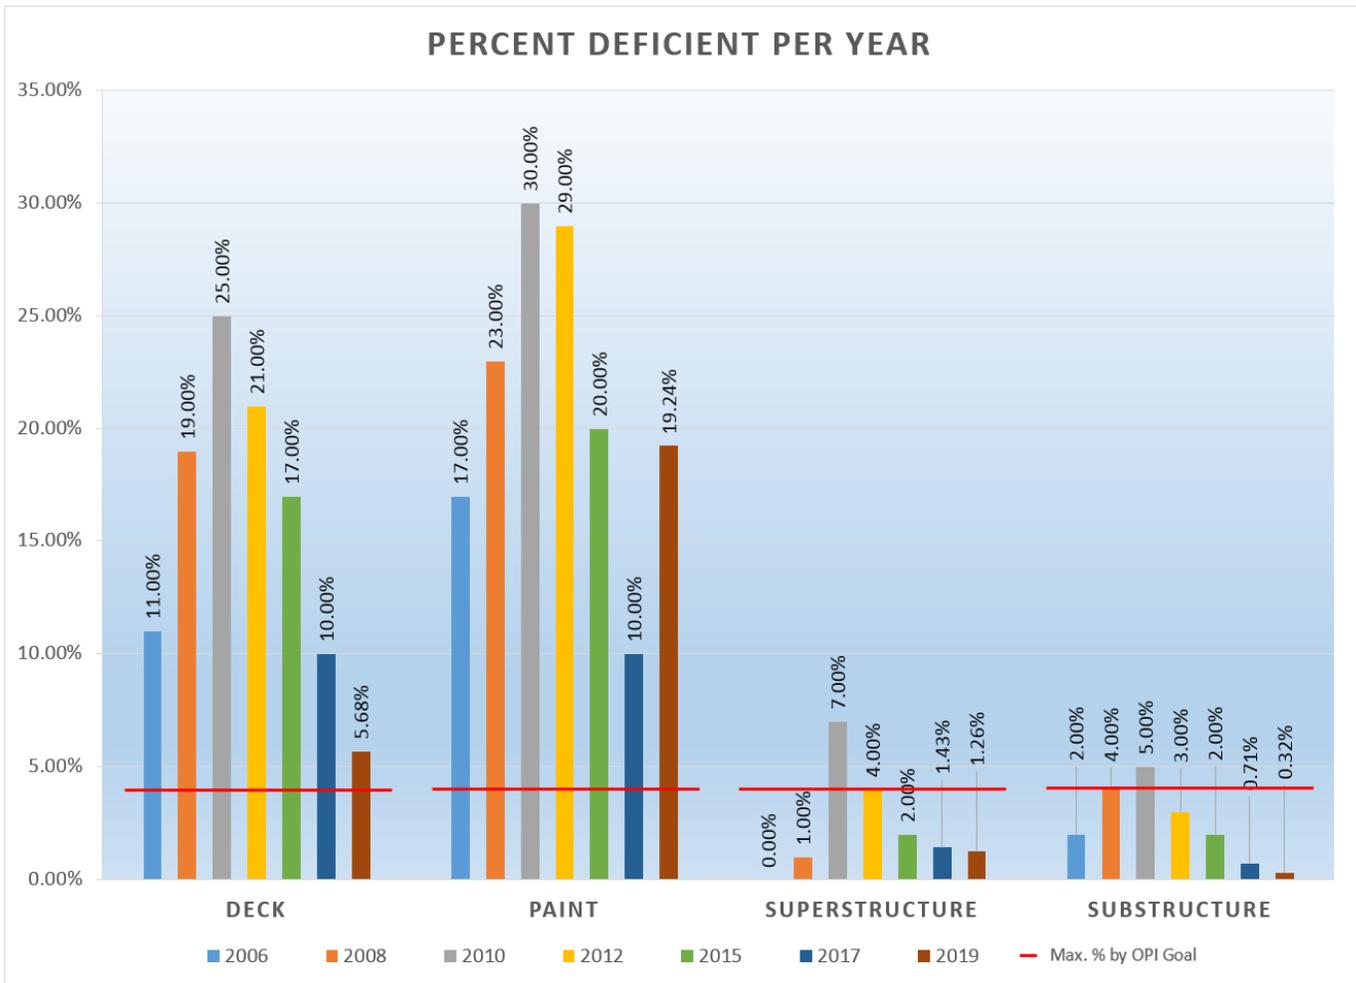
Figure 3.1: Bridge Condition Ratings

Figure 3.1: Bridge Condition Ratings illustrates that there has been a decrease in the percent deficiencies of the individual items compared to the previous years. This decrease is due to the implementation of the PUSH I and PUSH 2.0 projects as well as other structure specific contractors the ITR has procured since 2015. The PUSH projects have addressed over 20% of the structures within the ITR corridor. At completion of the PUSH 2.0 project, the new ratings will decrease the overall deficiency averages even further.

The paint condition rating is the only deficiency that has shown an increase. This increase is directly attributed to previous years inspection ratings containing a larger number of structures rated a 6 (satisfactory condition) which were lowered in the 2019 inspection cycle to a rating of a 5 (fair condition). This has resulted in a larger number of structures falling into the paint deficient category. The ITRCC is planning to address this deficiency group with job order contracts across the corridor specific to superstructure blasting and painting.

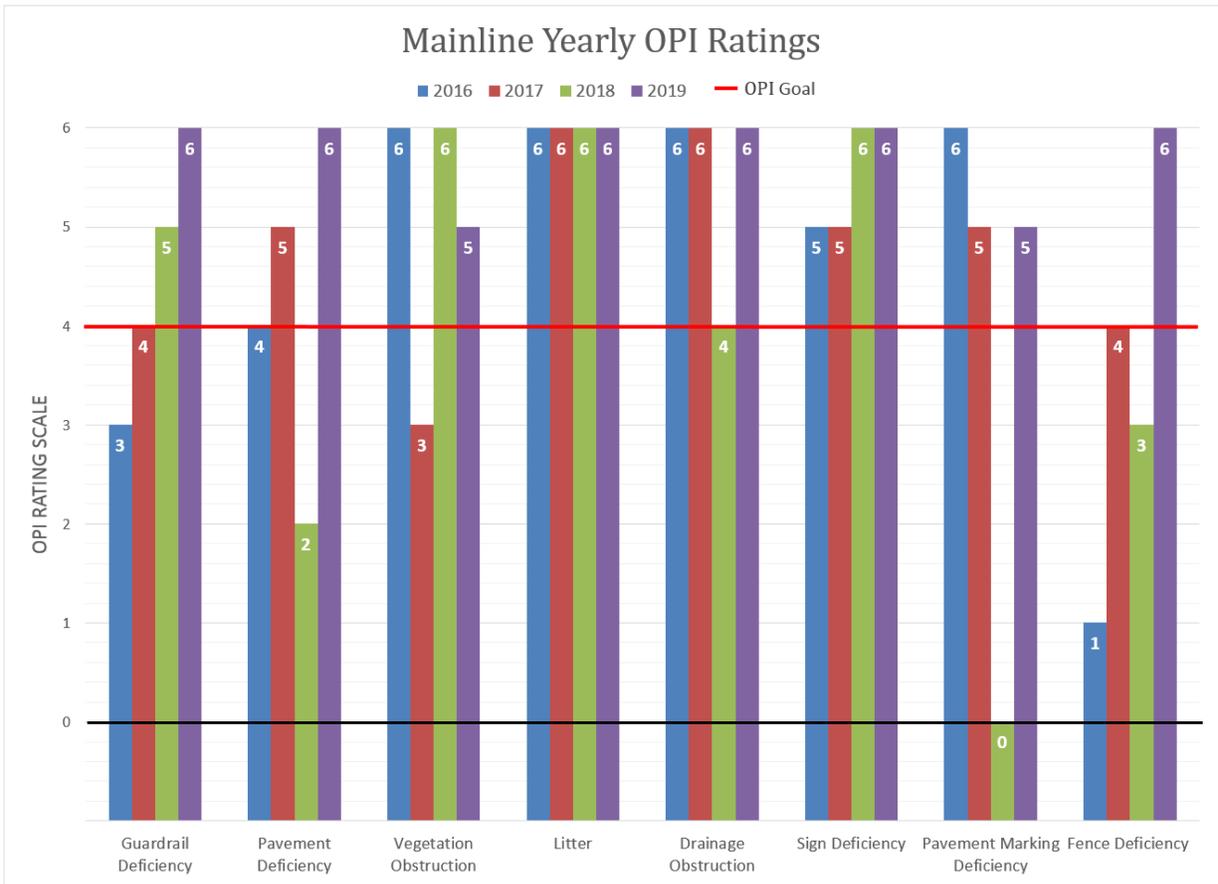
Figure 5.1: Mainline Yearly OPI Ratings

Table 5.2: Mainline Maintenance Items for ITR provides the total accumulated deficiencies for the entirety of the mainline. **Tables 5.3 – 5.7**, located in Appendix E, represent each maintenance district and list the number of deficiencies, deficiency rates, and OPI ratings for the eight mainline maintenance items. The ratings range from 0 to 6, with 6 being the highest. **Figure 5.1: Mainline Yearly OPI Ratings** (located below) illustrates the mainline maintenance OPI rating progression over the past four years in comparison to the 2019 ratings.

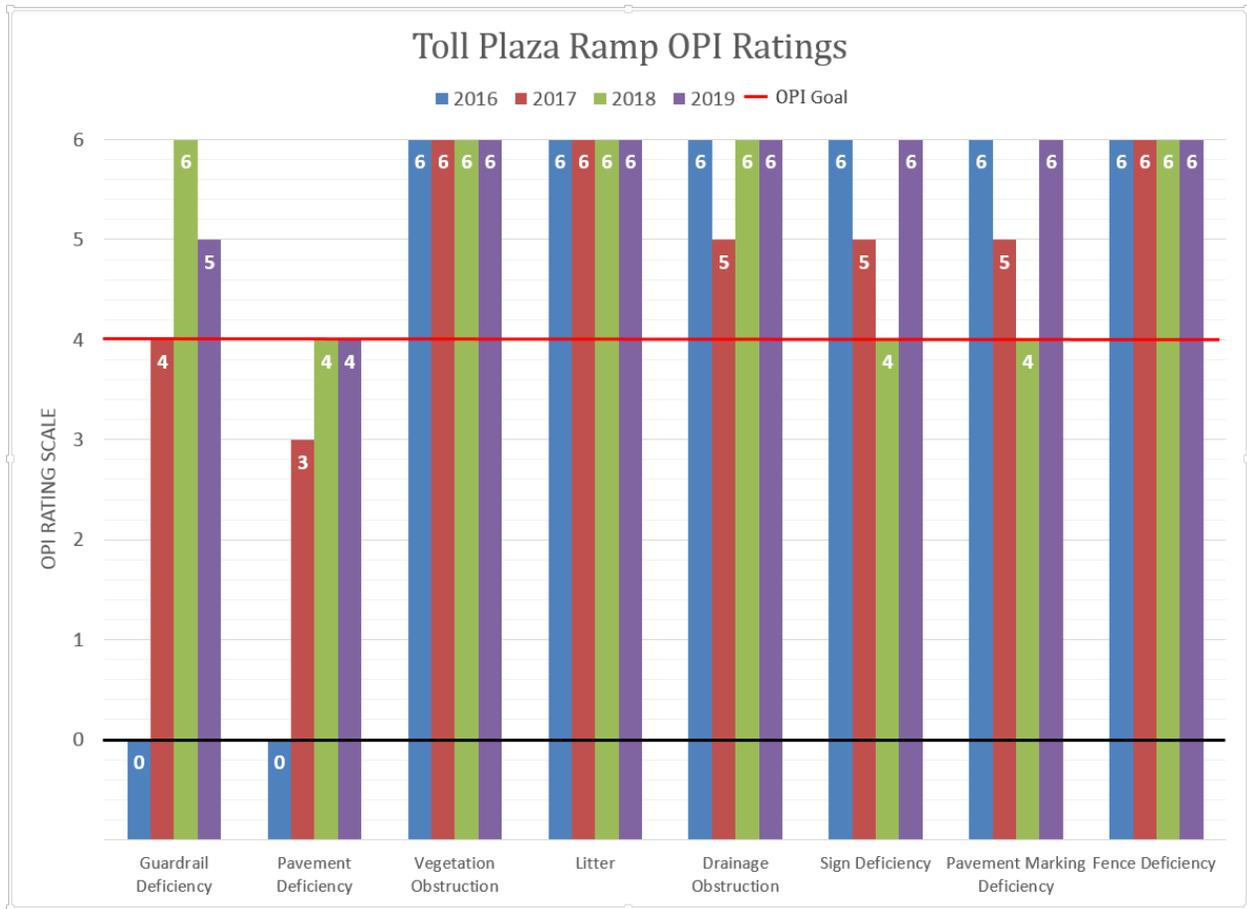
Figure 5.2: Toll Plaza Ramp OPI Ratings

Table 5.8: Toll Plaza Maintenance Items for ITR provides the total accumulated deficiencies for the entirety of the toll plazas. **Tables 5.9 – 5.13**, located in Appendix E, represent each maintenance district and list the number of deficiencies, deficiency rates, and OPI ratings for the eight toll plaza maintenance items. The ratings range from 0 to 6, with 6 being the highest. **Figure 5.2: Toll Plaza Ramp OPI Ratings** (located below) illustrates the Toll Plaza Ramp Maintenance OPI rating progression over the past four years in comparison to the 2019 ratings.

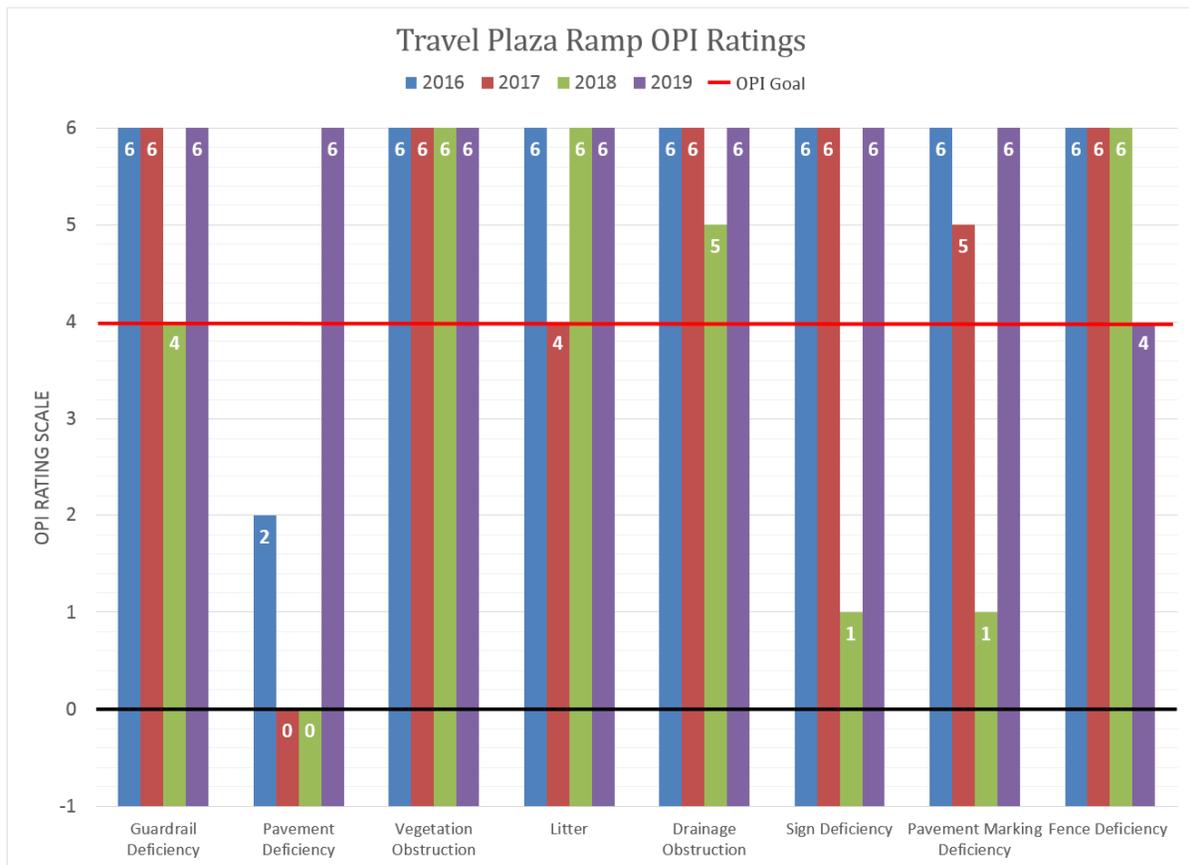
Figure 5.3: Travel Plaza Ramp OPI Ratings

Table 5.14: Travel Plaza and Truck Parking Maintenance Items for ITR provides the total accumulated deficiencies for the entirety of the travel plazas. Tables 5.15 – 5.19, located in Appendix E, represent each maintenance district and list the number of deficiencies, deficiency rates, and OPI ratings for the eight travel plaza maintenance items. The ratings range from 0 to 6, with 6 being the highest. Figure 5.3: Travel Plaza Ramp OPI Ratings (located below) illustrates the Toll Plaza Ramp Maintenance OPI rating progression over the past four years in comparison to the 2019 ratings.

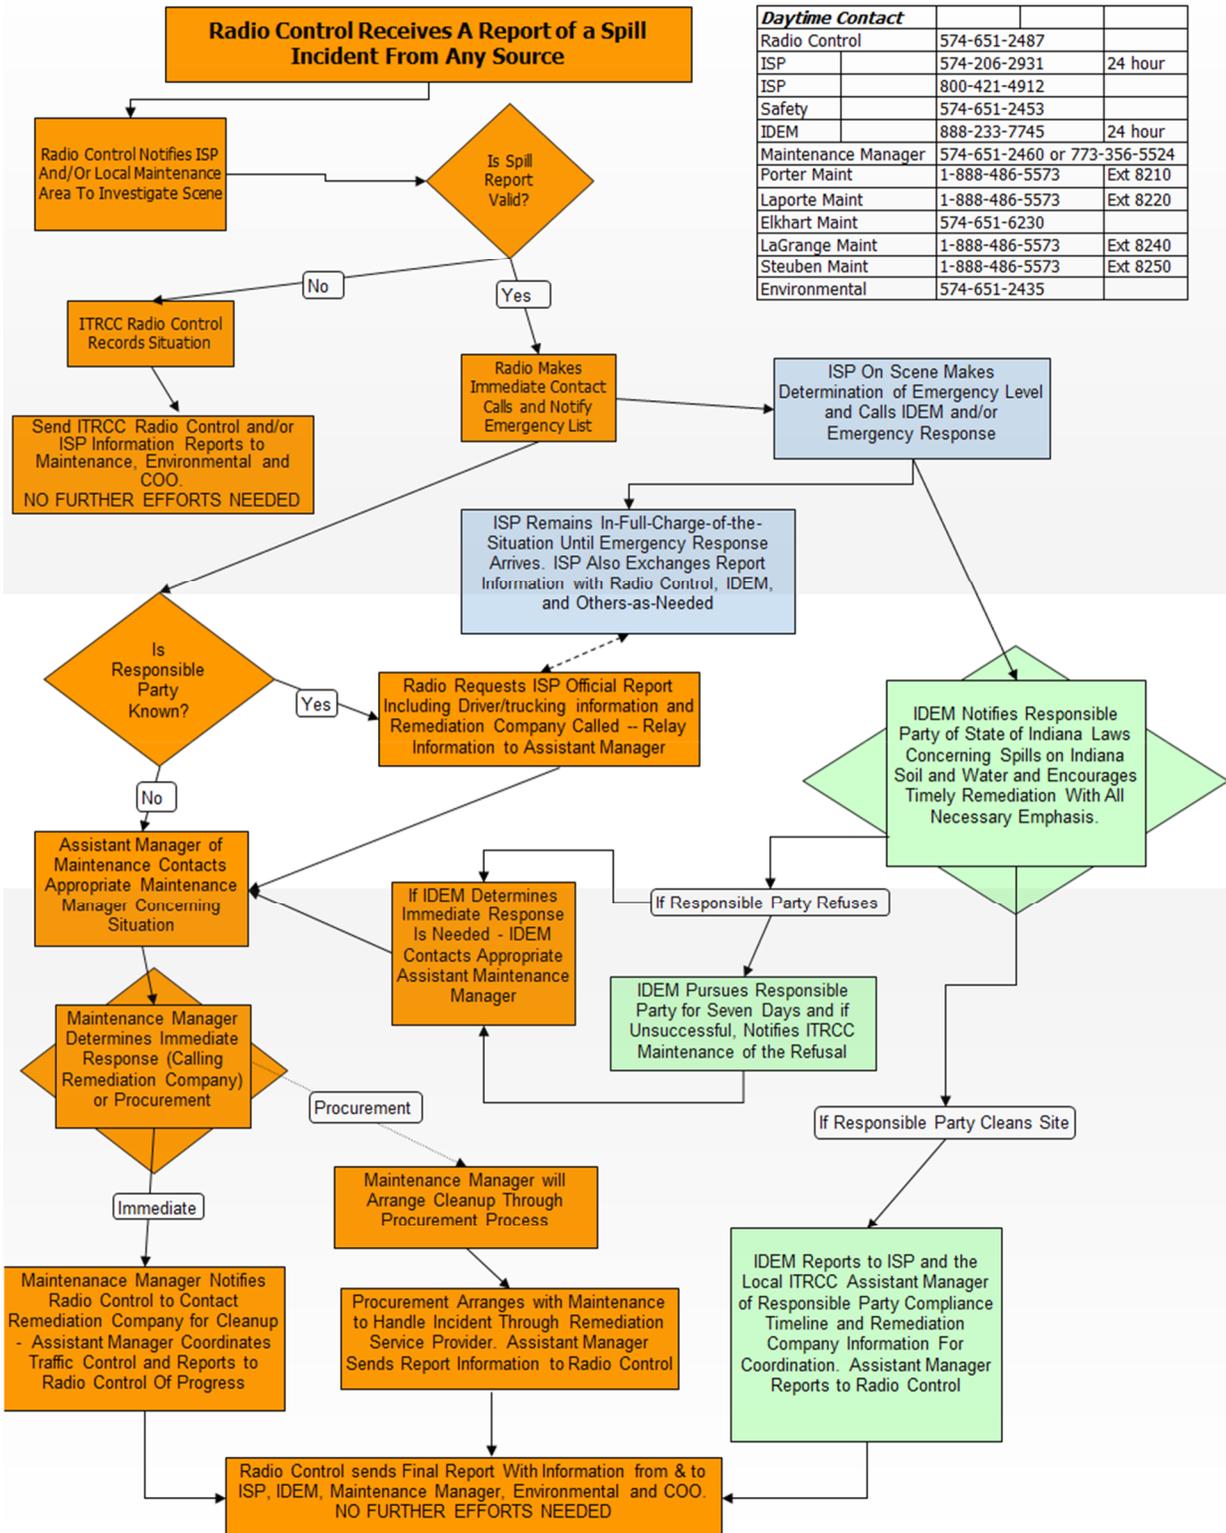
Daytime Contact		
Radio Control	574-651-2487	
ISP	574-206-2931	24 hour
ISP	800-421-4912	
Safety	574-651-2453	
IDEM	888-233-7745	24 hour
Maintenance Manager	574-651-2460 or 773-356-5524	
Porter Maint	1-888-486-5573	Ext 8210
Laporte Maint	1-888-486-5573	Ext 8220
Elkhart Maint	574-651-6230	
LaGrange Maint	1-888-486-5573	Ext 8240
Steuben Maint	1-888-486-5573	Ext 8250
Environmental	574-651-2435

Figure 7.2: Spill Response Flow Chart

ITRCC has developed an effective strategy to address all patron releases along the ITR. **Figure 7.2: Spill Response Flow Chart** demonstrates the process for responding to a release.
