Indiana Department of Natural Resources **Division of Reclamation, Abandoned Mine Lands Section**

Site 309, Mill Creek Highwall

An Innovative Solution

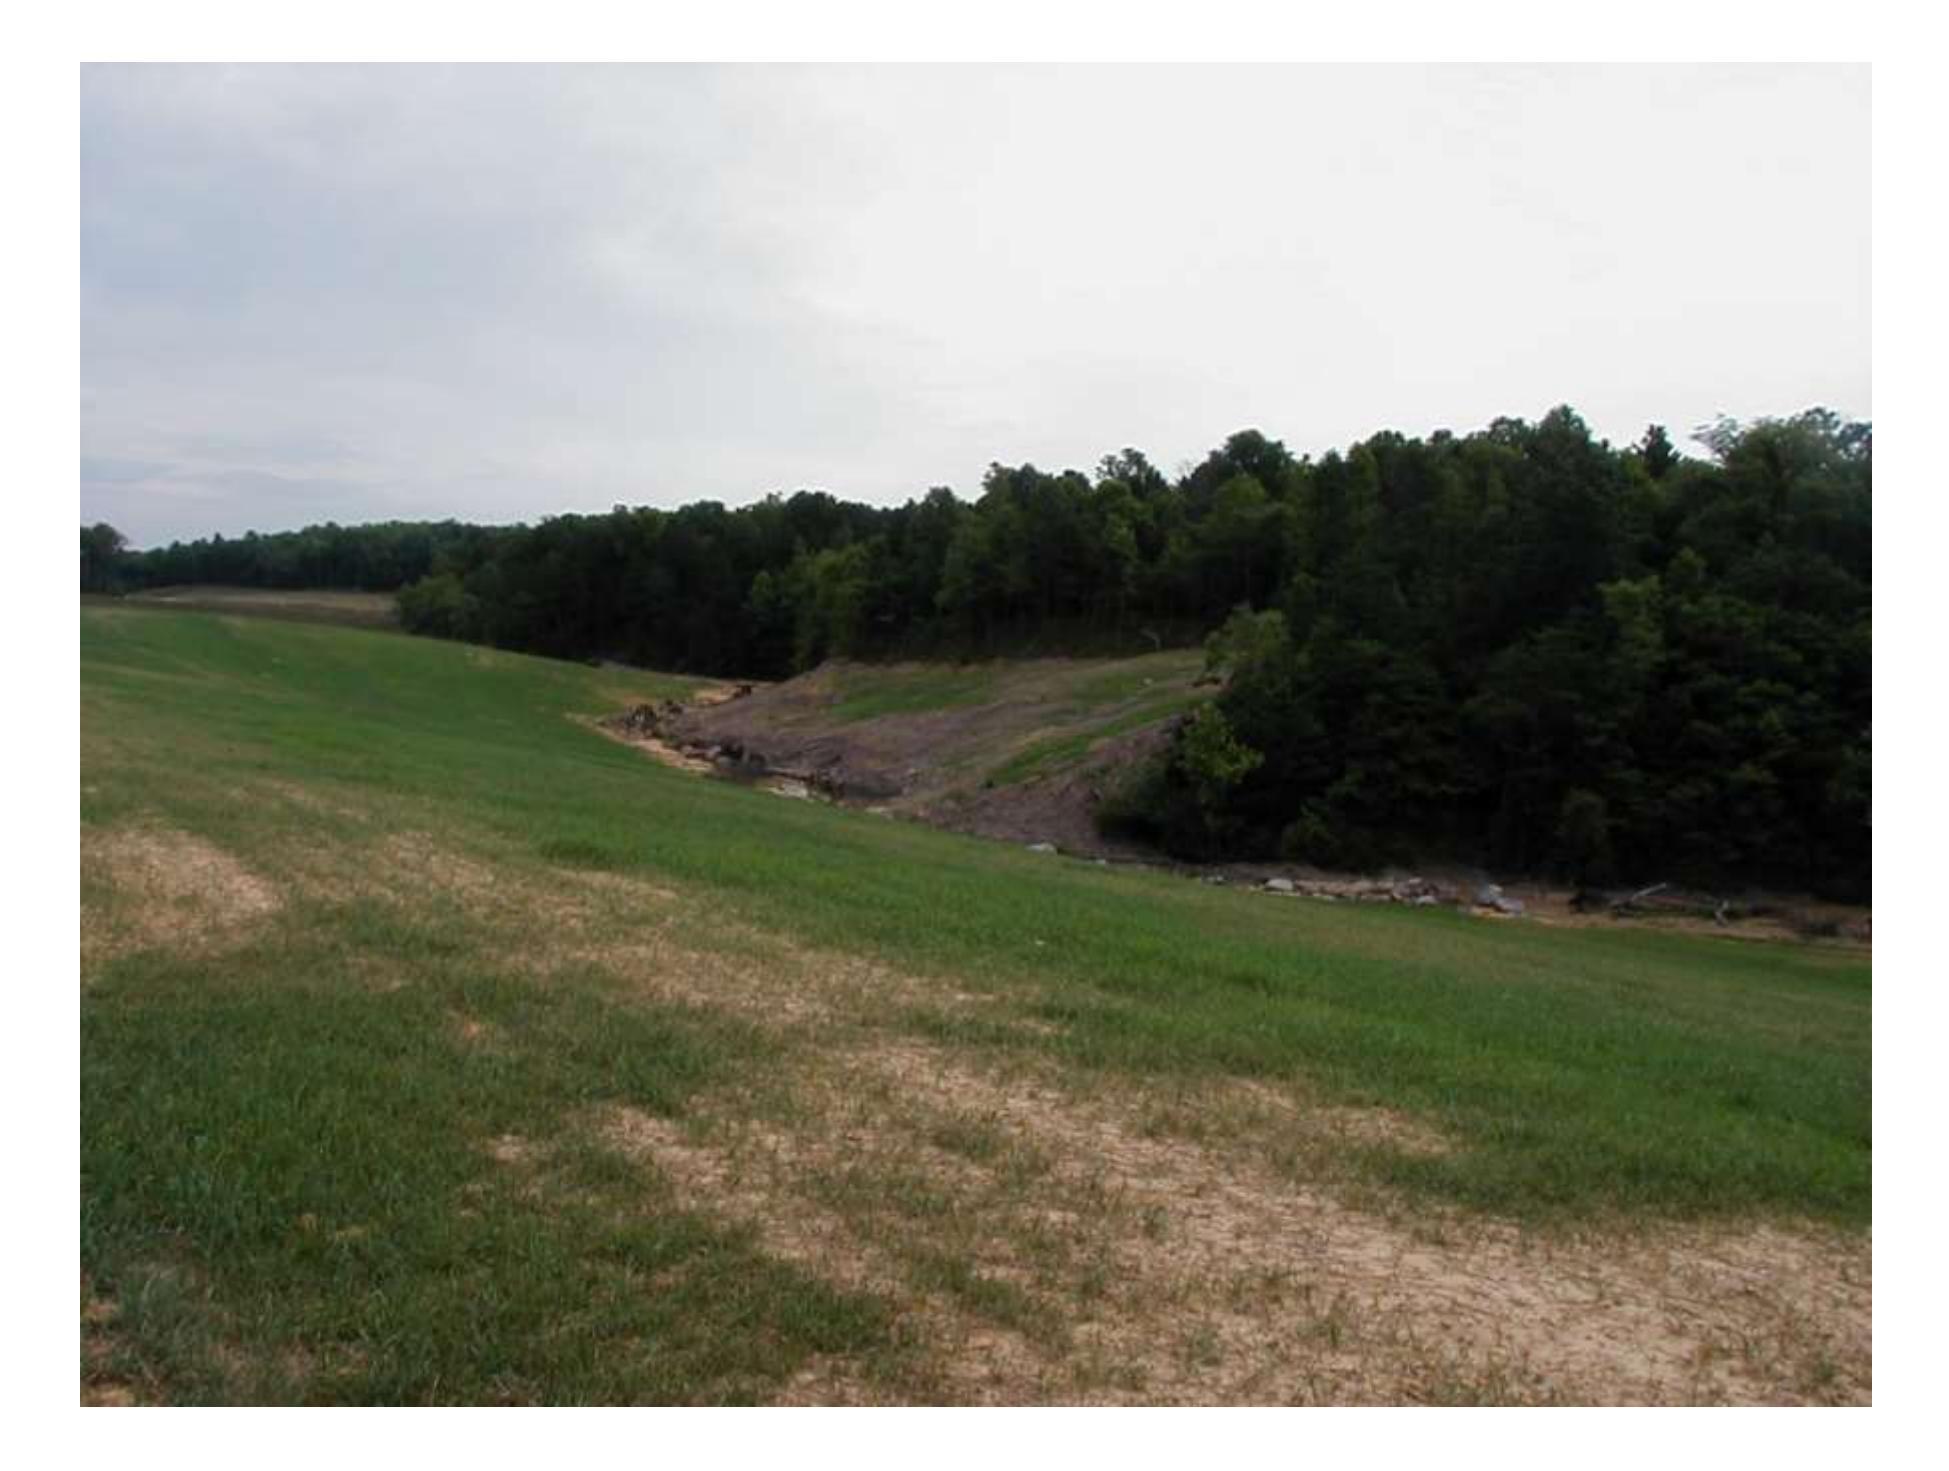
The new stream has a non-linear path and variable substrate.

This project included the construction of a new ephemeral stream, a unique and diverse habitat that supports many plant and animal species. The 1,400 foot stream designed using natural stream morphology has a nonlinear shape and a variety of substrates. The stream should provide valuable wildlife habitat in addition to improving the water quality of Augusta Lake, which has persistent water quality problems associated with acid seeps.

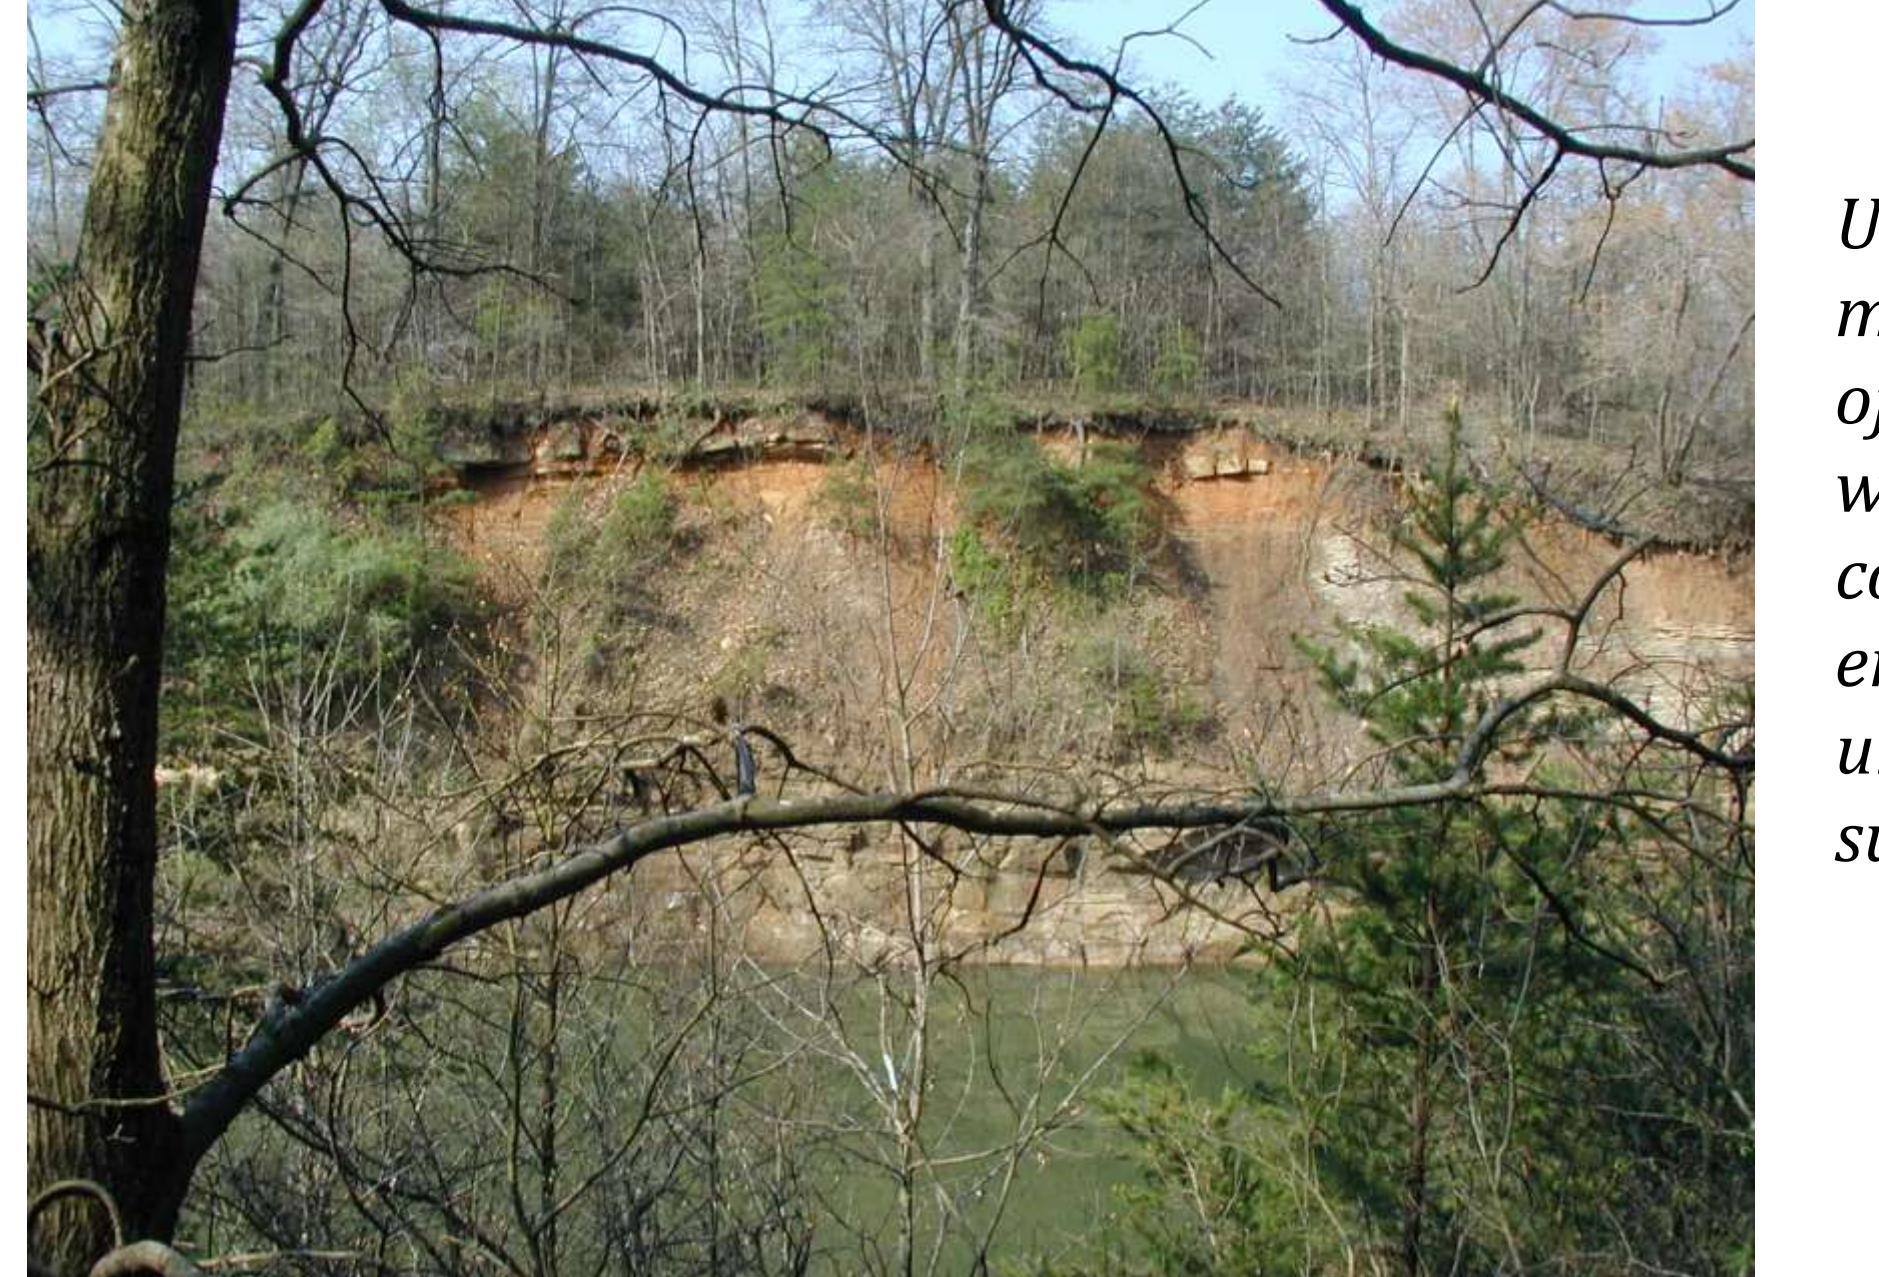
Unconsolidated material at the top of the highwall

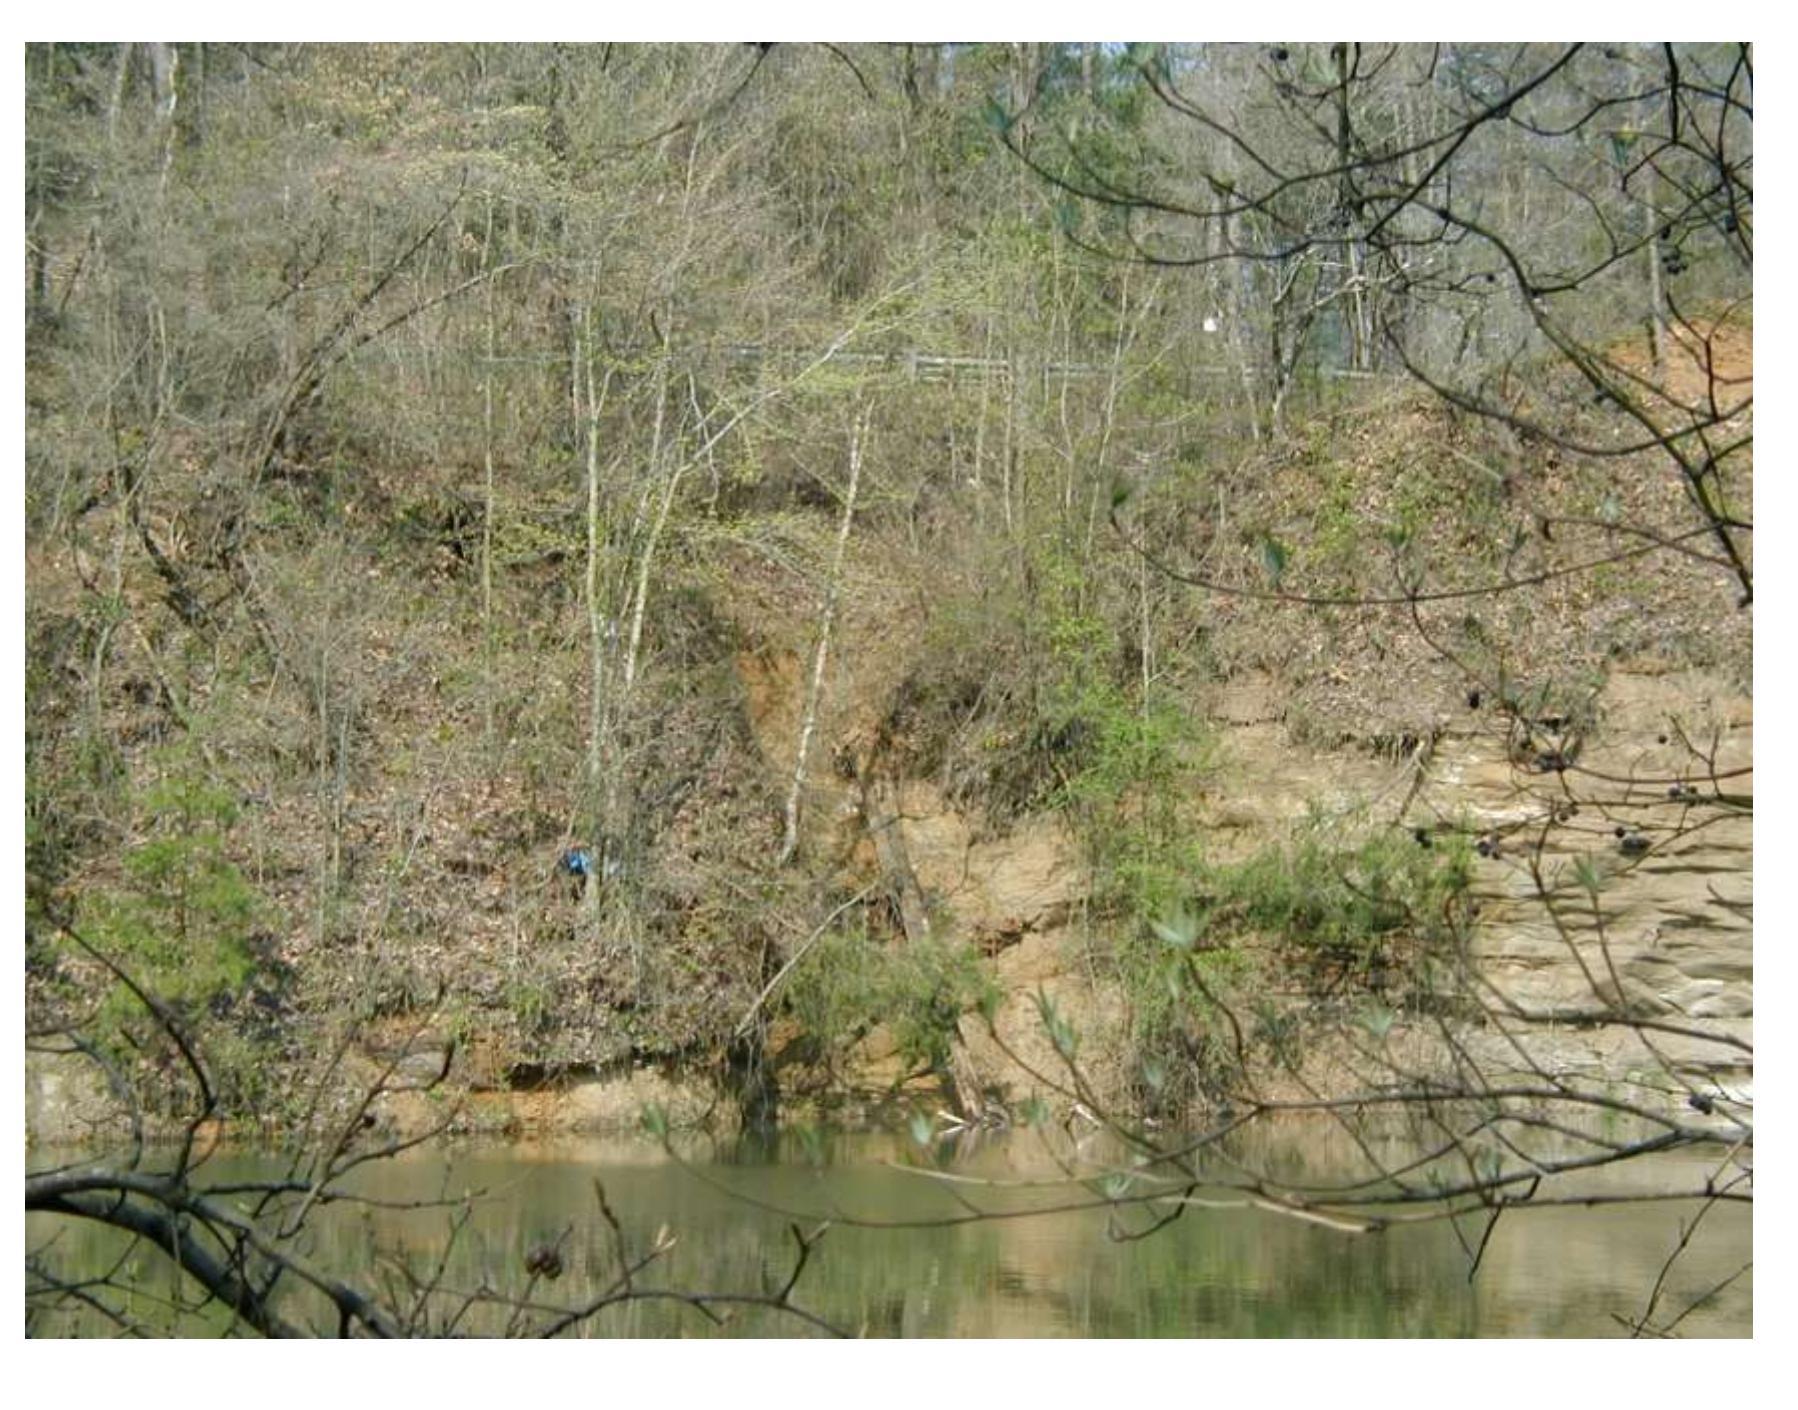
After IBR #7 was approved, AML staff worked with Triad Mining to delineate IBR's #8 and #9 so that the highwall could be reclaimed.

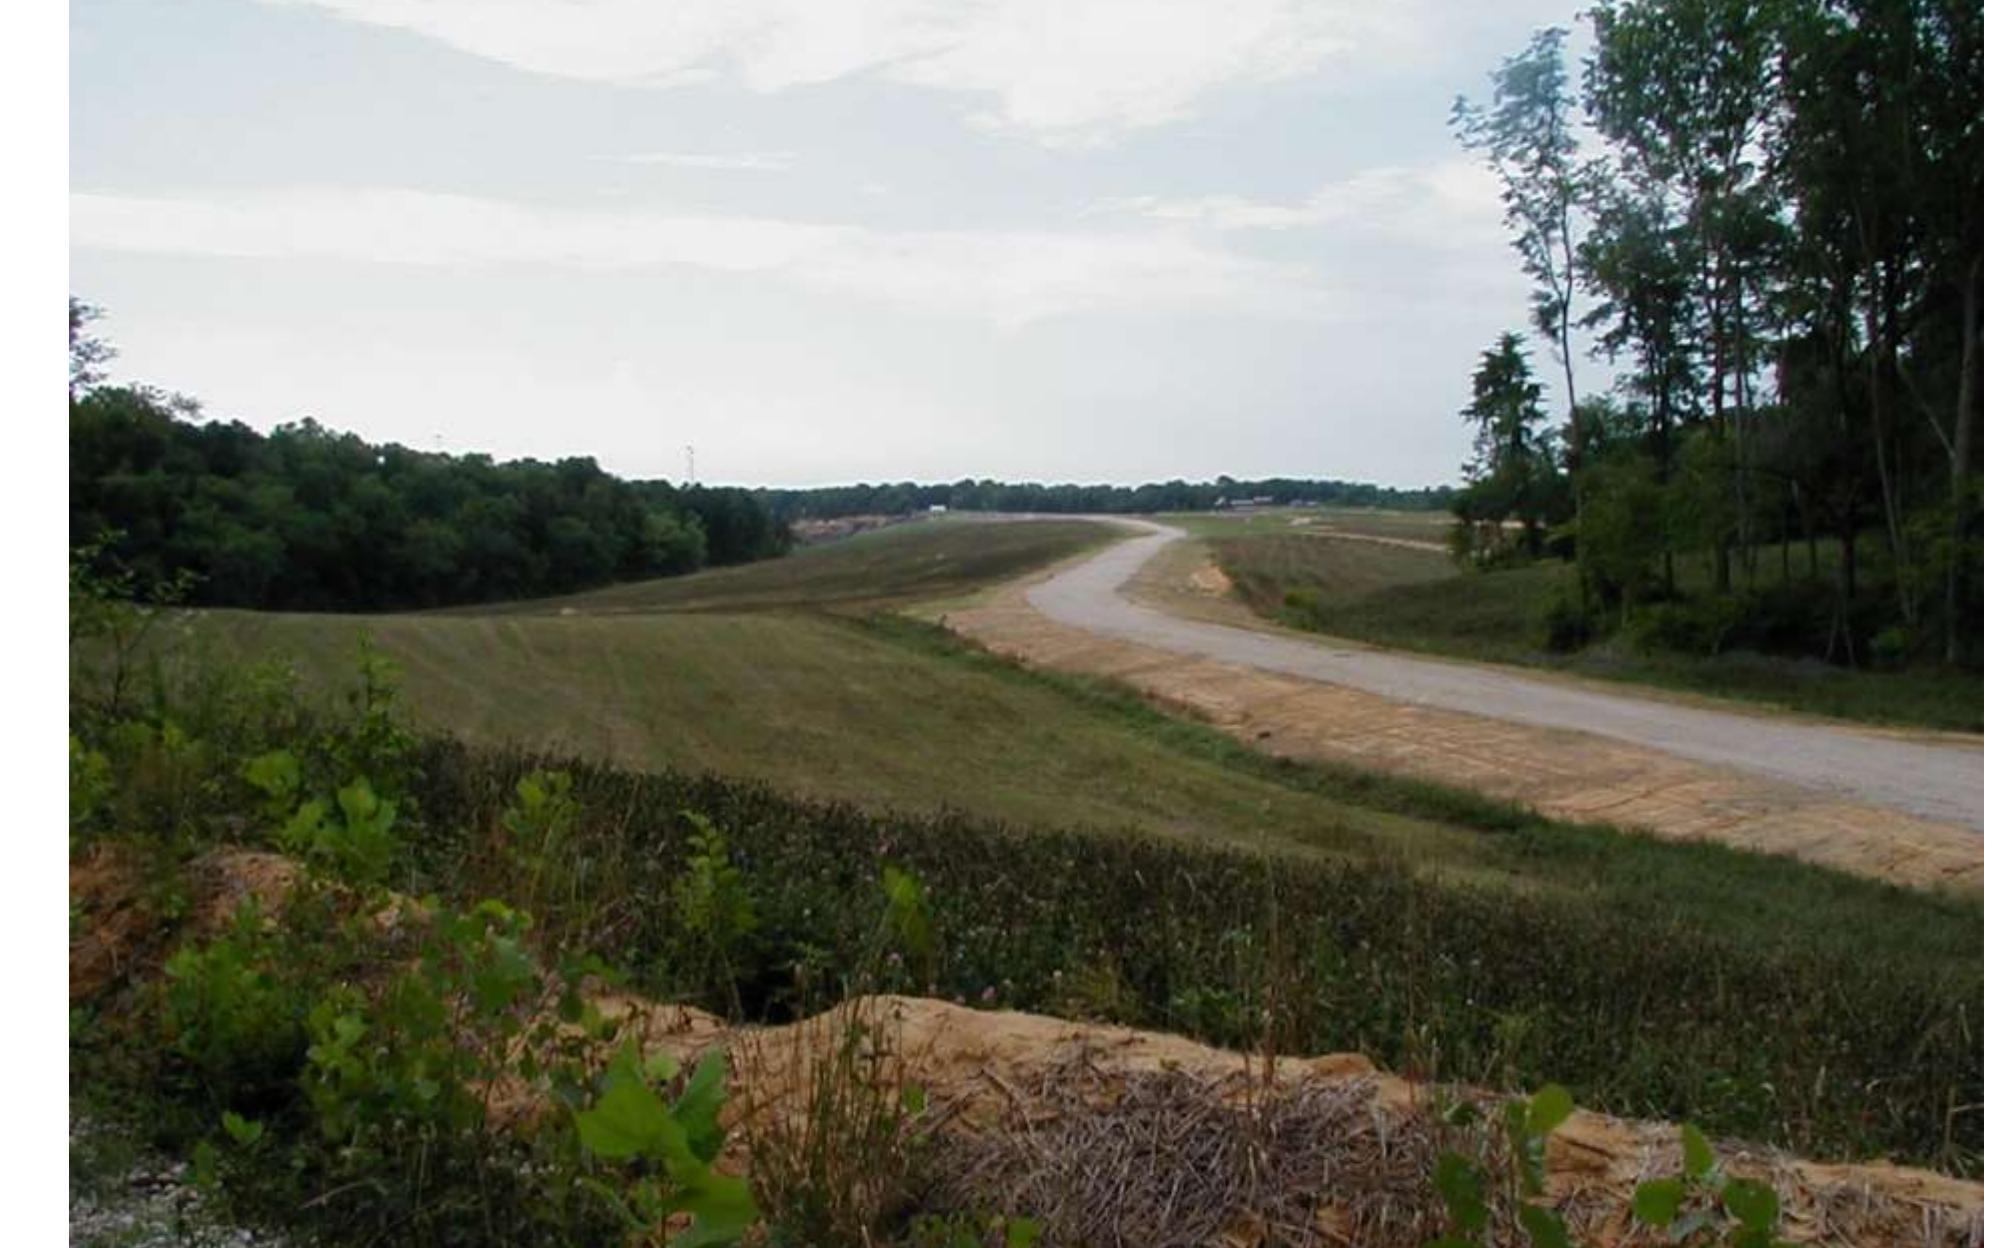
The

landscape

now enjoys

rolling hills.

gentle,

A typical highwall backfill leaves a relatively steep slope, because gentler slopes require more fill material and increase cost. This highwall reduction resulted in a better end product with rolling hills that approximate the original landscape of the area.
