National Register of Historic Places Registration Form

historic name Courthouse Square Historic District
other names/site number 105-055-67000

Section number 7 Page 1 Courthouse Square Historic District

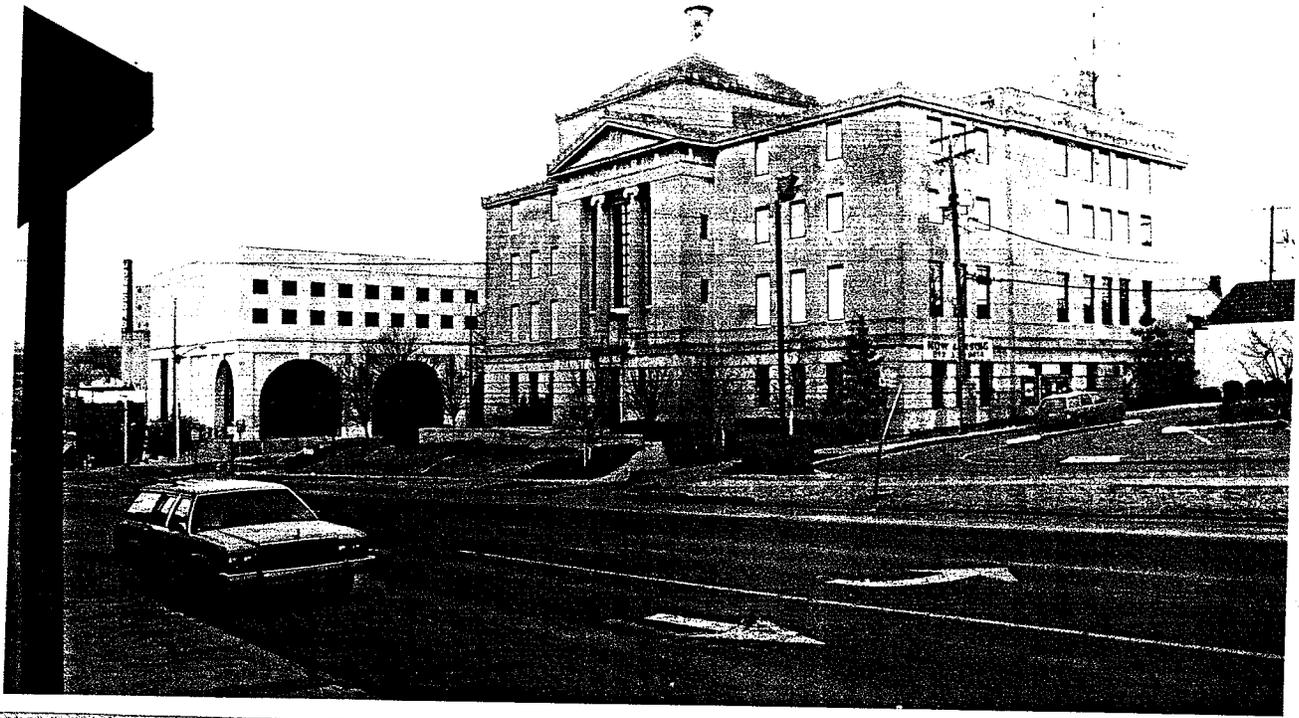
1.

The fourth building displaying Beaux Arts elements in the district is the former Masonic Temple at 120 West Seventh Street (photo 1.). This large, limestone, fraternal building combines elements of both the classic Beaux Arts style and the exotic Egyptian Revival style. The Beaux Arts influence is illustrated by the centrally located pyramid (which replaces the more traditional dome), the projecting front portico with its full, pedimented entablature, two large, engaged, Ionic columns and the rusticated ground floor. The Egyptian influence is evidenced by the stepped pyramid roof capped with a large ornate urn. In 1985 this former Masonic lodge was extensively renovated for use as an office building, which included the addition of windows on the formerly window-less edifice, some intersecting and obscuring a decorative frieze carved in bas relief just below the parapet.

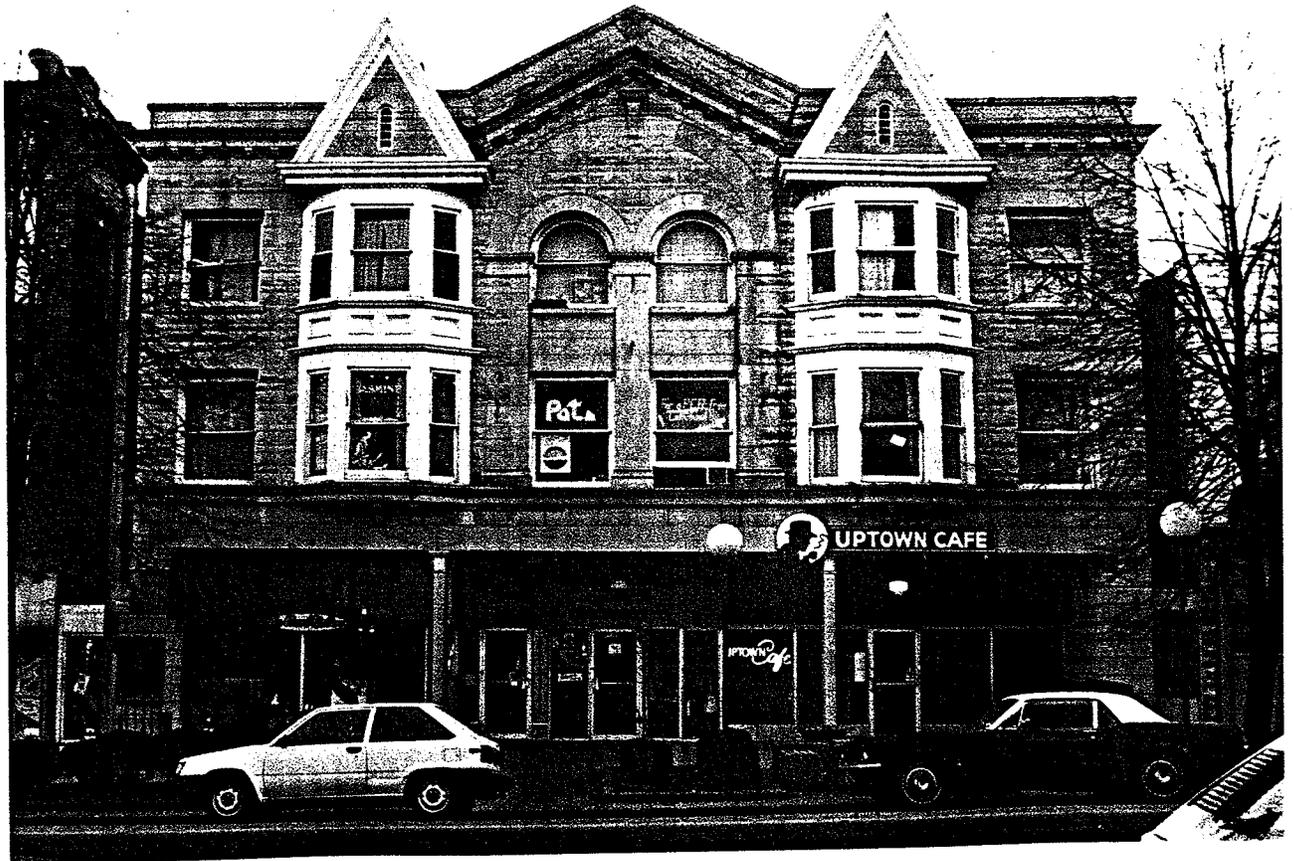
COURTHOUSE SQUARE HISTORIC DISTRICT  
BLOOMINGTON, IN  
17.

The appearance of limestone as a building material for commercial buildings around the Courthouse Square coincided with the appearance of elements of Revival styles of the late nineteenth and early twentieth centuries. The transition is neatly embodied in the Old Monroe County State Bank Building at 100 North Walnut Street (photo 18.) where an 1880's brick, Italianate, commercial structure, which had housed a grocery store, was updated with a rusticated, limestone first floor facade around 1900 to house a bank. The building at 115-119 West Kirkwood Avenue (photo 23.) built in 1898 has a rough faced limestone facade with three Roman arches, which give a Richardsonian Romanesque feel to the building. This same building as well as, the one next door at 121-125 West Kirkwood Avenue built in 1907 (photos 14. and 23.), the group of buildings from 213 to 221 North Walnut Street (photo 3.), which were joined by a common limestone facade c. 1906 and the Allen Building built in 1907 at 102-106 East Kirkwood Avenue (photo 17.) all have full classical entablatures.

The Allen Building built in 1907 at 102-106 East Kirkwood Avenue was first occupied by the Bloomington National Bank and subsequently by a variety of commercial enterprises. This three-story limestone building features a symmetrical front facade and combines elements of the Queen Anne and Classical Revival styles of architecture (photo 17.). Its twin set of bayed windows with steeply pitched gables is strongly reminiscent of the Queen Anne style. The classical influence is evidenced by the molded cornice below the roof line punctuated by the twin gables and the decorative double-arch within an arch framing the center set of windows with flanking Ionic pilasters. During a recent renovation, eight of the original leaded glass windows were reinstalled above the first floor display windows. The west side store space, currently housing the Uptown Cafe, was remodeled to reveal the original ten foot pressed metal ceilings.

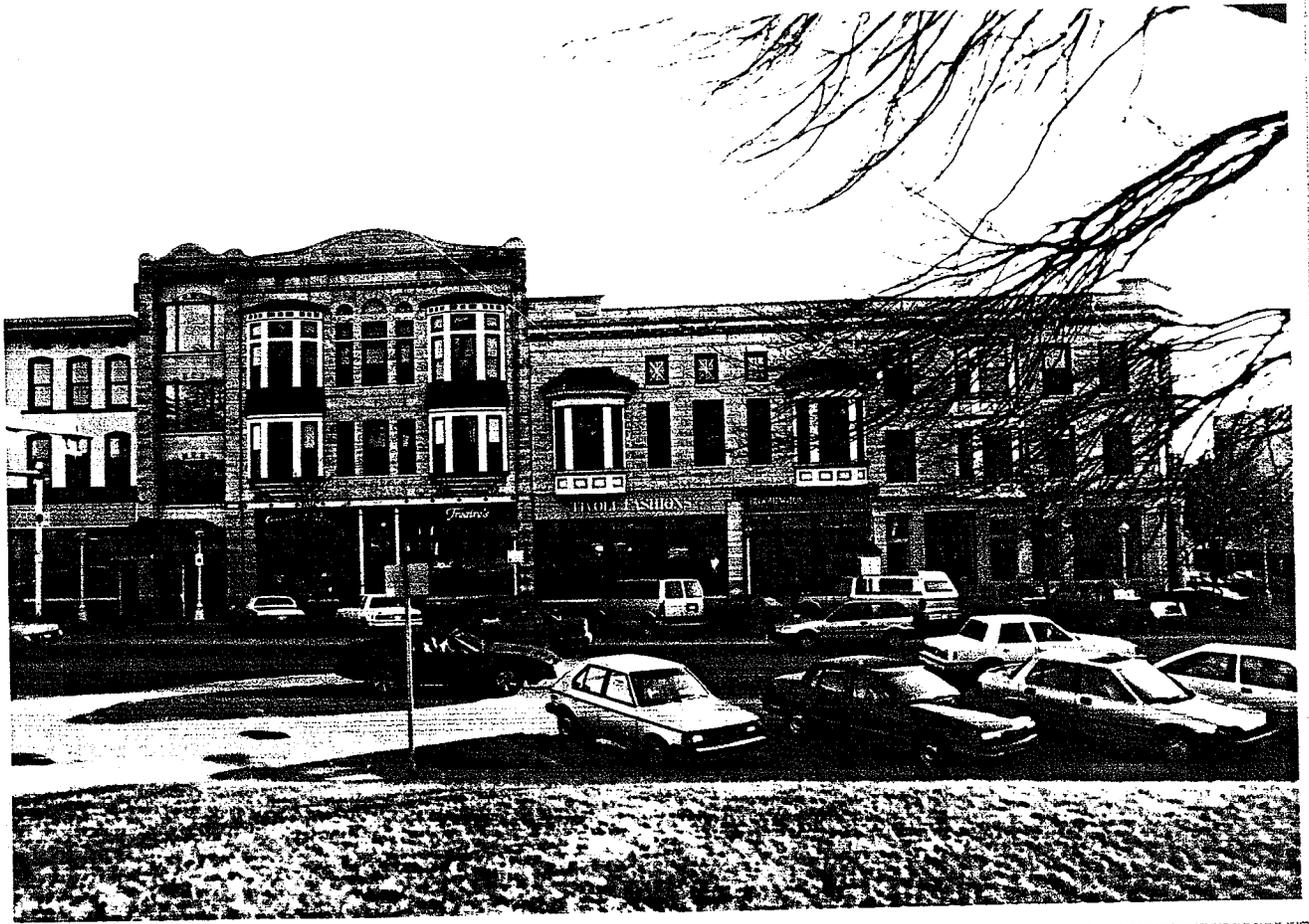
JOHN-ROSE SQUARE HISTORIC DISTRICT  
BLOOMINGTON, IN  
23

The building at 115-119 West Kirkwood Avenue built in 1895 (photo 23.), housed the Kahn clothing store on the first floor from 1898 until the early 1980's, the Knights of Pythias on the second floor and "Castle Hall" on the third floor. Arranged in a comparable fashion to the Allen Building, this three-story building features two-story bayed windows and a central window grouping on its rough-faced limestone exterior. A typical element of the Queen Anne style, the stacked bay windows have ornamental shaped shingles covering the space between

The former First National Bank Building built in 1907 at 121-125 West Kirkwood Avenue, is attributed to John Nichols (photo 14. and 23.). Designed in the Classical Revival style, this three-story, limestone building was obviously designed to complement the building immediately to its east. The vertical window bays punctuate the pattern of openings and display a variety of decorative motifs, including pressed metal ornamentation, classical pilasters and simple capitals. Similar pilasters frame the diagonal corner windows. The corner entry has a double door surrounded by a carved running palmetto motif. The limestone skin of the upper floors has alternating smooth and rusticated bands. A full entablature adorns the cornice. The grade drops one full story to the south on the west elevation of College Avenue.
