**National Register of Historic Places
Registration Form**

historic name Northern States Life Insurance Company
other names/site number _____

street & number 5935 Hohman Avenue N/A not for publication
city or town Hammond N/A vicinity
state Indiana code IN county Lake code 089 zip code 46320

Northern States Life Insurance Company, Lake County, IN

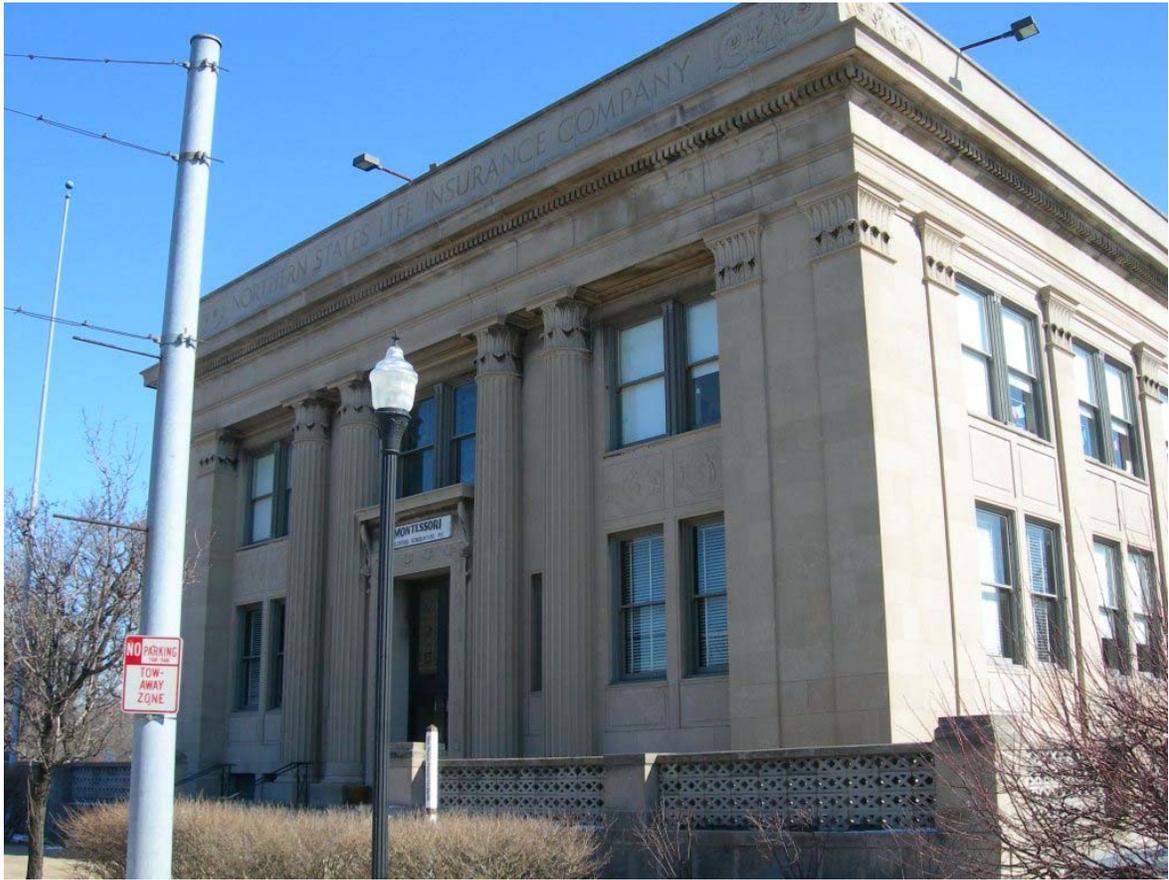
Northern States Life Insurance Company, Lake Co., IN photo 1

The front facade (photo 0001), facing Hohman Avenue/west, is symmetrically configured with a large center entry approached by a wide series of five limestone steps leading to the terrace. The terrace has a low wall/balustrade on each side of the steps, each side being divided into two sections with a lower, center stone pier and slightly taller corner and end piers. A continuous stone handrail caps the low wall/balustrade, forming the top of the center pier also. The corner and end piers have two additional stone blocks in receding size forming a taller cap. The stone balustrade (below the stone cap) on the front facade was replaced with decorative concrete block, c. 1960, probably due to deterioration of the stone spindles. One other feature of the stone piers, now removed, were tall stone columns that supported light fixtures on the corner and end piers. Stone pavers are located immediately in front of the entry at the top of the steps while buff colored brick pavers create the remaining floor of the terrace. The field of pavers has concrete paving against the balustrade and building. The depth of the terrace is approximately six foot from building to balustrade. The stone entry steps have two equally spaced bronze handrails flanking the entry. Each handrail has two rails joined together at the top and bottom of the steps and each are supported by an "S" design connecting them to the legs of the rail, anchored into the stone steps. Each leg is connected by an "X" design between.

Where the engaged columns form a deeper facade recess between the corners of the building, the entablature has an exposed soffit area that is coffered in stone (as seen at the top of photo 0002). The front facade's parapet has engraved "NORTHERN STATES LIFE INSURANCE COMPANY" centered across the building with low-relief carvings on each side, at the corners. These carved blocks have an urn supported by merman holding a scrolling acanthus vine in one hand and the urn in their other (as seen at the top of photo 0001). The parapet wall has a simple, flat-faced cap.

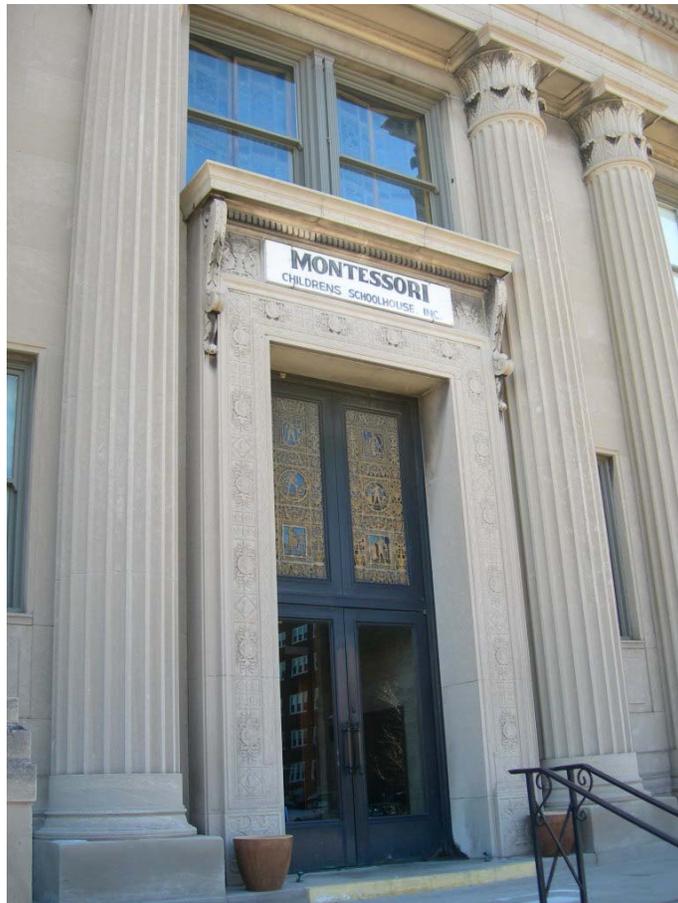
Northern States Life Insurance Company, Lake Co., IN photo 2

The front facade of the main building is divided into three principle bays. The center, entry bay is flanked by pairs of engaged fluted columns in antis (photo 0002); the outside bays are terminated at the corners by pairs of pilasters applied as ornament to antae. The pilasters and columns are set on stone bases. The center bay has a single stone step leading to the pair of brass doors. The entry opening has a projecting stone architrave surround that extends to incorporate the tall transoms above the entry doors (photo 0002). The surround has low-relief carvings in Greek figural motifs. On the base of each side of the surround are blocks with carvings of an urn with mermen on each side, griffins sitting on the urn and scrolling leaves and lotus flowers creating an organic pattern, each side with slightly different depictions of the Greek figures. The face of the surround continues with low relief carvings in a pattern of griffin in a diamond shape beaded frame, a woman's cameo surrounded by acanthus leaves, a grid of lotus flowers and leaves, a man's cameo surrounded by acanthus leaves, then the pattern repeats itself twice again before forming the top of the surround with the same pattern, but with a leaf design centered above the door. To the inside of the low-relief pattern is a simple pierced carving in a diamond and oval leaf pattern extending around the entire surround. The top of the surround has a pair of scrolled acanthus leaf covered console brackets supporting a denticulated cornice, with a pierced carving in a swag design on its lower face. Just below the cornice hood and above the carving of the surround is a sign with the building's current user's name on a wood board. Flanking the sign are low-relief blocks with the urn, griffin

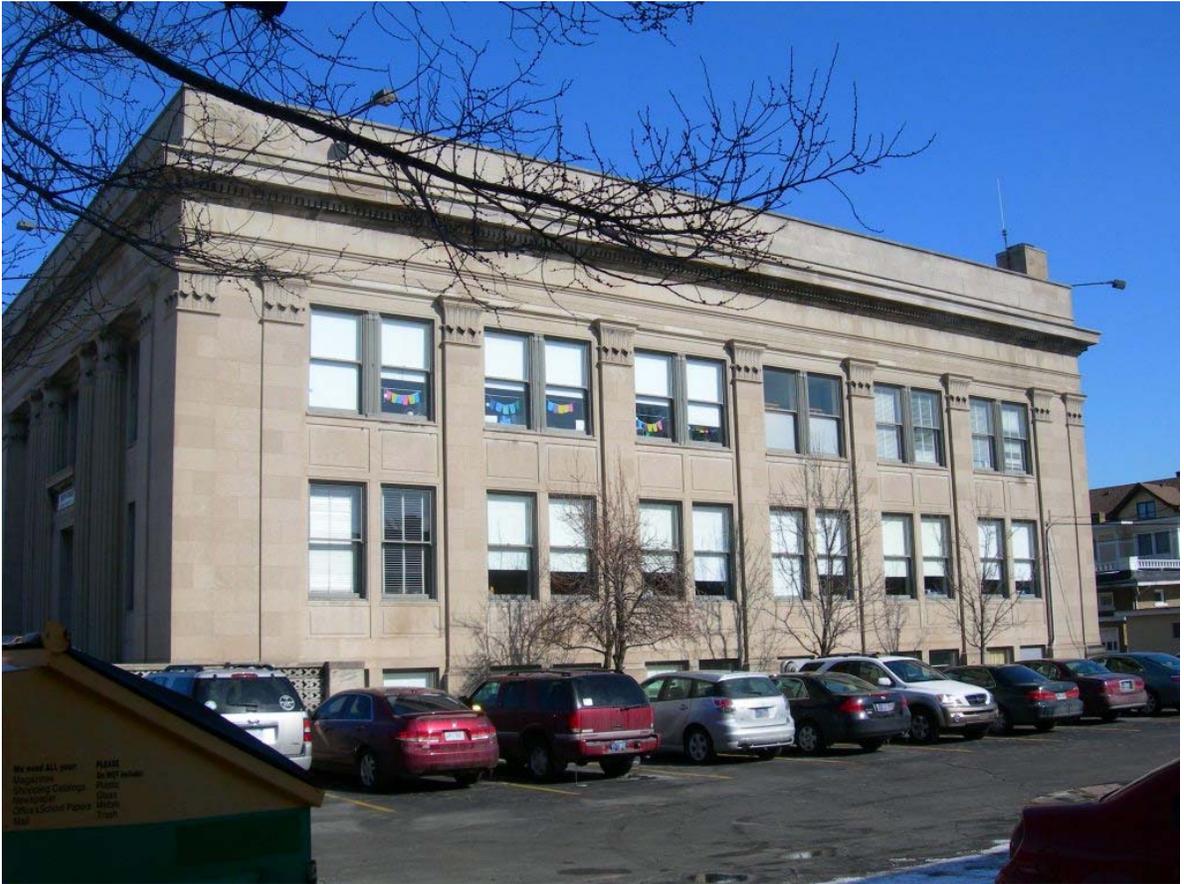
Northern States Life Insurance Company, Lake Co., IN photo 3

The north (Waltham Street) and south facades are essentially mirrored (photos 0003, 0004); the only variation is the terrace/building pedestal extends entirely along the north facade (photo 0004), but is located only in the west corner of the south facade (photo 0008). The north facade has a terrace with a balustrade constructed of stone spindles divided into nine sections by stone piers with a continuous stone cap/handrail. The corners are terminated by slightly taller piers. The terrace floor is brick pavers set between concrete paving against the building and balustrade (photo 0006). A set

The building fronts Hohman Avenue, facing west. Lining Hohman Avenue in this area is a mixture of architectural styles and types. To the north smaller scale commercial buildings dating to the period between c. 1940-1970 line Hohman on its west side and Harrison Park (1898), a large city park comparable in size to four city blocks fronts Hohman on the east side and is immediately north of the Northern States building on the north side of Waltham Street. Immediately west and south of the Northern States building are larger scale commercial buildings in a mixture of styles, most notably the five story Southmoor Hotel constructed in 1929 in the Colonial Revival Style, on the west side of Hohman facing east. Other buildings on the same block facing west on Hohman, as the Northern States building, are the First Presbyterian Church (1954), an apartment building (1923), a residence (1919), and an office building (c. 1950). Immediately south of the Northern States building is an asphalt parking lot (as seen in photo 0003).

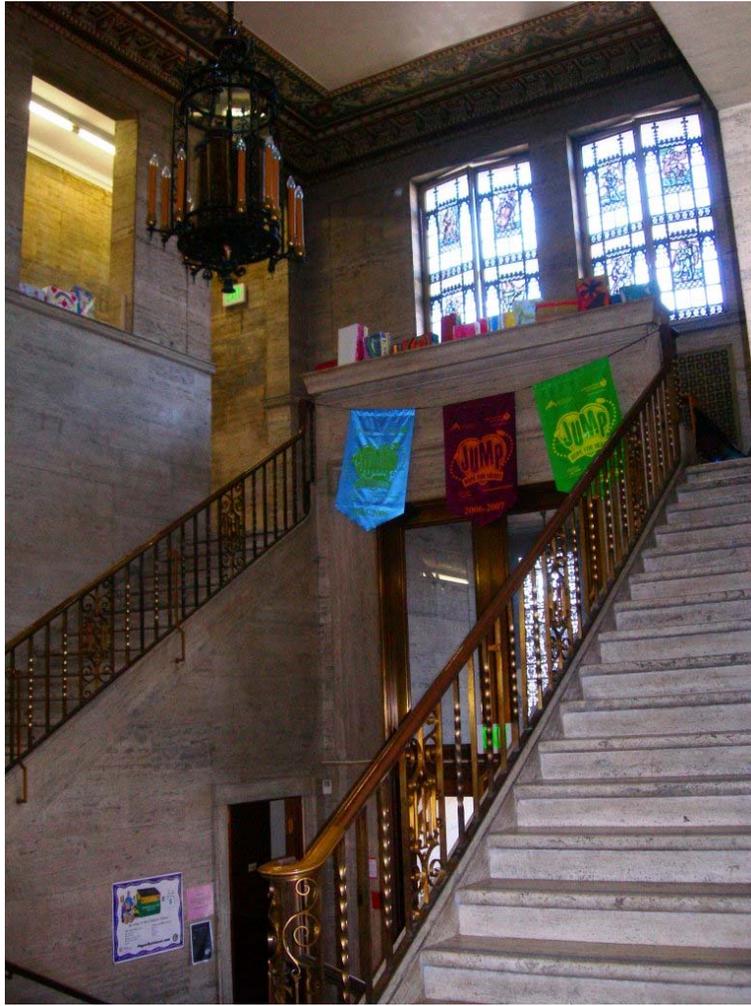
Northern States Life Insurance Company, Lake Co., IN photo 12

The west half of the atrium has second level staircases flanking the grand center stairs with a highly ornate brass balustrade on a travertine base (photo 0012). It has a flat metal, turned spindle design with three scrolled pattern panels on each side with N S L overlaid as a monogram. The base of the balustrade has its handrail curve back toward the center staircase with flat metal, turned spindles and the N S L monogram curved with the newels. This also occurs to the outside of the second level staircases, with the travertine base and balustrade curving back toward the side chambers (photo 0018). The tops of the second level staircases end at a balcony with a low travertine wall with ogee trimmed cap directly over the vestibule entrance below (as seen in the upper half of photo 0012). An opening to the north and south leads to a series of four steps and a hallway leading east with four openings overlooking the atrium, creating an arcade feel (photo 0017). The floor, walls and square columns of the arcade are also covered in travertine (photo 0024). The two window openings on the second level of the front facade's center bay are located at the balcony/landing of the interior second level staircases. The openings have pairs of art glass metal casement windows with metal filigree forming various patterns with two Medieval figural scenes on each leaf (as seen at the top of photo 0012). This is repeated in the two window openings on the east wall of the atrium, on the second level, with stained art glass in place of clear (photos 0015, 0016).

The large chandelier is wrought iron, suspended from a heavy wrought iron link chain. It has a reserved, ornate design with a medieval appearance. Four arms hold three electrified candles each, in polished brass holders. Four decorative, faux oil cylinders with finial tops are located in the fixture. (photos 0012, 0015, 0016)

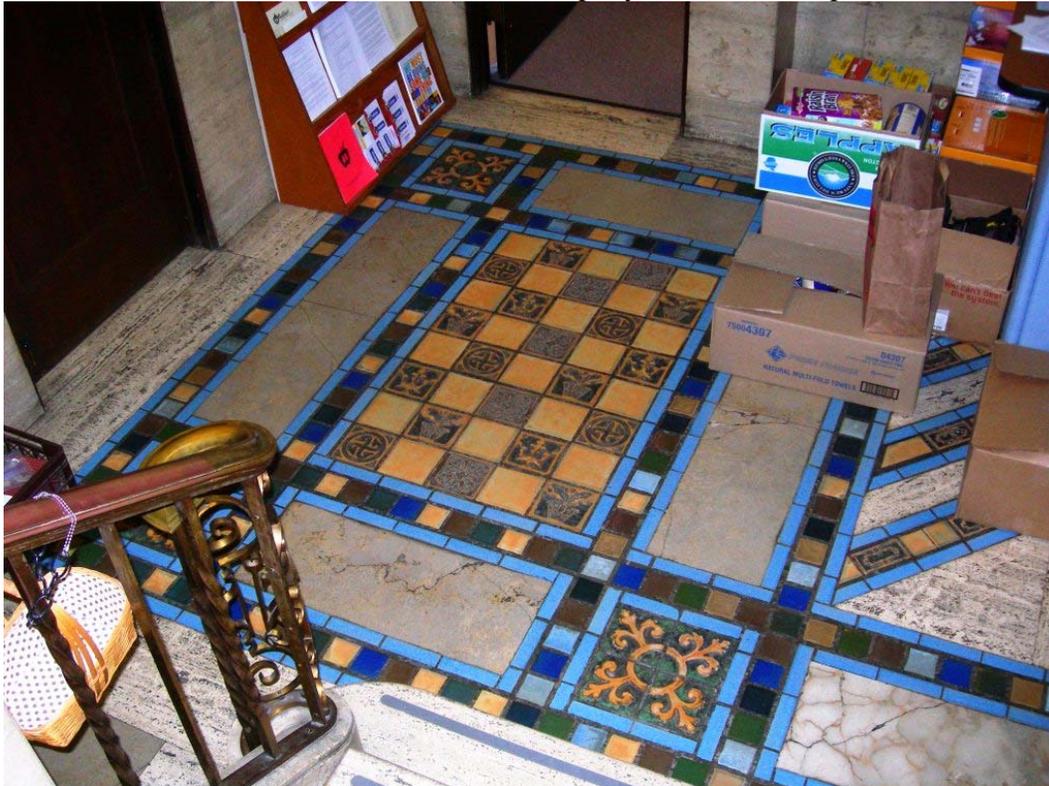
Northern States Life Insurance Company, Lake Co., IN photo 14

The main level of the atrium has extensive ceramic tile inlay in the travertine floor incorporating some varying marbles into the pattern (photo 0014-north side of atrium). A large square opening is located on the east wall of the main level, directly in line with the grand stairs (lower part of photo 0015). It has a deep counter/recess into the wall. Stepping out from the main east wall, to each side of the opening, is a wall with a door opening on each side. Above the opening is a round, metal clock with brass hands and roman numerals (center of photo 0015). Above the clock is a belt course of ogee trim in travertine that forms the base of second level windows on the east wall and the base of the openings creating the arcade on the north and south sides of the atrium. From the main level landing, a side chamber opens off of each the north and south sides, a single story in height, but also having walls and floor covered in travertine (photo 0013-south side). A doorway is centered in each side (south and east or north and east). The west walls have openings to a smaller ante-chamber which leads to the president's office on the north side of the atrium (photo 0019) and to the board room on the south side.

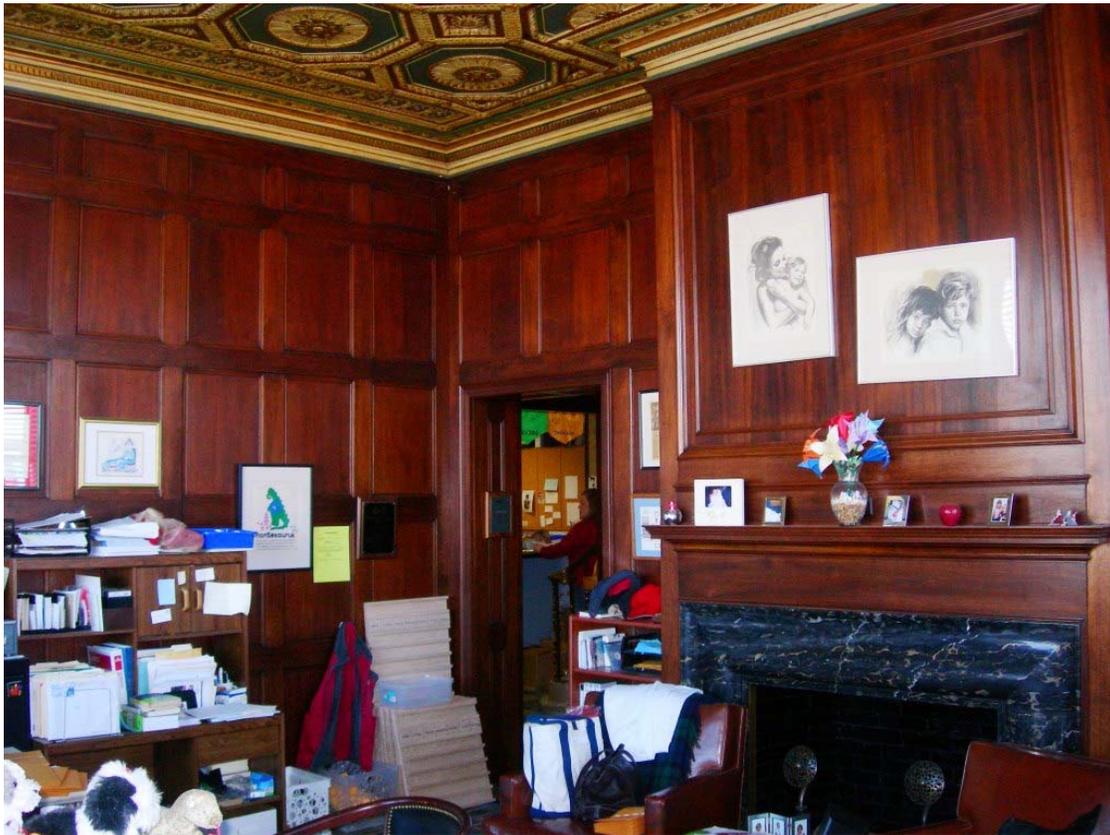
Northern States Life Insurance Company, Lake Co., IN photo 20

The cove molding and coffered ceiling of the office are highly ornate and also have been intricately finished with a high amount of gilding (as seen at the top of photo 0020). The ceiling is divided into octagonal and diamond coffers with large medallions in the octagonal sections and smaller medallions in the diamonds. Each coffer is defined by egg and dart moldings and octagonal coffers have floral medallions. A private toilet room is located off the southwest corner of the office. The toilet room floor is gray terrazzo, with a secondary two panel wood door for an interior closet. The toilet rooms in each the board room and president's office are where the narrow windows on the front facade's main level are located.
