INDIANA DEPARTMENT OF TRANSPORTATION

CONSTRUCTION MEMORANDUM 23-07

SUBJECT: Notice of Termination (NOT)

Photographic Documentation Instructions

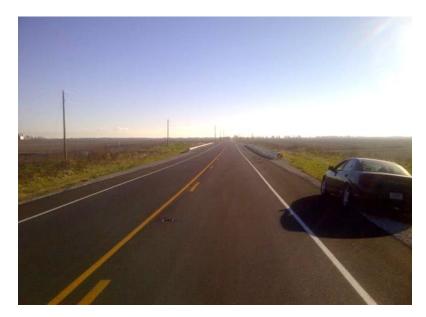
Image 1 Example of both poor placement of the roadway within the picture and poor lighting conditions.

The photographs for both the panoramic and perpendicular spot locations should be taken at a time of day that best minimizes shadows. This time normally occurs between 11:00 am and 4:00 pm. When taking panoramic photographs, ensure the general focus of the photo is on the turf areas offset from the road. Do not center the road in the picture as indicated in Image 1 of this appendix. Pick a time of day when a good representation of the area can be seen as indicated in Image 2.

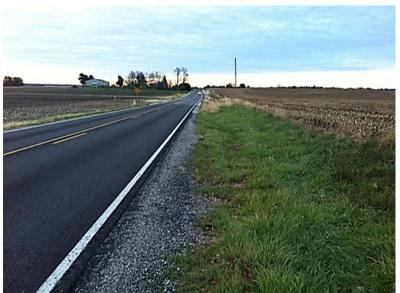
Image 2 Example showing a good representation of the area.

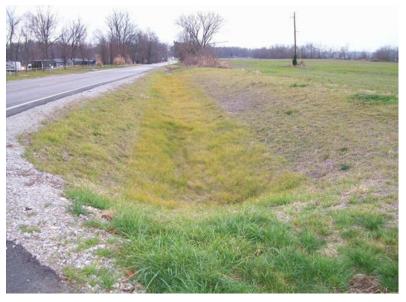
Image 3 Yellow vegetation may be viewed as unhealthy and may require soil enrichment.

Yellow color of vegetation may be viewed as being unhealthy and may require soil enrichment as indicated in Image 3.

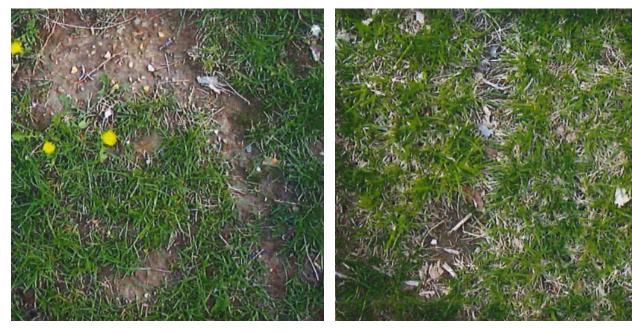
Image 4 Vegetation Coverage: 40-50%.

Image 5 Vegetation Coverage: 50-60%.

A series of pictures are shown below to provide examples of vegetation coverage percentages.

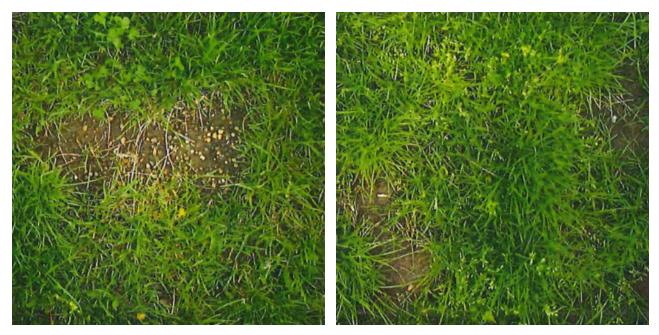
Image 6 Vegetation Coverage: 60-70%.

Image 7 Vegetation Coverage: 70-80%.
