### SOUND BARRIER PROTUSIONS

Figure 51-9B

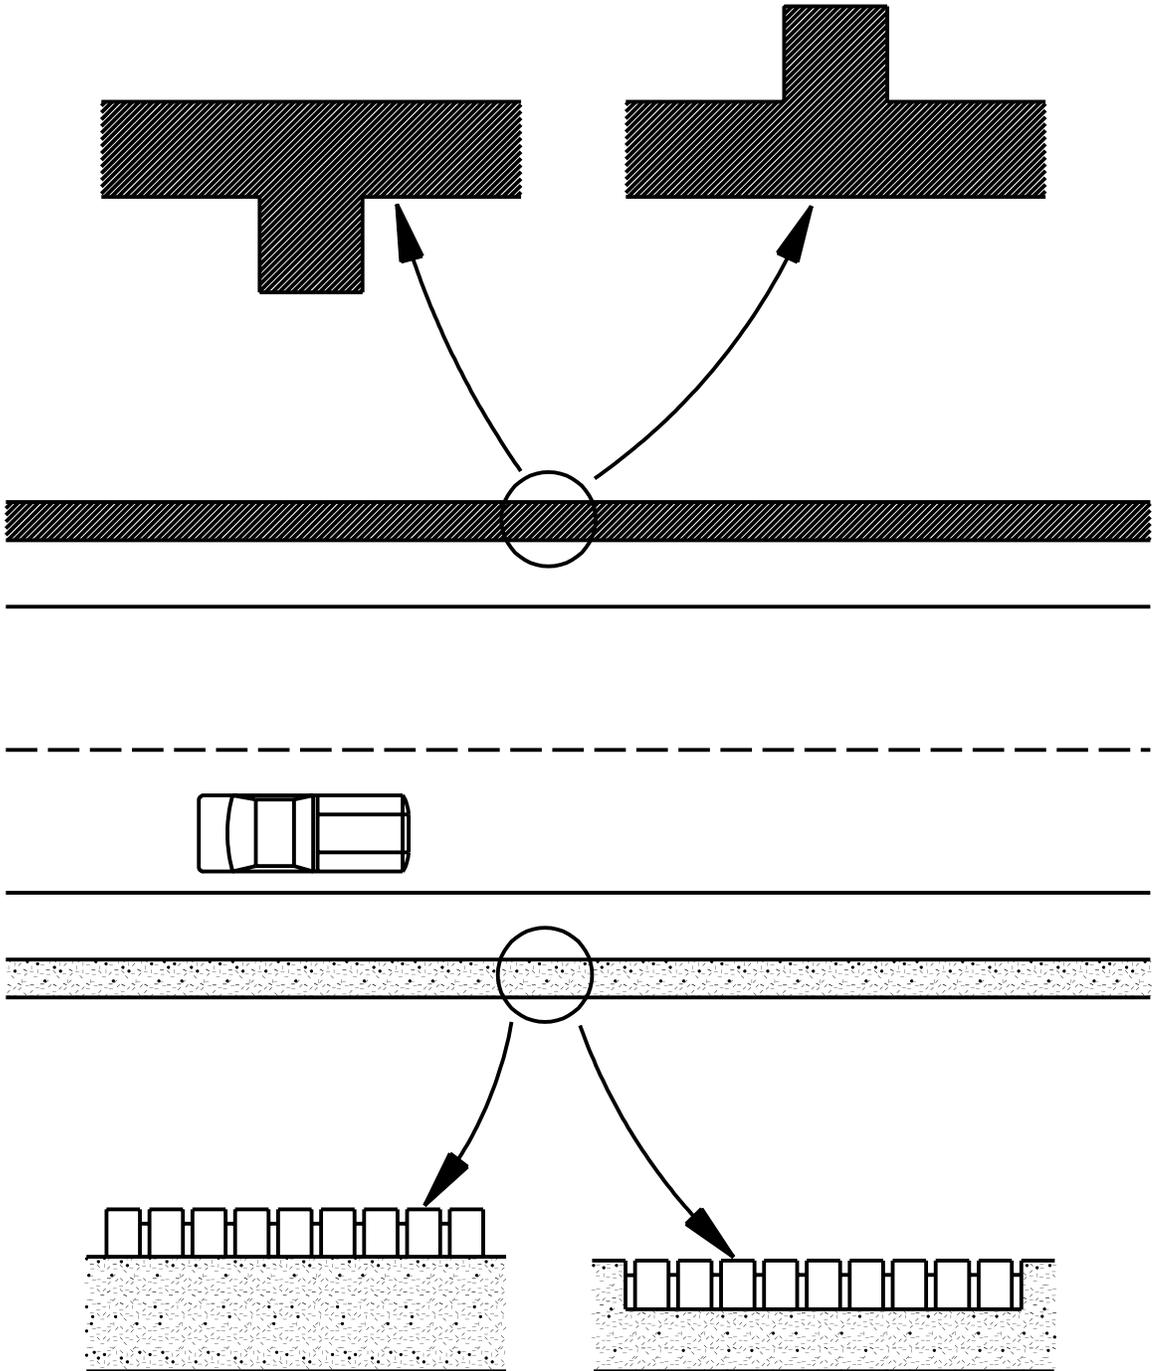
AVOID LARGE COLUMN  
PROTRUSIONS ON WALL  
ADJACENT TO TRAFFIC  
LANE

ACCEPTABLE

AVOID FACING WHICH  
MAY BECOME SAFETY  
HAZARDS WHEN HIT

FACING SET INTO  
RECESS
