Conditional Sales Agreement

INDOT's Hazardous Materials Unit is pleased to submit our report describing the findings of the Phase I Environmental Site Assessment of excess properties on both the south and north sides of SR 62 (Lloyd Expressway) between N 6th Avenue eastwards to N 2nd Avenue. These properties were acquired by INDOT for the construction of the Lloyd Expressway and associated Fulton Avenue entrance and exit ramps. This assessment was prepared in general accordance with the American Society of Testing and Materials (ASTM) Standard Practices for Environmental Site Assessments: Phase I ESA Process (ASTM Designation: E1527-2000).

Vincennes District engaged INDOT's Hazardous Materials Unit to conduct a Phase I Environmental Site Assessment (ESA) of six excess parcels. The six parcels were acquired for the construction of Lloyd Expressway and associated entrance and exit ramps in Evansville. The six parcels are located at or near the new overpass where the Lloyd Expressway passes over Fulton Avenue and the associated entrance and exit ramps off of Lloyd Expressway onto Fulton Avenue.

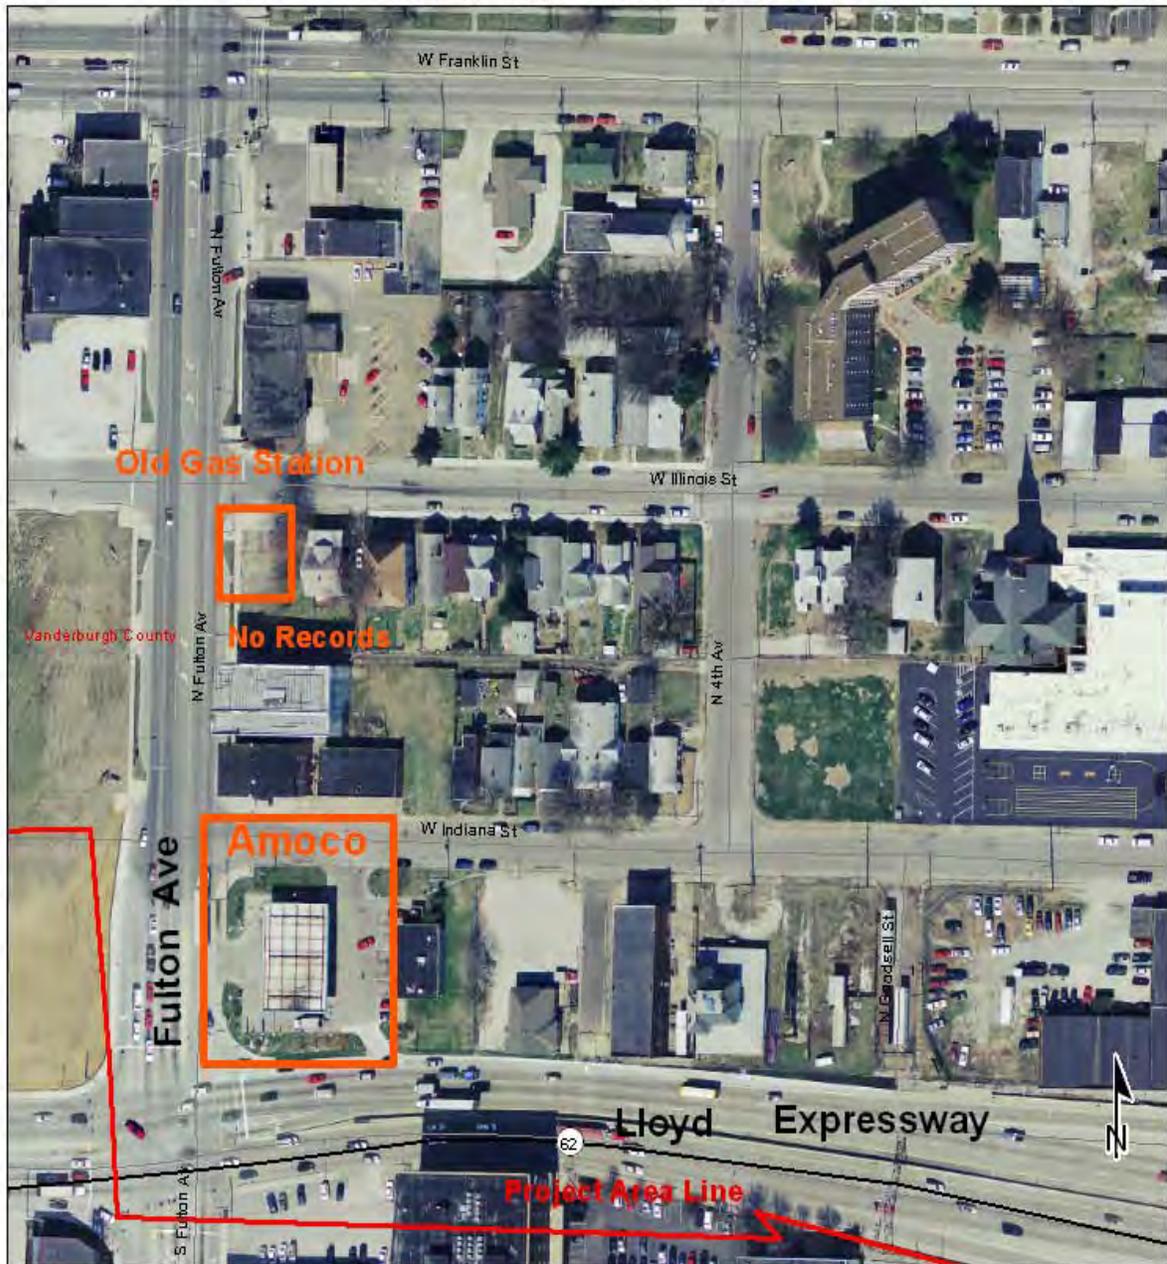
Figure 3 - Aerial Detail NE Quad
 Lloyd Expressway & Fulton Ave
 LA Code 4603, Parcel # 1 , Excess Parcel Disposal
 Vanderburgh County, Indiana

Northeast Quadrant is only Quadrant with no INDOT Excess parcels

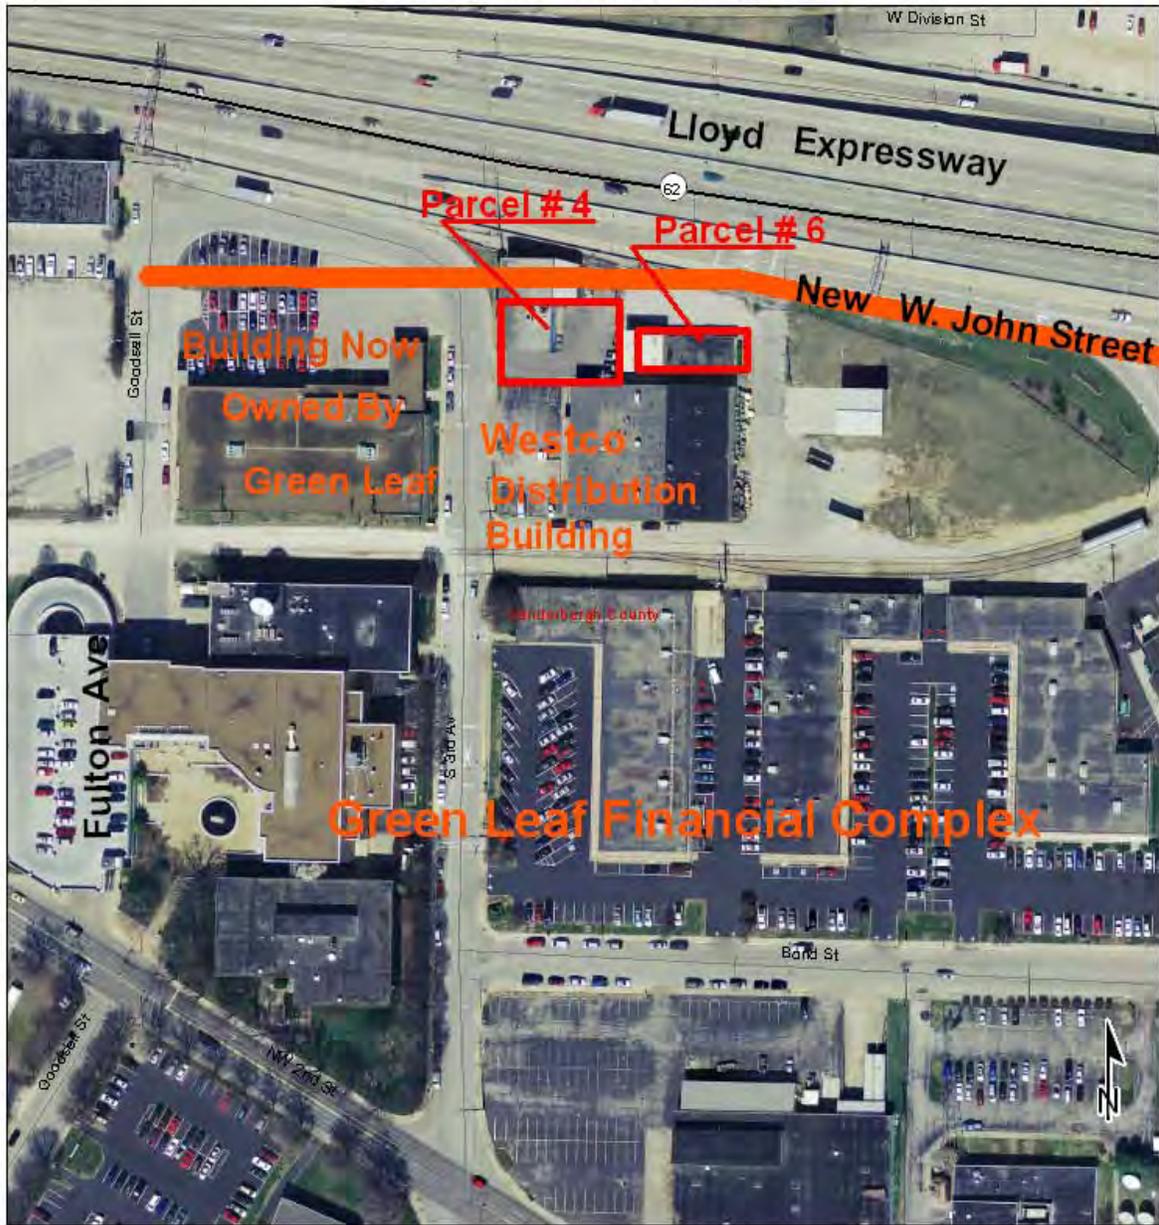
Figure 5 - Aerial Detail SE Quad
 Lloyd Expressway & Fulton Ave
 LA Code 4913, Parcels # 4 & #6 Excess Parcels
 Vanderburgh County, Indiana

Parcels #4 and #6 are very small parcels that are east of the Shelby O’Neal Steel building. These lay immediately south of the Lloyd Expressway, and part of these parcels was taken and used for the construction of John Street and for the entrance/exit ramps for Lloyd Expressway. No environmental records for either parcel could be found. The area is now used for parking, and a 2005 aerial photograph indicates the presence of a small storage shed on parcel # 4.

Southwest Quadrangle, Parcels #4 & #6
 ——— Boundary INDOT Excess Property
 ——— Location of New Street (St. John)

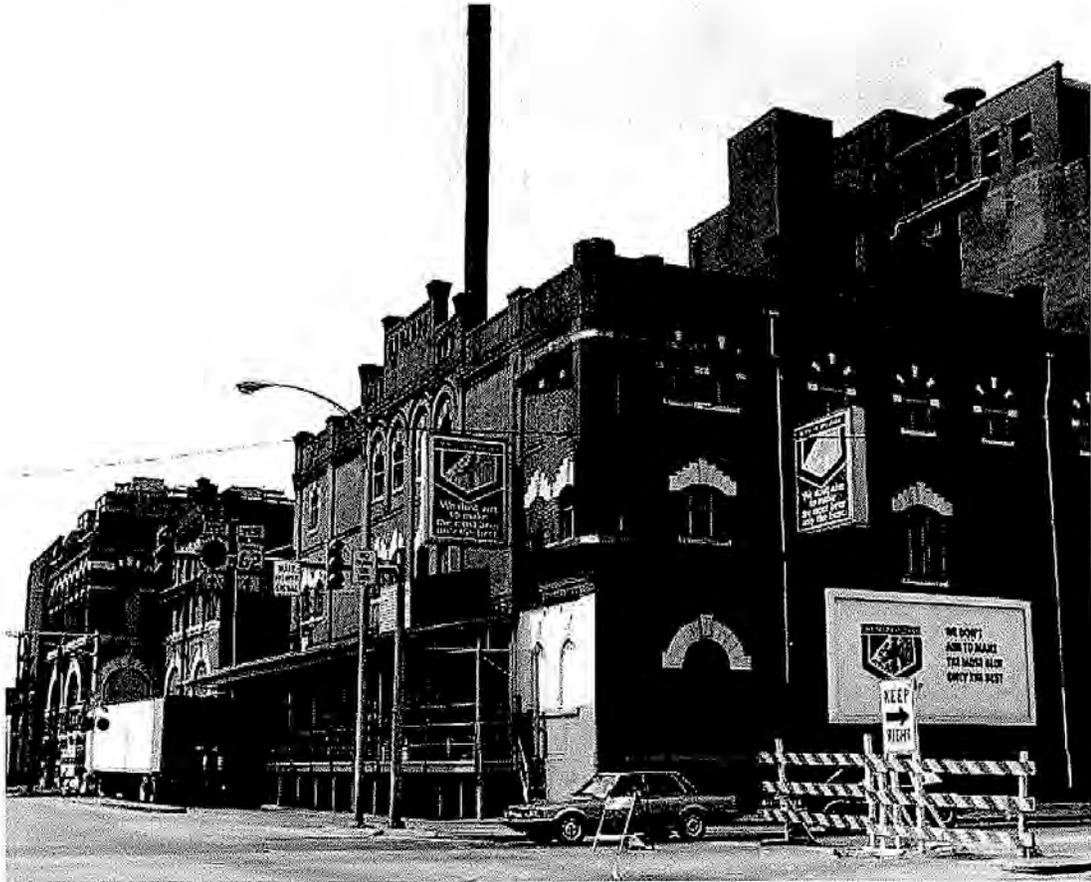
Sterling Brewers Inc

Photograph of the now demolished Sterling Brewers building. This building was on the corner of Fulton and Pennsylvania (now Lloyds Expressway). This is in the northwest quadrant of the Lloyds Expressway and Fulton Avenue overpass.

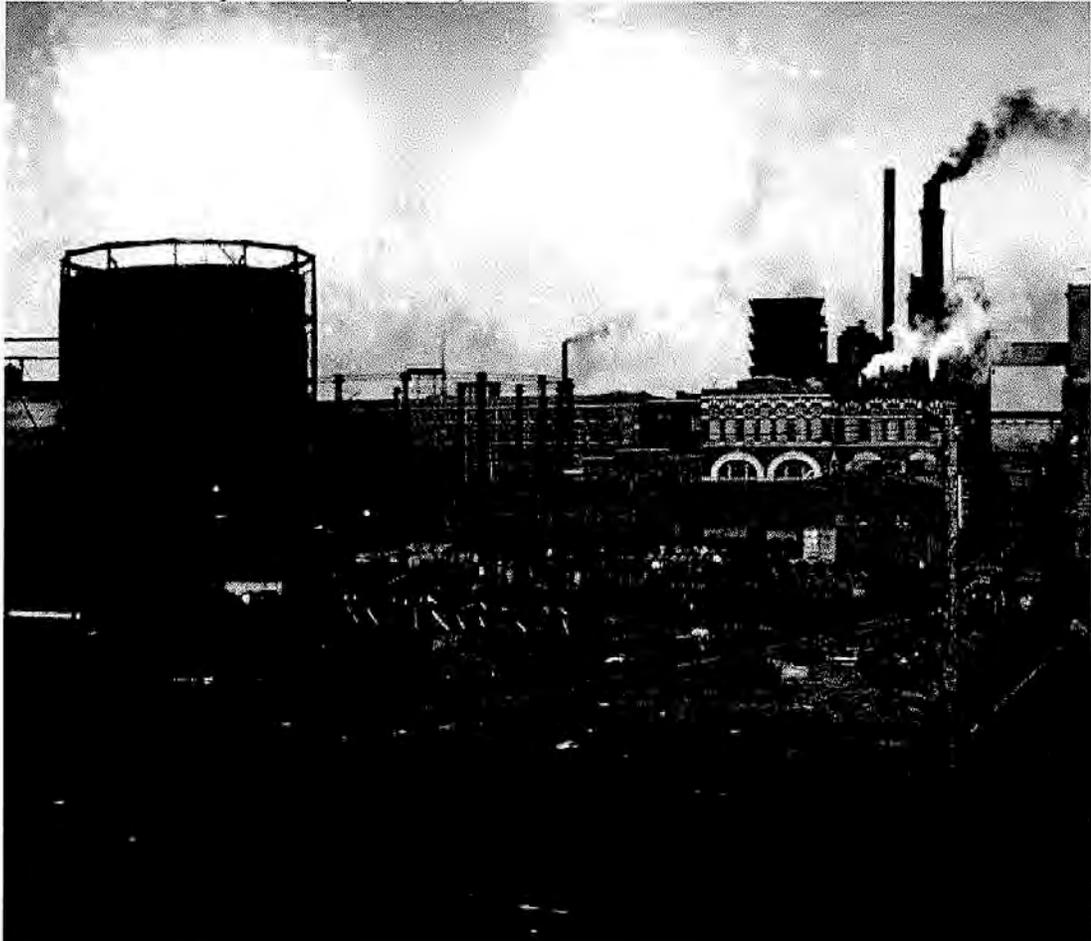
View of Gas & Electric Light Co

With Sterling Brewery in the distance. View is looking northwest from roof of 400 Fulton (corner of present-day John St)

This photograph is of the Evansville Gas and Electric Company. The view looks mostly to the north. The Evansville Brewery Association building is visible in the back of this photography.

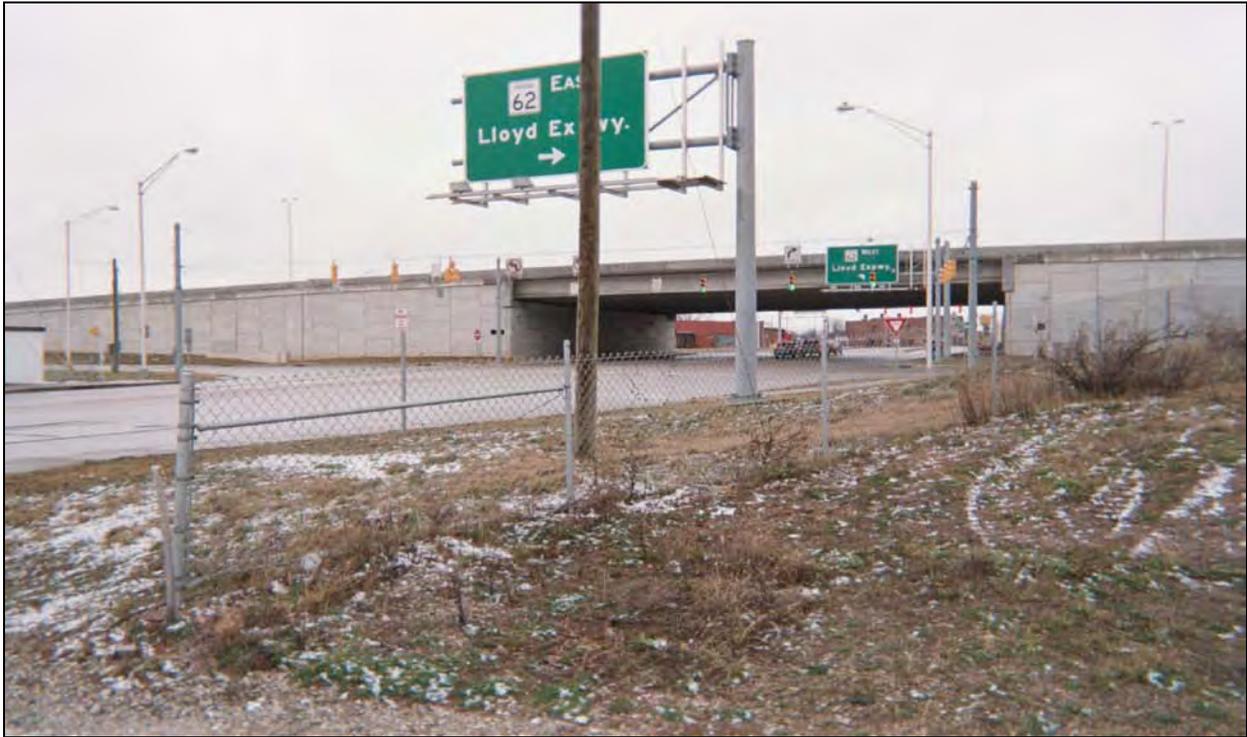
Lloyd Expressway overpass over Fulton Avenue. The construction of this overpass and its entrance and exit ramps necessitated the purchase of many parcels and the demolition of many buildings. View is to northwest, from the now vacant lot of the former Creative Press (LA Code 4913, parcel 1).

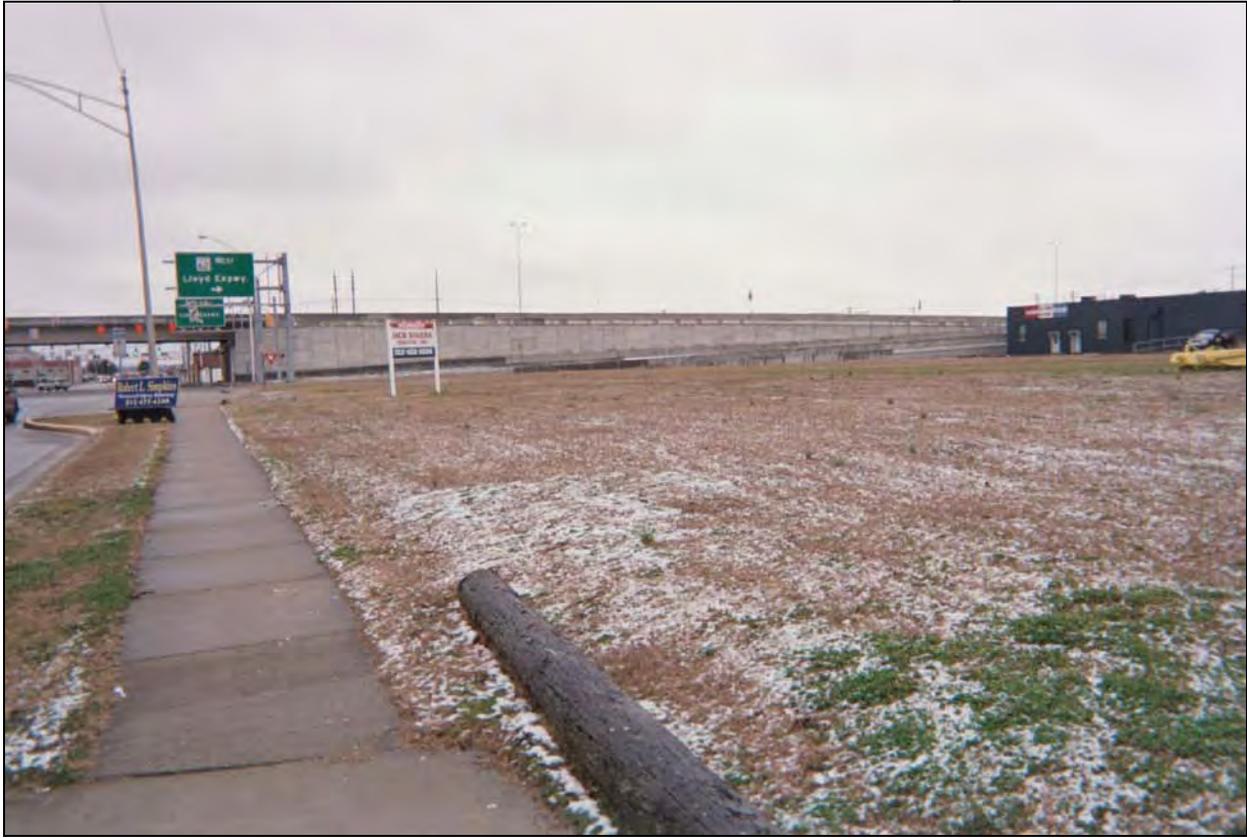
LA Code 4603 Parcel 1 (only excess parcel that is north of Lloyd Expressway. Now vacant, was site of Evansville Brewing Association mixing vat building).

- LA Code 4603 parcel 1, northwest quadrant. This property once housed the Sterling Brewery, but is now a vacant lot. During a site visit to this area, an abandoned gas station was found to the northeast of this parcel. IDEM had no records of this former gas station, possibly because the station may have been abandoned before the regulation of Underground Storage Tanks. Given the location of the station and the groundwater flow direction, it is possible that leaking petroleum product may be migrating from this former gas station towards or beneath INDOT LA Code 4603 Parcel 1. The historical records do not indicate that the brewery used solvents or chemicals. There is no indication that there were environmental issues stemming from the brewery; any environmental issues are likely to have originated from the upgradient former gas station.

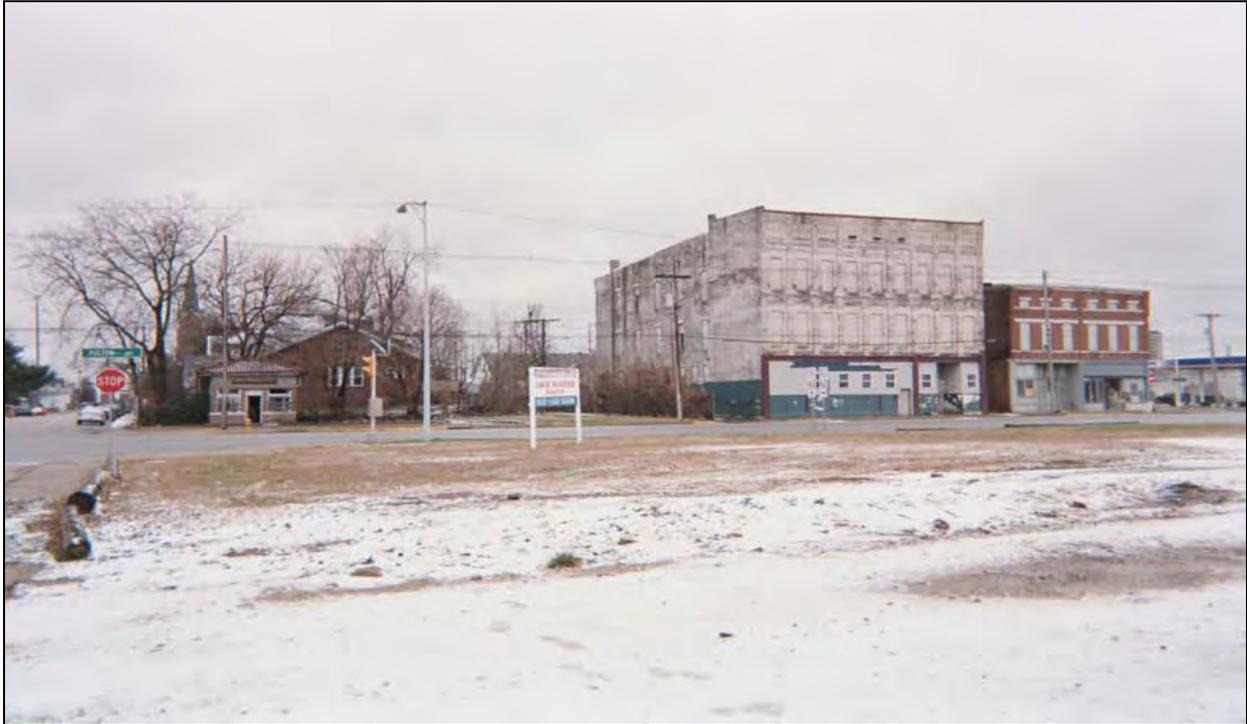
View to east, Fulton Avenue in background. At extreme right is part of Amoco Station UST site (7 N. Fulton Ave, FID # 19654) At the extreme left, just right of the red stop sign is the abandoned gas station that has no IDEM records. This gas station is discussed in the Recommendations Section.

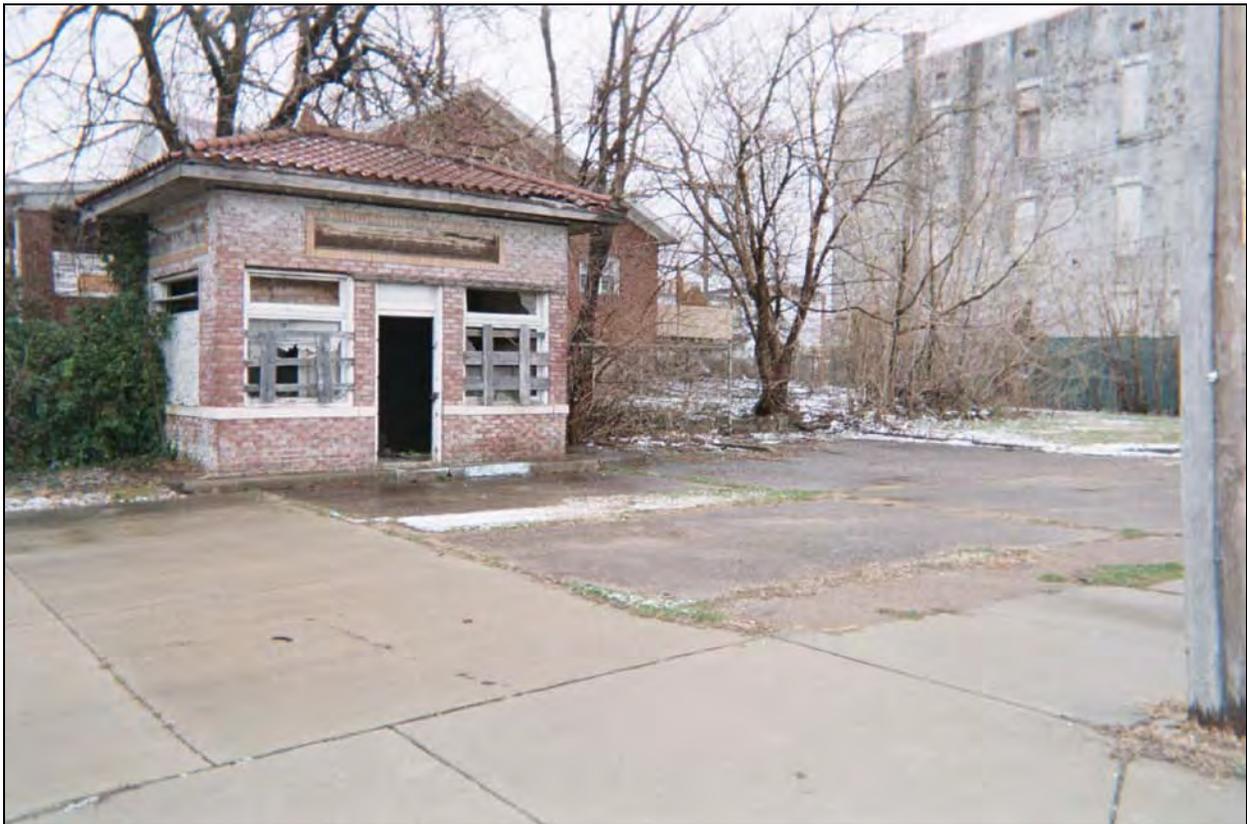
View to east, abandoned gas station with no IDEM records.

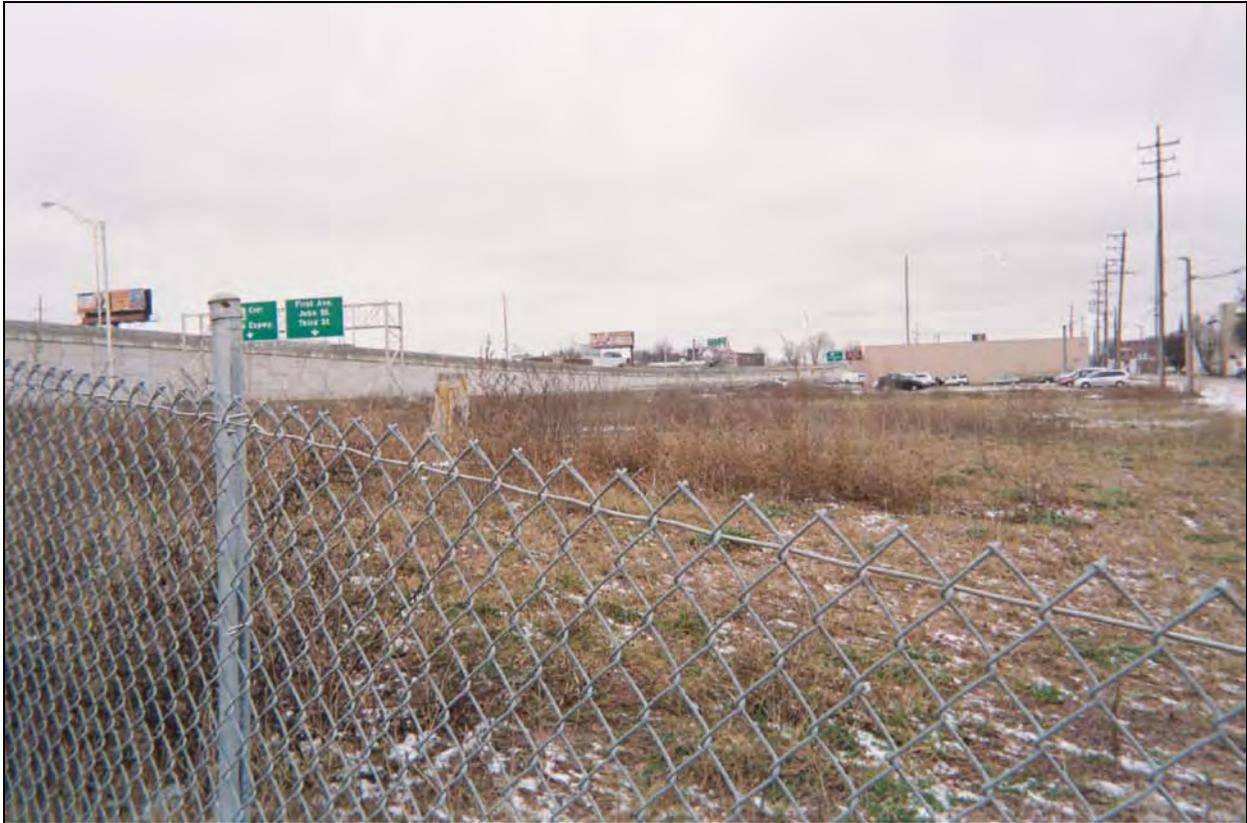
View to east. Vacant lot that was Creative Press. LA Code 4913, Parcels 1 and 2 are behind Teh chain link fence. Parcels 4 & 6 are still further east, behind the tan building in the background of this photograph. Lloyd Expressway on left (north), is elevated some 20 feet above the INDOT parcels.

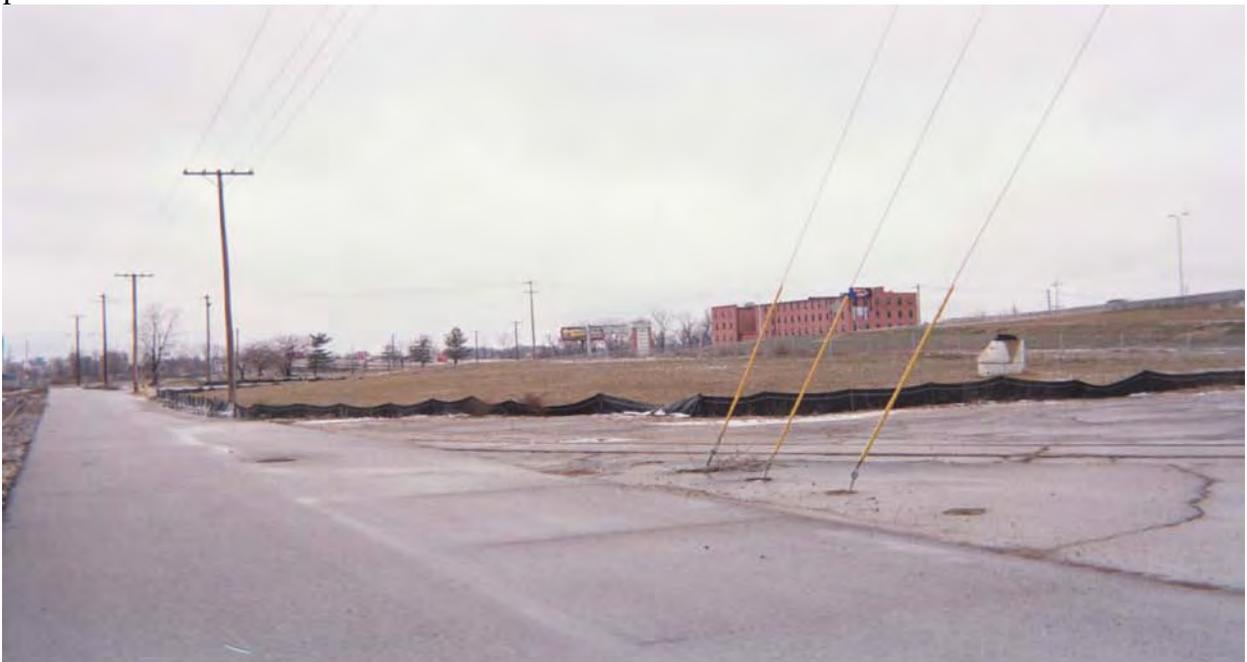
View to west, in the southwest quadrant. Shows now vacant lot that was manufactured gas plant, and later was Brake Supply building.
