## Pipeline Safety Division Investigation Report

### Investigation regarding: **Jason Sturgeon Superior Services**

UPPAC Database Record ID: 3604

**Synopsis:** A natural gas service was damaged during excavation to install an electric line.

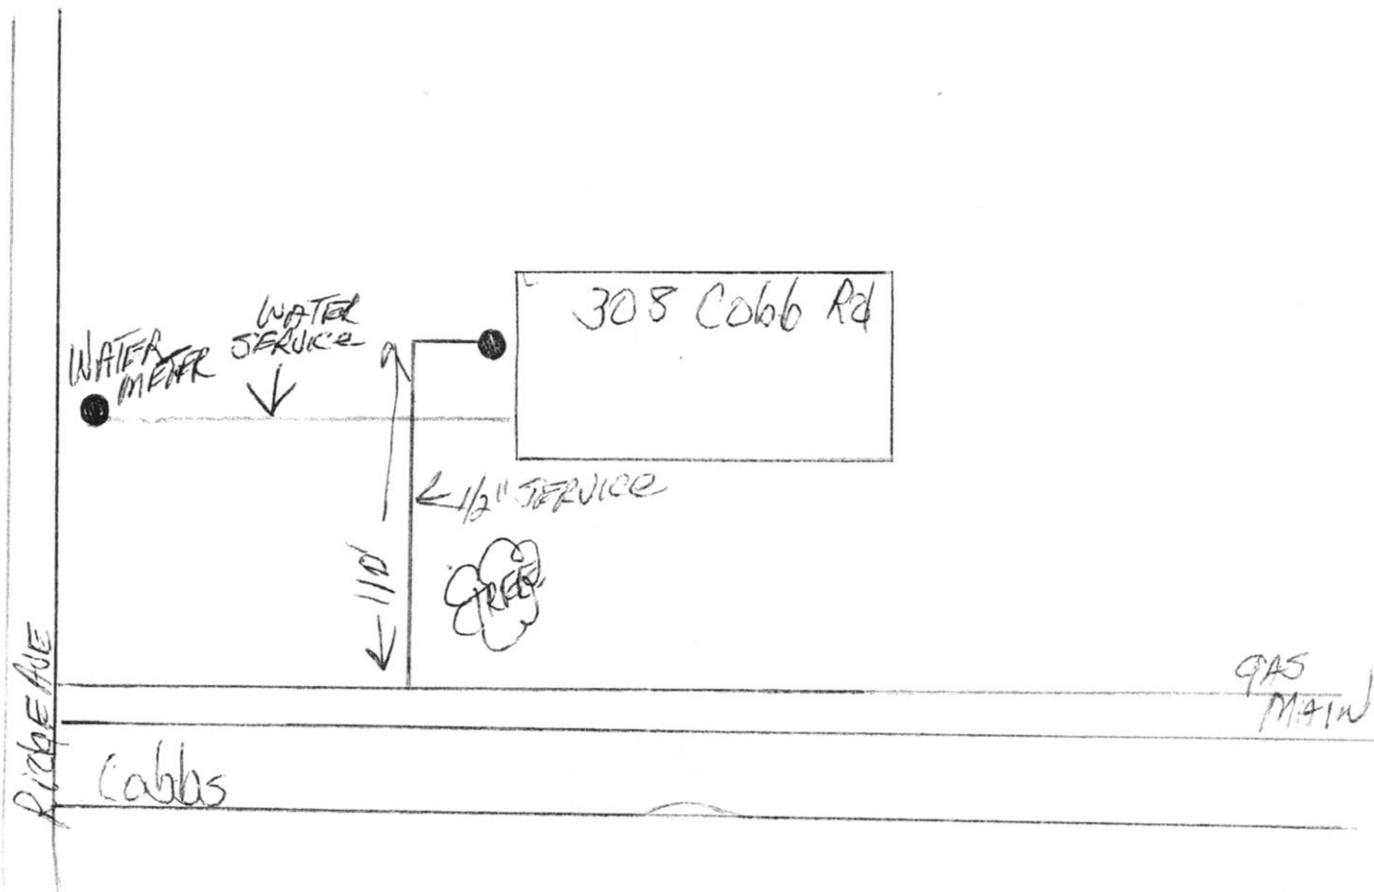
SERVICE SKETCH ON BACK

GAS		WATER		SEWER	
SIZE	LENGTH	SIZE	LENGTH	SIZE	LENGTH
<u>1/2"</u>	<u>110'</u>				
KIND OF PIPE <u>PLASTIC</u>		KIND OF PIPE		KIND OF PIPE	
DEPTH	SOIL TYPE	DEPTH	SOIL TYPE	DEPTH	SOIL TYPE
METER LOCATION <u>side</u>		METER LOCATION		EXITS HOUSE	
CURB VALVE LOCATION		CURB VALVE LOCATION		CLEAN OUT LOCATION	
TAP LOCATION		TAP LOCATION		TAP LOCATION	
MAIN SIZE	DEPTH	MAIN SIZE	DEPTH	MAIN SIZE	DEPTH
DATE INSTALLED		DATE INSTALLED		DATE INSTALLED	
COMPLETED BY
