## Pipeline Safety Division Investigation Report

### Investigation regarding: City Of Bloomington Utilities

**Synopsis:** Excavator struck and damaged an underground natural gas service while performing water work.

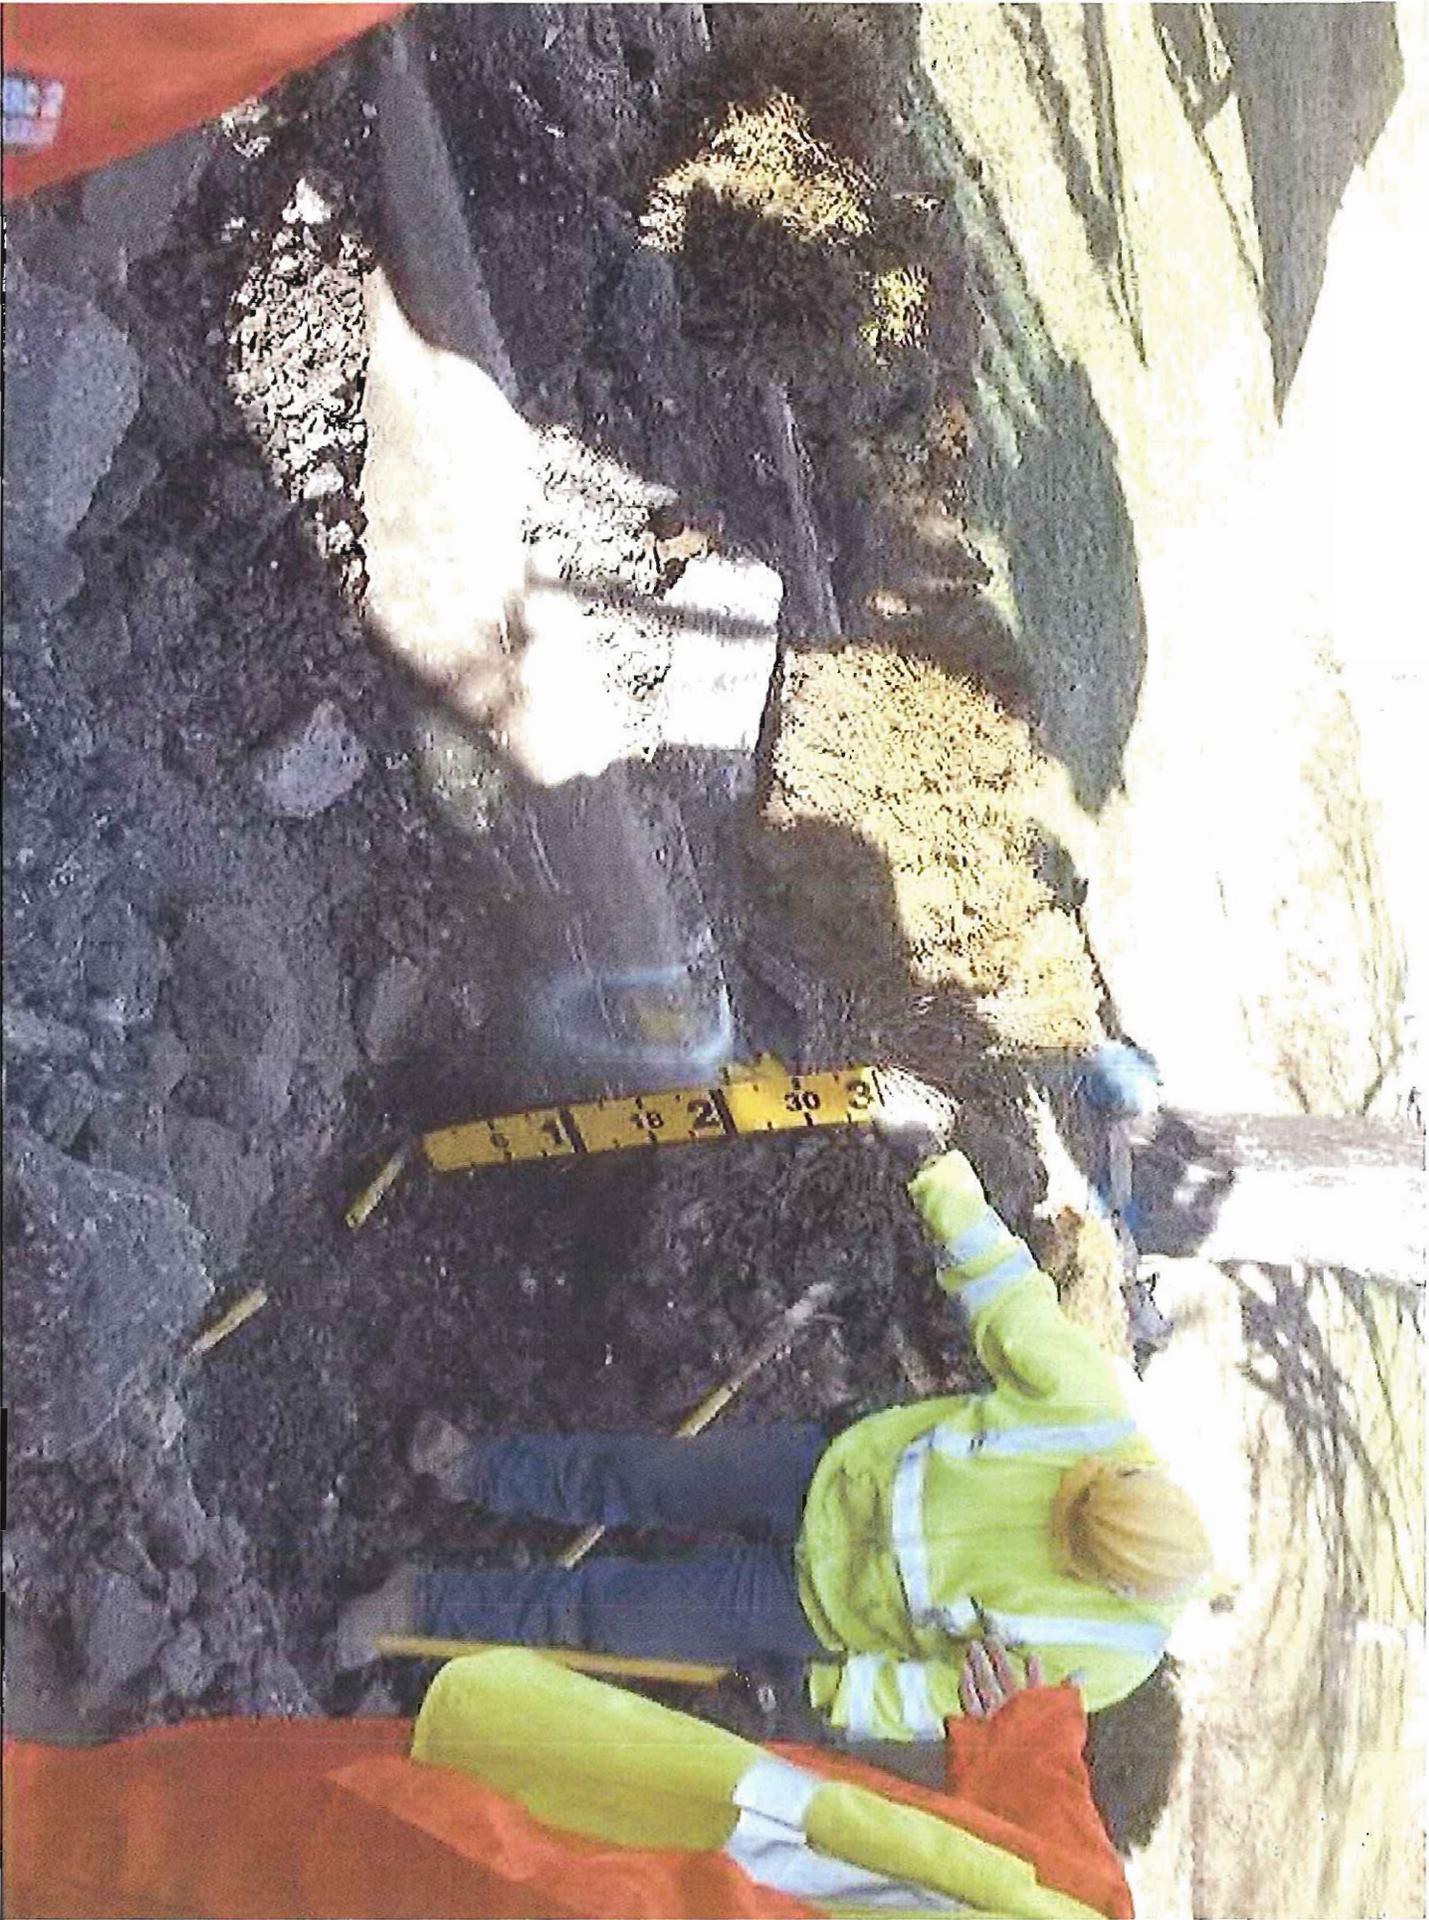
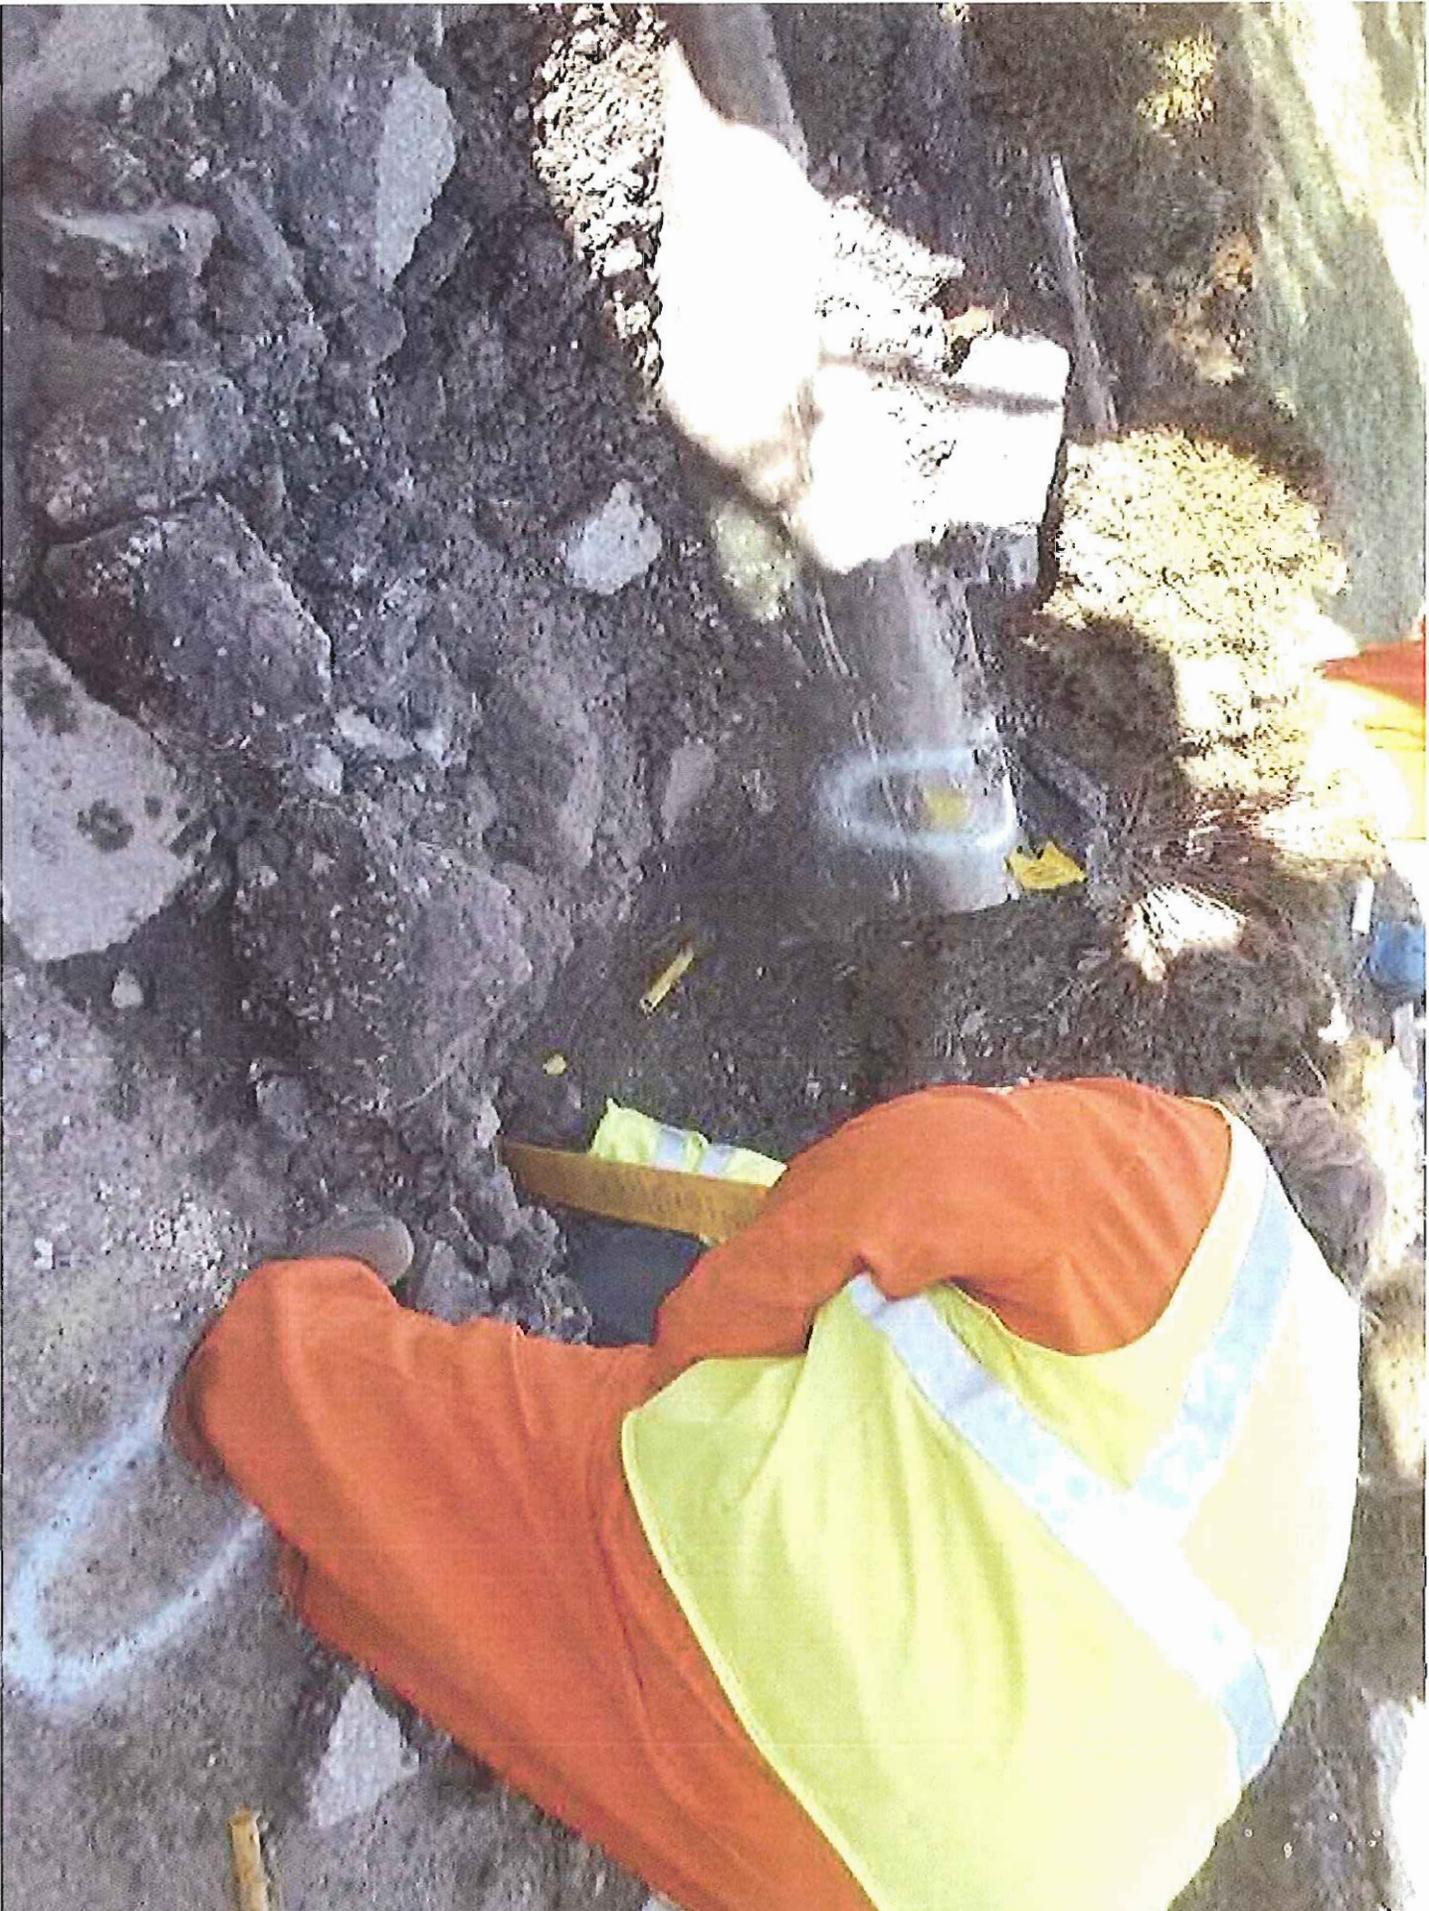
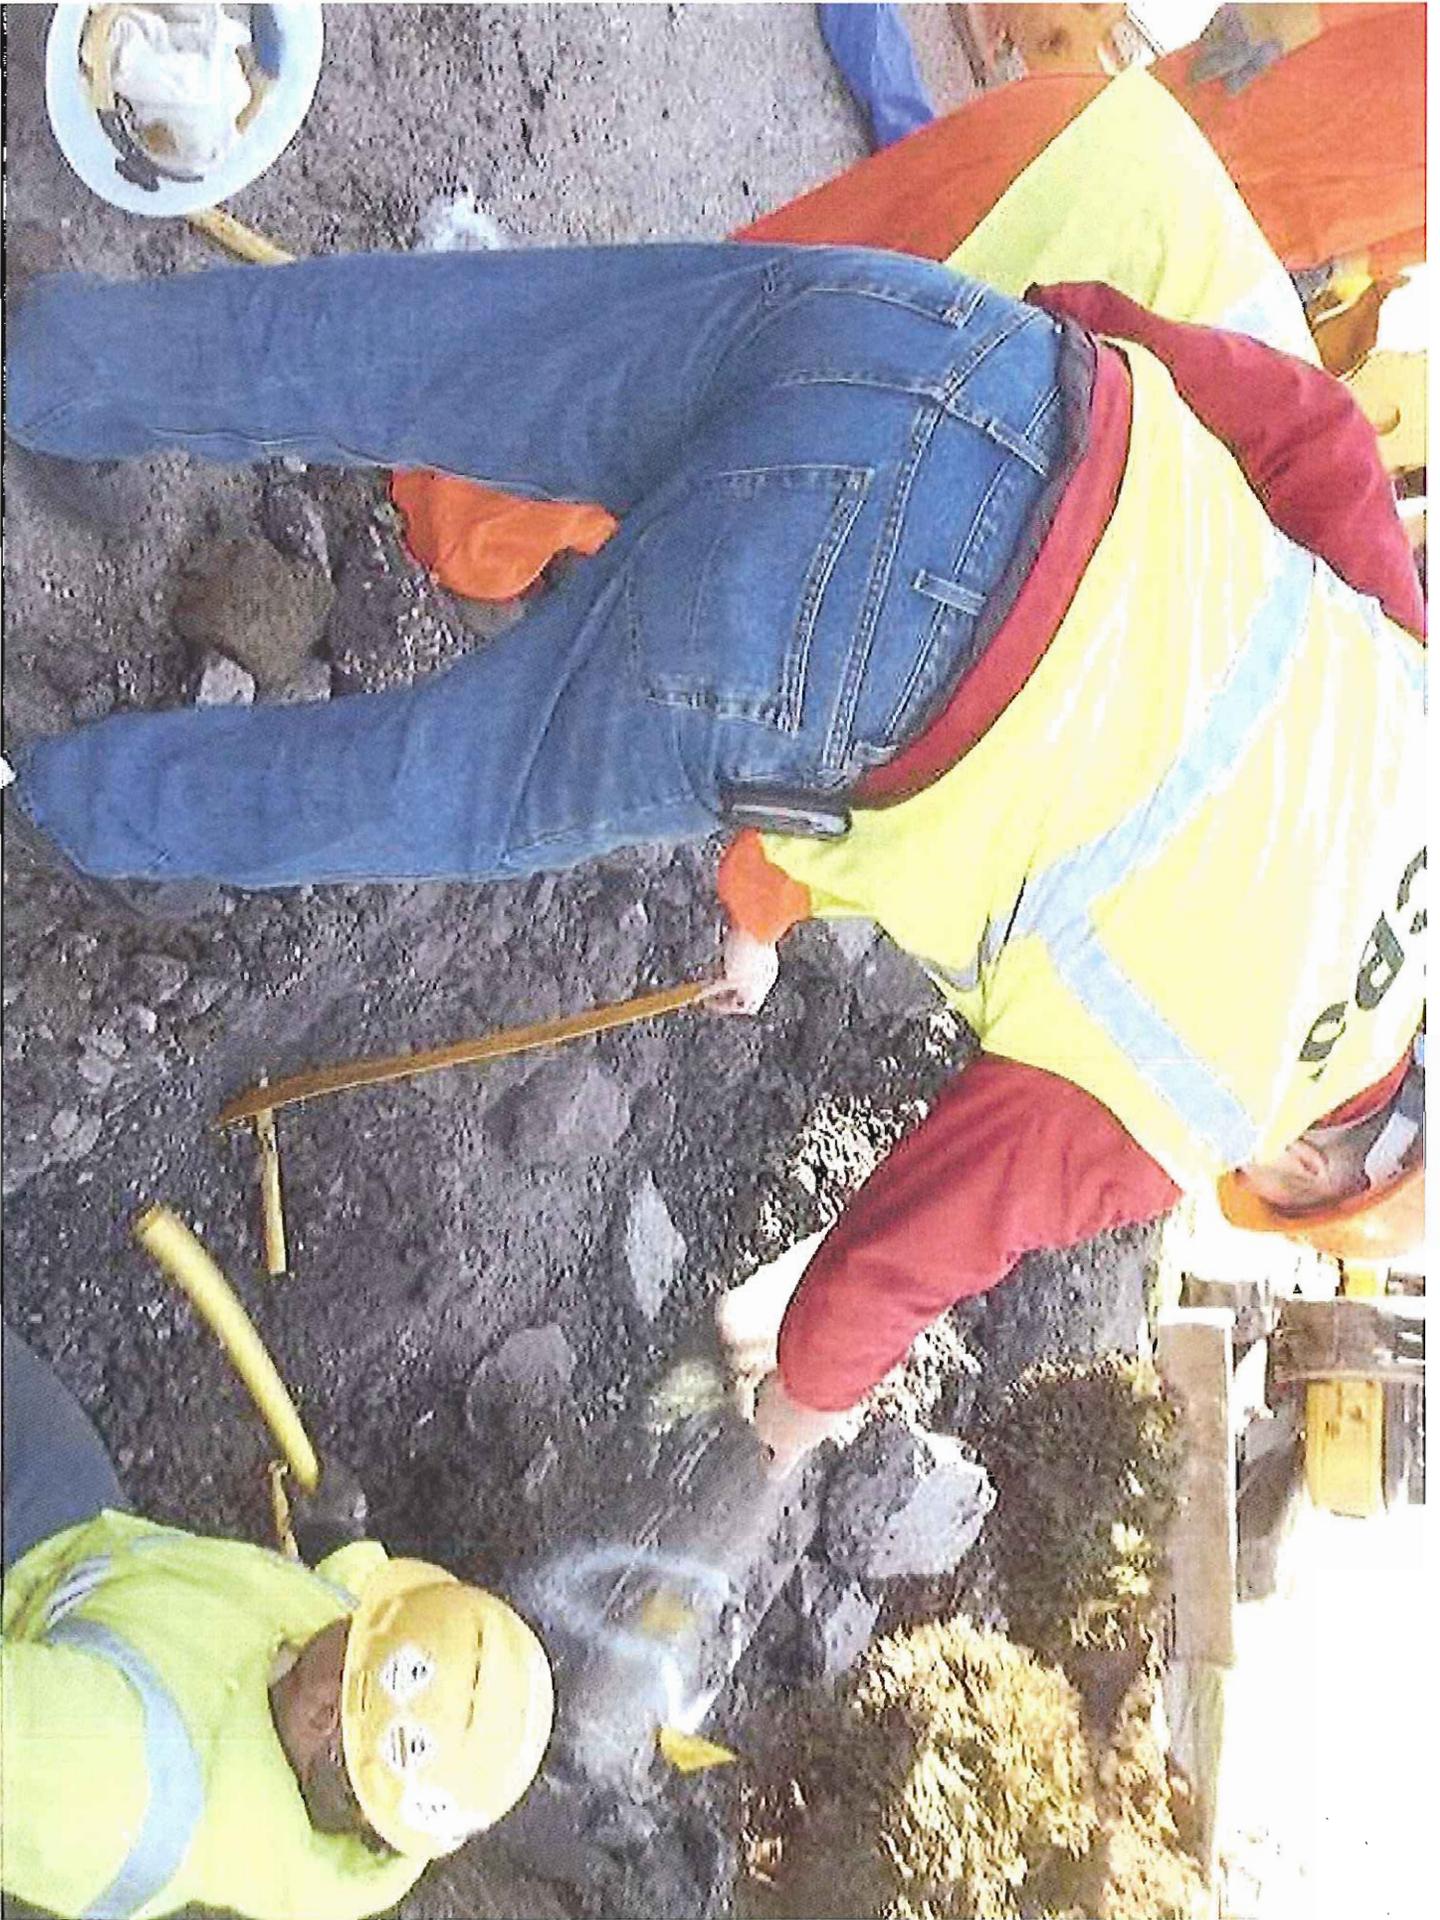
**Findings:** Reported by Indiana 811; excavator's response to initial notice was received on 4/2/2013. Excavator does not adequately respond to the damage incident. Excavator indicates uncovering an abandoned 6 inch main and called gas operator to verify line is abandoned. Excavator photos indicate the address as 2719 E. St. Rd 45. The damage occurred at 1633 E. 8th St. The excavator claims the incident occurred on 2/20; but, Vectren indicates it happened on 2/13. Vectren's response indicates the line was cut by a backhoe and the locates were accurate. Vectren also has pictures of the incident indicating accurate locates and the use of mechanized equipment.

Property of United States Infrastructure Corporation  
Photo taken on 2/13/2013 3:42:34 PM

Property of United States Infrastructure Corporation  
Photo taken on 2/13/2013 3:42:42 PM

Photo taken on 2/13/2013 3:42:50 PM

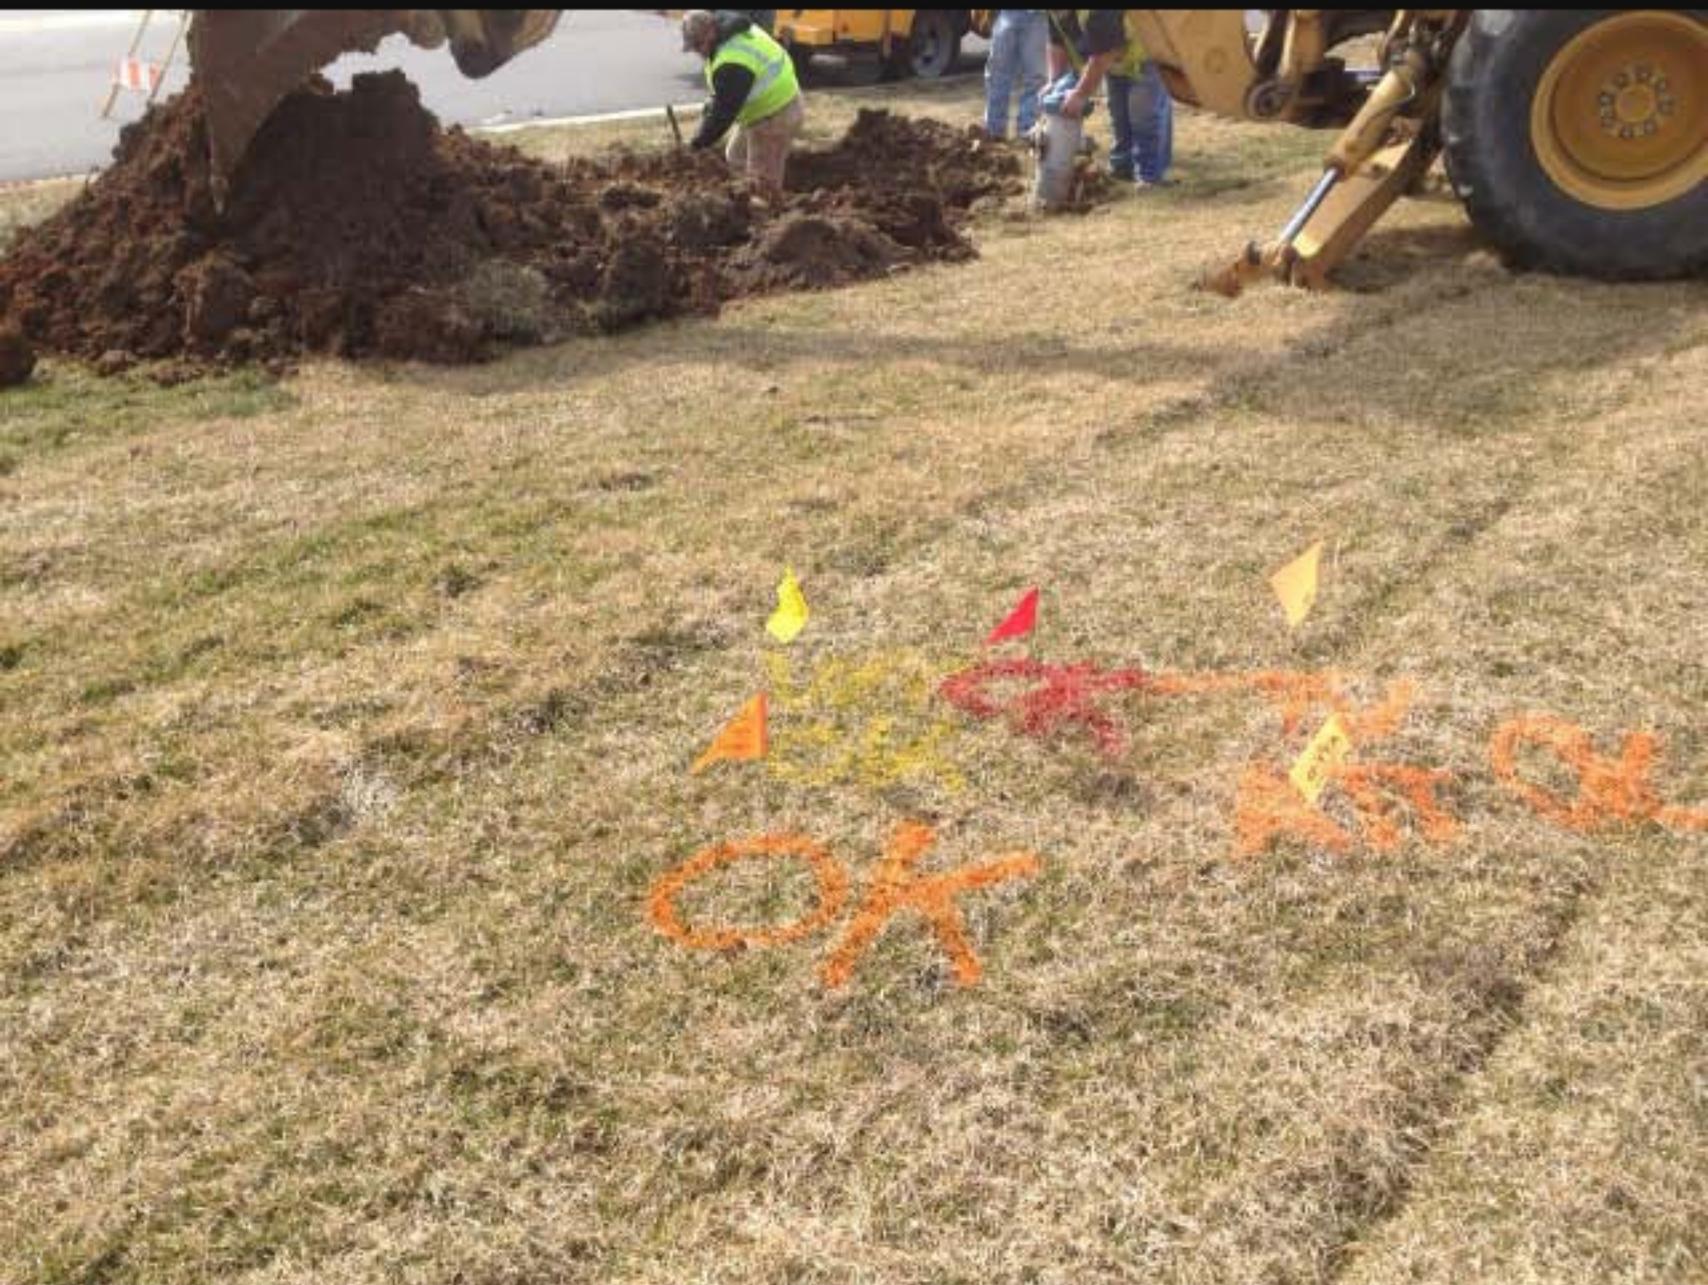
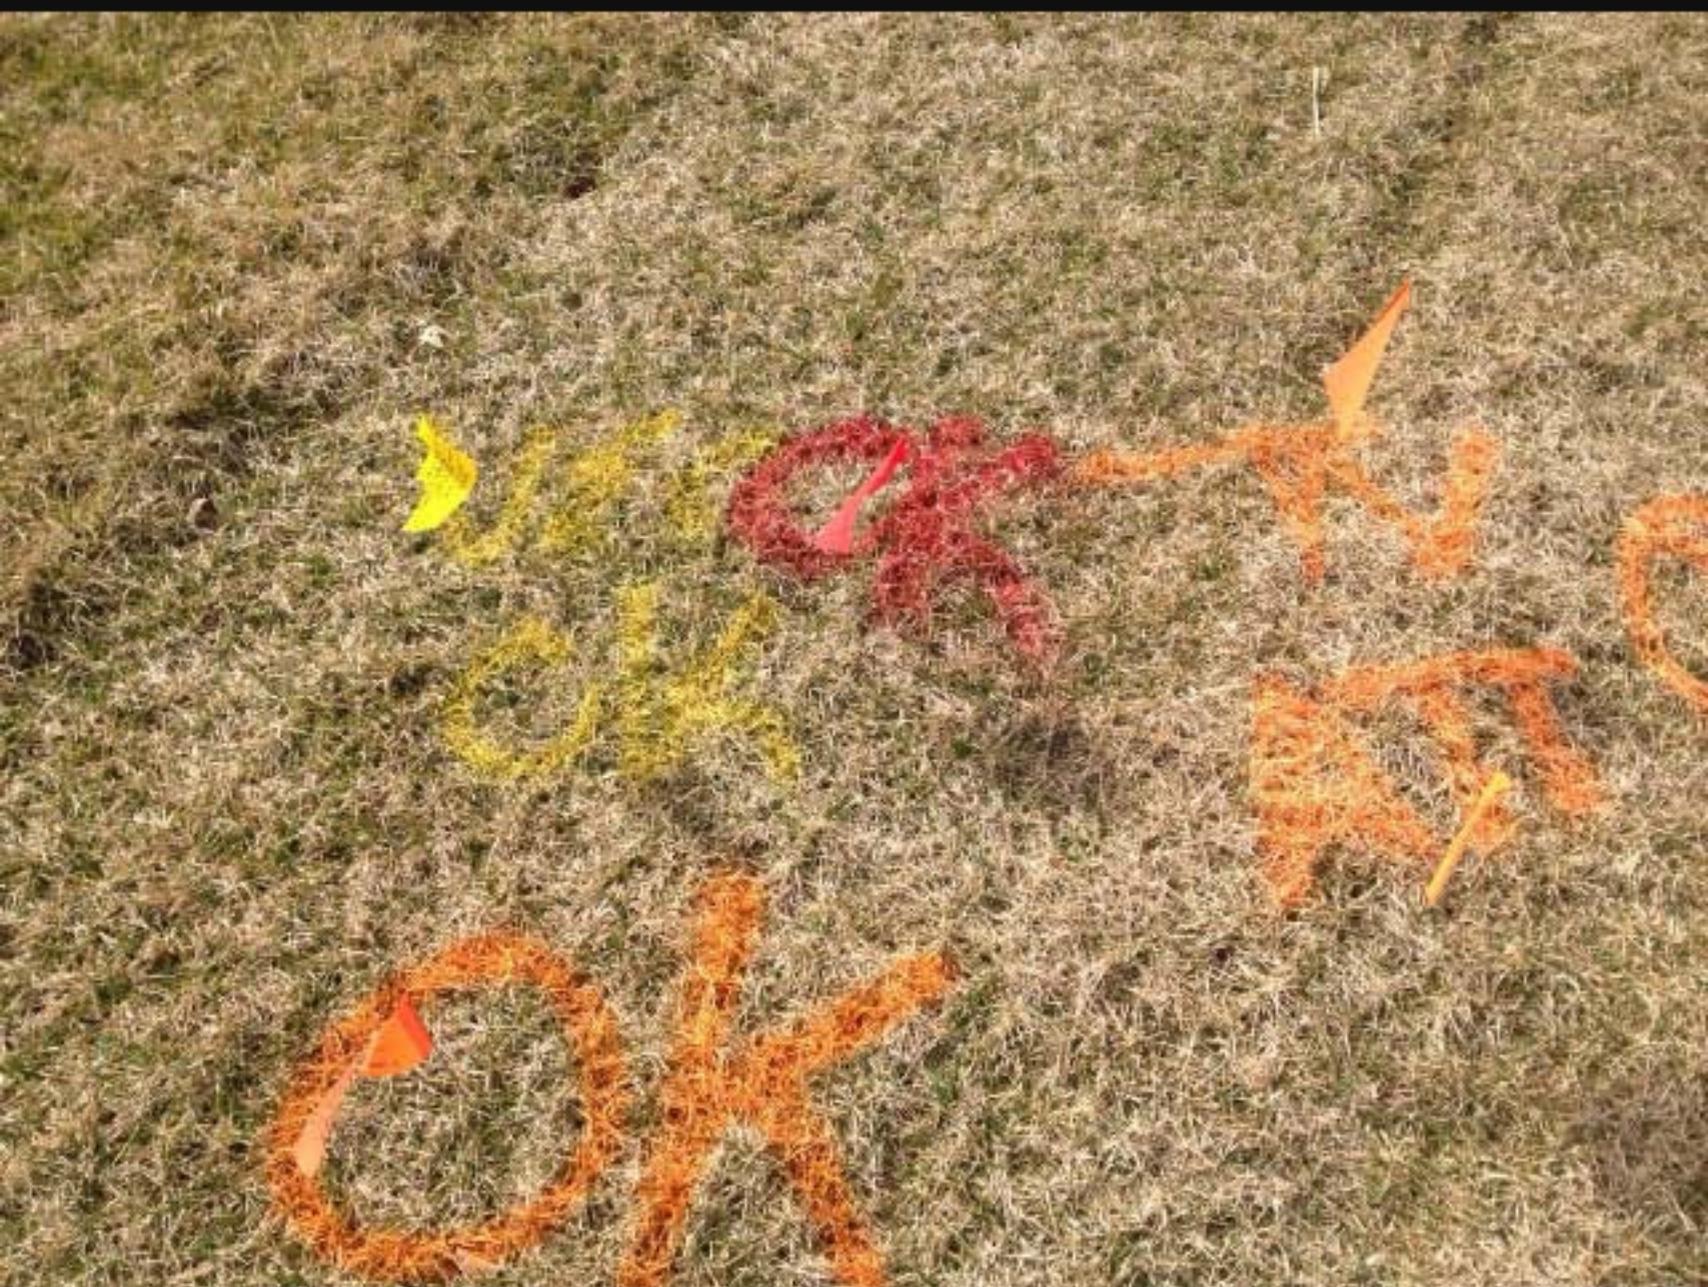
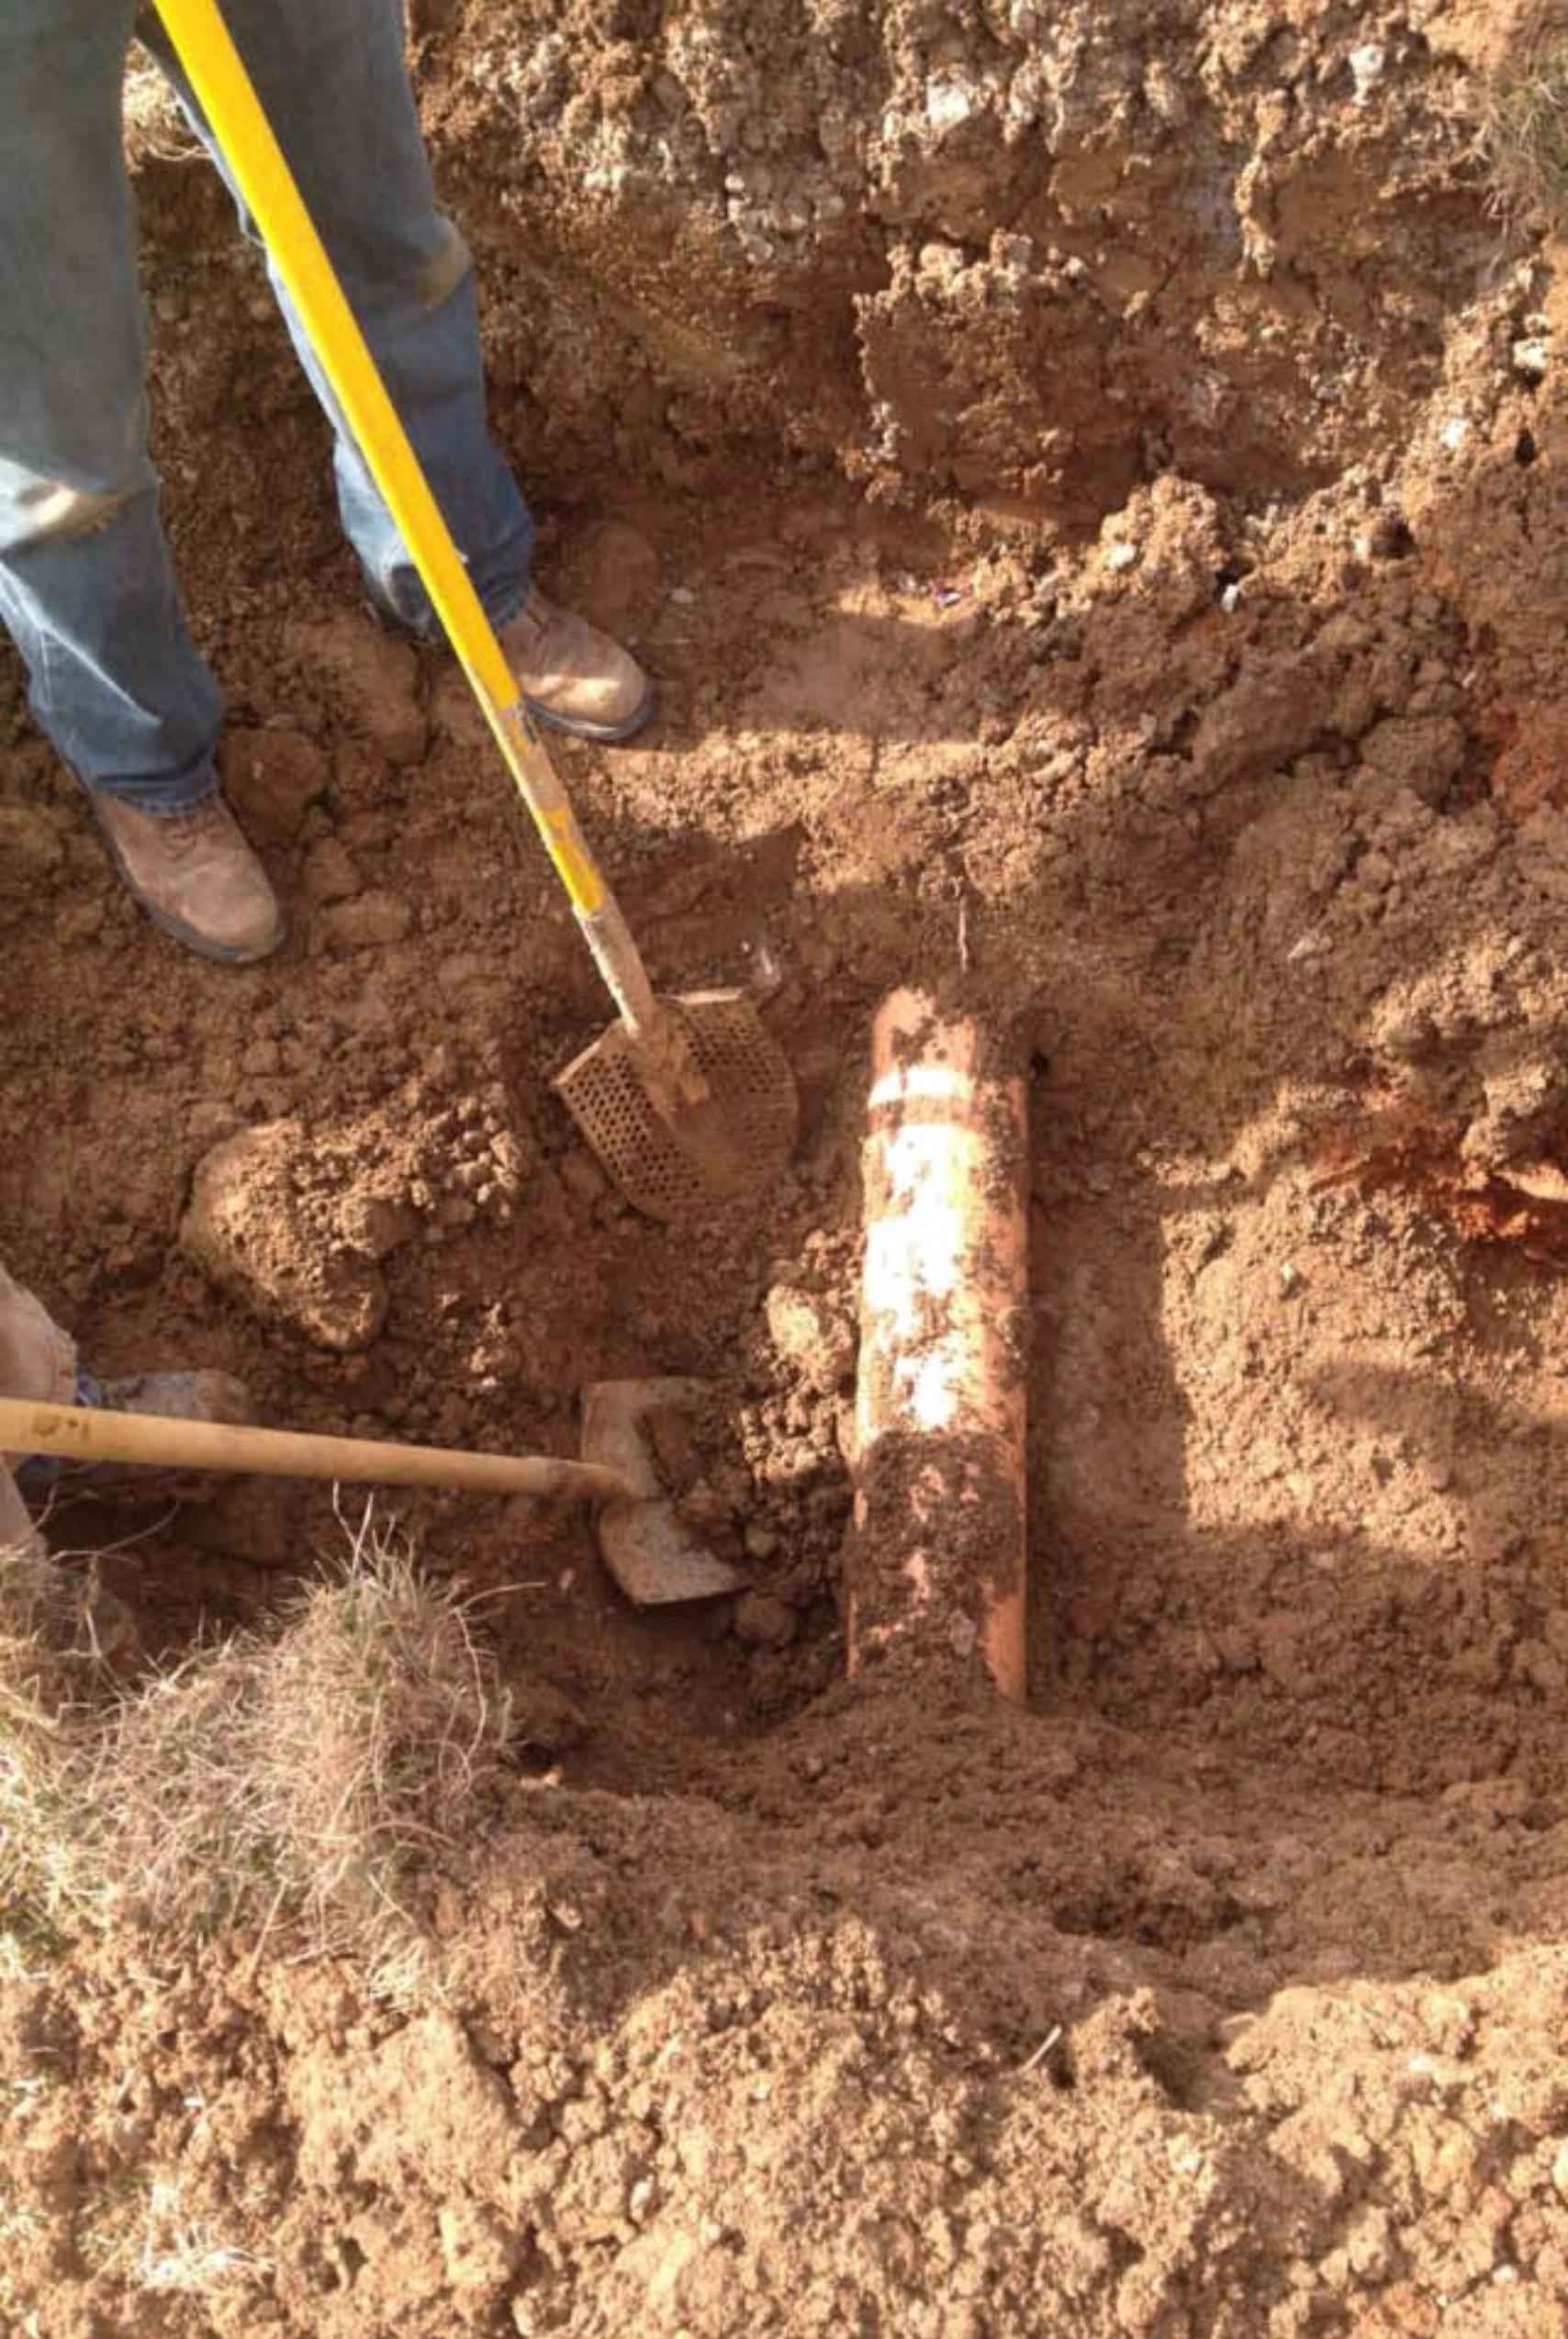
**From:** Tom Axsom [axsomt@bloomington.in.gov]  
**Sent:** Tuesday, April 02, 2013 10:05 AM  
**To:** IURC PipelineDamageCase  
**Subject:** Case # 4478  
**Attachments:** Unmarked gas main at 2719 E. St. Rd. 45 001.png; Unmarked gas main at 2719 E. St. Rd. 45 002.png; Unmarked gas main at 2719 E. St. Rd. 45 004.png

I am responding to case #4478. On 2/20/13 The City of Bloomington Utilities started repair work on a fire hydrant that was struck by a car. We called in our locate request on 2/12/13. The area was flagged OK by all utilities. We started our repair and uncovered an unmarked 6" gas main. We did not damage the main. At that time we called in a second notice, Vectren arrived at the job site and determined the main to be dead. I have attached pictures of the job site.
