Pipeline Safety Division Investigation Report

Investigation regarding: Ed Graber

UPPAC Database Record ID: 5292

Synopsis: Excavator struck and damaged an underground natural gas service while performing landscaping work.

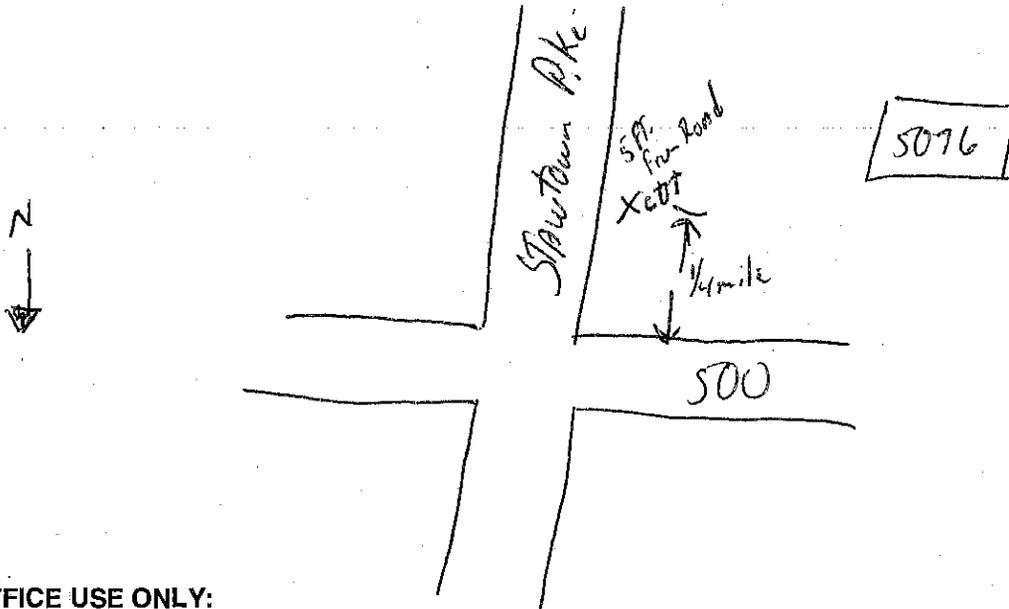
SKETCH: - Show position of all pertinent information

putting in post - service cut in half by
contractors - never called in Locates

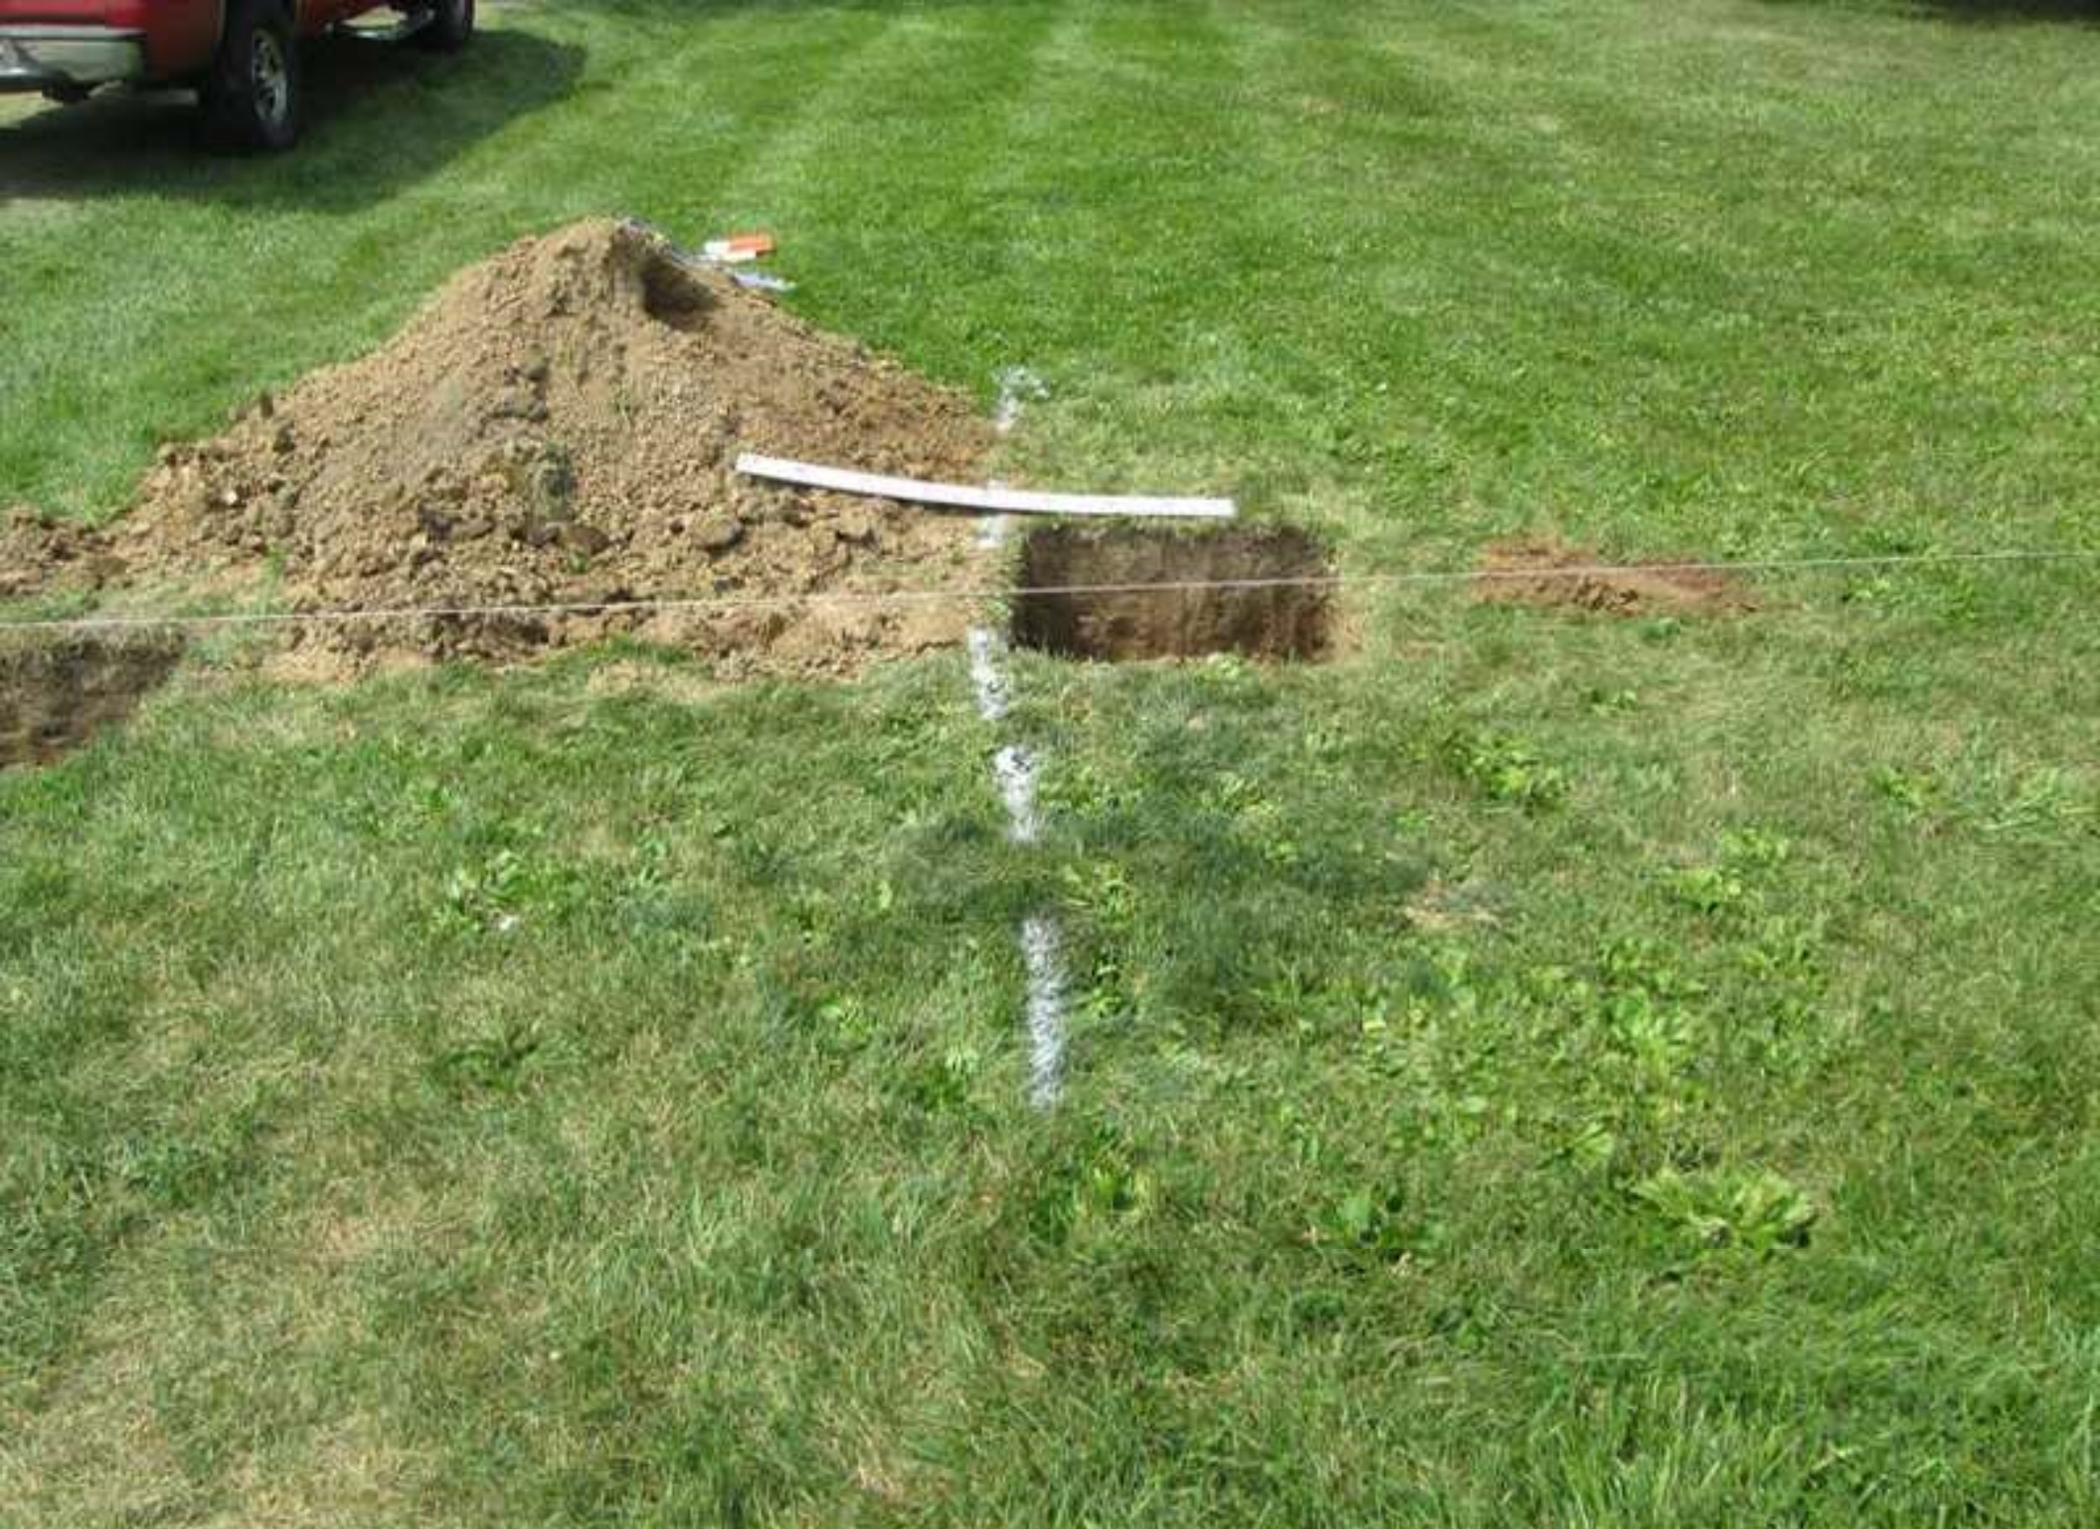
Property of United States Infrastructure Corporation
Photo taken on 8/16/2013 1:22:14 PM

Investigator Statement/Causal Factors
Facility was not marked - there was no ticket called in.
Names of Utility Representatives Contacted or on Site and Statement
n/a
Names of Excavator's Representatives Contacted or on Site and Statement
Ed Graber - stated he did not call in a ticket.
Other individuals on site
n/a

Were any markings visible on the damage site upon arrival? No
Were any other indicators of facility present in the area? No
Was the excavation within the tolerance zone of marks? No
Extent of facility damage damaged service
