## Pipeline Safety Division Investigation Report

**Investigation regarding:** Dave O'Mara Contractor

**Synopsis:** A natural gas distribution line was damaged during excavation related to underdrain work.

# DAMAGE INFORMATION REPORT – PIPELINE SAFETY

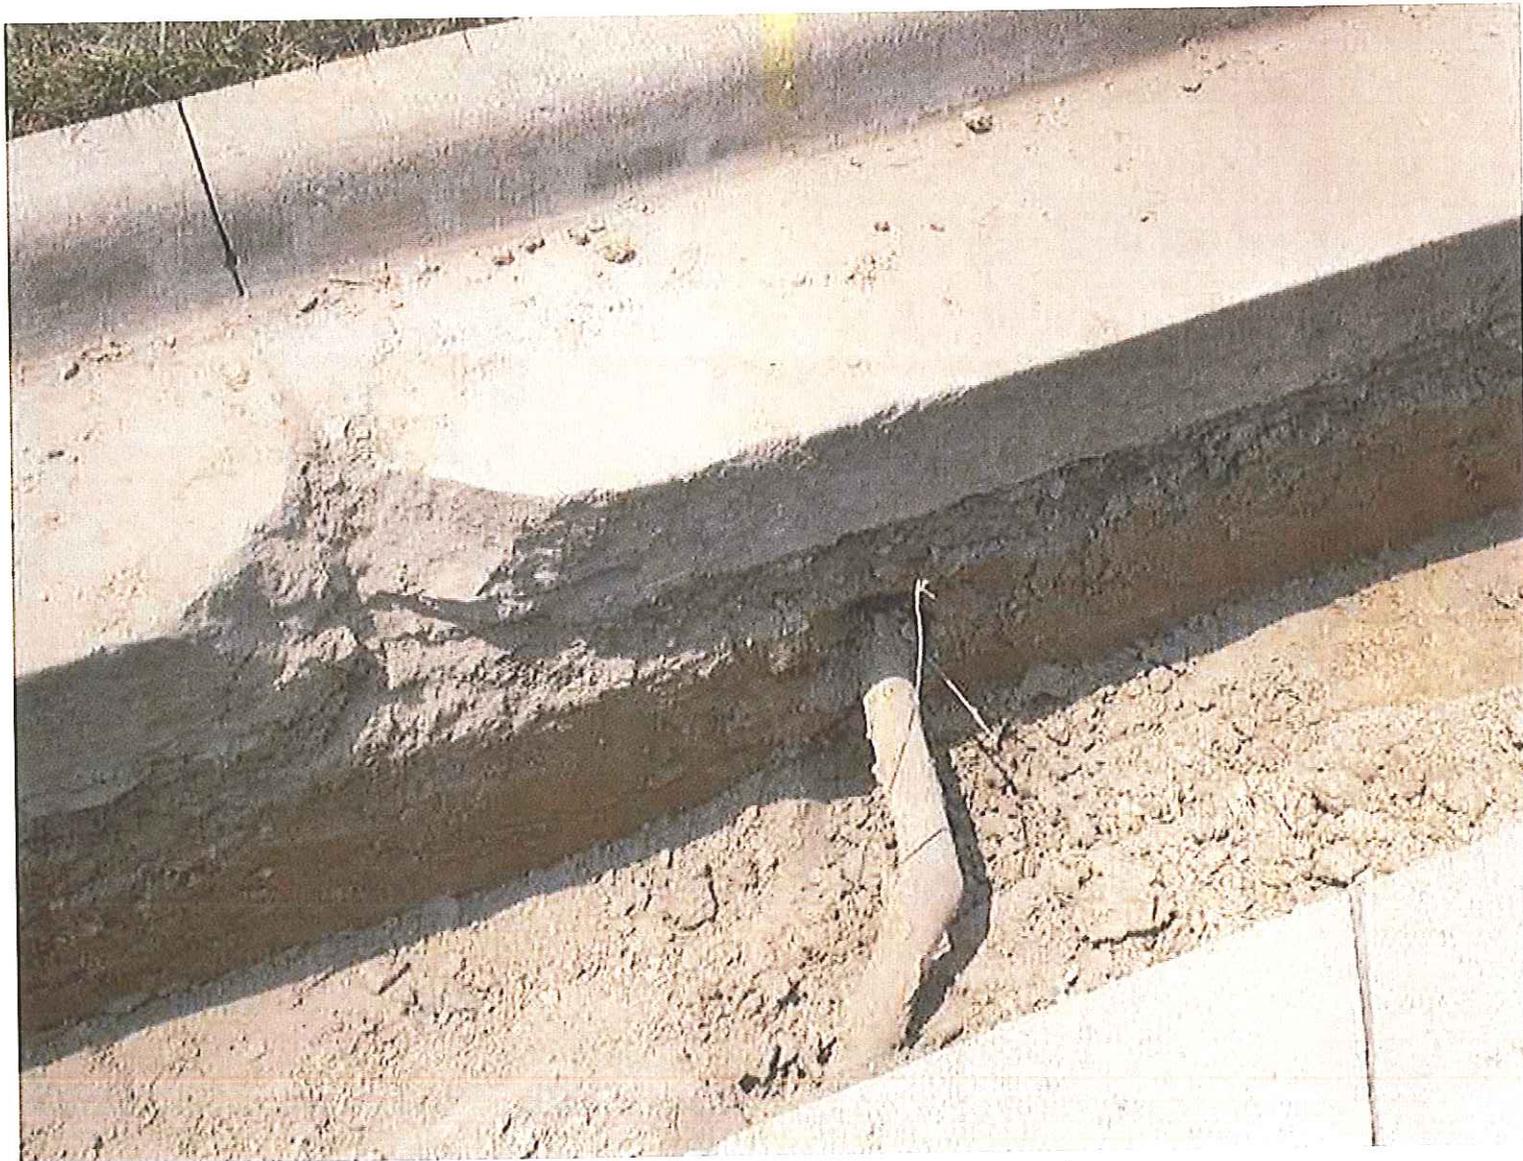
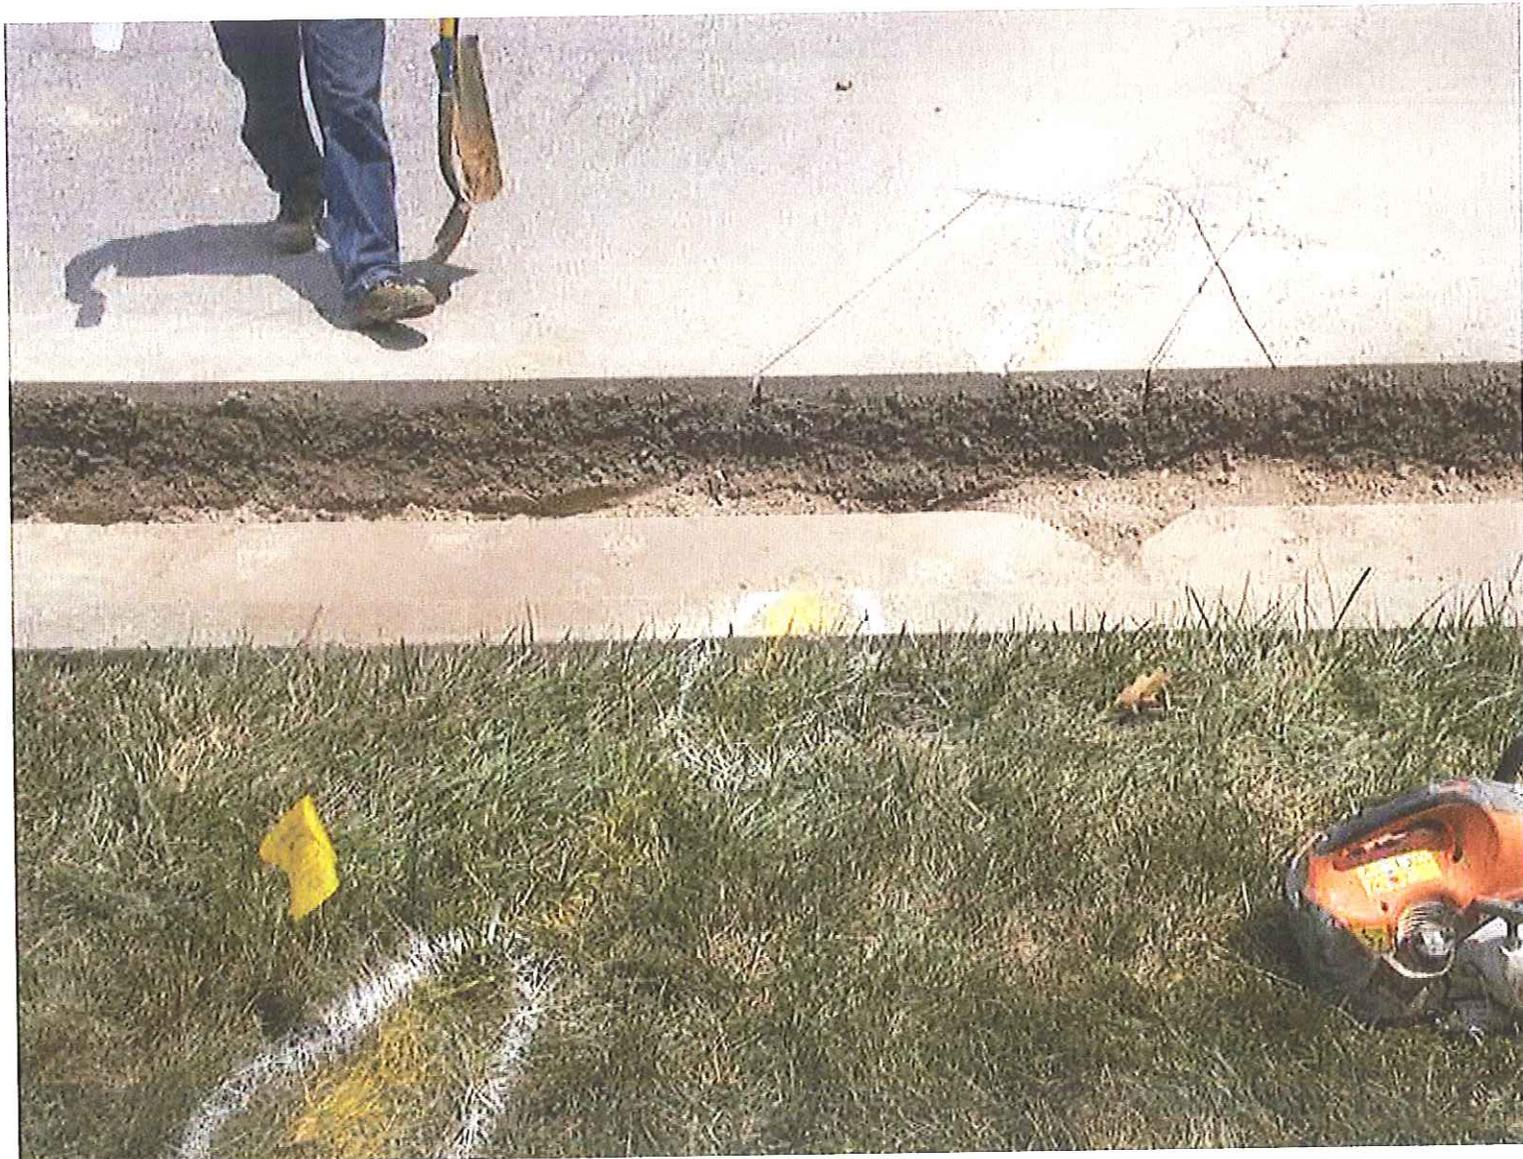
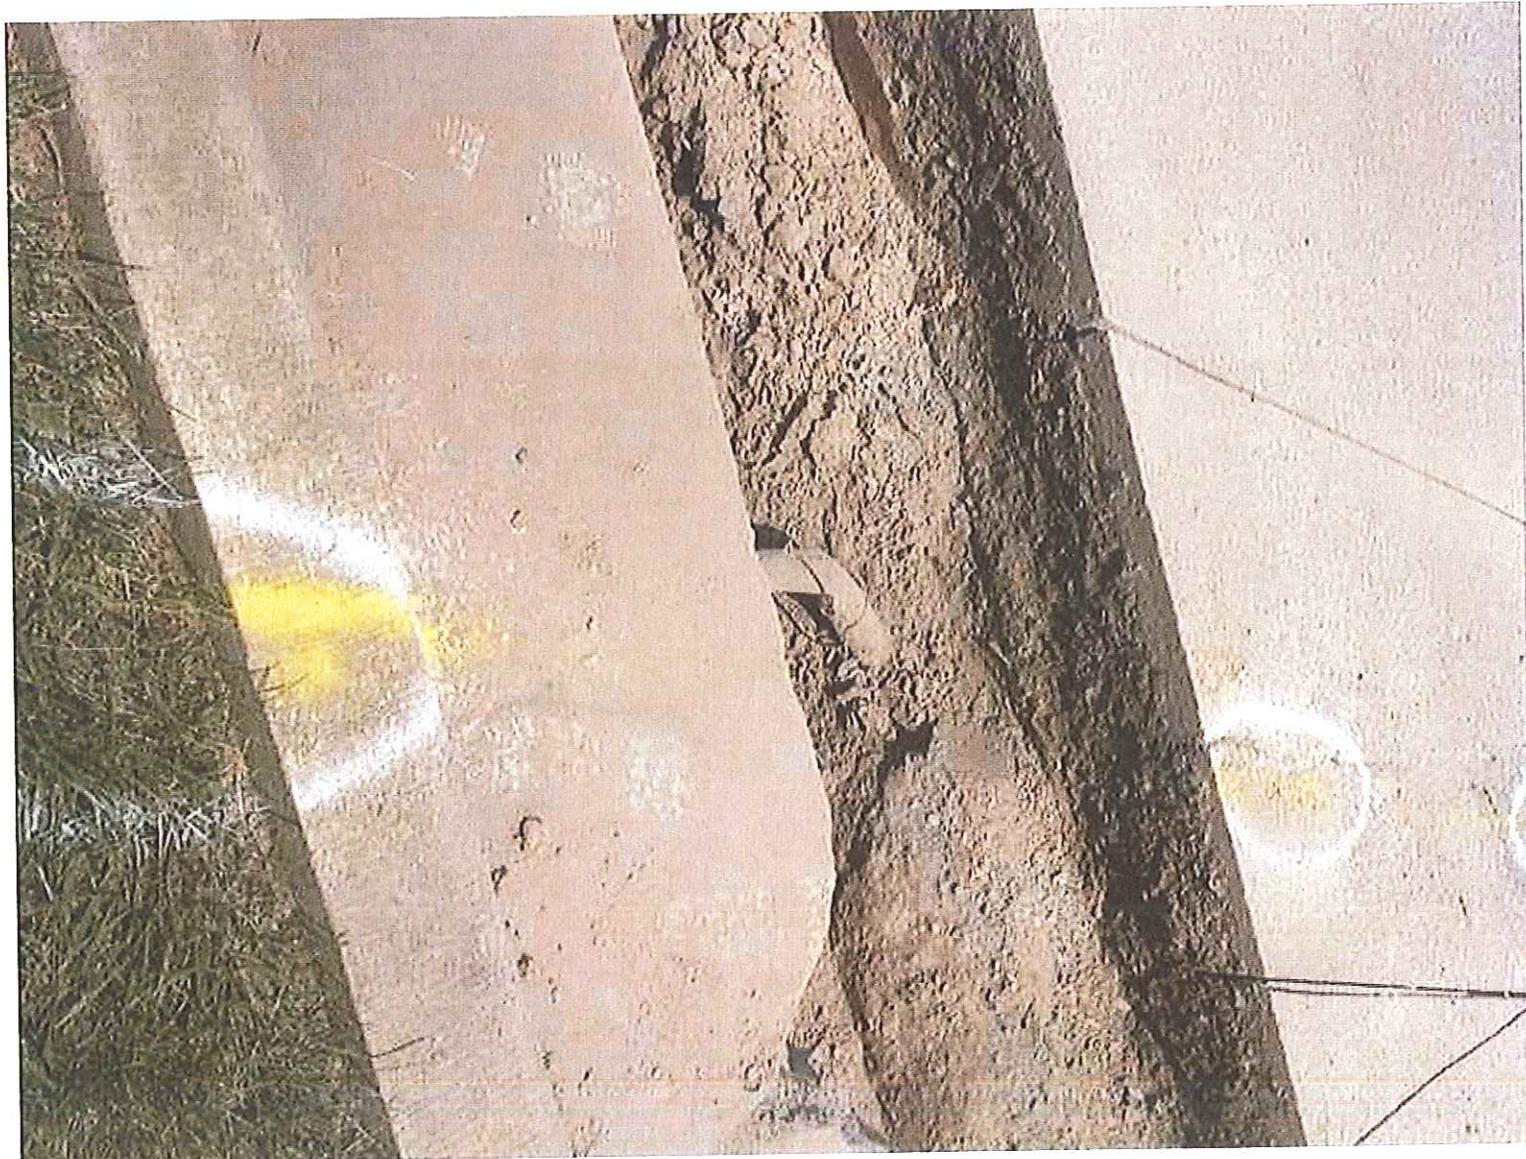
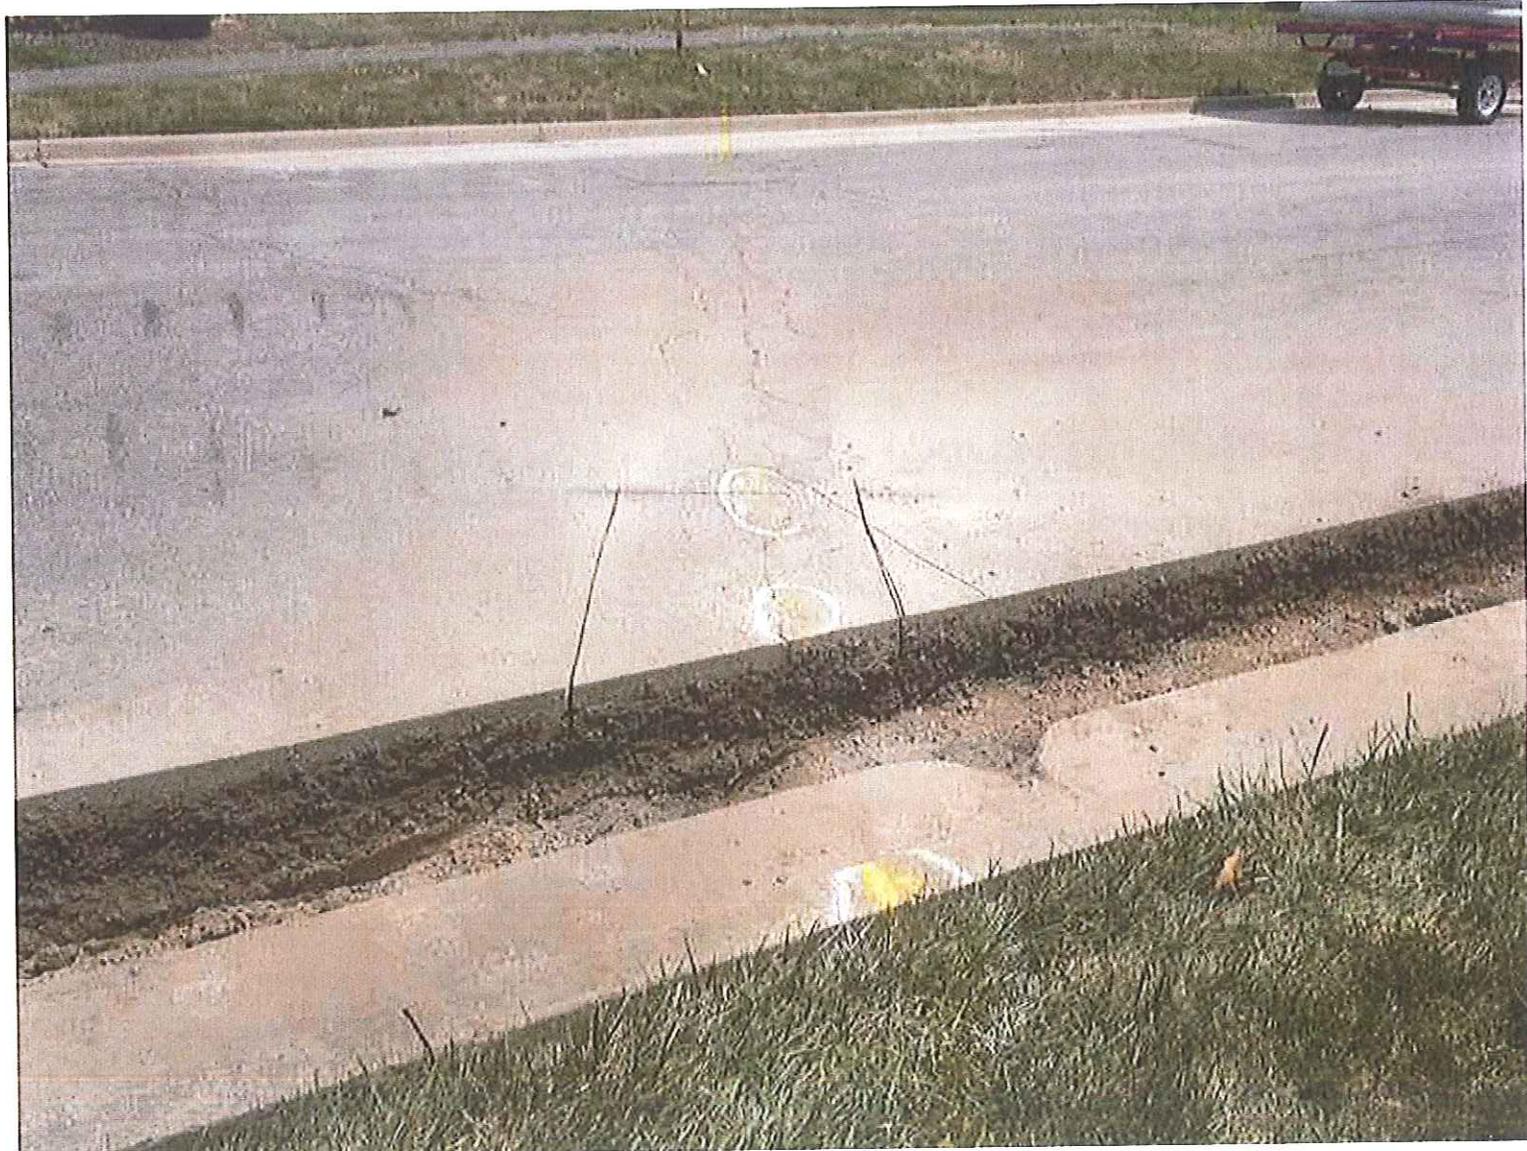
**Findings:** Operator indicated it was failure to maintain clearance as the cause of the damage, excavator provided no explanation for the cause of the damage. Pictures provided by operator indicate the markings were accurate. Based on information provided this is an excavator violation, failure to maintain clearance with mechanized equipment.

2" plastic main damaged by hoe. Not hand exposed.

Dave omara cont. pulled 2inch main with hoe didn't cut or leak.crimped main.Crew called out arrived 1:54 pm to replace section of 2inch.
