KENTUCKY INDIVIDUAL BUILDING SURVEY FORM  
(KHC 2011-1)

COUNTY Jefferson  
RESOURCE # JF 846  
EVALUATION N / Eligible: member of a group  
SHPO EVALUATION  
DESTROYED \_\_\_\_\_

6401 River Road

Harrods Creek Village Historic District

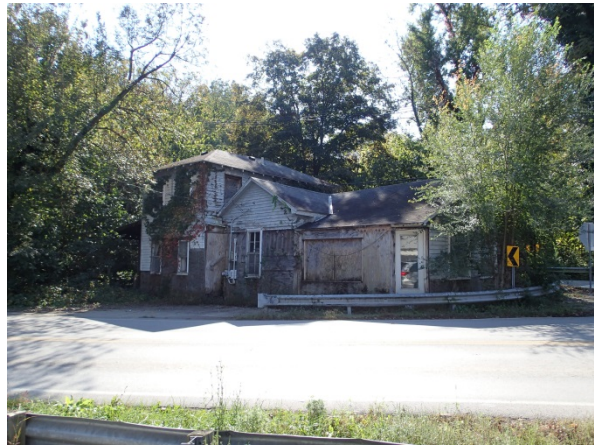
P / Poor-in need of major repairs

23. MODIFICATION: 2 / Moderate alteration

JF 846 has served as served as the local post office, grocery store and commercial business. It is a one-story, five-bay (w/w/w/d/w) frame building topped with a cross gable roof covered in asphalt shingles. The site sits on the east side of River Road and is oriented to the west. The structure is clad in weatherboard siding. The fenestration pattern has been altered and the windows are a mixture of types. The building is in poor condition.

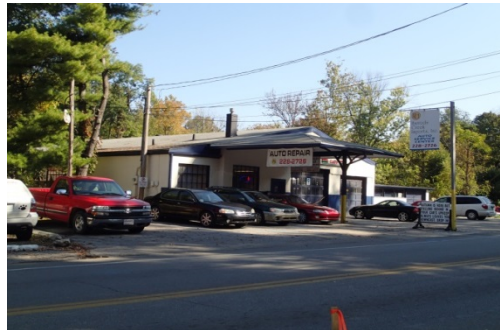
G / Good-in good state of repair

JF 847 is Lang's Garage. It is a one-story, five-bay (w/w/d/d/d) building topped with a front gable roof covered in asphalt shingles. The site sits on the north side of River Road and is oriented to the south. The structure is constructed from concrete block and rests on a continuous concrete block foundation. The fenestration pattern appears unaltered and the windows are original. The building is in good condition.

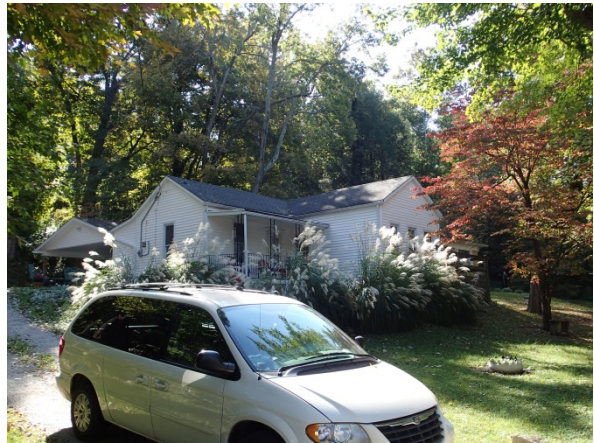
JF 935 is a one-story, three-bay (w/d/w) frame building topped with a cross gable roof covered in asphalt shingles. The site sits on the east side of River Road and is oriented to the west. The structure is clad in vinyl siding and rests on a continuous concrete block foundation. A ½ width porch adorns the front façade. It is topped by a shed roof that is supported by iron posts. A matching iron balustrade is present. The porch decking is wood. The fenestration pattern appears unaltered; however the windows are vinyl replacements. The building is in good condition.

There is one outbuilding, a frame carport.

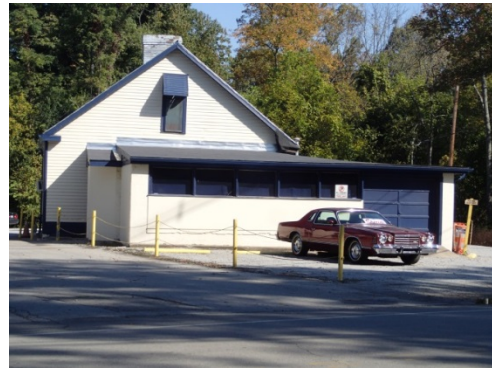
**JF 936** is a one-story, frame building topped with a front gable roof covered in standing seam metal. The site sits on the north side of River Road and is oriented to the south. The structure is clad in weatherboard siding. The fenestration pattern has been altered and most of the windows are covered by a large addition. An internal brick chimney is present. A large frame addition is present on the front façade and east elevation. The building is in good condition.

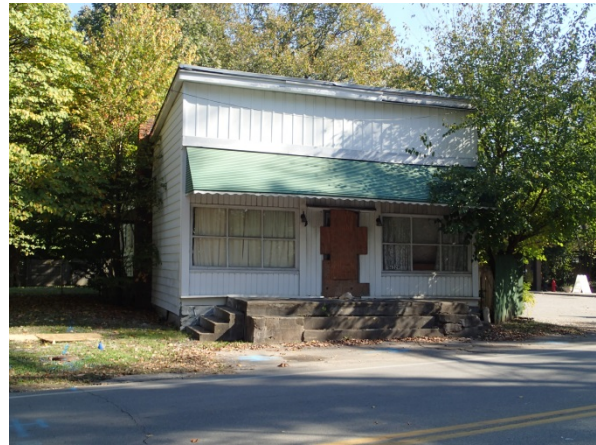
JF 937 is a one-story, three-bay (w/d/w) frame building topped with a shed roof covered in metal. The site sits on the north side of River Road and is oriented to the south. The structure is clad in aluminum siding and rests on a continuous foundation that has been covered in a thin coat of cement. The fenestration pattern appears unaltered and the windows are wood sash. A frame addition topped by a shed roof is located on the rear elevation. The building is in good condition.

Originally served as a station stop for passengers traveling on the interurban railroad. It also has been a commercial building.

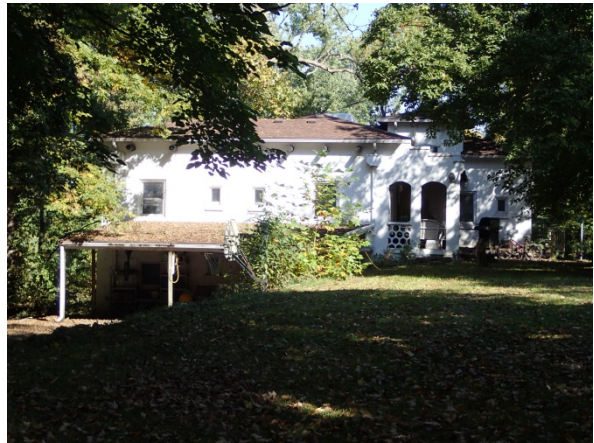
JF 939 is a one-story, three-bay (w/d/w) frame building built in the Spanish style. It is topped with a hip roof covered in asphalt shingles. The site sits on the east side of River Road and is oriented to the west. The structure is clad in stucco plaster which extends down to grade. A ½ width porch adorns the front façade. It is topped by a flat roof that is supported by wood posts. The decking is brick. The fenestration pattern appears unaltered and the windows are original to the house. The building is in good condition.

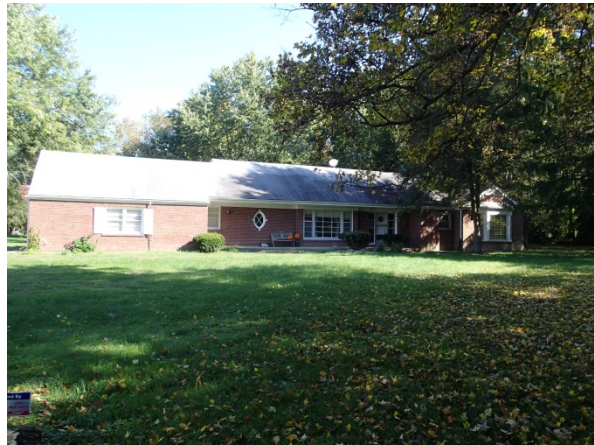
JF 1965 is a one-story, Ranch style house topped with a side gable roof covered in asphalt shingles. The site sits on the north side of River Road and is oriented to the south. The structure is clad in brick which extends down to grade.

The central portion of the front façade that includes the main entrance is inset beneath the main roof of the house. The fenestration pattern appears unaltered and the windows are a variety of types including a large bay window and an oval window that adorns the front façade. The building is in excellent condition.

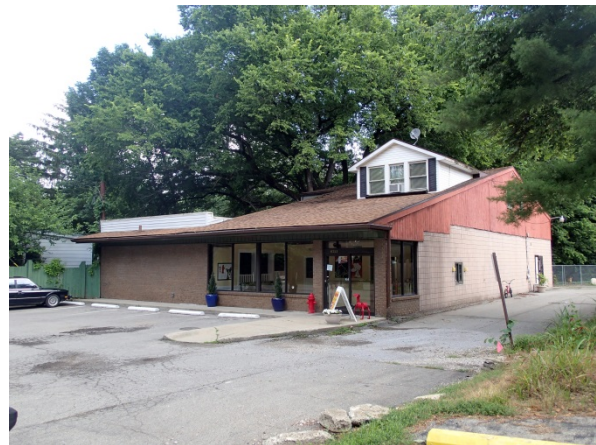
JF 1966 is a one and one-half story, frame building topped by a side gable roof that is covered in asphalt shingles. The site sits on the north side of River Road and is oriented to the south. The structure is clad in brick veneer, wood panels and concrete tiles. The building has several additions and has undergone numerous alterations. The building is in good condition.

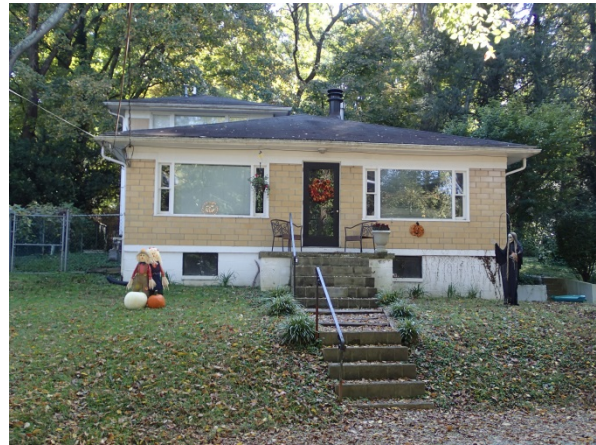
JF 1967 is a one-story, three-bay (w/d/w) frame building topped with a hip roof covered in asphalt shingles. The site sits on the east side of River Road and is oriented to the west. The structure is clad in brick veneer and rests on a continuous concrete block foundation. A concrete stoop adorns the front façade with concrete steps leading up to the main entrance. The fenestration pattern appears unaltered and the windows are original. A large addition is located on the rear elevation. The building is in good condition.

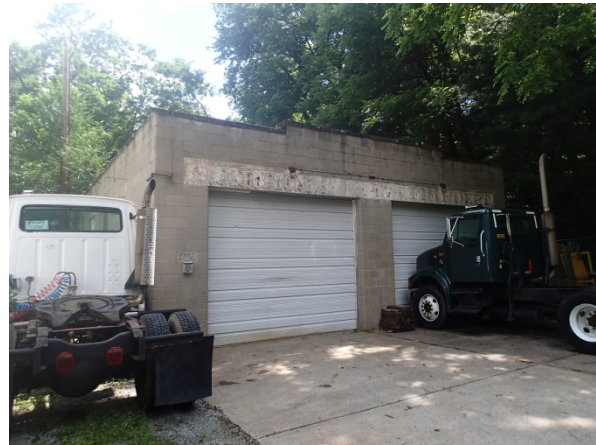
JF 2081 is a one-story, two-bay (d/d) concrete block building topped with a flat roof and stepped parapet wall with concrete coping. The site sits on the east side of River Road and is oriented to the south. The structure is constructed from concrete block and rests on a continuous concrete block foundation. Two large bay doors are located on the façade. Above the doors is painted, "Harrods Creek Fire Dept". An internal brick chimney is present. The windows and doors on the remaining elevations are boarded over. The building is in good condition.

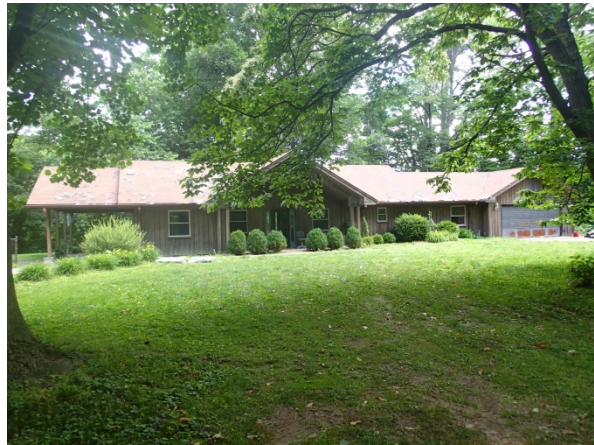
**JF 2802** is a one story, frame building topped by a side gable roof that is covered in asphalt shingles. The site sits on the west side of River Road and is oriented to the south. The structure is clad in wood paneling. A three-bay porch adorns the front façade. It is topped by a gable roof. The building is currently being renovated. It is in good condition.
