National Register of Historic Places Registration Form

Historic name: <u>Stipp-Bender Farm</u>

Street & number: 5075 Sou	th Victor Pike	
City or town: <u>Clear Creek</u>	State: Indiana	County: Monroe
Not For Publication:	Vicinity: X

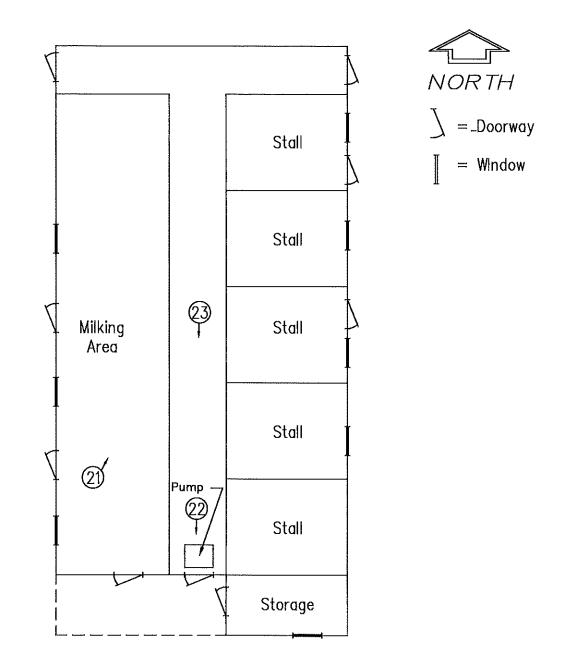
DAIRY BARN FLOOR PLAN First Floor Stipp-Bender Farm, Clear Creek, Monroe County, Indiana

The interior is a three-bay configuration (Photo 0021). The west bay is open from north to south while the east bay is divided into stalls. The building is constructed of nailed, circular sawn timbers resting on hewn sills and stone piers. The ground floor is dirt. A raised, wood walkway makes up the center bay and extends from the nearly centered door on the south end to a ledged

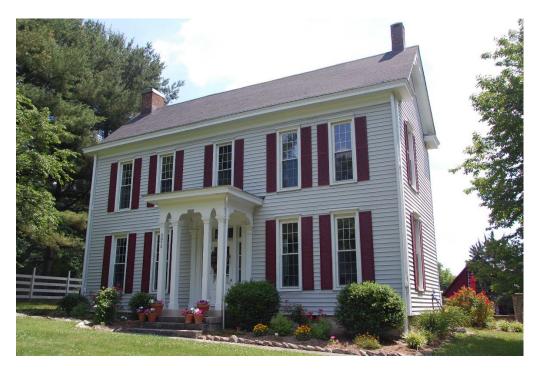
IN_MonroeCounty_StippBenderFarm_0001

(Photo 0001)

The west elevation of the main house is the primary facade and fronts Old Capitol Pike (historic Victor Pike). At grade of the sloping land and off-center in the south half of the elevation is a metal foundation grate. Centered in the elevation, three limestone slab steps access an Italianate style entry portico. At the base of the steps a limestone pad is at grade and a limestone slab walkway leads due south to the driveway. Beneath the portico, the single-light wood entrance door has three lower vertical panels, and the storm door is a four vertical-light wood door. A three-light transom is above the doorway and five-light sidelights are on either side of the doorway. The flat roof and wide eaves of the portico are supported at each corner by a pair of square wood posts with cyma reversa caps. A matching pilaster is on either side of the doorway. The posts support a high, decorative entablature and paneled ceiling. Placement of the five openings on each floor across the facade, one of which is the centered entrance on the first floor, emphasizes symmetry and with it a sense of order and formality. Above the second-floor windows is a wide frieze board.

(Photo 0001)

The two-story frame, five-bay Greek Revival and Italianate style I-house was constructed in 1876. It has a two-story rear gabled wing (Photo 0002). Over time the house was further expanded to the rear c.1985 with a single-story shed roof sunroom, a c.1990 single-story gabled roof addition, and a c.1995 single-story flat roof addition recently remodeled with a gabled roof. Knowing the farm was established well before the house was constructed, it is unknown what prompted the Stipps to build. However, the tax duplicates support the 1876 construction date with improvement values jumping from \$500 in 1875 to \$1,800 in 1877.

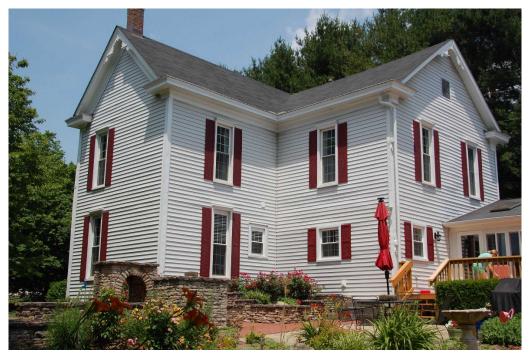
IN_MonroeCounty_StippBenderFarm_0002

(Photo 0002)

The south elevation is the secondary facade visible from portions of Old Capitol Pike (historic Victor Pike) and properties to the south. At grade of the main house a metal foundation grate is off-center to the west. A single window is at the first floor, and another is at the second floor, both in the west half of the main house elevation. The gable features a frieze board, decorative millwork, and gable returns.

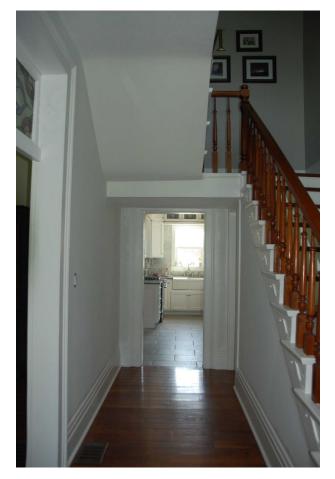
IN_MonroeCounty_StippBenderFarm_0004

The west entrance opens into a center hall that leads to a room on either side of the hall, and further back to the basement stairway, a small bathroom, the second-floor staircase, and the kitchen (Photo 0004). The flooring in the hallway is four-inch-wide replacement hardwood; the tall, original molded baseboards have a top edge roll; and the wide, original door trim has an edge roll leading to a flat outer edge.

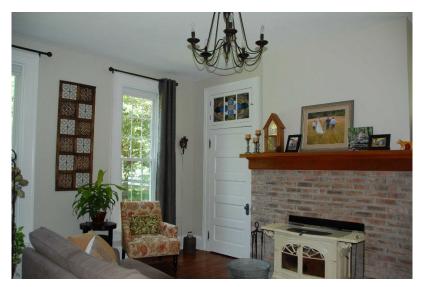
IN_MonroeCounty_StippBenderFarm_0006

In the north hallway wall a transomed doorway leads into the parlor (Photo 0006). The door has been removed and the transom opening has been filled with a contemporary colored and leaded glass piece. The flooring is a continuation of the replacement flooring in the hallway. The baseboards and window and door trim matches that in the hallway. Two windows are in the west wall. Centered in the north wall is a wide chimney breast with a wood stove insert, contemporary brick fireplace surround, and stained wood mantel. To the left of the chimney breast is a transomed, horizontal panel door leading into a shallow closet and to the right of the chimney

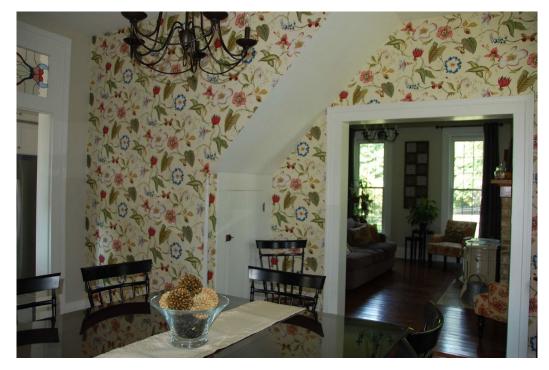
IN_MonroeCounty_StippBenderFarm_0007

Name of Property County and State breast is a window. In the east wall a wide doorway without doors leads into the dining room within the rear wing (Photo 0007).

Flooring in the dining room is a continuation of that found in the hallway and parlor. The tall baseboards and wide door trim are plain with little ornamentation. In the north wall are a window and transomed, four-panel door that leads to the exterior. The transom is filled with a contemporary stained and leaded glass piece. In the east wall a former exterior doorway now leads into the sunroom addition. The single light door is transomed, the opening of which is filled with a contemporary stained-glass piece. The south wall has a large pass-thru opening and a transomed doorway into the kitchen. The door into the kitchen has been removed and the transom has a contemporary stained and leaded glass piece. Along the west wall is a boxed staircase to the second floor. A small vertical batten door with a thumb latch accesses a closet beneath the stairway. The corner of the box has a decorative turned wood cap. To the right of the doorway into the kitchen, once inside the kitchen, is a doorway with plain trim and a horizontal panel wood door with a filigreed metal knob and plate that accesses the box stairway to the second floor. The kitchen was completely remodeled in 2019 with tile flooring, a farmhouse sink under the east wall window, and paneled cabinetry reflecting a period style.

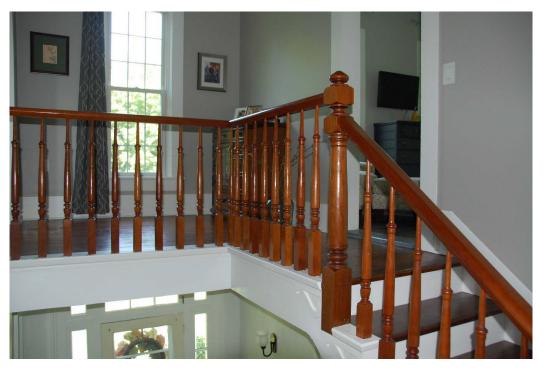
IN_MonroeCounty_StippBenderFarm_0008

The hall stairway concludes at a landing that begins along the north wall of the stair hall and wraps along the west wall (Photo 0008). The baseboards, door, and window trim on the second floor are all plain wide boards.

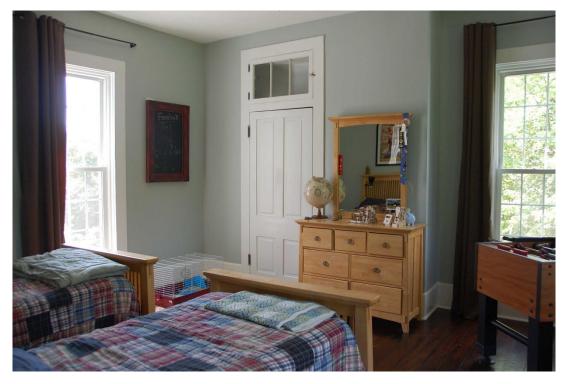
IN_MonroeCounty_StippBenderFarm_0009

In the west wall of the second-floor landing are two windows. In the south wall a transomed doorway with a four-panel wood door with a porcelain knob leads into a bedroom (Photo 0009). The three-light transom has panels of stained and leaded glass. The doorway retains the wide threshold, and the flooring is the original six-inch wide wood. There are two windows in the west wall. The south wall has a window, a chimney breast for a wood stove, and a shallow closet with a four-panel wood door and three-light transom. One window is in the east wall.

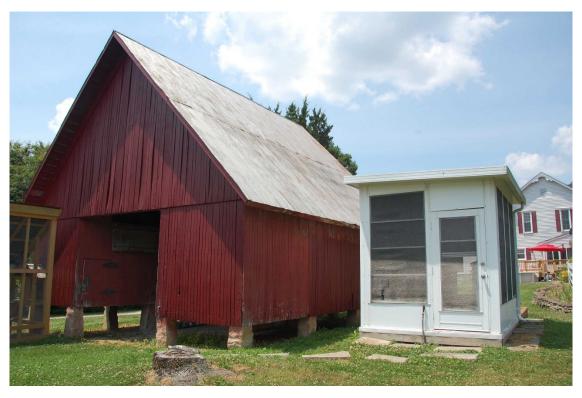
IN_MonroeCounty_StippBenderFarm_0015

The drive-thru corn crib, sited east-west, was constructed c.1895 and is approximately 105' east of the rear wing of the house. The approximately 24' wide by 32' deep building is elevated on tapered limestone piers, has vertical wood strip siding, and a steeply pitched, front gable roof covered with corrugated metal. The building retains the sealed board crib on the north side and vented board crib on the south side. A recently constructed chicken coop is attached to the

southeast corner (Photo 0015, far left). Immediately adjacent on the north side of the crib is the non-contributing c.2005 canning shed. (Photo 0015, to right in foreground). Resting on pressure-treated timbers, it is constructed of particle board with walls primarily consumed by large four horizontal-light vinyl windows and four horizontal-light vinyl doors. The west elevation has a door and window, the north elevation has three windows, and the east elevation has a door and window. The south elevation is without fenestration. An uncovered wood deck of roughly the same dimension as the shed is attached on the west elevation.

Further east and less visible from the road are the c.1895 drive-thru corn crib north of the driveway (Photo 0015) and the c.1875 granary (Photo 0016) south of the driveway. A mature cedar tree is at the west end of the drive-thru corn crib, the noncontributing c.2005 canning shed (Photo 0015) is adjacent to the building on the north side, and a vegetable garden is further north in the open yard. The c.1875 granary (Photo 0016) has a mature apple tree and mature conifer on the north side with smaller trees to the south.

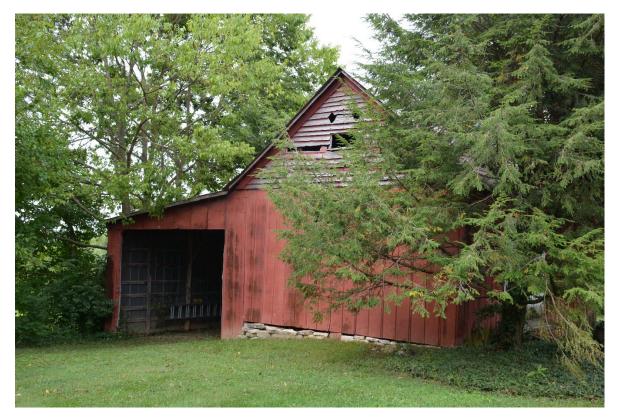
IN_MonroeCounty_StippBenderFarm_0016

The c.1875 granary, sited east-west, is approximately 65' slightly southeast of the drive-thru grain crib. The approximately 24' wide by 30' deep building has a shed roof addition added c.1935 along the south elevation. The original building is elevated on limestone piers, was sided with clapboards, and has a front gable roof. Pieces of limestone have been inserted into some areas around the foundation, perhaps to keep animals out of the building, but the stones provide no structural support. The building is now sided with ribbed metal panels and the roof is covered with corrugated metal. The west elevation is without fenestration except for a small rectangular gable vent, and the south elevation is also without fenestration. The east elevation has a wide opening without doors in the shed roof addition and a small square, fixed glass window in the wall of the granary. The gable reveals the original clapboard and wood cornice and has a rectangular gable vent and two small diamond-shaped vents. The north elevation has a centered wood ramp leading to a pair of ledged and braced doors. Sheltered inside the shed roof addition is the original south elevation of the granary (Photo 0017). The wall is covered with clapboard and has a nearly centered single-light wood, human-scale door. The hewn and sawn mortise and tenon framing supports 8" wide floorboards. Tree trunks serve as the posts in the braced framing of the shed roof addition.

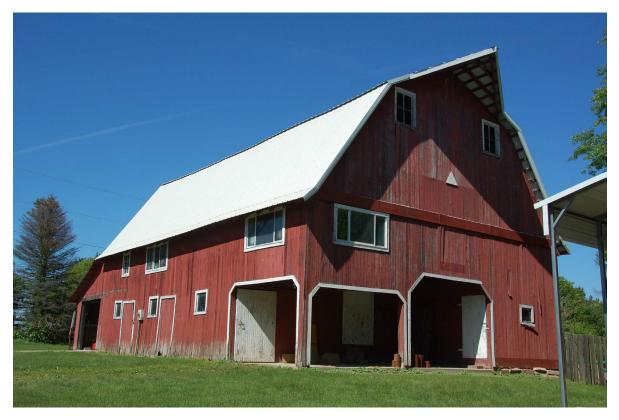
IN_MonroeCounty_StippBenderFarm_0018

The west elevation has a notched corner opening at the southwest corner. Through the recessed entry area is a ledged and braced door in the west wall of a room at the southeast corner of the building. North of the notched corner opening is a row of three square, fixed glass wood frame windows and two ledged and braced, human-scale doors. A metal overhead door replaces the original ledged and braced sliding door in the wall of the shed roof addition. A poured concrete pad extends west from the opening. Two later wood frame tripartite windows and a six-light wood frame window are un-evenly spaced at loft height.

The south elevation has two notched corner openings, the eastern one of which is taller. A ledged and braced sliding door nearly flush with the concrete pad is at the recessed southwest corner and another, at considerable height from the concrete pad, is nearly centered in the recessed wall. A small square, fixed-glass window is in the southeast wall that is not recessed. A tripartite, wood frame window is at the southwest corner at loft height. Above the window a cornice band is across the elevation. A centered decorative white diamond-shaped panel marks the top of the hay door. At either outer edge of the roof gable at the highest point in the wall is a four-light, fixed glass window. A pointed hay hood crowns the gable and retains the original hay hook and trolly. Due south of the barn a concrete pad originally held the platform for the conveyor belt that was used to transfer hay into the loft in later years.⁷ An aluminum roof was erected over the pad c.2000 for use as boat storage.

The c.1910 dairy barn, sited north-south, is approximately 90' east of the drive-thru grain crib. The large building is approximately 38' wide by 52' deep with a shed-roof addition across the north elevation. The hewn sill beams rest on stone foundation piers, the exterior walls are covered with vertical tongue and groove wood siding, and the gambrel roof is covered with corrugated metal. The southwest corner is a recessed entrance with three notched corner openings and a poured concrete pad accessing three doors to varying original functions inside the barn.
