Re: Section 106 Review Letter  
Former Advance Plating Facility  
**1005 E. Sumner Avenue**  
Indianapolis, Indiana  
USEPA ACRES ID: 226781  
Indiana Brownfields Site ID: 4200507

**Site Plans**

FORMER ADVANCE PLATING FACILITY  
1005 EAST SUMNER AVENUE  
INDIANAPOLIS, INDIANA

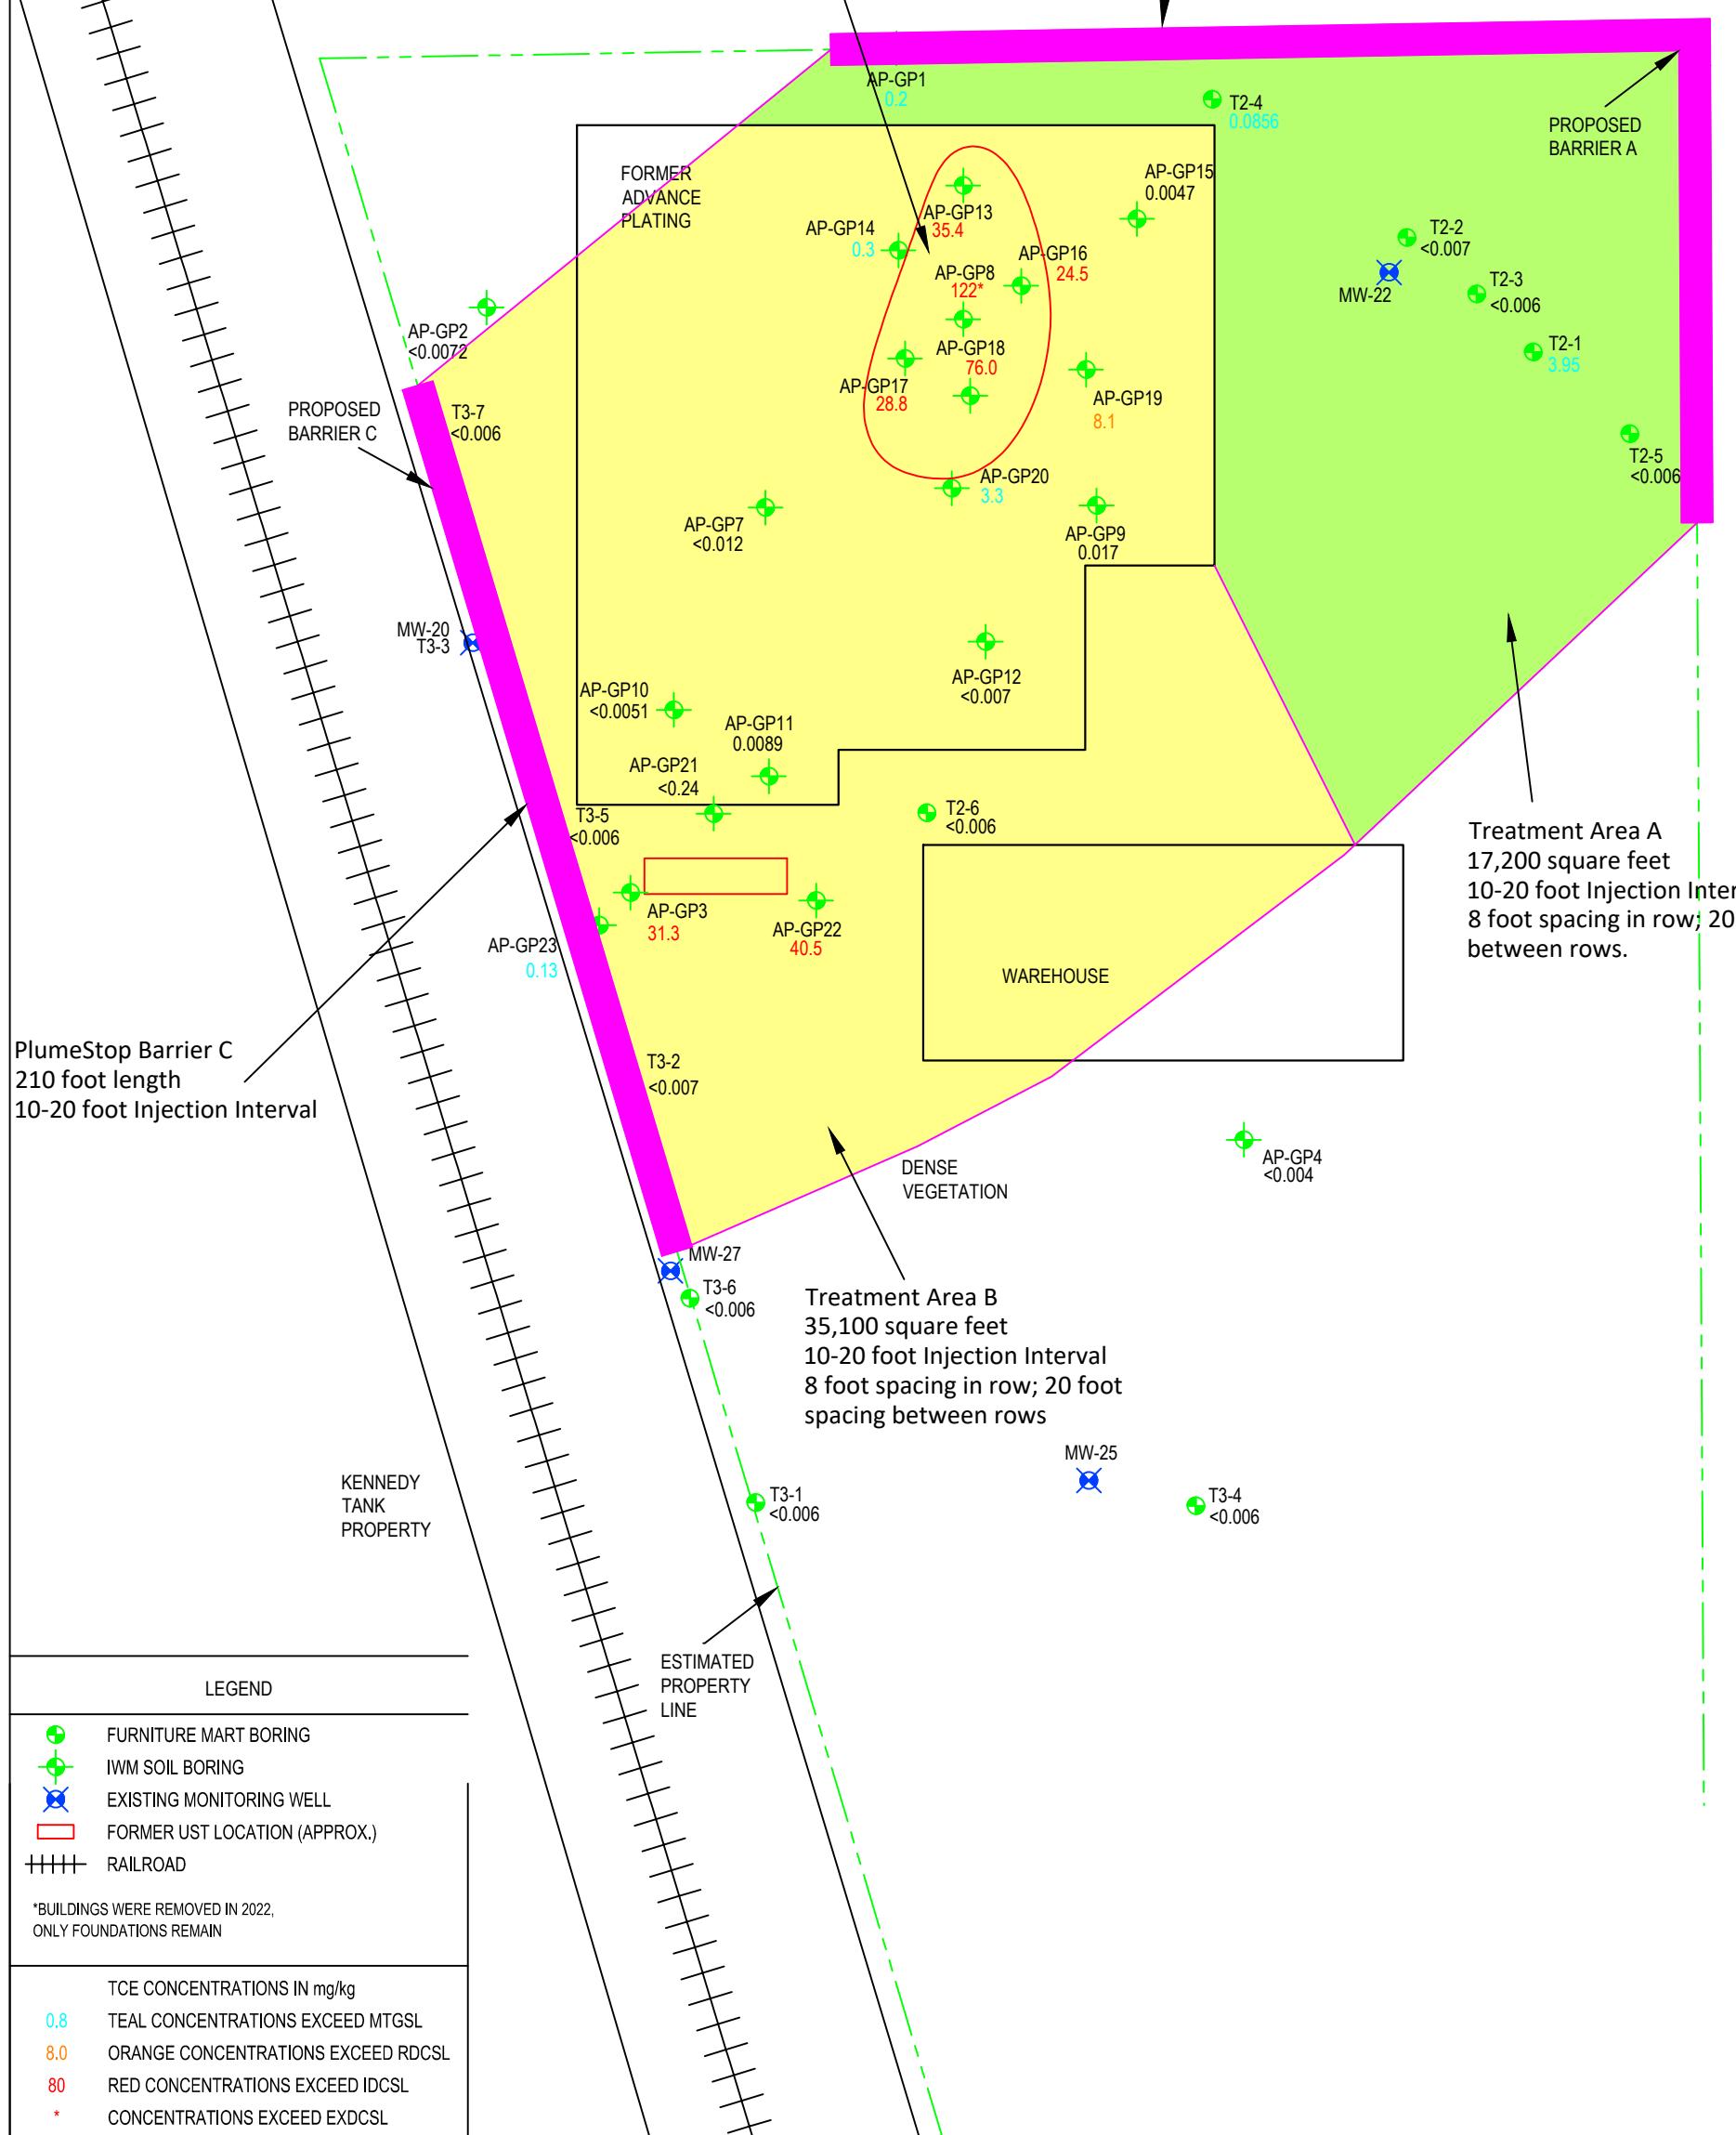
FIGURE 2  
OVER-EXCAVATION & SITE-WIDE  
INJECTION/PRB LOCATION MAP

PlumeStop Barrier A  
300 foot length  
10-20 foot Injection Interval

EAST SUMNER AVENUE

Impacted groundwater beneath the Site will be treated via the installation of 417 temporary injection points, that are approximately 2-inches in diameter. Remedial amendments will be injected into the subsurface via the temporary injection points in order to facilitate destruction and microbial degradation of the cVOCs. After the injection activities, the surface or each injection point will be restored with similar material (concrete, asphalt, or soil) that was present prior to the injection activities. Eight (8), flush mounted 2-inch diameter groundwater monitoring wells will be installed as part of the remediation activities in order to document groundwater conditions after the remediation activities have been completed.

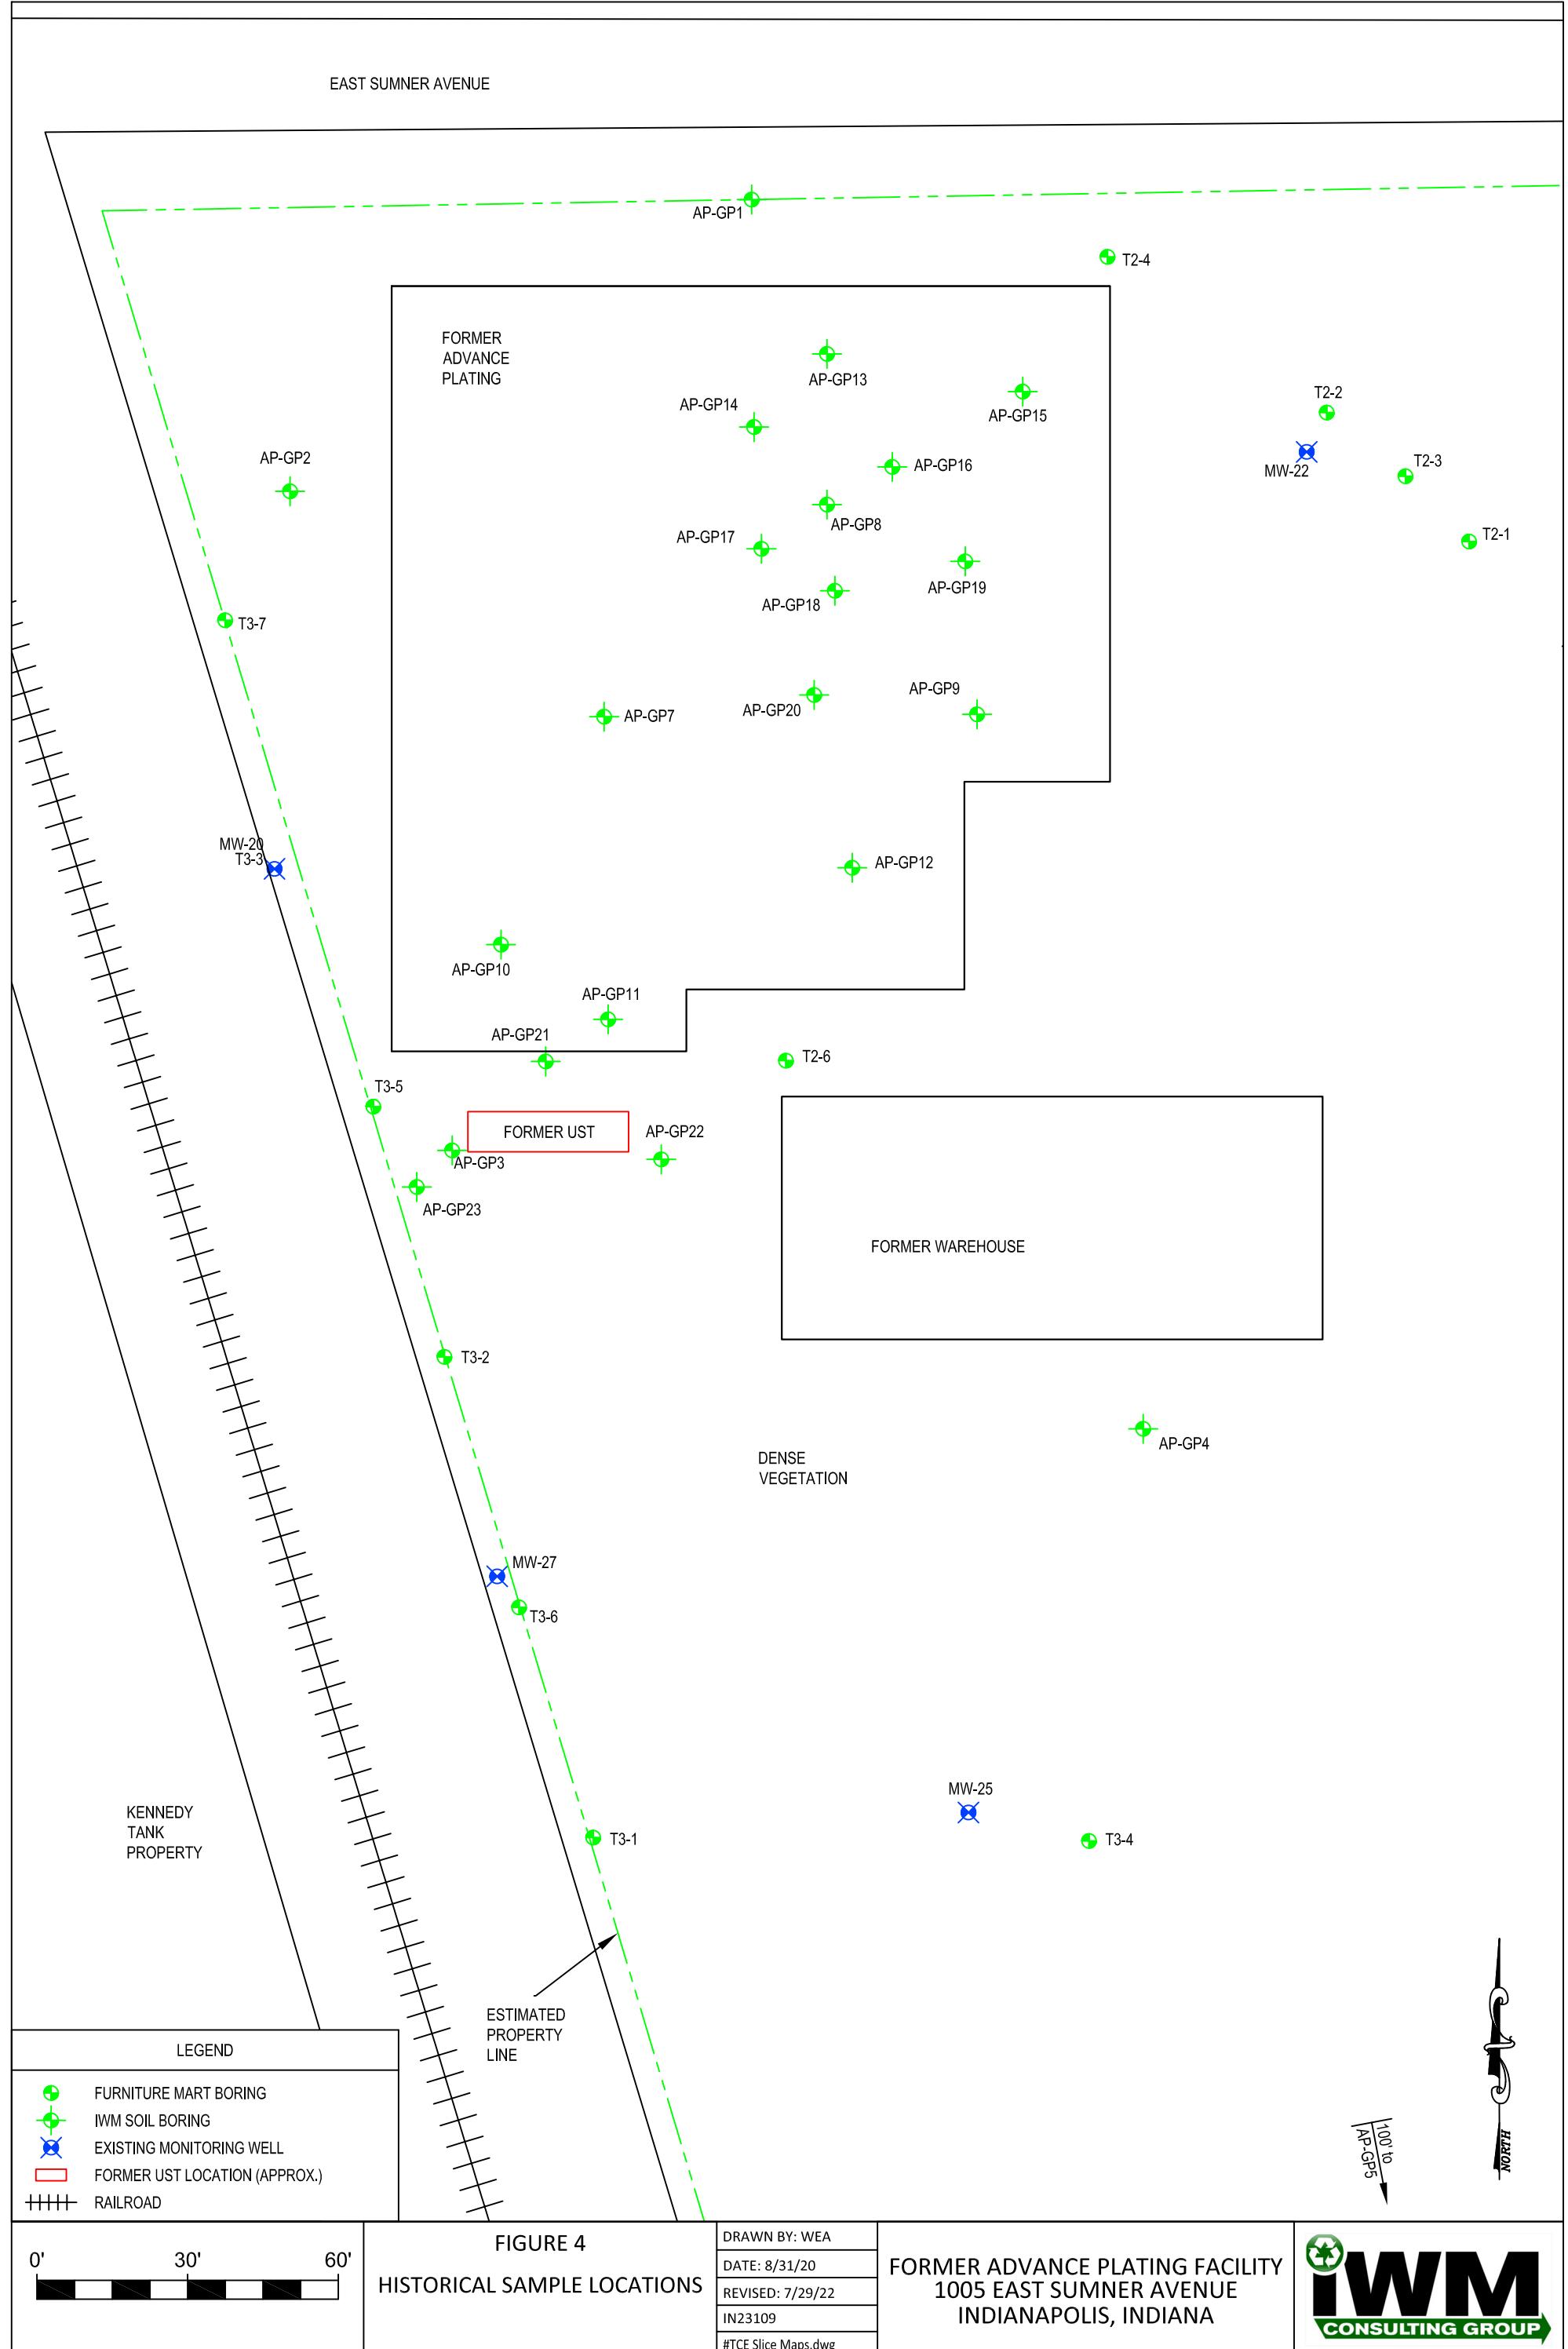
DRAWN BY: WEA  
DATE: 8/31/20  
REVISED: 2/9/2024  
IN23109  
#TCE Slice Maps.dwg

Historical experience has indicated soils impacted with TCE at concentrations as high as 100 mg/kg may be characteristically non-hazardous, primarily dependent on soil characteristics. For the purposes of estimating, IWM Consulting will assume TCLP sampling is conducted, and any TCE concentration over 50 mg/kg will be hazardous (Scenario 2). This would result in a hazardous volume of about 500 tons (needing in-situ conditioning), a non-hazardous volume of about 1,310 tons (not requiring in-situ soil conditioning), and an overburden of about 225 tons (for stockpiling and re-use). The approximate 100-ton discrepancy between the treatment/disposal volumes of Scenario 1 and Scenario 2 of this Soil Alternative is due to the difference in volume of soil which would need to be conditioned in-situ. The addition of remedial amendments to degrade concentrations and then dry out and stabilize the soil will increase the weight of the conditioned soil. Consequently, the greater treatment volume under Scenario 1 results in more remedial amendments (oxidizers, water, lime, etc.), which in turn results in a greater final tonnage. Please refer to **Figure 5** for the estimated footprint of the potential TCE excavation cell.

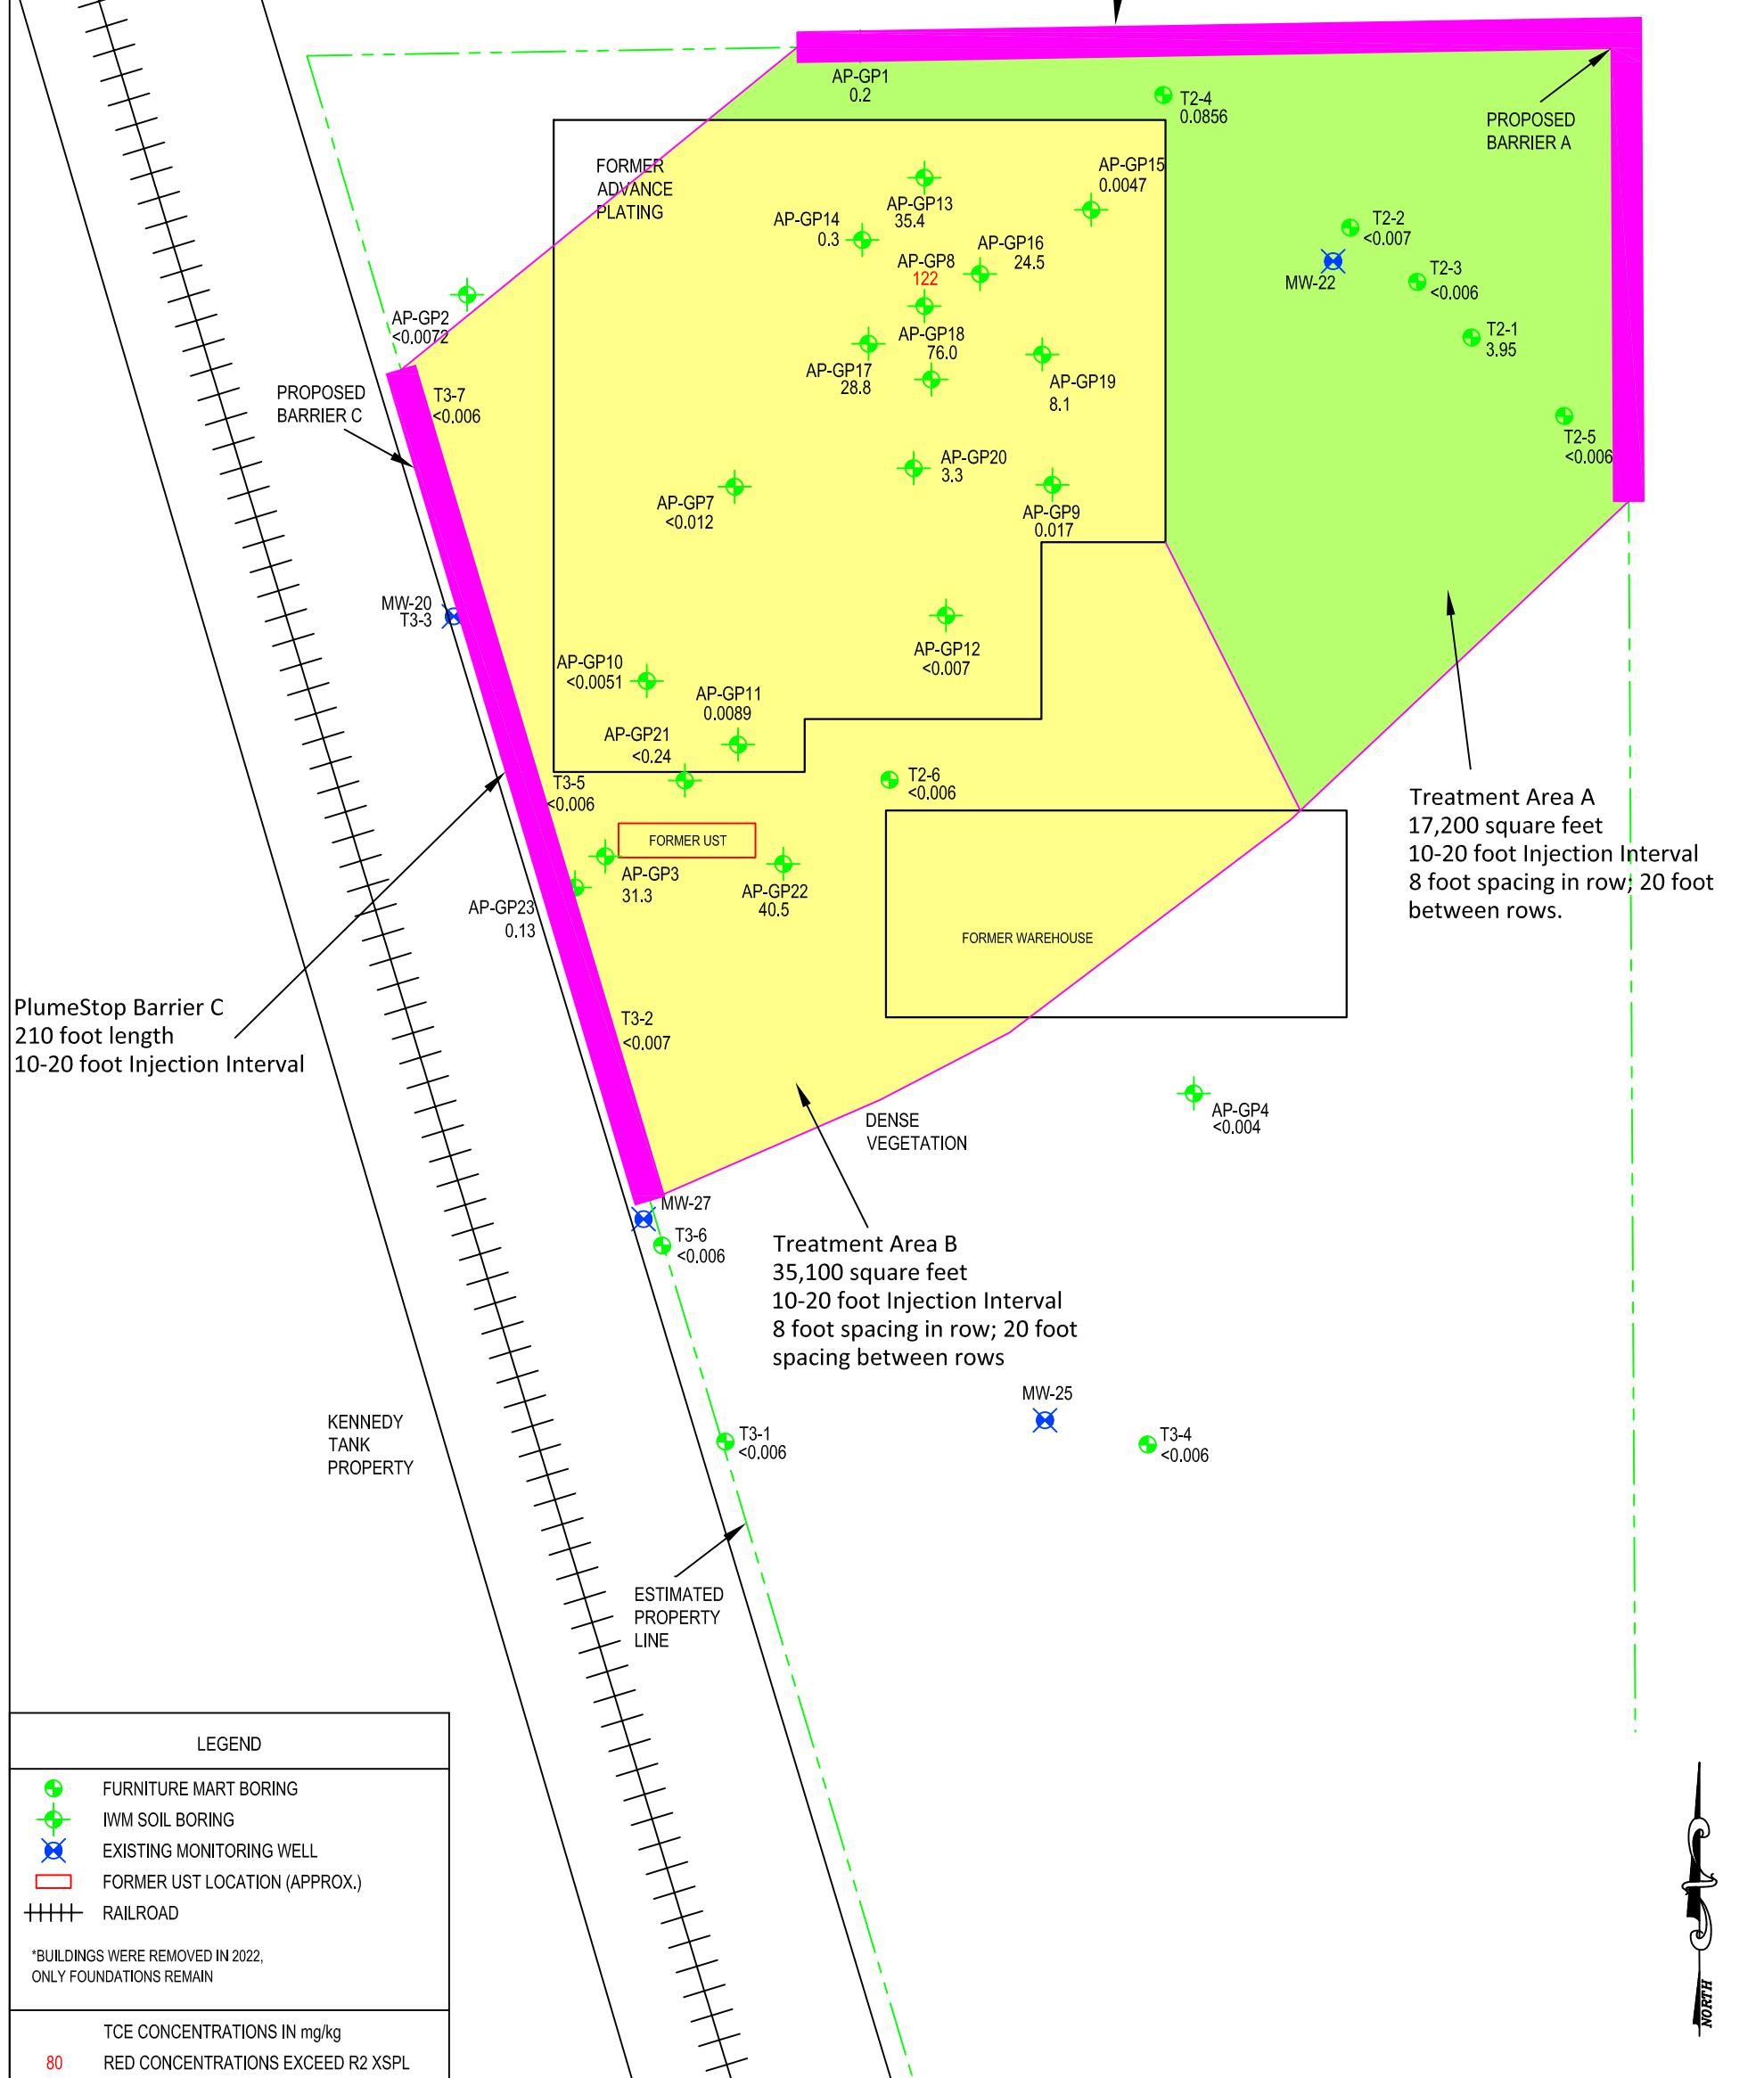
PlumeStop Barrier A  
300 foot length  
10-20 foot Injection Interval

EAST SUMNER AVENUE

The most feasible and appropriate cleanup alternative is Soil Alternative 4 (Targeted Excavation and Hazardous Disposal) along with Groundwater Alternative 4 (Site Wide Injections with Upgradient and Downgradient PRBs). An ERC restricting land use to non-residential and prohibiting groundwater extraction (except for assessment and remediation purposes) should also be instituted on the Site. The total estimated combined cost to implement Soil Alternative 4 and Groundwater Alternative 4 is approximately **\$1,645,000** plus supplemental administrative reporting requirements for an additional **\$10,000**.
