Re: RED FLAG INVESTIGATION  
Local Project  
Southeast Corridor Planning Project  
S. Anthony Blvd, E & W Paulding Rd, E Tillman Rd, and Fairfield Ave  
Fort Wayne, Allen County, Indiana

# Red Flag Investigation - Site Location Southeast Corridor Planning Project

# Red Flag Investigation - HazMat Concerns

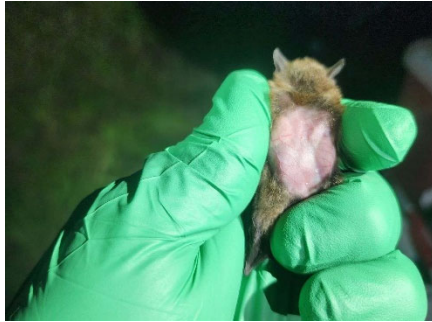
**FIGURE 3.** A photo of a back of an Indiana bat with significant fur loss three weeks after transmitter was attached using GluTure. In this example, the transmitter was applied using a small dab of GluTure between the scapulae.

**NOTE:** Surveyors who recapture a bat after using any adhesive should observe the bat's skin for signs of irritation, infection, excessive fur loss, and take photos or a video of the area where transmitter was applied (for example, see Figure 3). Report information to the Guidelines Team (FW4\_Bat\_Survey\_Guidance@fws.gov).

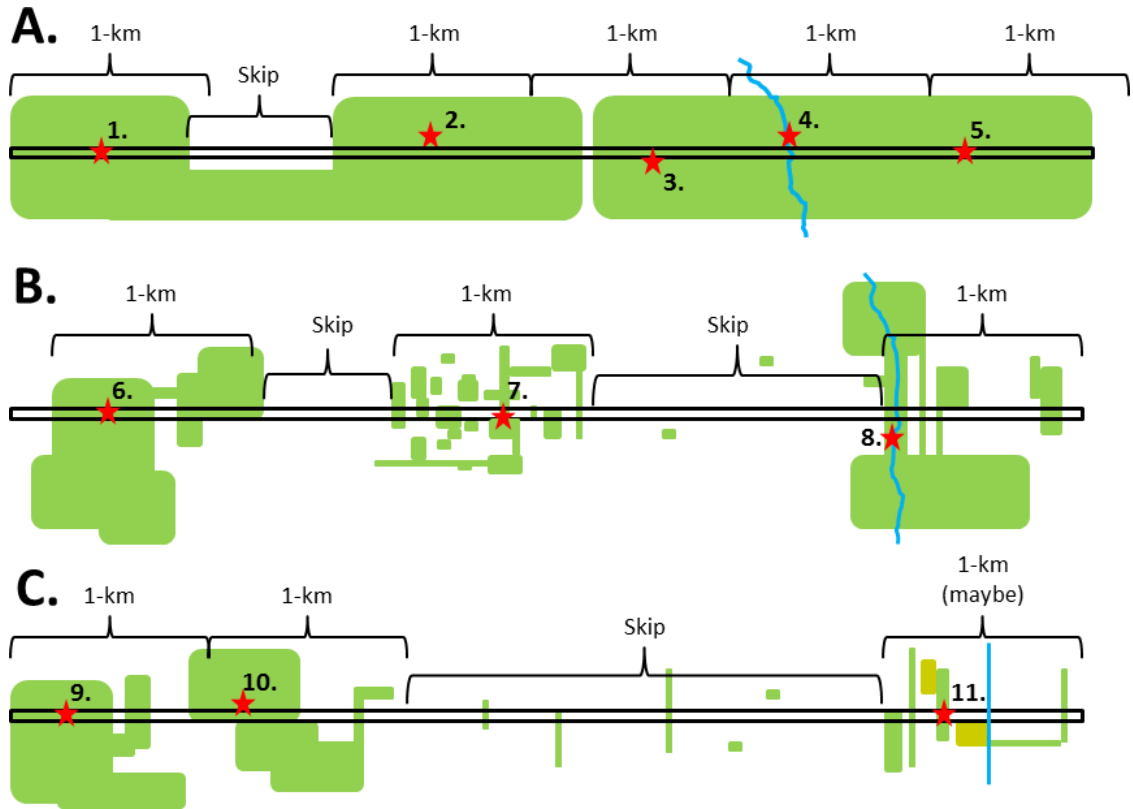
**FIGURE 4.** Conceptual linear project (black double lines) through relatively contiguous (A.) and fragmented (B. and C.) forested habitats (green patches) delineated into approximate 1-km survey sections. Numbered red stars represent suitable survey sites (1-11) on or near the project boundaries. Blue lines represent natural streams (A. and B.) and a ditch (C.). Yellow-green patches near Site 11 represent low-quality habitat.

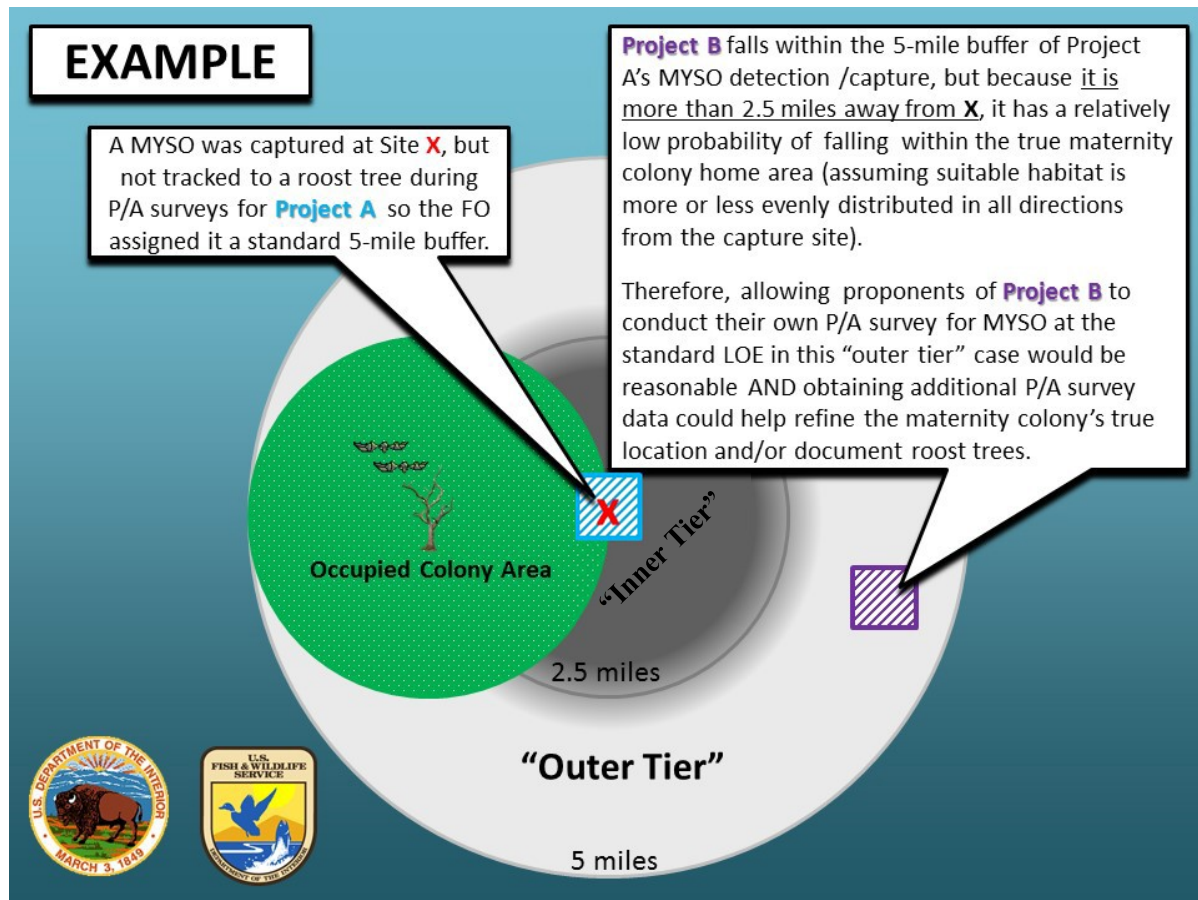
**FIGURE 5.** Graphical example depicting the proper application of the outer-tier guidance.

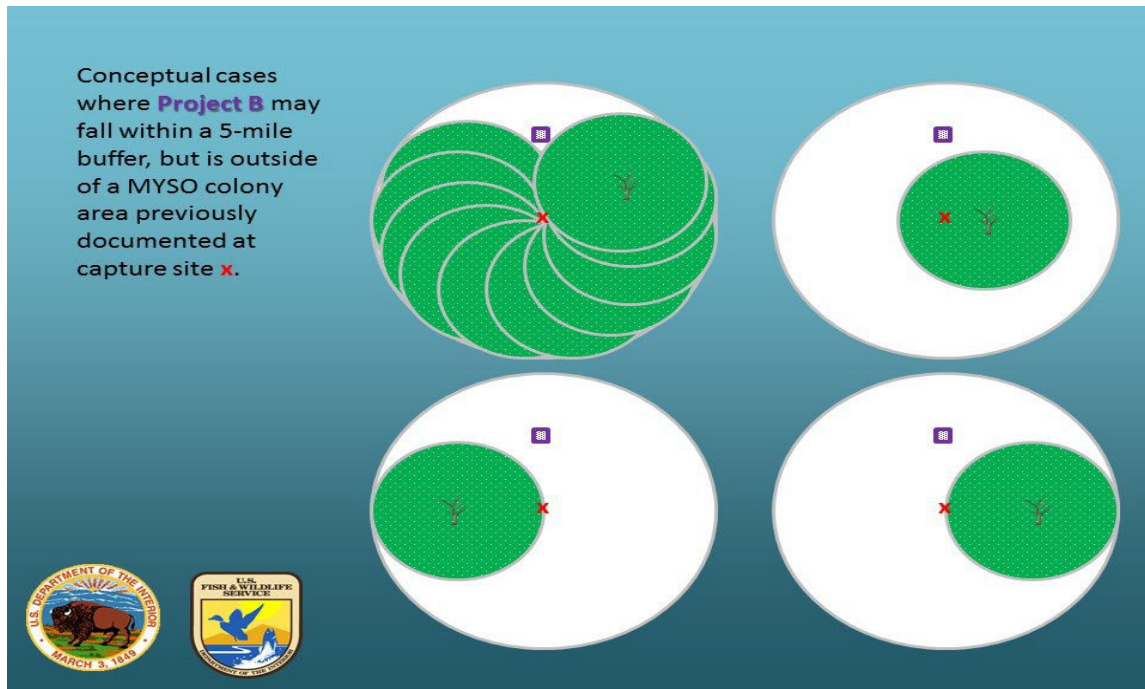
**FIGURE 6.** Hypothetical outer-tier scenarios where a proposed project area (depicted by a purple square) falls outside of the “true” IBAT maternity colony area(s) (depicted in green).

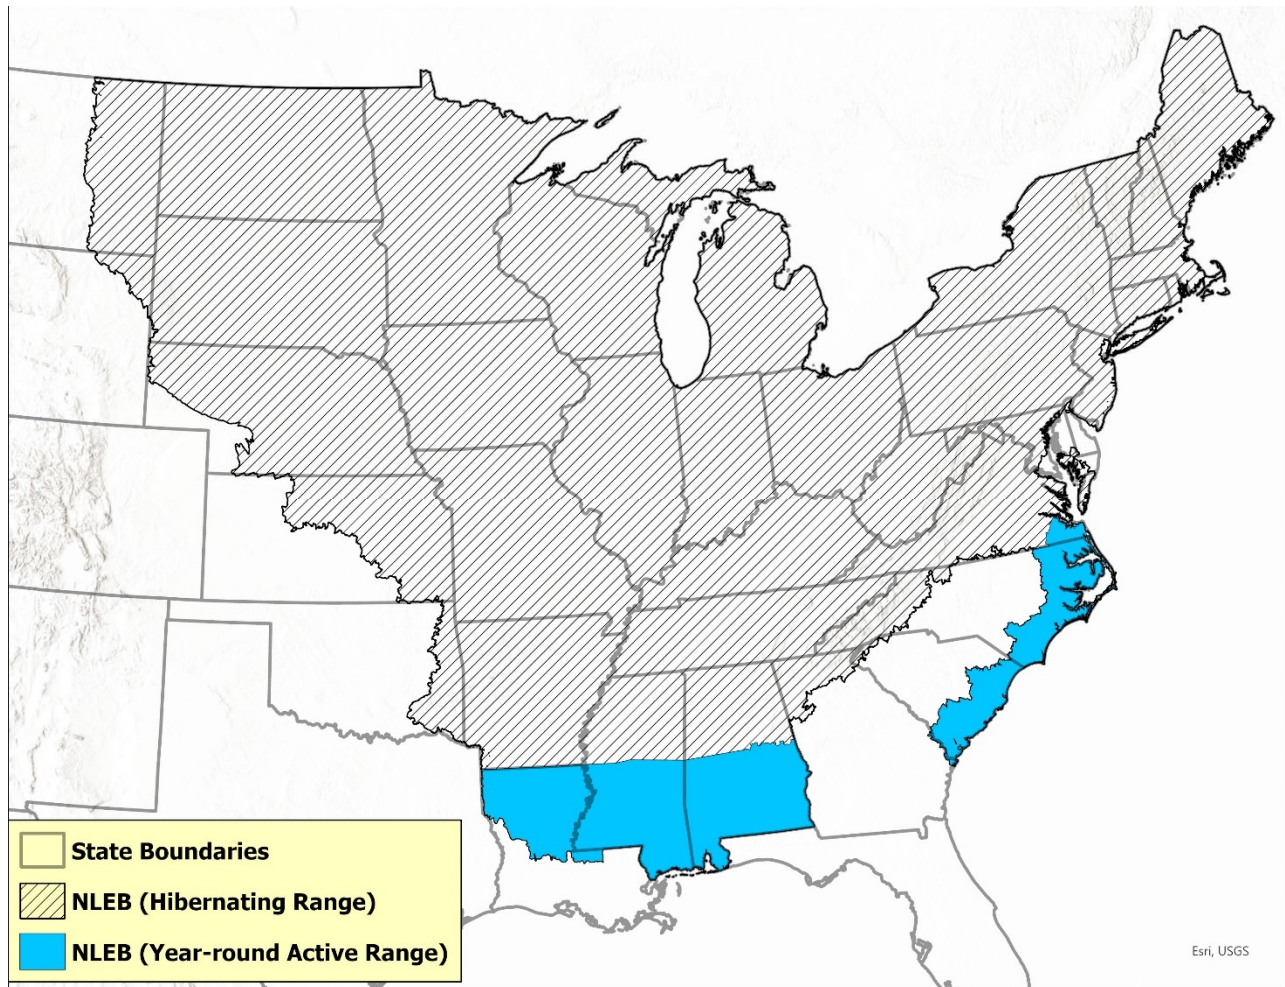
FIGURE 7. Areas delineated for use of year-round active NLEB survey guidance.

A portion of the NLEB's range overlaps with coastal areas of the eastern and southern U.S. where NLEB behavior, habits and habitat use differ significantly from the rest of the species' range. Bats may be active in these areas (see Figure 7) at any time of year and have not been documented utilizing traditional hibernation strategies found in the rest of the species range. Because of this, the USFWS collated and analyzed mist-netting data from local partners and worked with USGS and Virginia Tech to calculate year-round active NLEB minimum recommended LOE for mist-net surveys to provide expanded survey opportunities where allowed (also see Armstrong et al. 2023). Both acoustic and mist-netting techniques may be used in this region as a presence/probable absence method (Phase 2 surveys). Alternatively, mist-netting can be conducted for the purpose of attempting to capture NLEBs after detection during acoustic presence/probable absence surveys (Phase 3 surveys). The same recommendations (e.g., habitat assessments, personnel, coordination with USFWS FOs, nightly survey period, equipment, net/detector placement, checking nets, weather and other environmental conditions (temperature and precipitation), analysis of recorded echolocation calls, radio-tracking, emergence surveys, linear project guidance, outer-tier guidance, etc.) provided in other guidance appendices apply for either use of mist-netting or acoustics in the year-round active portion of the NLEB's range unless specifically addressed below.

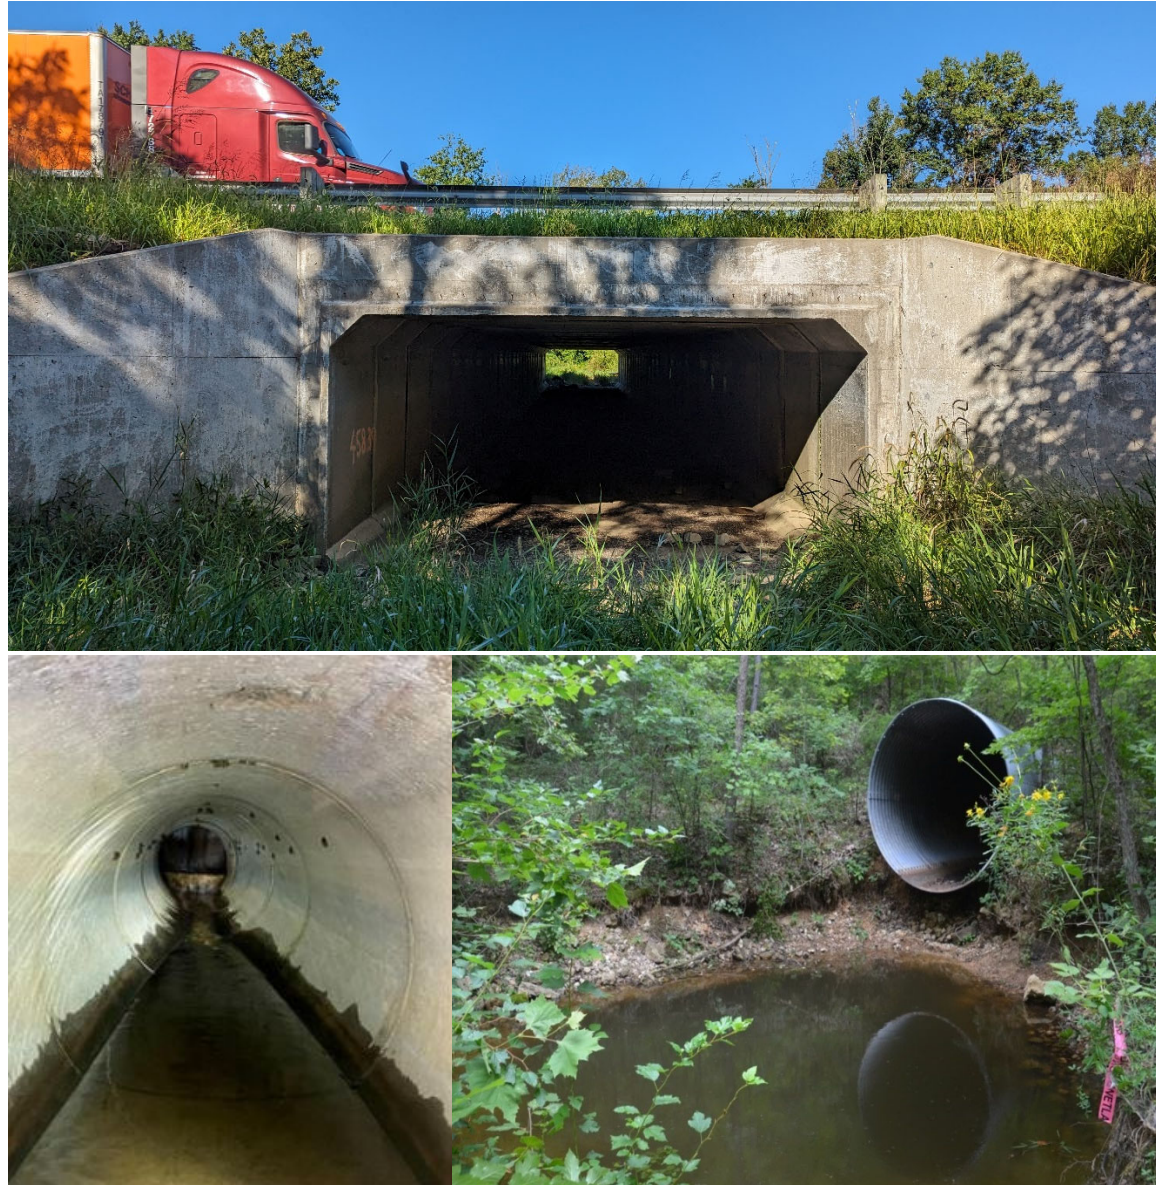
**FIGURE 8.** Representative culvert structures of various types, including a box culvert in Indiana (top; photo by USFWS); a round, concrete pipe culvert design in Georgia (bottom left; photo provided by Georgia Department of Natural Resources); and a corrugated metal pipe culvert design in Missouri (bottom right; photo provided by L. Droppelman).

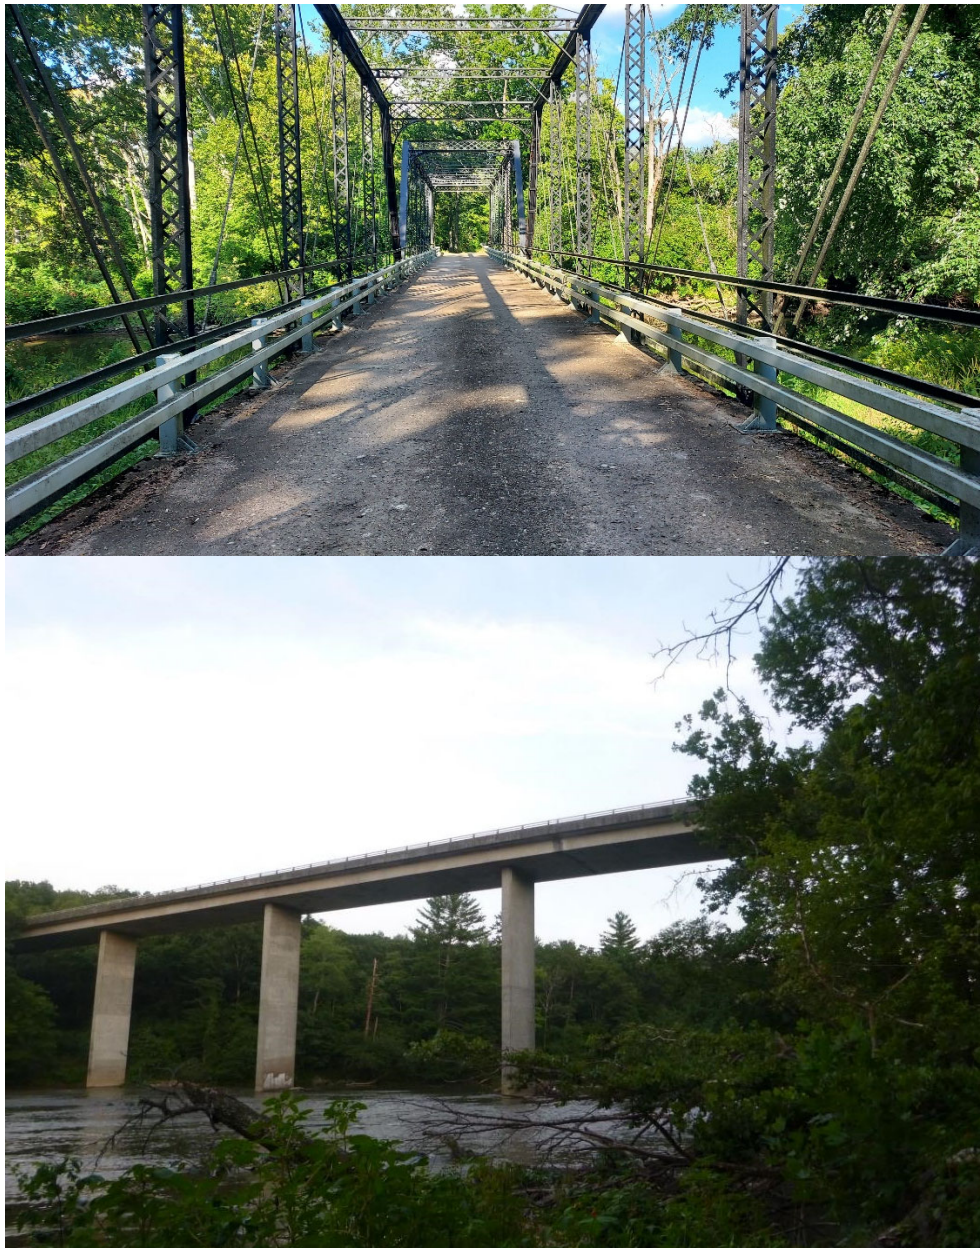
**FIGURE 9.** Representative bridges with documented bat use, including a bridge with metal struts in Indiana (top; photo provided by Indiana Department of Transportation) and a concrete bridge in North Carolina (bottom; photo provided by North Carolina Wildlife Resources Commission).

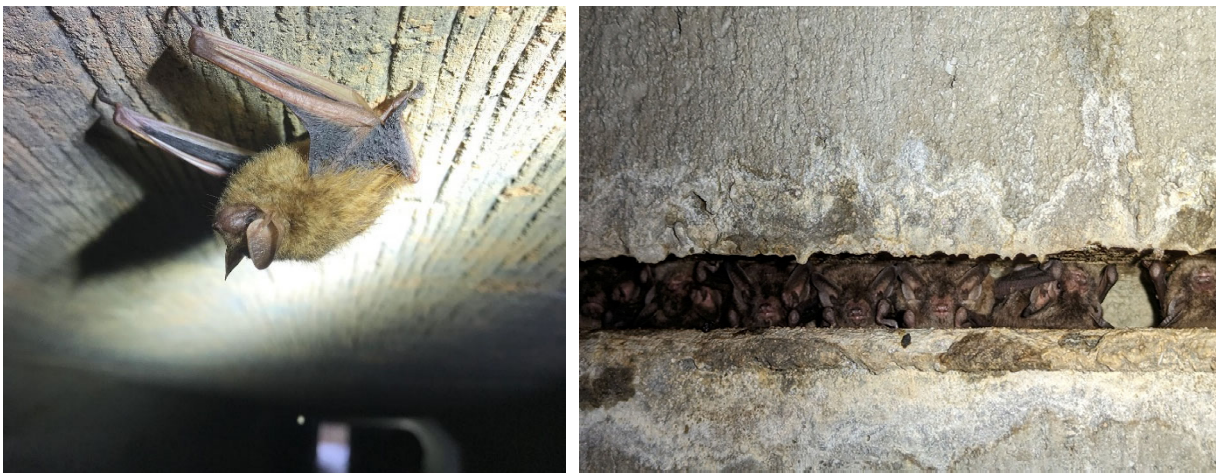
**Figure 10** A TCB roosting on the ceiling of a culvert in Georgia (left; photo provided by Georgia Department of Natural Resources) and IBATS roosting in an expansion joint in Indiana (right; photo provided by USFWS).

- Roosting Bats:** Upon entry of the bridge/culvert, check for bats roosting out in the open. Open-roosting bats will typically be near the ceiling or on the ceiling itself of a culvert or similarly along the underdeck of a bridge. Bats will occasionally roost on or within bird nests, such as those composed of dried mud and created by various species of swallow (CBWG 2022). Bats may also take flight when disturbed and can be quickly accounted for during the assessment. Use binoculars/spotting scopes when attempting to locate bats roosting in higher areas of the bridge/culvert. If bats are present, record species (if determinable), total number, a description of the respective roosting locations, and representative photographs of the individuals (see Figure 10). Additionally, provide a sketch map, if possible, showing the locations of where the bat roosts exist on the bridge/culvert (use the bridge/culvert plan sheet as base for sketch). If any dead or injured bats are observed, take photographs and promptly notify the local USFWS FO(s) and respective State Agency(ies).

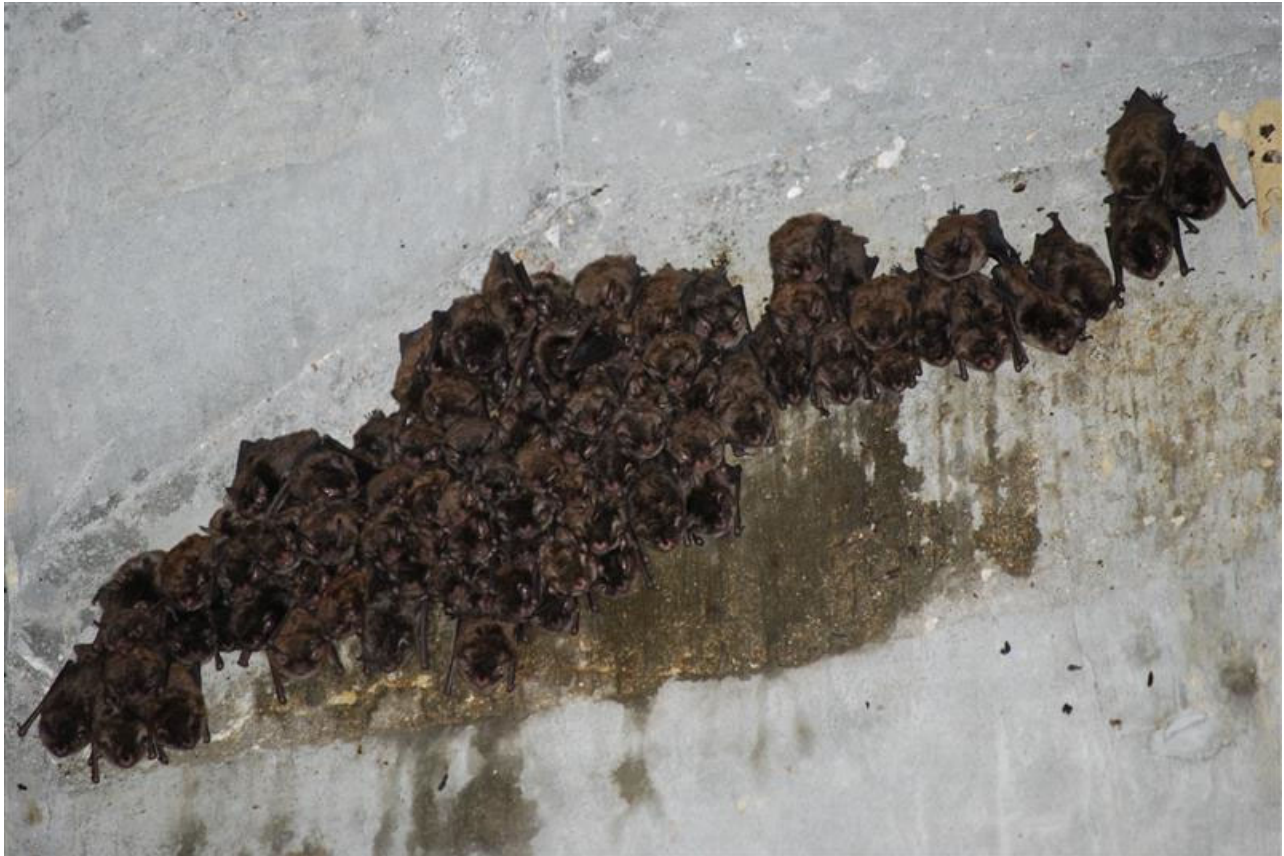
**Figure 11.** Open-roosting Indiana bats (*Myotis sodalis*) and associated urine staining on the underside of a bridge in Indiana (photo provided by R. Yaeger).

appears along cracks in concrete or masonry). For body oil staining, look for 4-6 inches-wide dark stains located on concrete support beams and walls immediately below the underdeck of the bridge, and beneath joints (Figure 11). It's important to note that staining on bridges and culverts can be caused by a wide variety of things other than bat presence. Guano deposits almost always accompany bat urine or body staining at structures, so "suspect" staining alone may not be sufficient evidence of bat presence (with the notable exception of structures with roost locations situated over waterways, where guano deposits would be washed away).

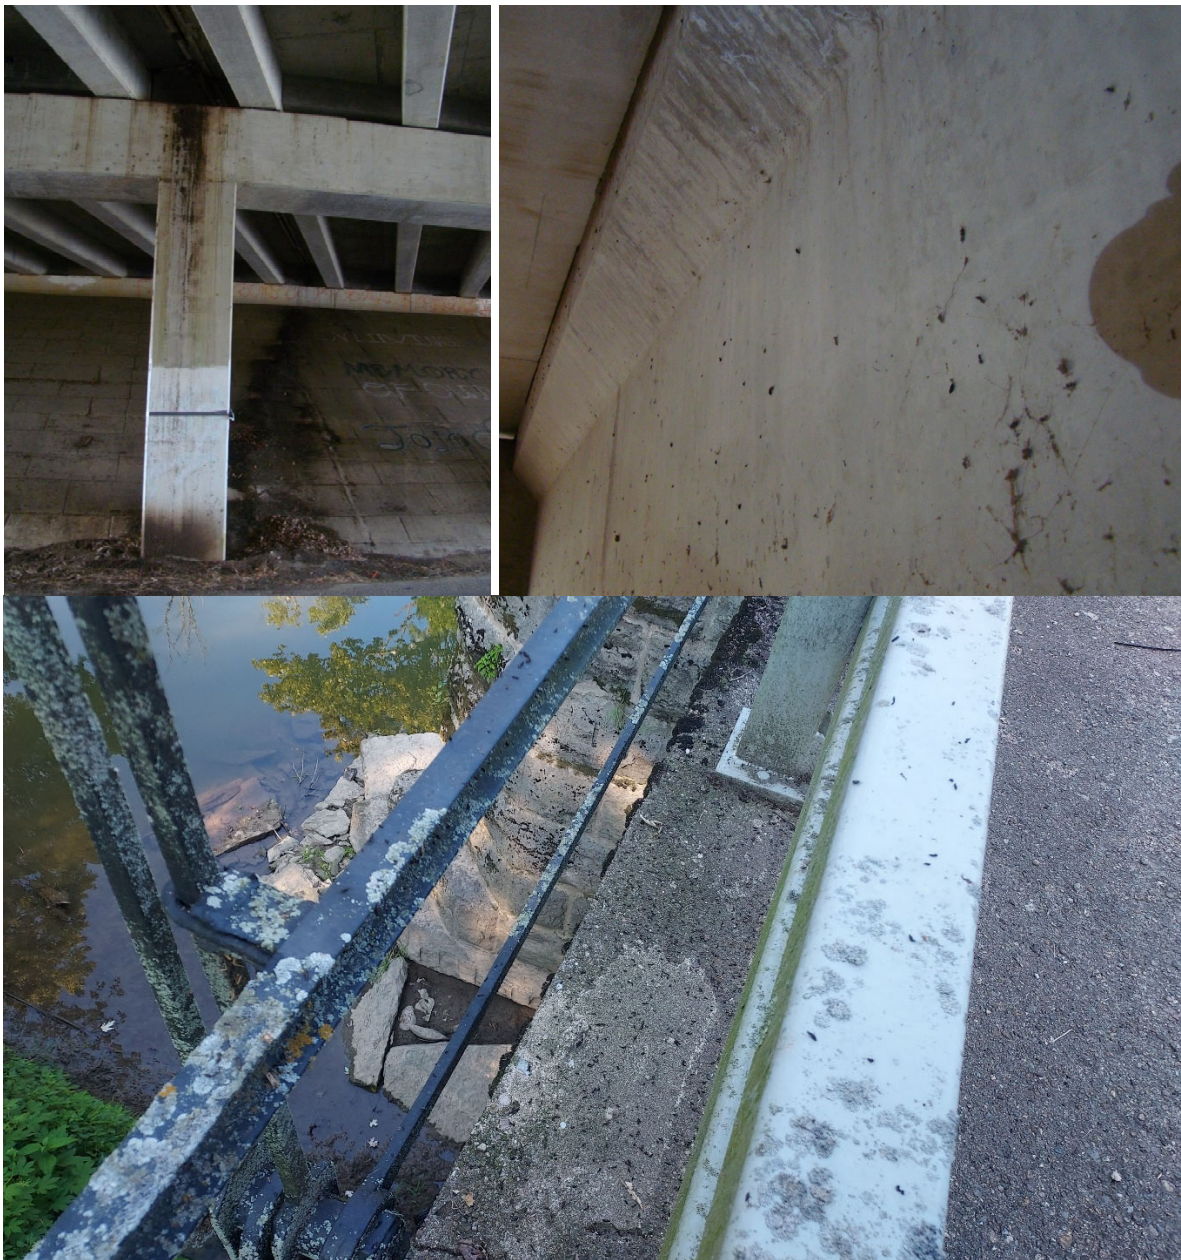
**Figure 12.** Examples of guano accumulations on bridges. (photos provided by Georgia Department of Natural Resources (top) and Indiana Department of Transportation (bottom)).

through large guano deposits. All accessible cracks, cave-like areas, and expansion joints should be checked for the presence of guano. Confirmed and suspected bat droppings should be noted and their location within the bridge/culvert should be documented. Additionally, representative photographs should be taken of guano deposits in-situ, with a ruler or other object for scale, prior to crush-testing or collecting any guano samples (note: if guano samples are intended to be collected, refer to the guano sampling section of this Appendix). It is notable that in many cases, guano accumulation in culverts or at bridges over water will be minimal due to the regular inflow and outflow of water. In these situations, urine and body staining may be a more important indicator of bat use than guano accumulation.

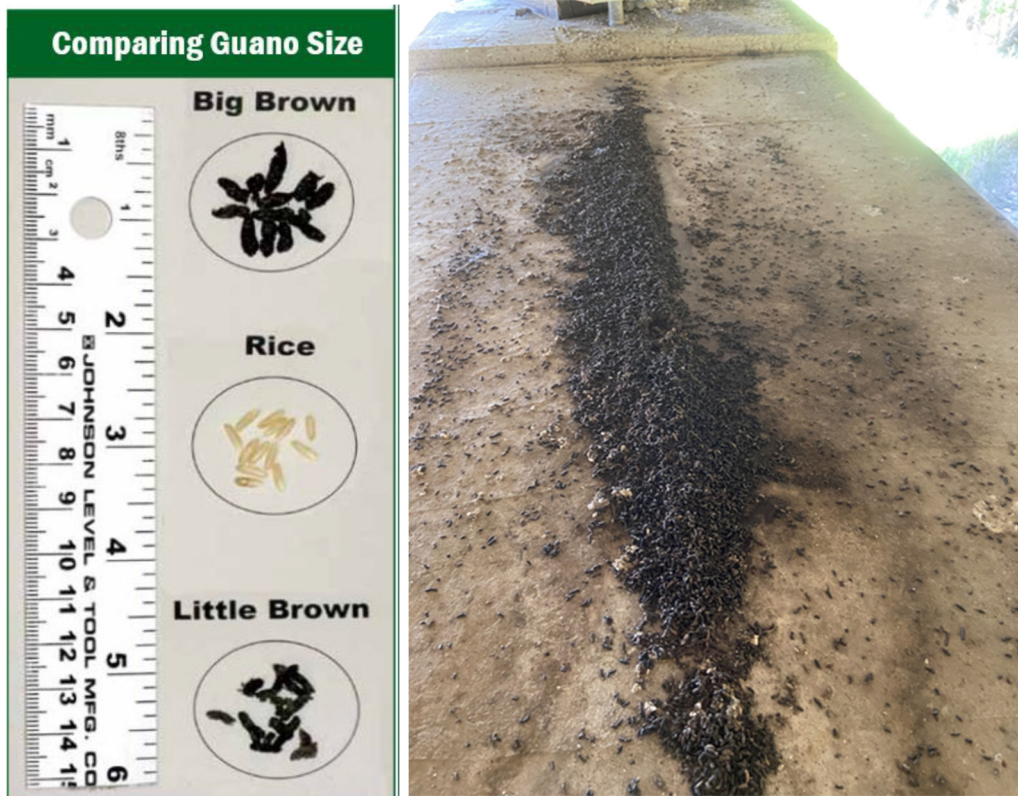
**Figure 13.** Examples and comparative sizes and characteristics of bat guano from little brown bat (*Myotis lucifugus*) and big brown bat (*Eptesicus fuscus*) (left; photo provided by Vermont Fish and Wildlife Department); Guano deposit from colony of Yuma bats (*M. yumanensis*) on horizontal bridge structure (right; photo provided by P. Crawford/ Oklahoma Department of Transportation).

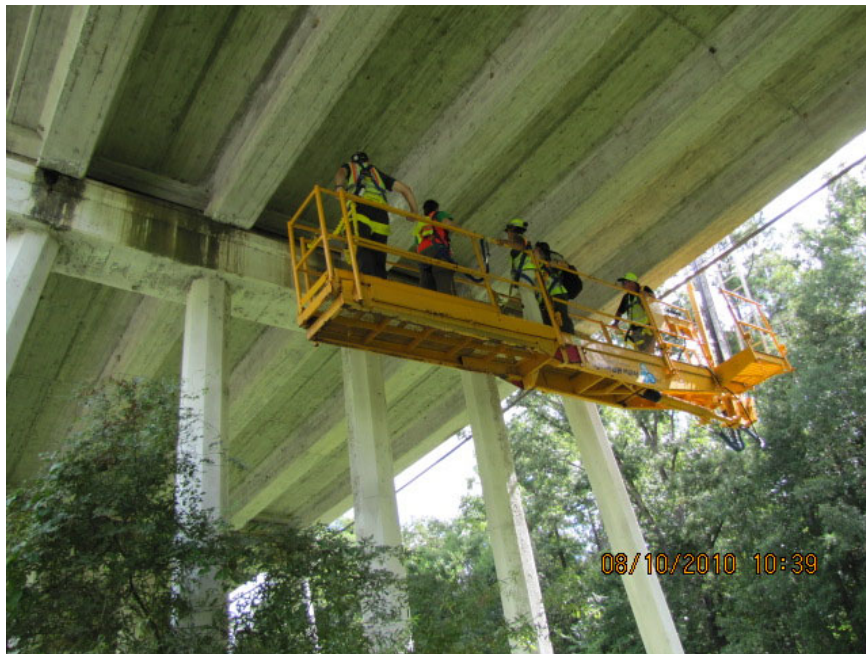
**Figure 14.** Biologists use a snooper truck to assess expansion joints and concrete caps over deep water (photo provided by Georgia Department of Transportation).

Assessments from kayak/boat with binoculars to inspect areas over deep water, as well as ladders or construction equipment (cherry pickers, snooper truck, etc.; Figure 14) to access high areas of structures or areas over deep water may be necessary in certain situations.

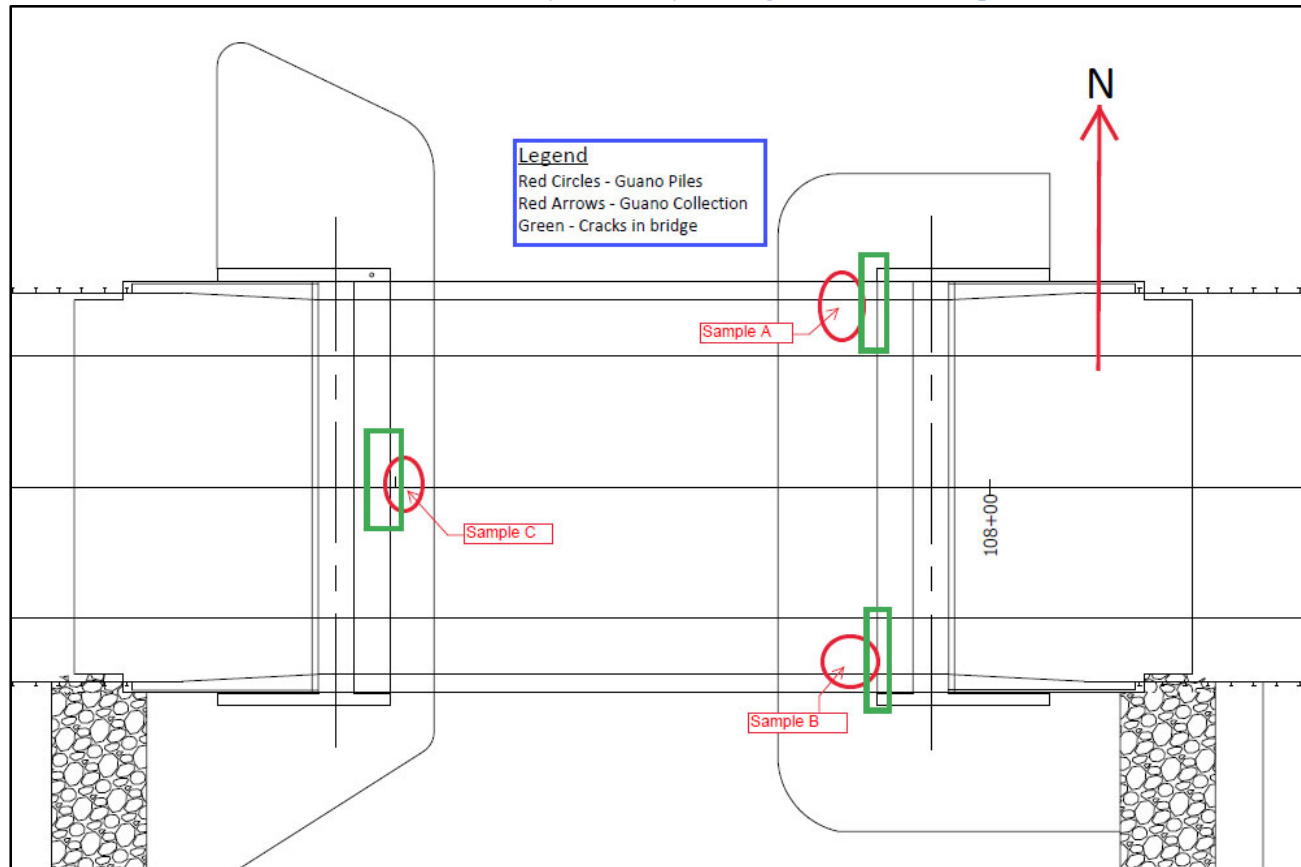
**Figure 15.** Example map for a guano collection plan, showing top-down view of a bridge, showing linear guano piles located along the abutment walls (underneath the structure’s expansion joints). Arrows indicate proposed sample collection locations (Photo provided by Indiana Department. of Transportation).
