# HAZARDOUS AND REGULATED MATERIALS INSPECTION REPORT

Gordon's Annex  
810 Massachusetts Street  
Parcel ID: 45-08-03-355-005  
Gary, 46402

Northwest Indiana Regional Development Authority  
9800 Connecticut Drive  
Crown Point, Indiana 46307  
Client Reference: Gary Blight Elimination Program

Egis  
48797 Alpha Drive, Suite 130  
Wixom, MI 48393  
Egis Project ID: 240100  
April 22, 2025

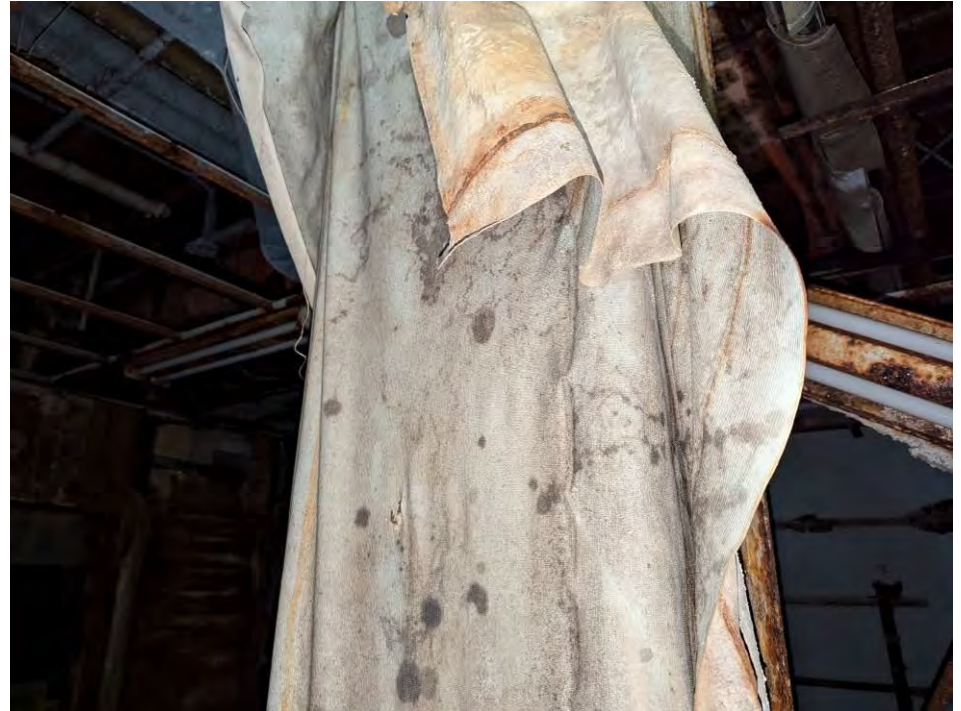
DATE: September 23, 2024  
LOCATION: 801-811 Broadway Street in Gary, Indiana  
SUBJECT: View of sampled column wrap (CW-1)  
PHOTOGRAPHER: Ryan M. Orzechowicz (Heartland)  
PHOTO: 20

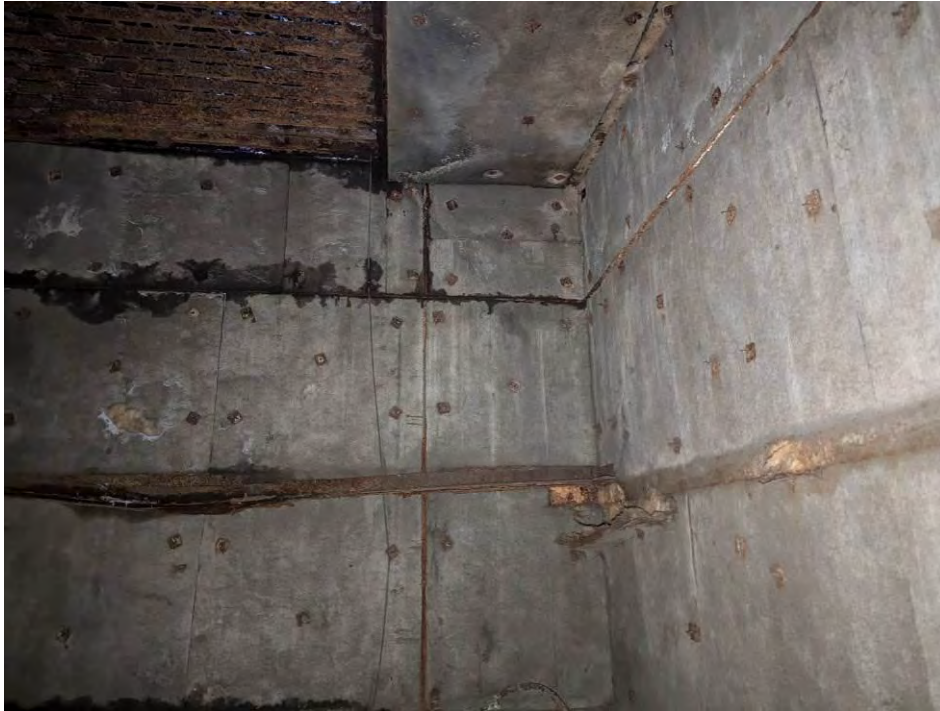
DATE: September 23, 2024  
LOCATION: 801-811 Broadway Street in Gary, Indiana  
SUBJECT: View of sampled insulation within air handling ducts (IN-1)  
PHOTOGRAPHER: Ryan M. Orzechowicz (Heartland)  
PHOTO: 21

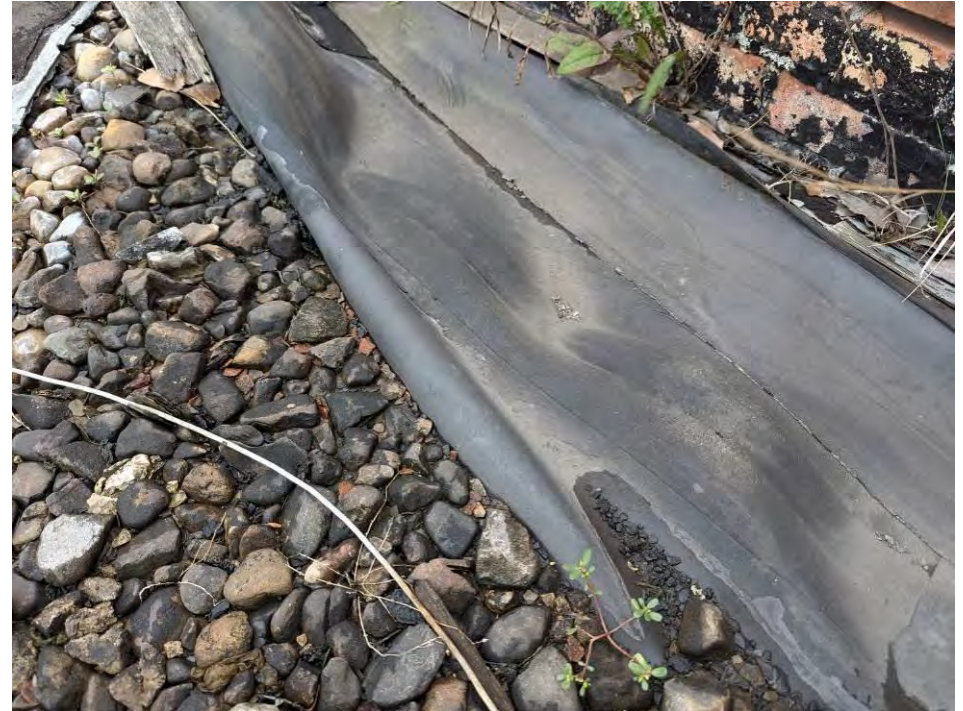
DATE: September 23, 2024  
LOCATION: 801-811 Broadway Street in Gary, Indiana  
SUBJECT: View of sampled rubberized roofing (RF-1)  
PHOTOGRAPHER: Ryan M. Orzechowicz (Heartland)  
PHOTO: 24

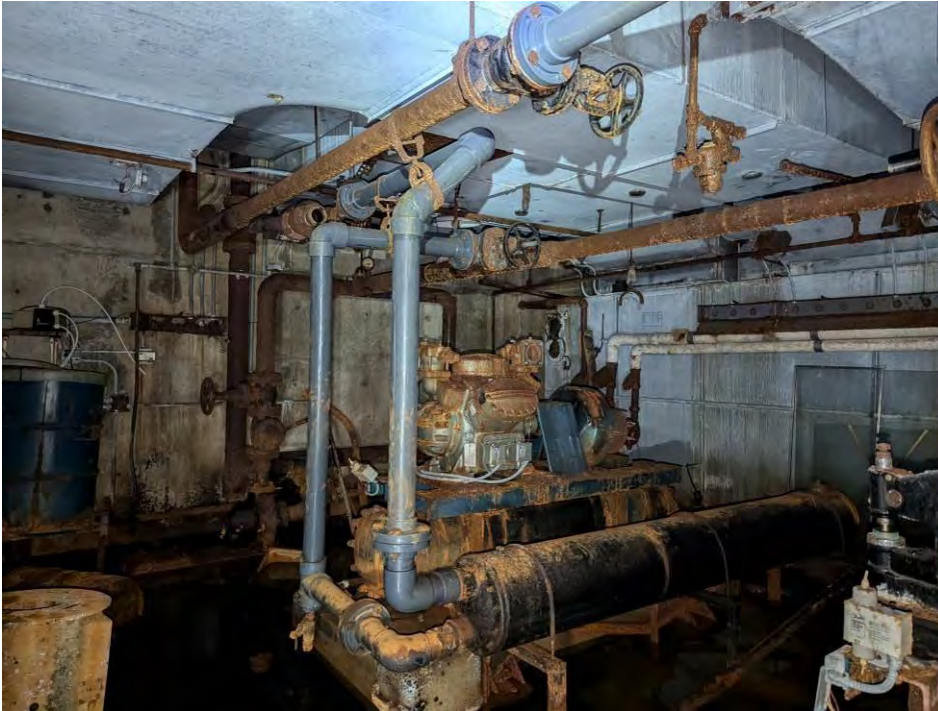
DATE: September 23, 2024  
LOCATION: 801-811 Broadway Street in Gary, Indiana  
SUBJECT: View of basement water pumping station  
PHOTOGRAPHER: Ryan M. Orzechowicz (Heartland)  
PHOTO: 39

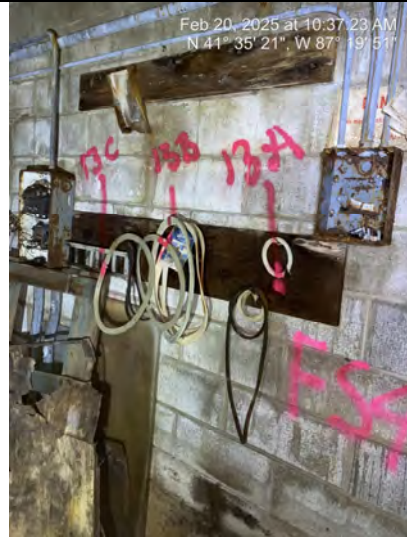
Sample # 13 Gasket Material - Pipe Flange gaskets, white, in storage

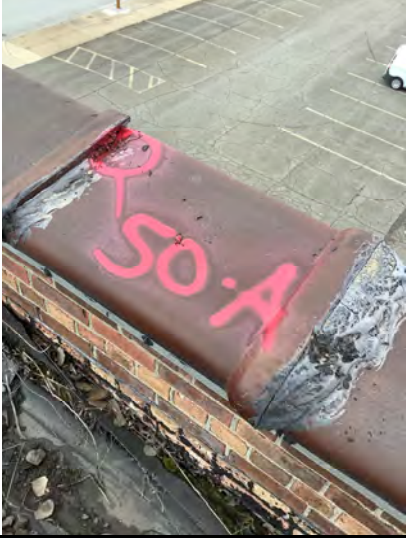
<p>Sample # 50</p>	<p>Roofing Material - Flashing- Used on ceramic caps</p>

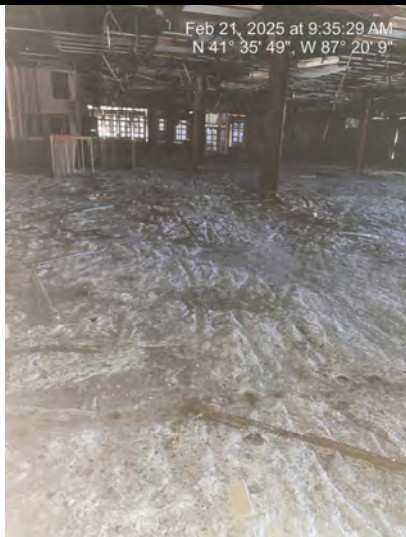
<p>Assumed Material # A-2</p>	<p>Ceiling Panel - Debris w/ACM pipe insulation and ACM floor tile mixed in</p>

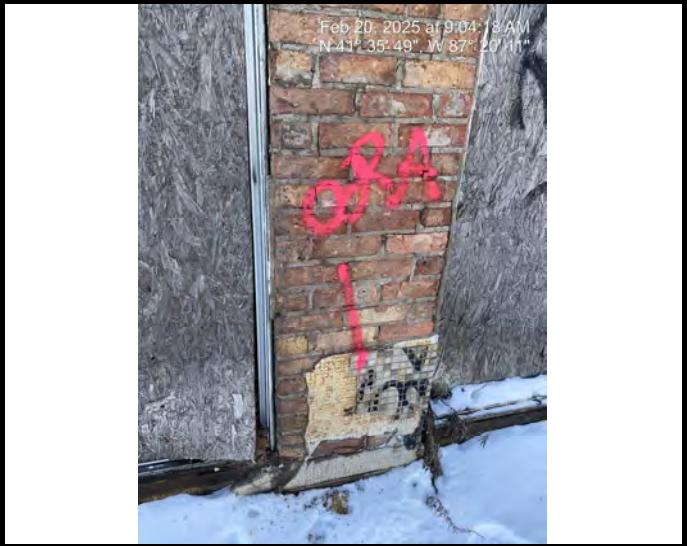
Sample # 8      Ceramic Tile - w/ Grout & Mortar, gray/white/yellow

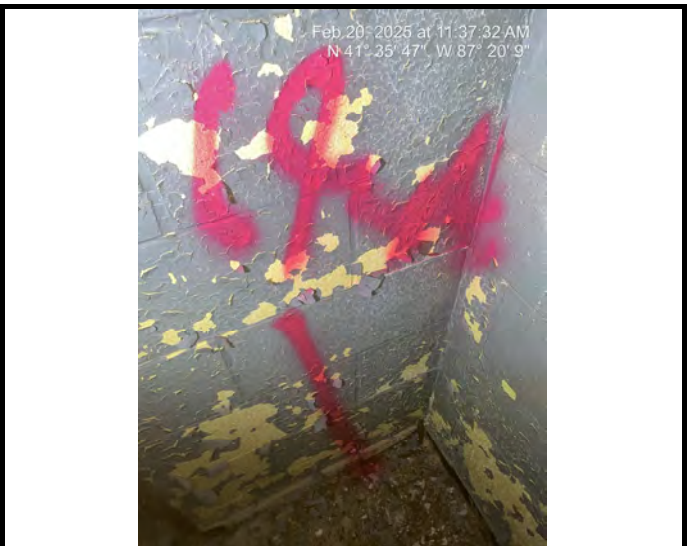
Sample # 14      Cove Base - with Adhesive, Black

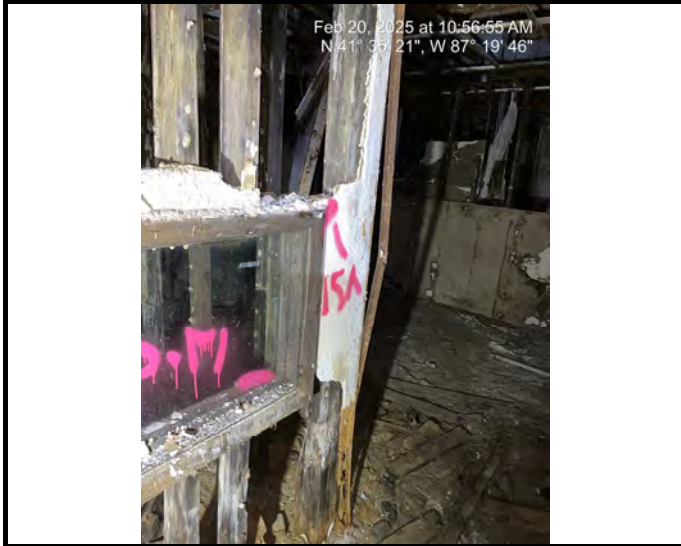
Sample # 15 Plaster - Skim & Base Coat Walls on Wall Board

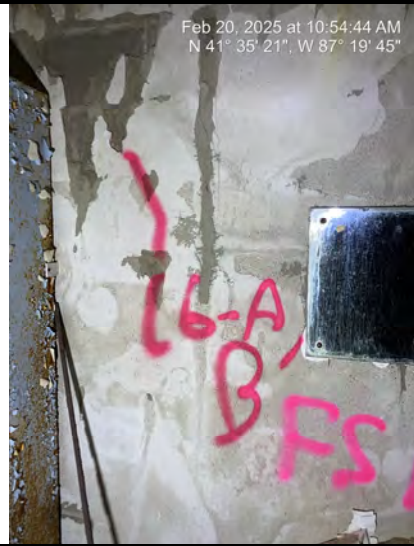
Sample # 16 Plaster - Base Coat Walls on Brick/Block

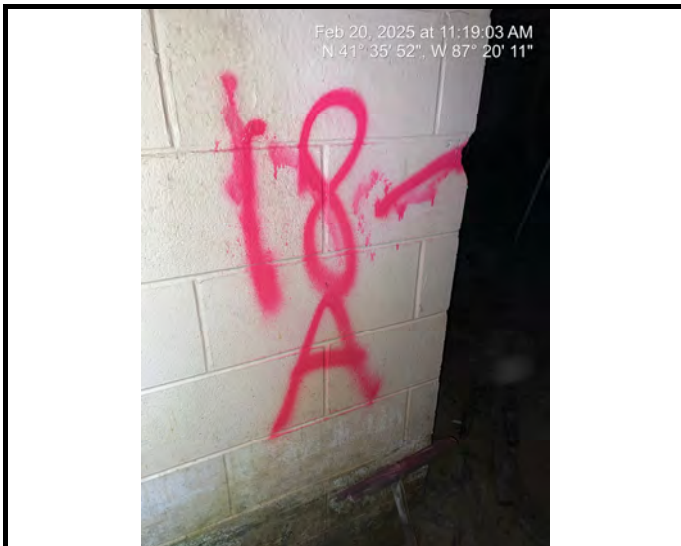
Sample # 18 Block Mortar - Interior Wall Block with Mortar

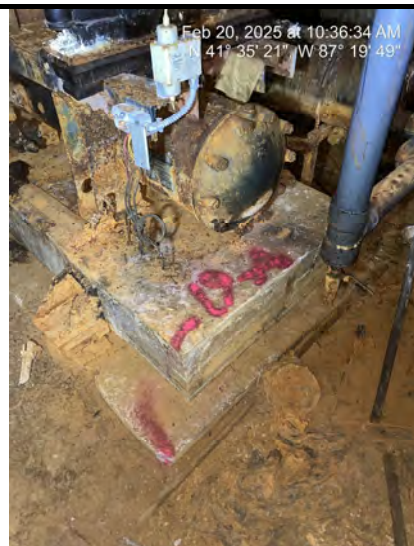
Sample # 19 Concrete - Slabs in pump room

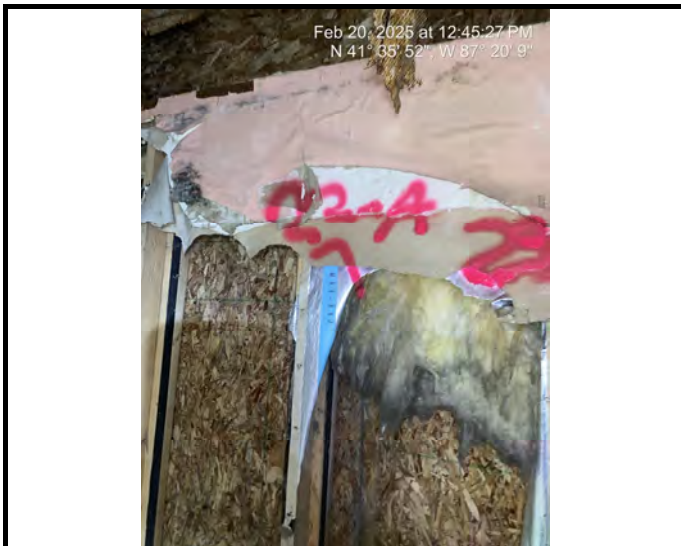
Sample # 22 Rolled In Insulation - Yellow with Foil

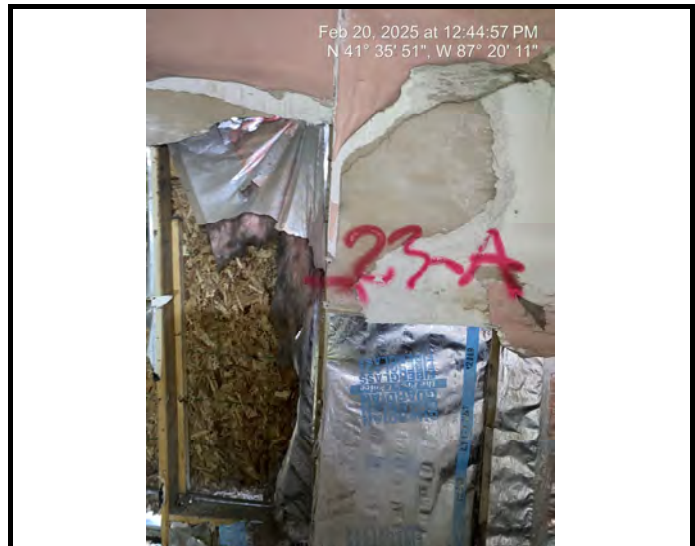
Sample # 23 Rolled In Insulation - Pink with Paper

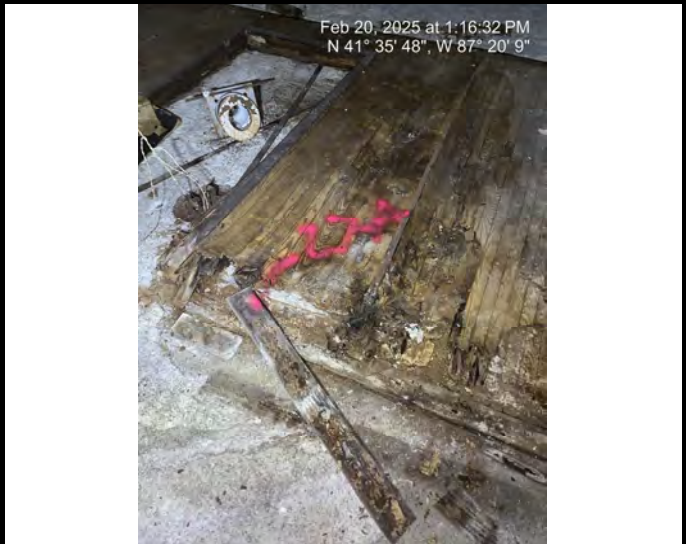
Sample # 27 Cove Base - with Adhesive, gray/beige

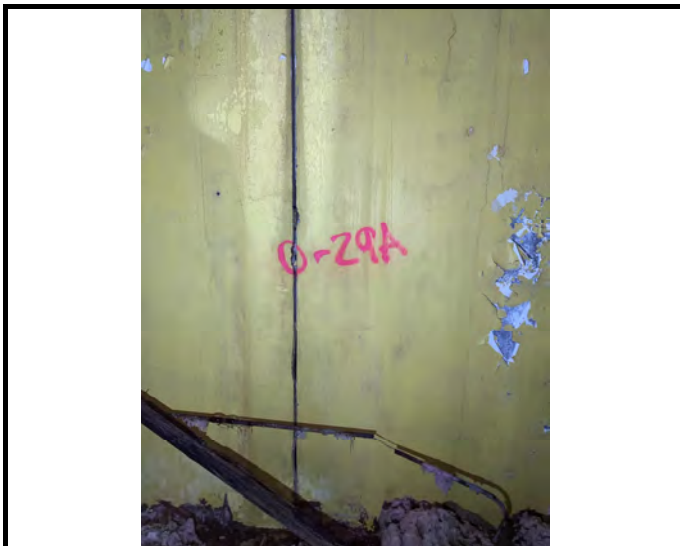
Sample # 29 Concrete - Slabs, vertical on walls

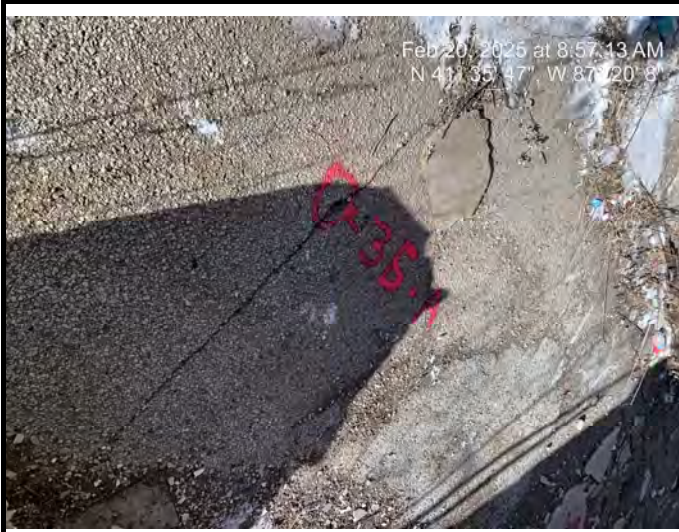
Sample  
# 35

Asphalt Paving - Driveway

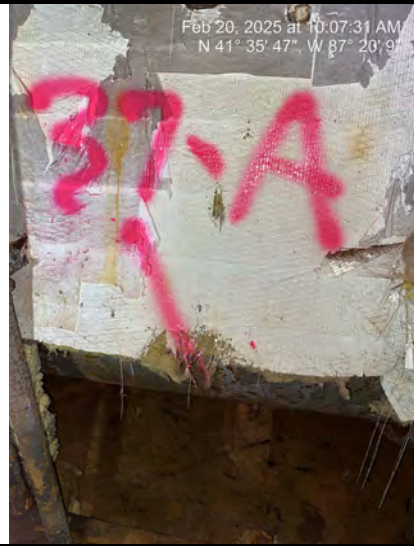
Sample  
# 37

Boiler Insulation, exterior - Fiberglass with  
Foil

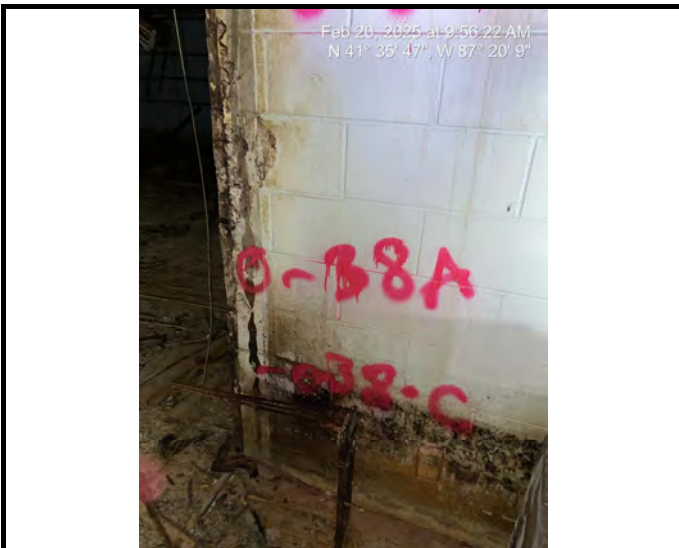
Sample  
# 38

Construction Adhesive - Gray on cinder block

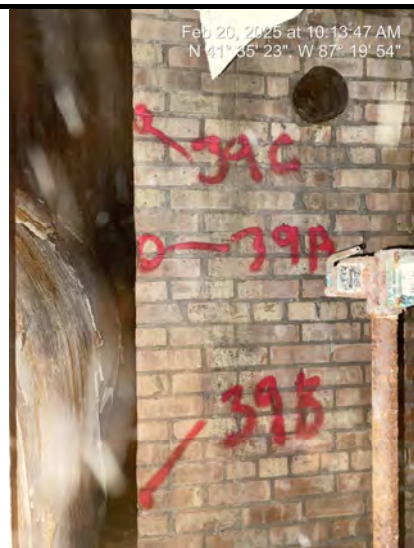
Sample  
# 39

Brick Mortar - Boiler chimney

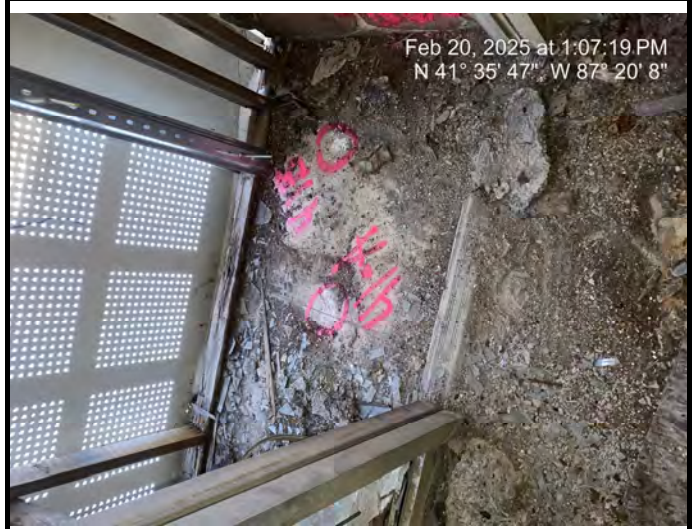
Sample # 41      Flooring - Terrazzo, cream colored, at east vestibule

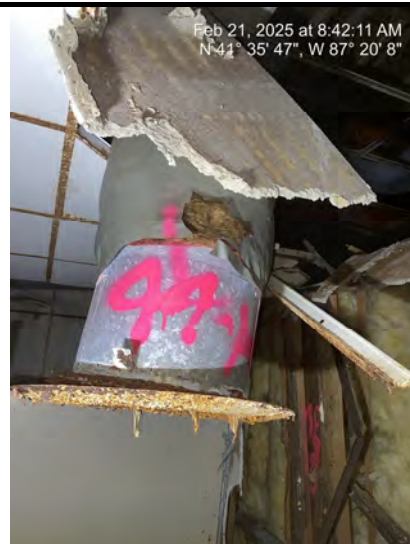
Sample # 44      Insulator - Fiberglass sound proofing
